# PROPERTY INSPECTION REPORT FORM

| Laverne Pivonka<br>Name of Client | 02/08/2024<br>Date of Inspection | |
|---|---|--|
| 3025 Rosefield Drive , Houston, TX 77080<br>Address of Inspected Property | | |

PROPERTY INSPECTED: 3025 Rosefield Drive Houston, TX 77080 DATE OF INSPECTION: 02/08/2024 Inspection No. 52965-1-929

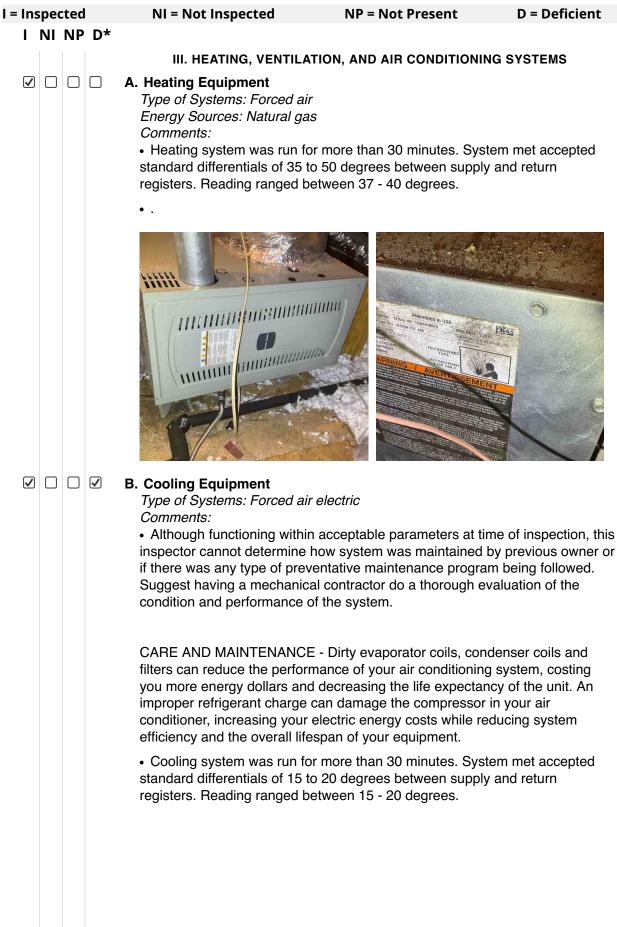
- NP = Not Present D = Deficient I = Inspected NI = Not Inspected
  - I NI NP D\*
- 2015 R-410A max breaker 40 amps.

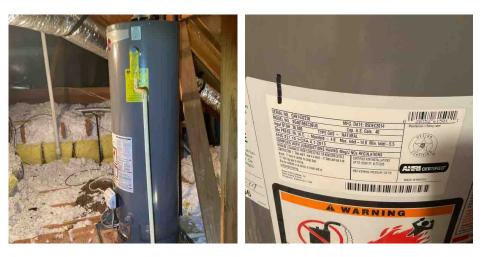
I
   NI NP D\*
   Image: C. Water Heating Equipment
   Image: C. Water Heating Equipment
  - Energy Sources: Natural gas Capacity: 40 gallon Comments: • 2014.

Temperature and Pressure Relief Valve functioned properly when tested.
