Property Inspection Report

3806 Country Rd, Pasadena, TX, 77505

Inspection Date: 2/28/2024

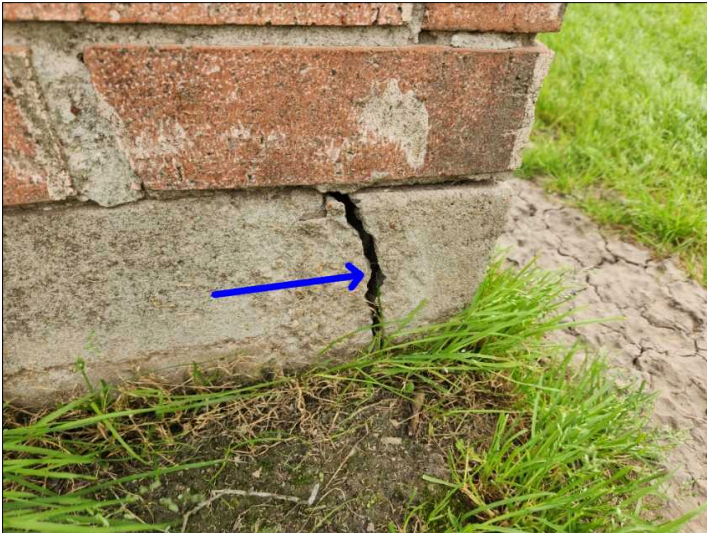
Corner pops were noted on one or more corners of the foundation. These are usually considered cosmetic in nature unless other movement is noted. Recommend sealing all cracks to help prevent further deterioration.

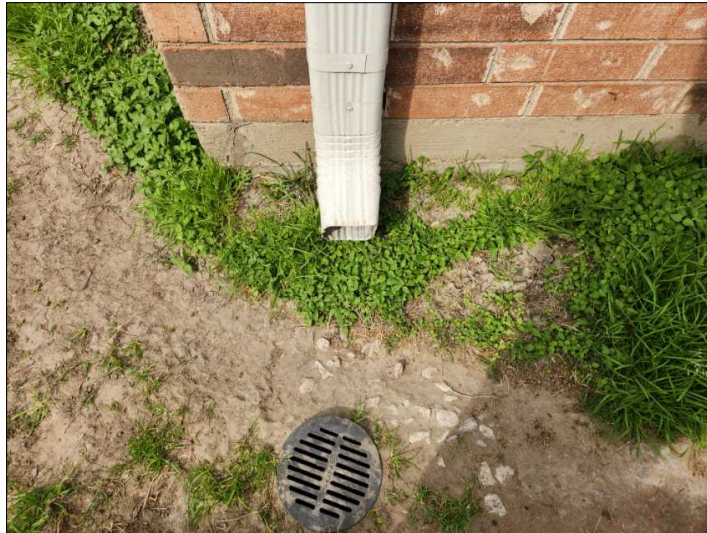
Splash blocks or downspout extensions should be installed to direct water away from foundation.

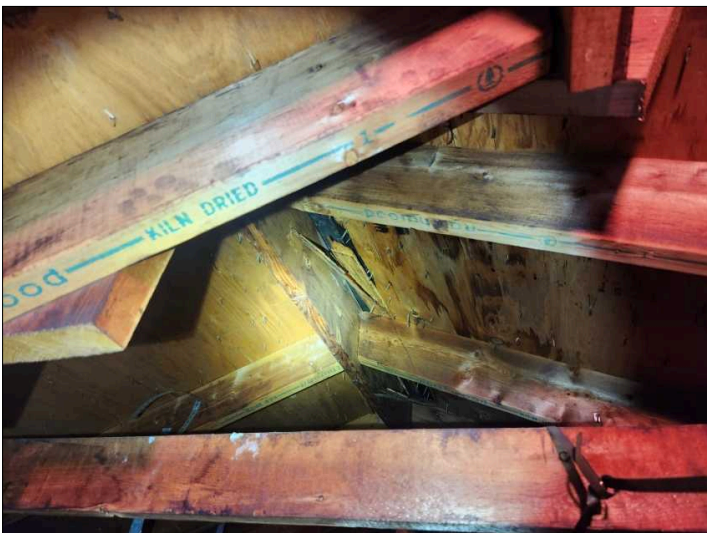
The roof decking was deteriorated, recommend all deteriorated decking be replaced to help prevent further damage and water penetration into home. Mainly at -

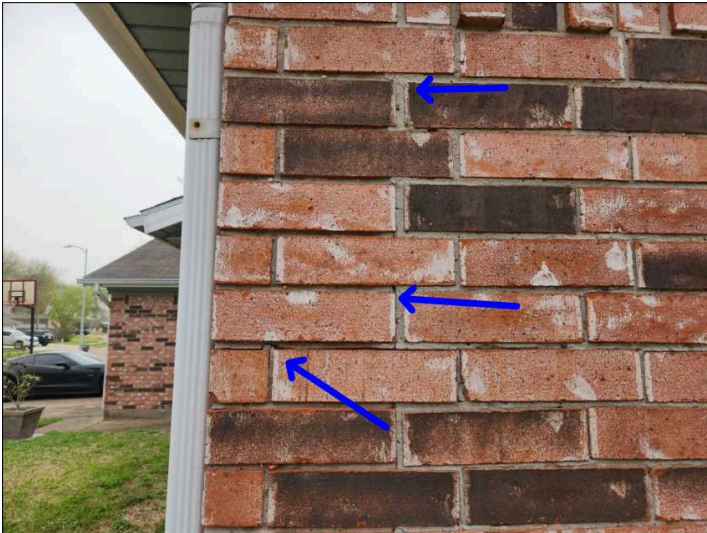
Settlement cracks were noted in the brickwork.
Mainly at - right

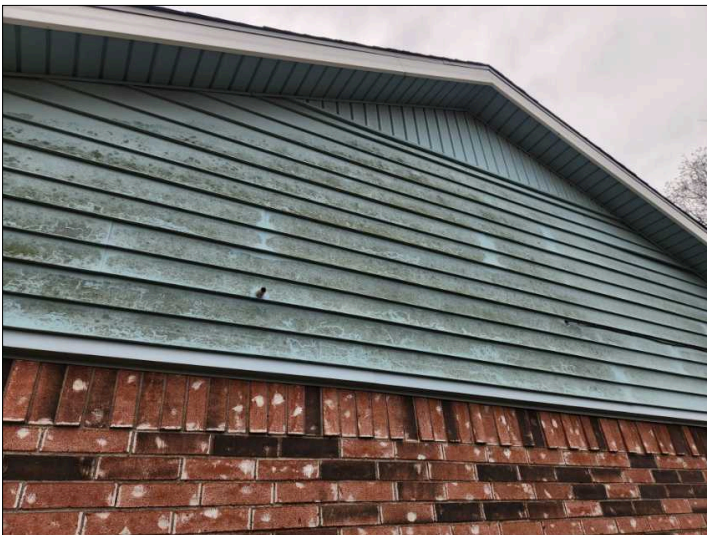
There are signs of growth on exterior brickwork/siding, recommend cleaning to help prevent deterioration.

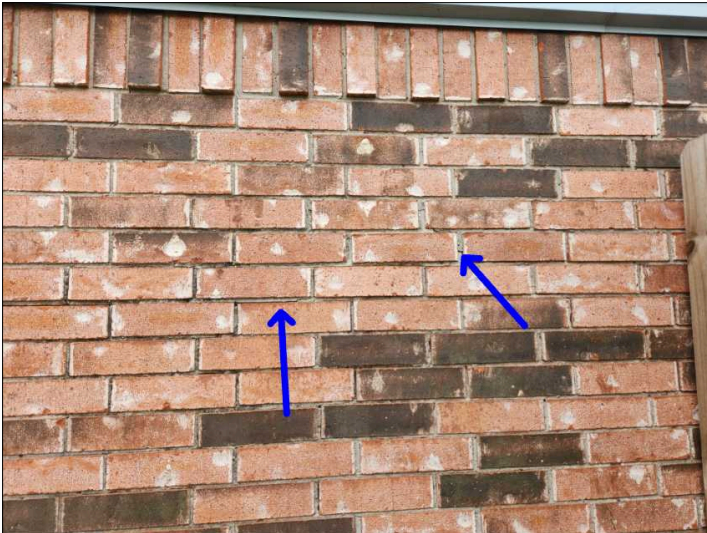
Settlement cracks were noted in the brickwork. Mainly at - right

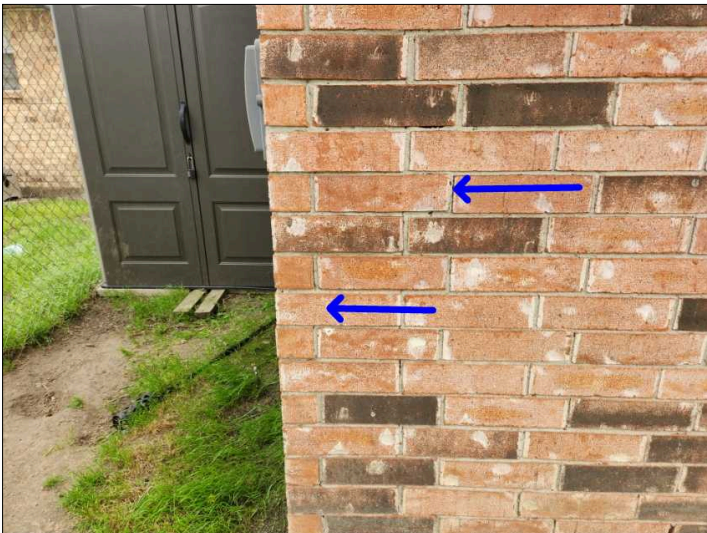
Settlement cracks were noted in the brickwork. Mainly at - rear

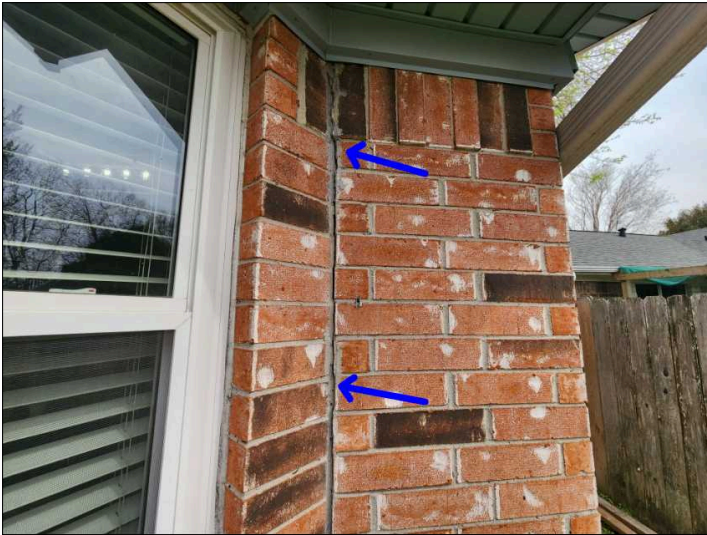
There is a separation at the brickwork which is an indication of settlement or foundation movement. This may require further attention if other movement is noted. Mainly at - rear

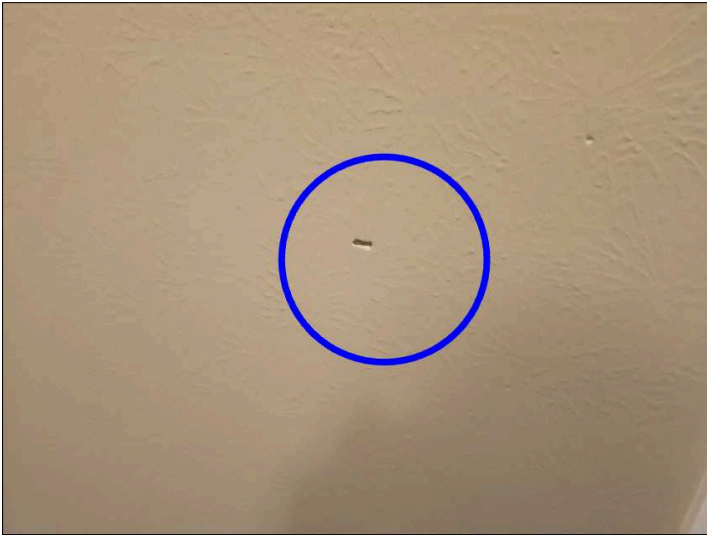
There is damage to the drywall, recommend repairs as needed. Mainly at - front entryway

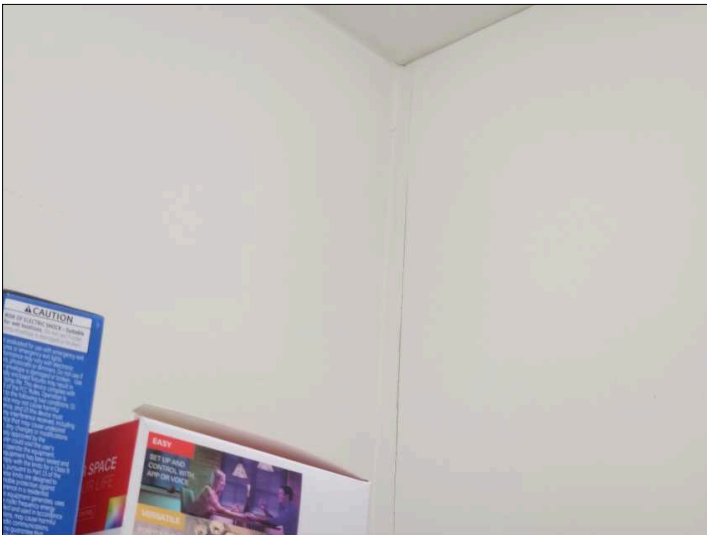
Settlement cracks were noted at the corner bead/tape joint in the drywall. Mainly at - pantry

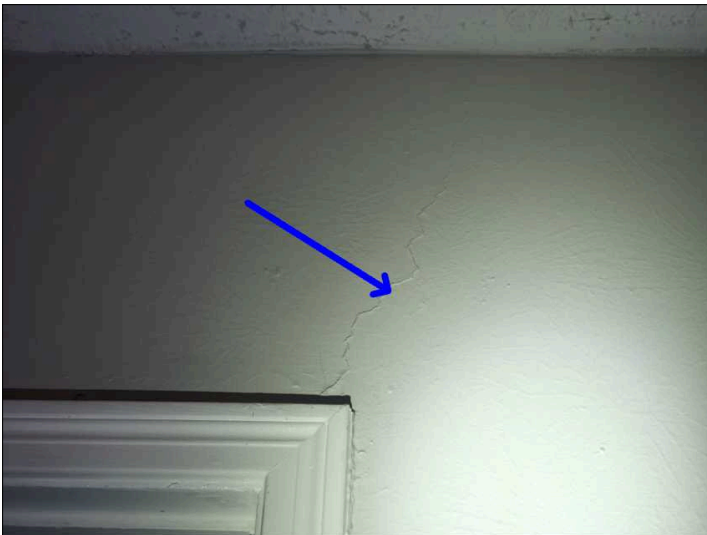
Settlement cracks were noted in the drywall.
Mainly at - primary bedroom

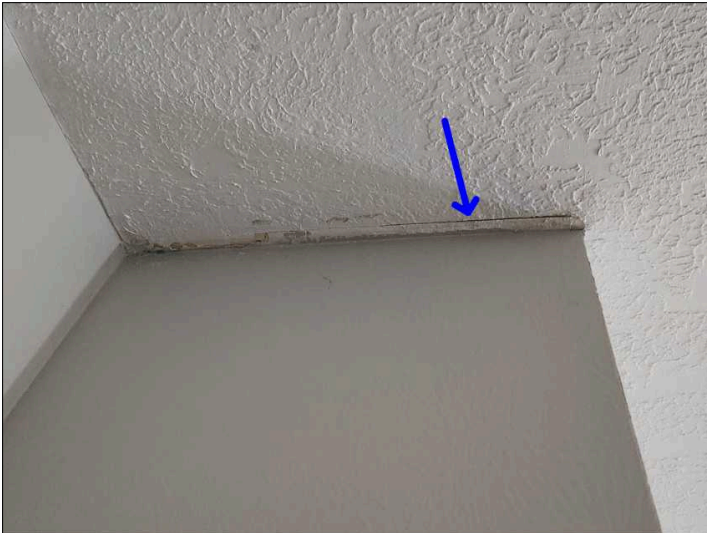
Settlement cracks were noted at the corner bead/tape joint in the drywall. Mainly at - living room

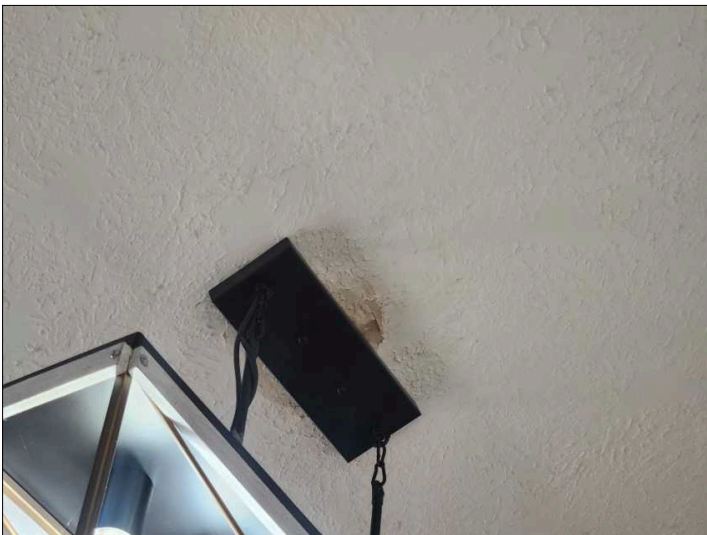
There is damage to the drywall, recommend repairs as needed. Mainly at - dining room

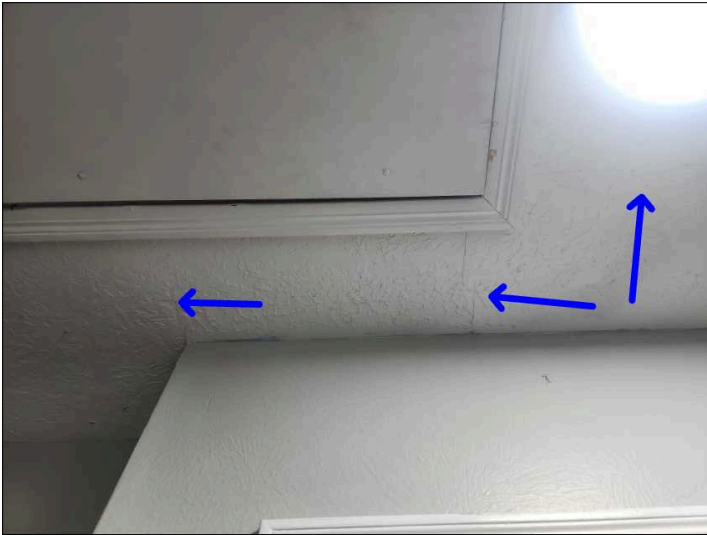
Settlement cracks were noted in the drywall. These are generally considered cosmetic only, unless otherwise noted. Mainly at - hallway

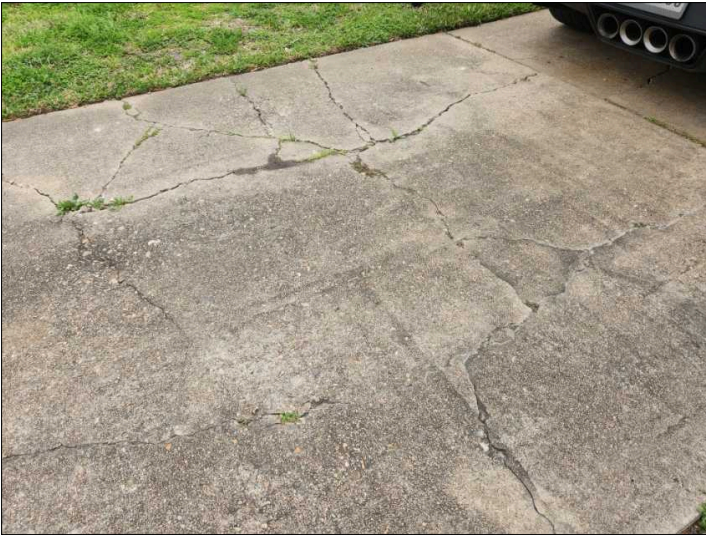
Cracks were noted in the pavement. The pavement is unlevel and can be a tripping hazard if not corrected, recommend repairs. Mainly at - driveway

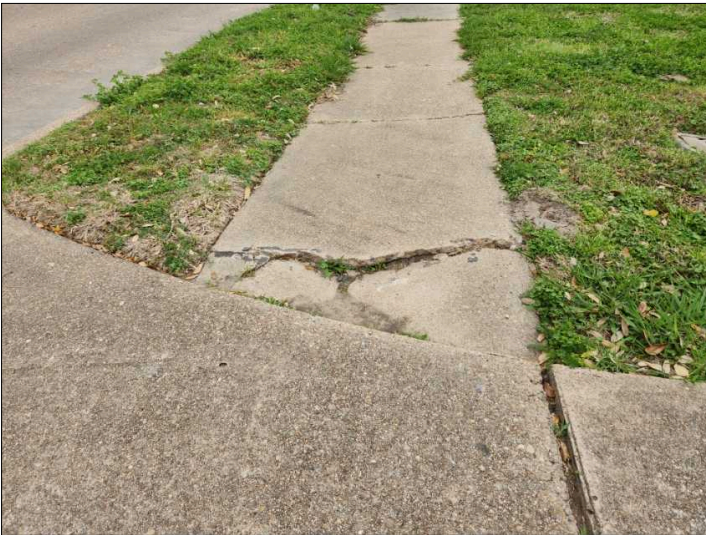
Cracks were noted in the pavement. The pavement is unlevel and can be a tripping hazard if not corrected, recommend repairs. Mainly at - sidewalk

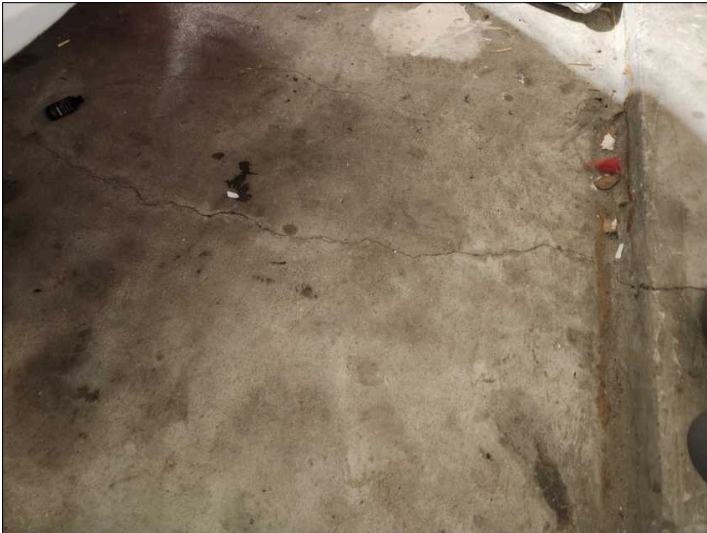
Cracks were noted in the pavement. These are cosmetic in nature at this time. Recommend sealing to help prevent further deterioration.
Mainly at - garage

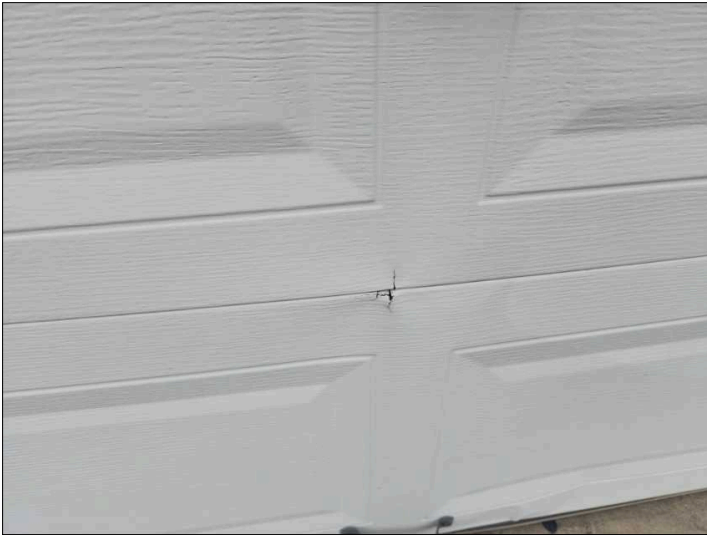
Garage door is cracked or split.

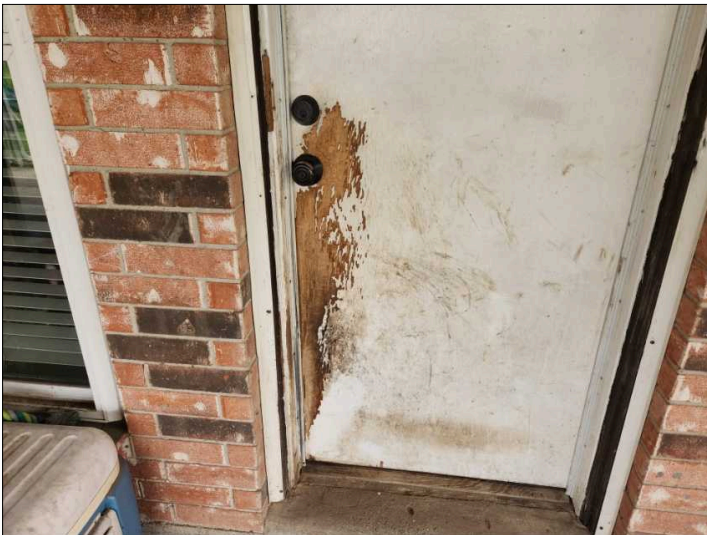
There is pet damage on the door. Mainly at - back door

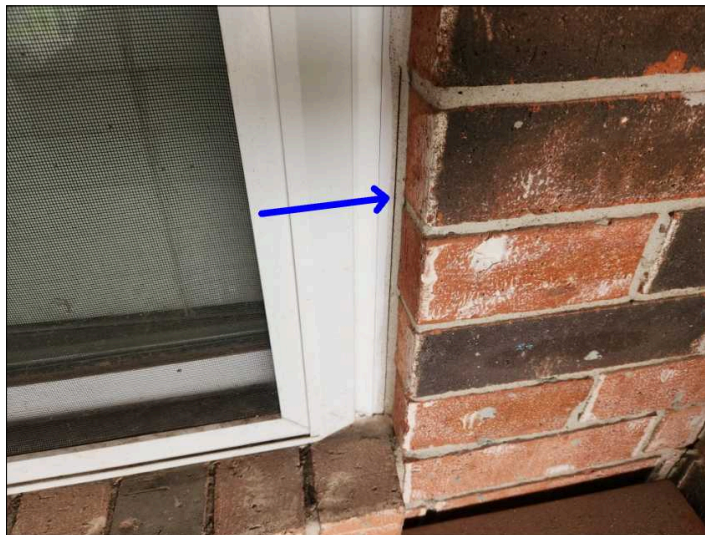
J.1. Sealant is needed around various windows between the window framing and exterior brickwork or trim to help prevent water penetration, recommend checking all windows for proper sealant.

Sealant is needed around various windows between the window framing and exterior brickwork or trim to help prevent water penetration, recommend checking all windows for proper sealant.

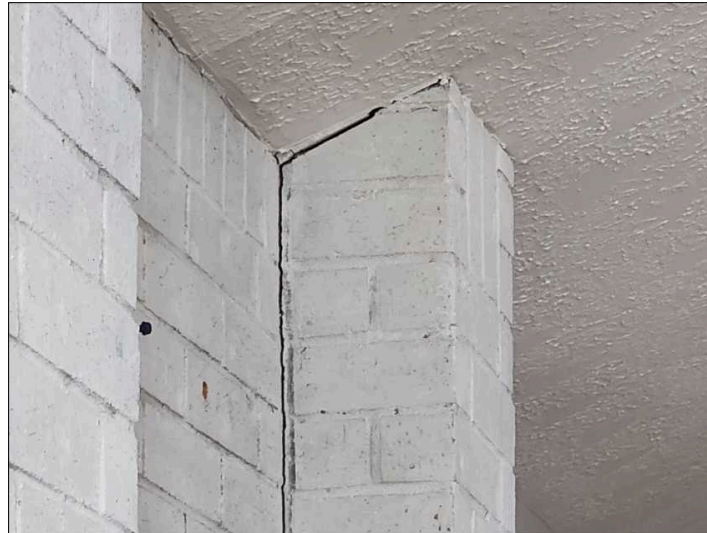
L.2. There are cracks present in the materials surrounding the fireplace firebox. Recommend repairs to seal the finished materials to prevent further deterioration.

There are cracks present in the materials surrounding the fireplace firebox. Recommend repairs to seal the finished materials to prevent further deterioration.

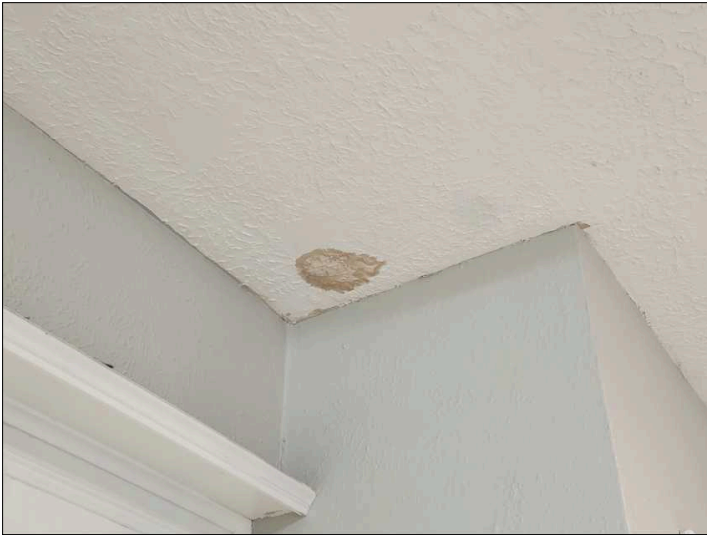
There are indications of water penetration to the ceiling evident mainly by staining. Unable to determine condition of the underlying materials.
Mainly at - kitchen

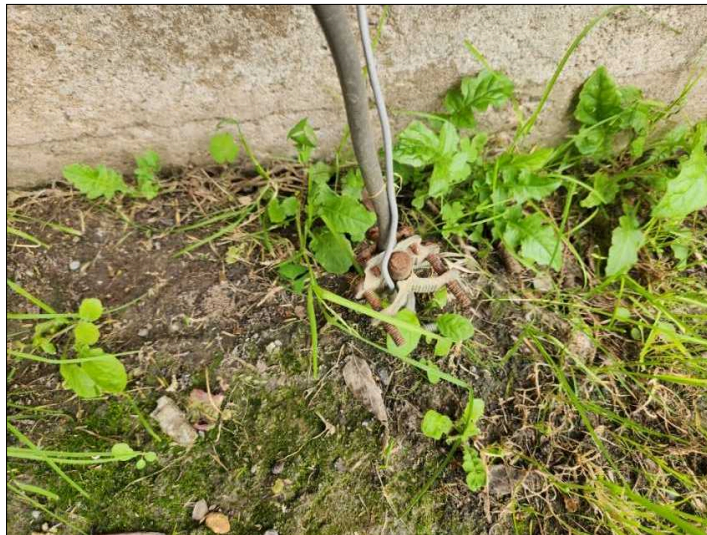
There is an improper ground rod clamp, it is recommended that ground wires be secured with the proper acorn style clamp for proper protection.

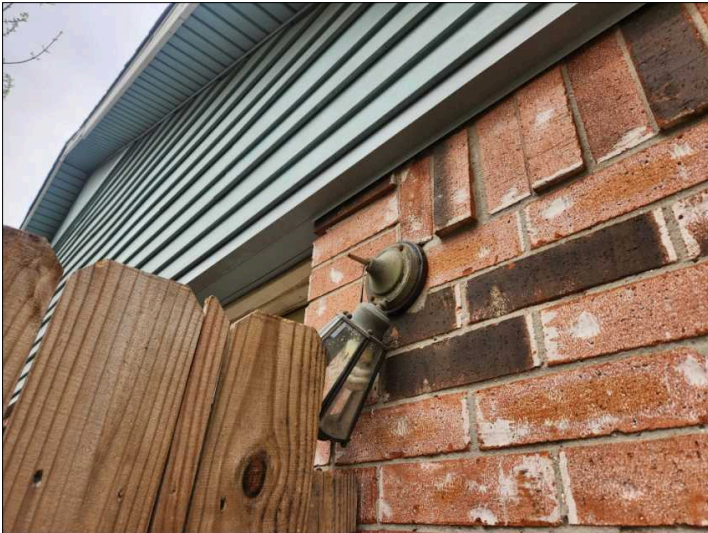
The light fixture is hanging by its wires. Mainly at - left

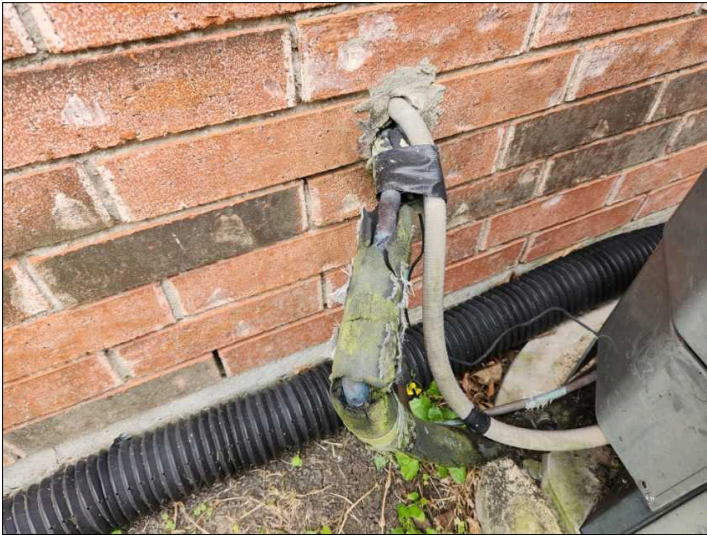
B.2. The insulation is missing or damaged on the A/C suction line at the condensing unit. Recommend repair or replacement to prevent cooling loss from exterior temperatures.

The insulation is missing or damaged on the A/C suction line at the condensing unit. Recommend repair or replacement to prevent cooling loss from exterior temperatures.

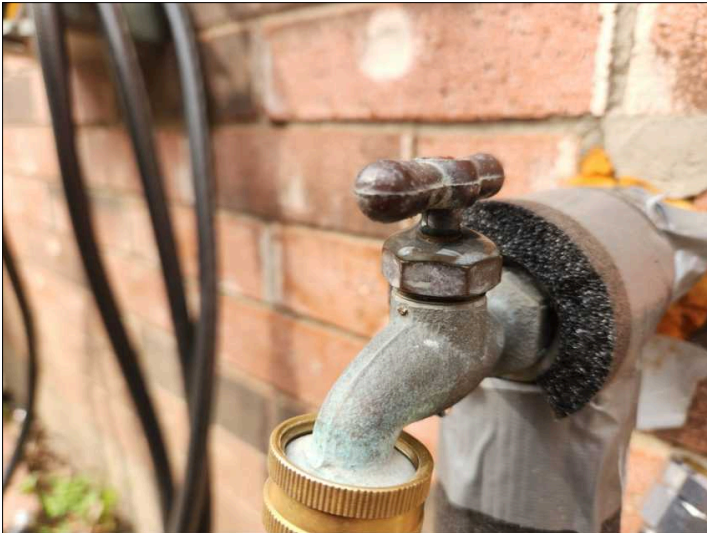
A.3. There is a leak at the valve stem on the exterior water faucet, recommend tightening packing nut, adding packing cord or replacing packing if needed.
Mainly at - left

There is a leak at the valve stem on the exterior water faucet, recommend tightening packing nut, adding packing cord or replacing packing if needed. Mainly at - left

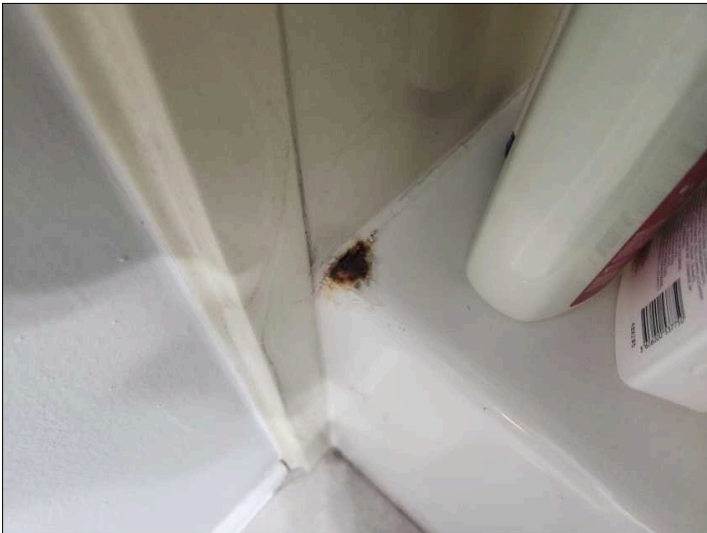
A.10. Rust has been noted in the tub, recommend repairs to help prevent deterioration. Mainly at - primary bath

Rust has been noted in the tub, recommend repairs to help prevent deterioration. Mainly at - primary bath

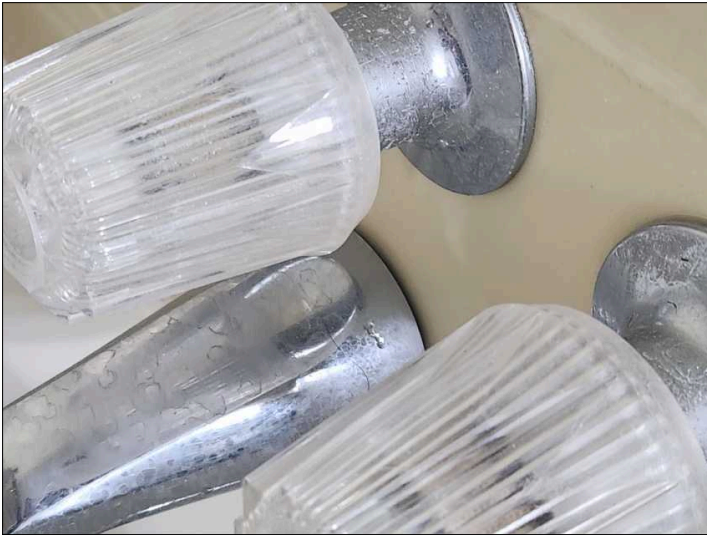
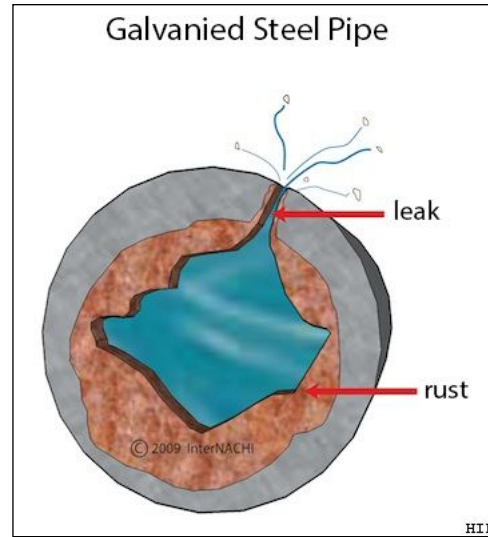
All tub shower faucets and spouts should be sealed to help prevent water penetration behind the fixture.

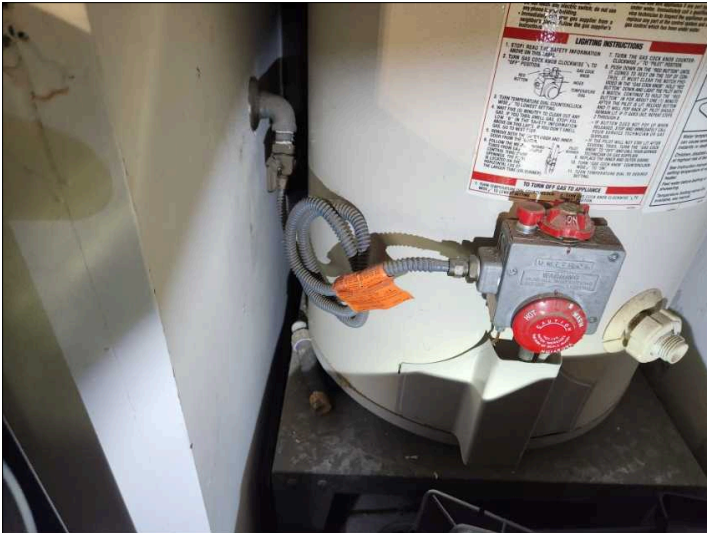
No drip leg or sediment trap for gas line on water heater. This helps prevent trash from clogging jets.

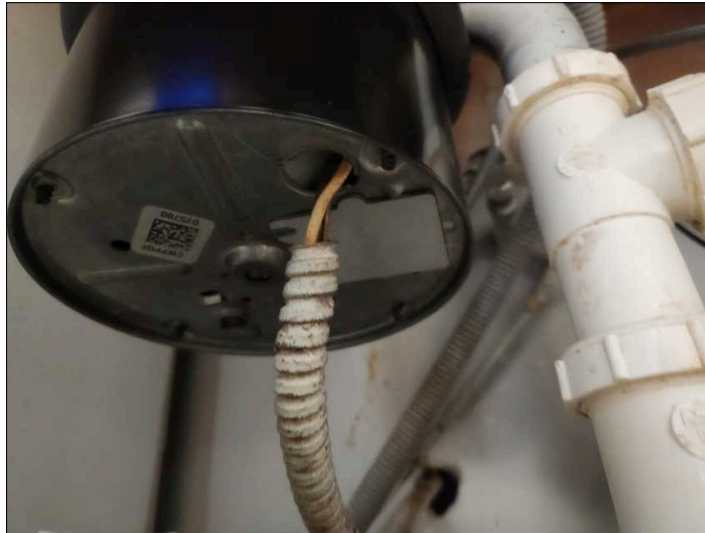
B.1. Improper electrical connection at disposal, recommend adding wire clamp at disposal connection.

Improper electrical connection at disposal, recommend adding wire clamp at disposal connection.
