# Harry H. Jones Inspection Service

## PROPERTY INSPECTION REPORT

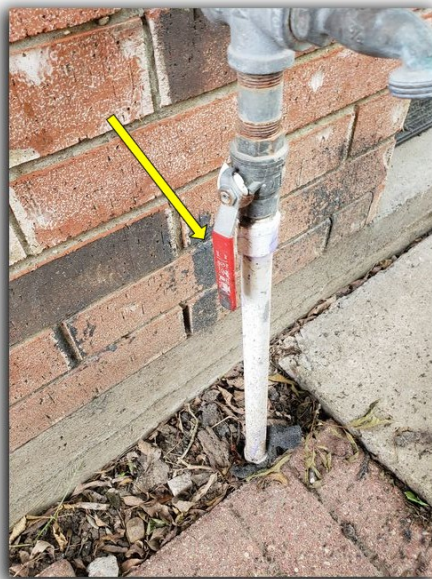
*Location of main water supply valve: Exterior left side*

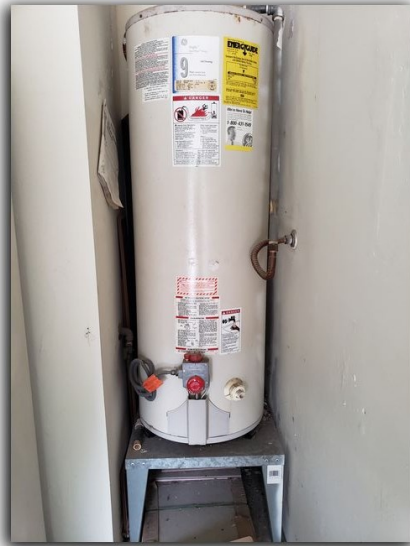
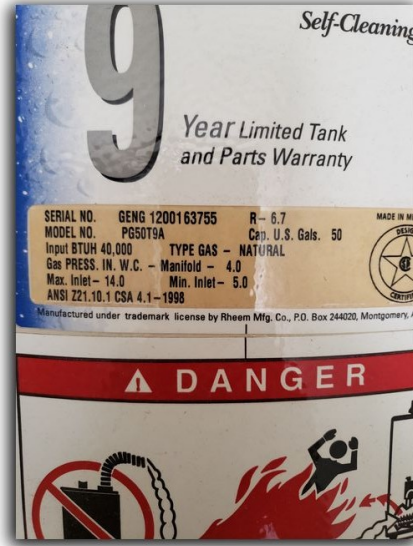
The water heater was installed on a stand in the garage.

The flexible appliance gas connector (CSST) was not properly bonded.
