Inspection Report

Property Address:
23146 Tranquil Springs Ln
Katy Texas 77494

PROPERTY INSPECTION REPORT FORM

12/8/2023

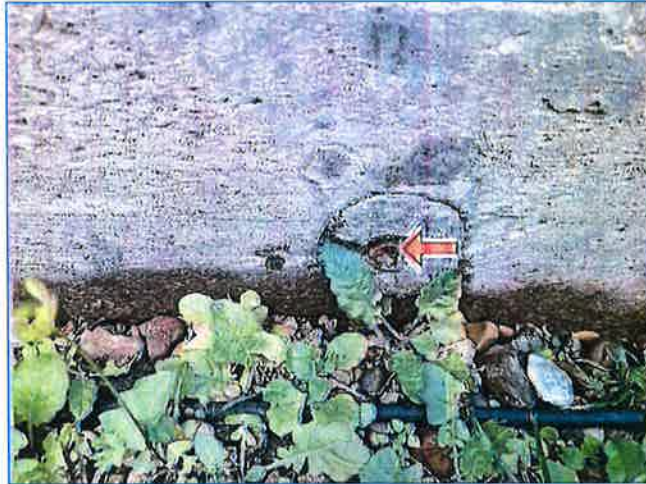
A. Item 3(Picture)

(1) Post tension cable ends are exposed to the elements at the right side and rear of structure. Recommend filling the exposed areas with a mastic compound to prevent the further deterioration of the cable. Exposed cables can rust, thus expand, damaging the surrounding foundation. This is a small repair.

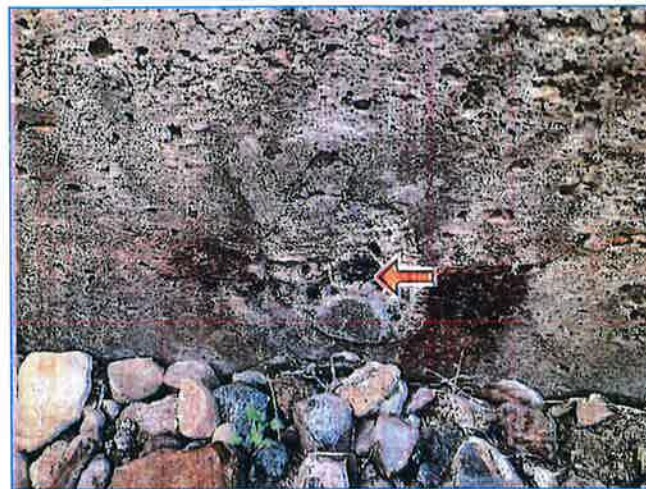
A. Item 4(Picture)

(2) There are typical corner cracks in the concrete slab occurring at the front, rear and sides of structure. Many homes have hairline or settlement cracks which have no effect on the function of the slab. These areas should be properly prepped and sealed with a concrete patching material. It is recommended that you monitor periodically.

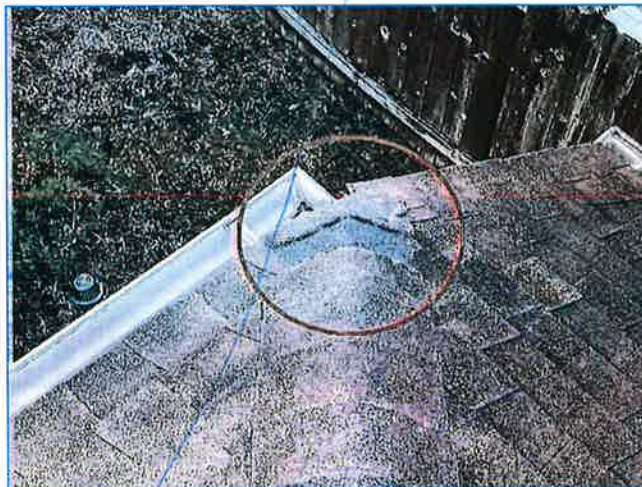
C. Item 6(Picture)

- 🏠 (4) The roof covering has exposed nail heads at multiple locations . Exposed nail heads can let water seep into the roof structure leading to further issues. A qualified person should seal as needed. This is a small repair and will be periodical maintenance item.

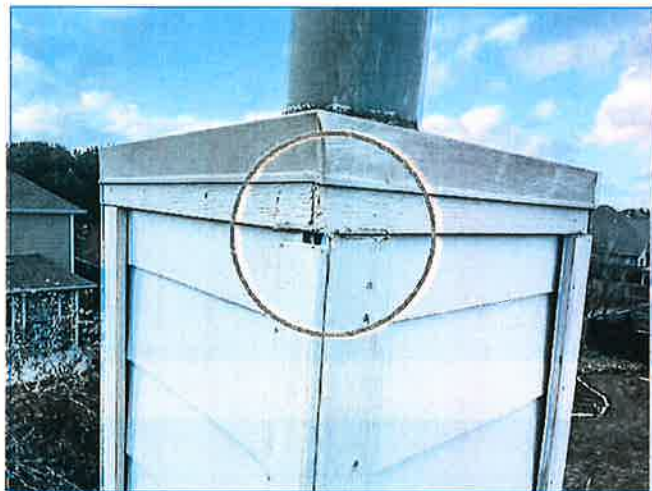
J. Item 4(Picture)

(3) Fireplace and chimney were inspected and were found to be functional and within requirements.

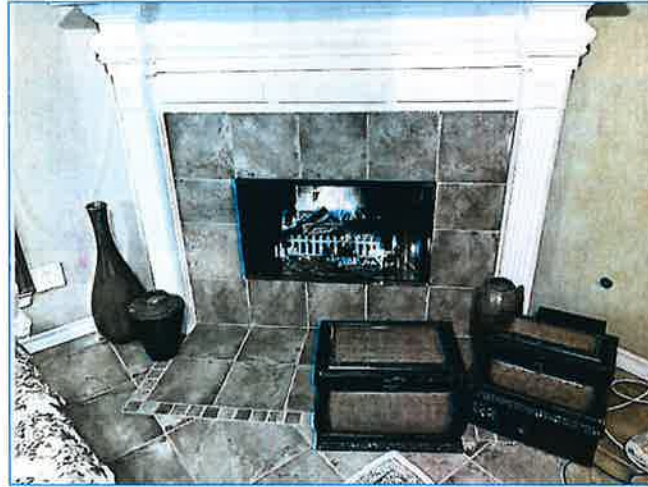
J. Item 5(Picture)

Note: While it is not a requirement, this fireplace's damper is not equipped with a "C" clamp type stop device. Failure to open the damper during operation will result in CO being released into the living area.

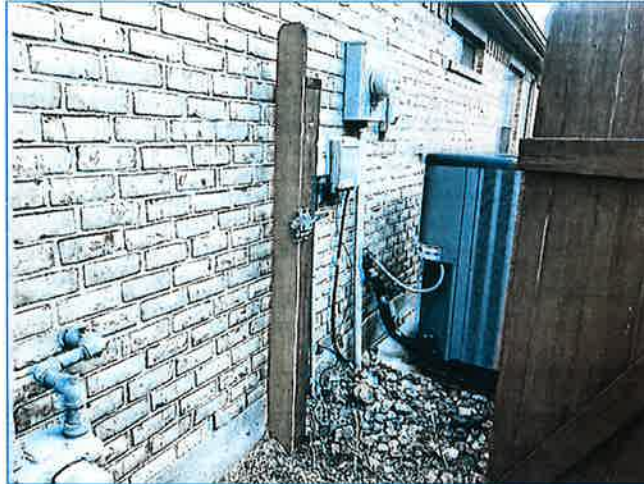
A. Item 1(Picture)

- 1. Ground wire is loose at ground rod.**
- 2. All breakers are not properly labeled, or are difficult to read. Each electric panel breaker should be adequately labeled as to what appliance or circuit it serves.**

These and any other deficiencies noted by a qualified electrical contractor should be corrected.

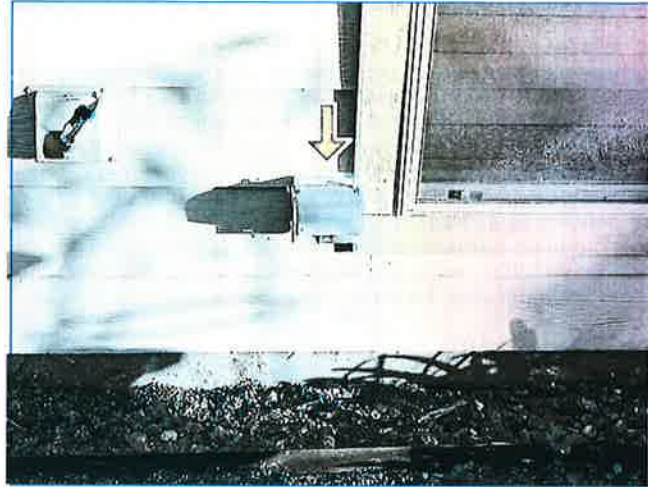
B. Item 1(Picture)

(2) Electrical receptacle at rear of structure has no power at time of inspection. Recommend further evaluation and repair by a licensed electrician.

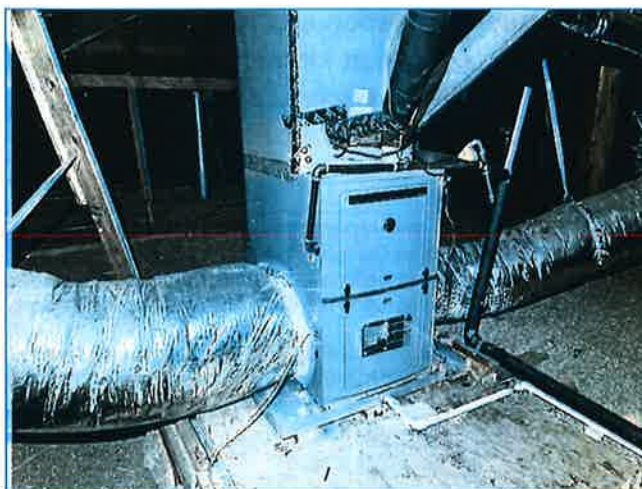
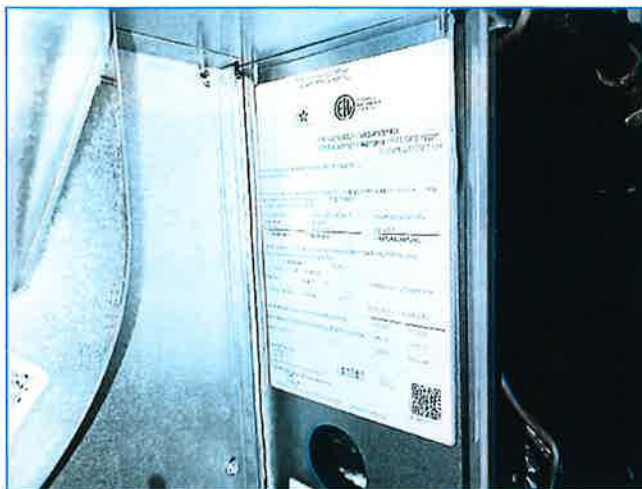
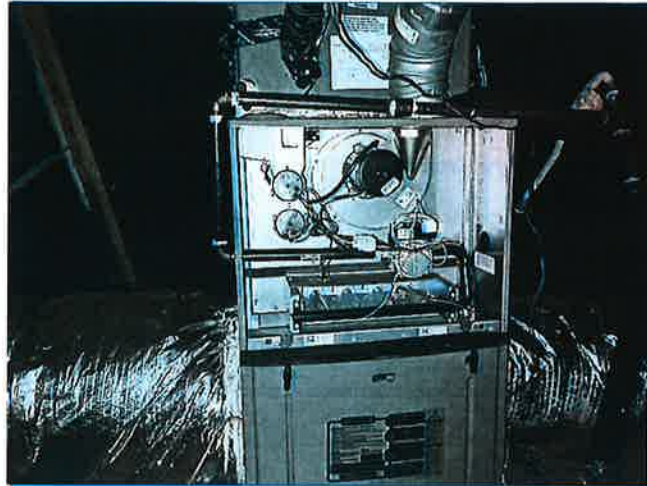
Turned up thermostat and the unit fired as expected.

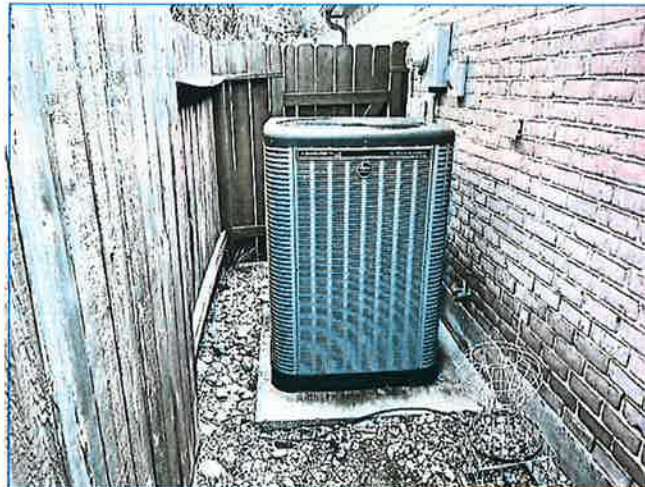
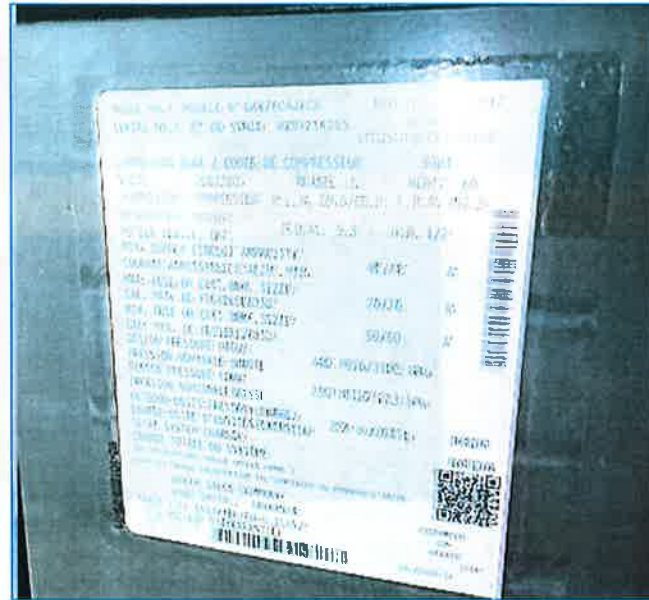
Temperature variance calculations were not taken due to the fact that this method is **highly inaccurate** during colder months. The system was activated from the thermostat and over time the actual indoor temperature was lowered. The temperature of the refrigerant piping was observed to be in the normal range of operation. Based upon the information gathered, it has been determined that the system is functioning as intended at the time of inspection.

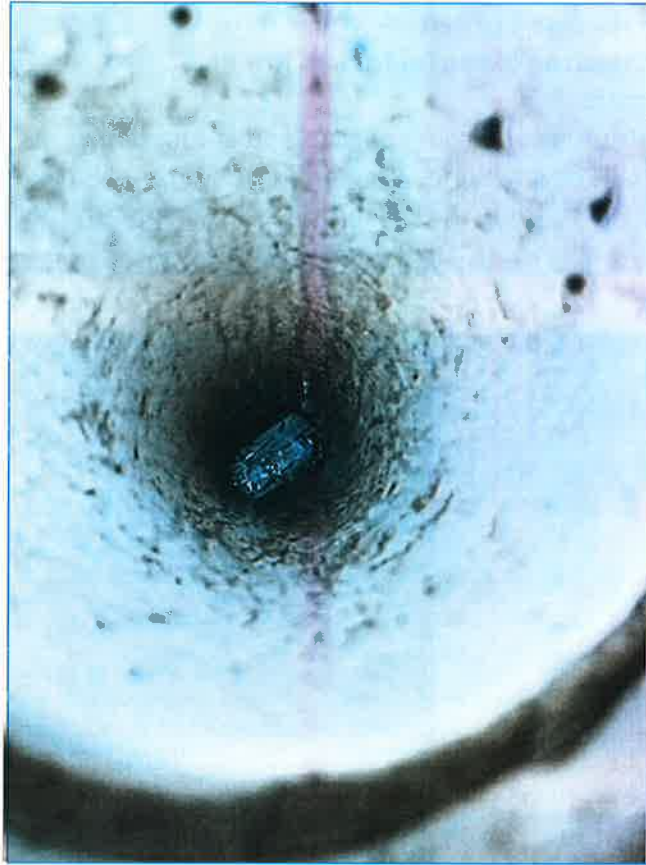
B. Item 1(Picture)

(1) There is standing water visible at sewer clean out. This is likely due to poor negative slope away from structure. This can cause long-term back up issues. Recommend further evaluation and repair by a qualified plumber.

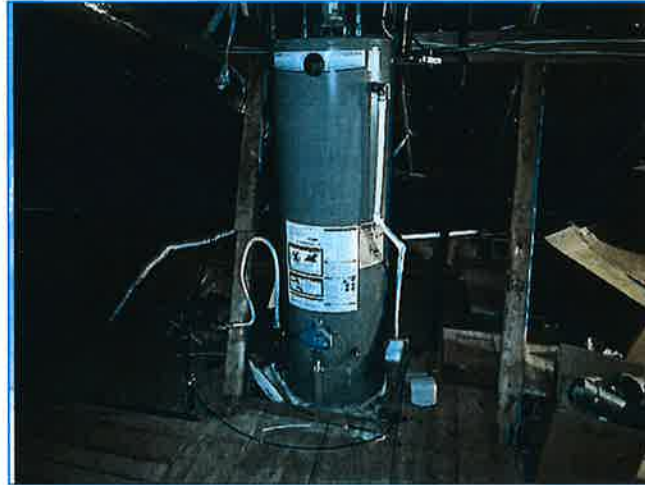
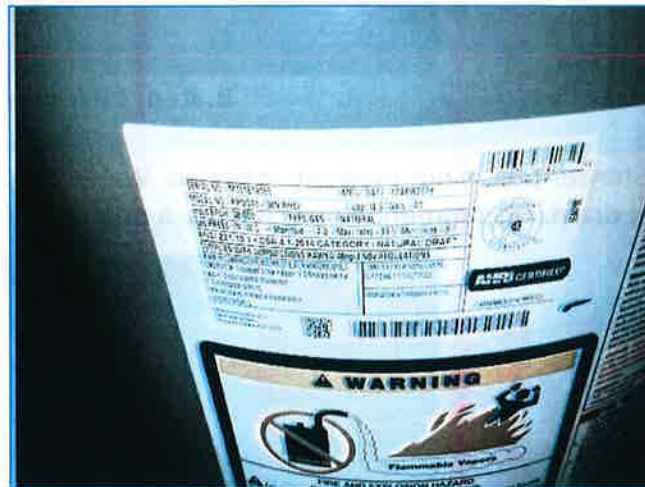
The water heater was inspected and is functioning as intended. A 1.5" minimum pan is present. TPR valve lines are configured properly as well as the overflow drain line. Both are gravity fed to the exterior and the TPR valve terminates between 6" and 24" above grade.

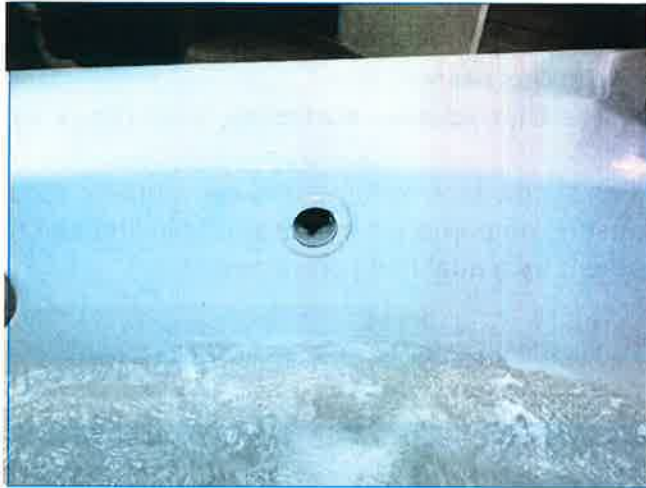
D. Item 1(Picture)

(1) Air control valve is missing for jet tub. Recommend replacement by a qualified person. This is a minor repair.

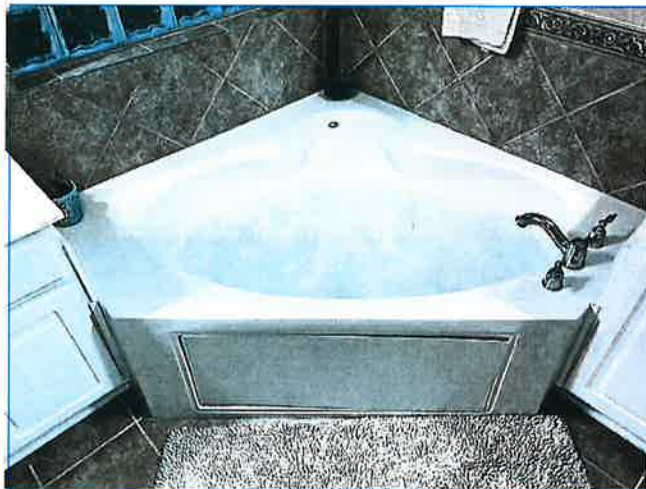
D. Item 2(Picture)

(2) The jet tub appears to be functioning GFCI overcurrent protection device for the jet tub is located at Master bath.

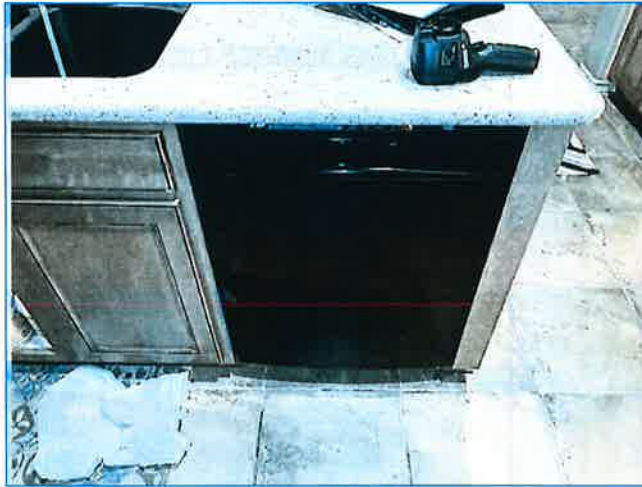
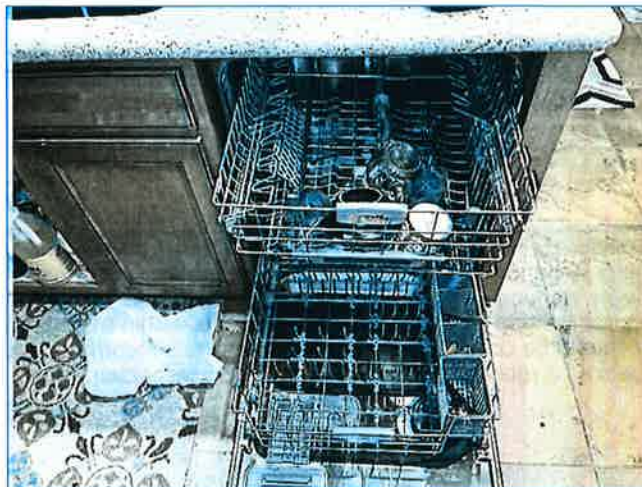
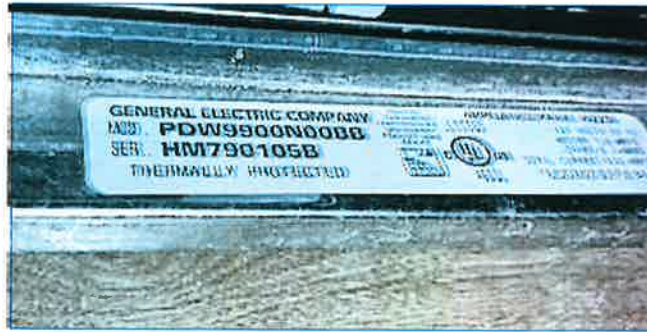
Dishwasher appears to be functioning as intended at the time of inspection. Completed normal cycle as required. There were no broken or missing parts observed.

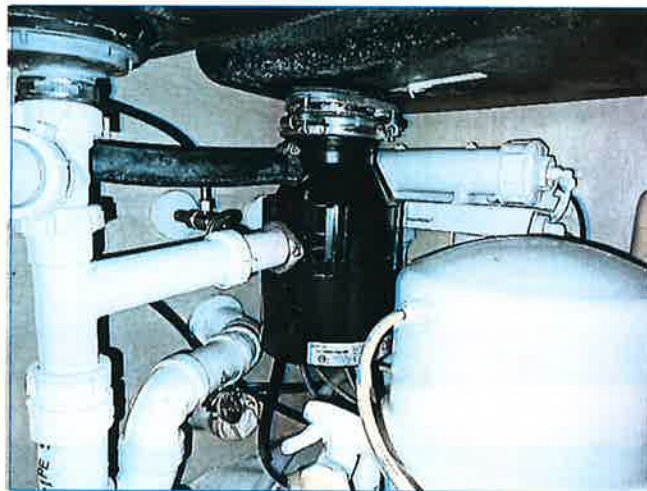
B. Item 1(Picture)

Appears to be functioning as intended at the time of inspection. Splash guard present. No unusual vibrations or noise detected.

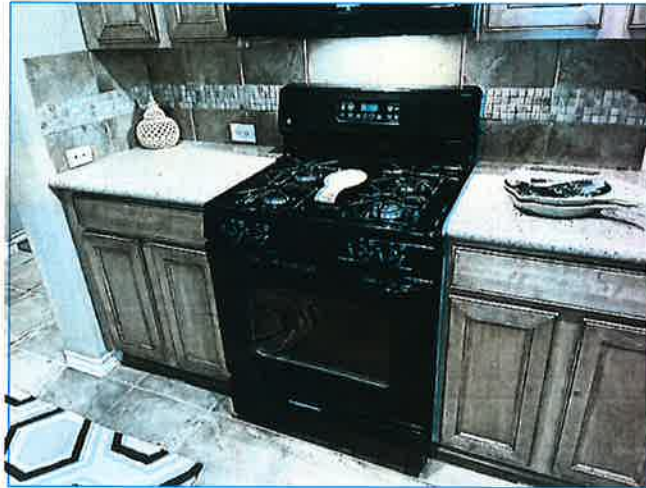
D. Item 1(Picture)

Ranges/Ovens/Cooktops appear to be functioning as intended at the time of inspection. All burners tested on low and high. Oven preheated to 350 degrees, within 20 min the final temperature was measured at 356 degrees. This is within the +/- 25 degrees required.

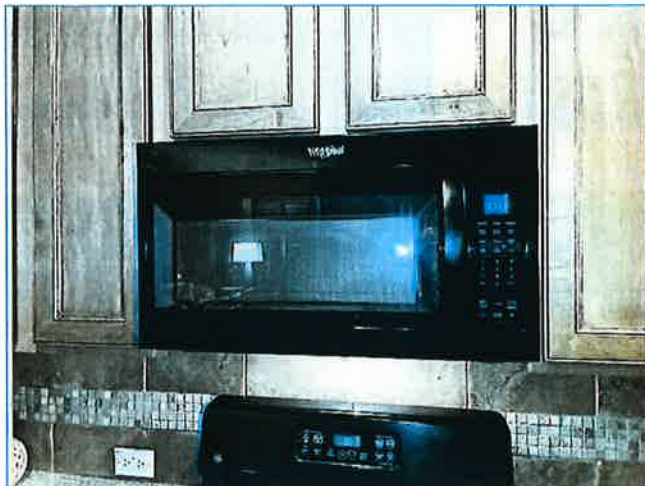
E. Item 1(Picture)

The microwave appears to be functioning as intended at the time of inspection. No broken or cracked glazing, and no damage to seal.

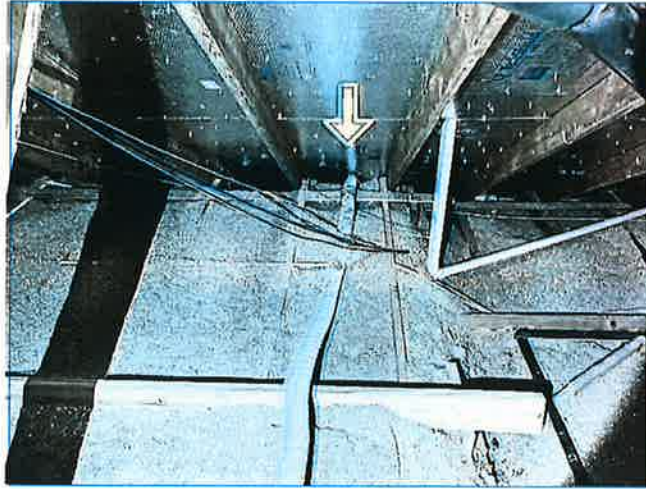
F. Item 1(Picture)

Mechanical exhaust fans for bathrooms do not terminate to exterior as required. At least one vent is terminating in attic space towards soffit vent. This was likely an as built condition and was common when structure was constructed. Recommend repair as desired.

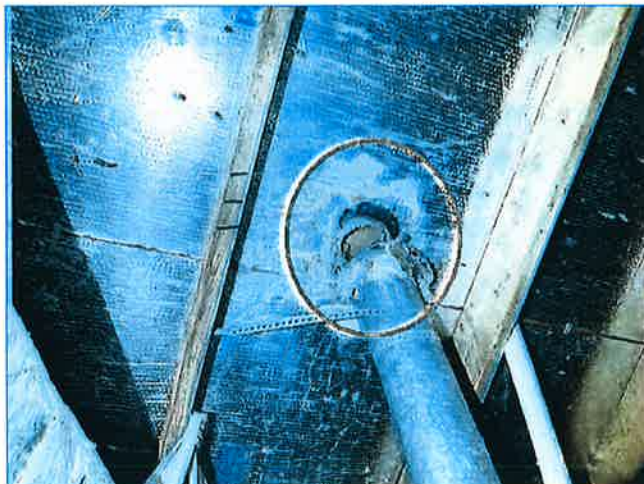
H. Item 1(Picture)

Dryer exhaust duct is separated in attic space at roofline letting lint discharge into attic. Recommend repair by a qualified contractor.

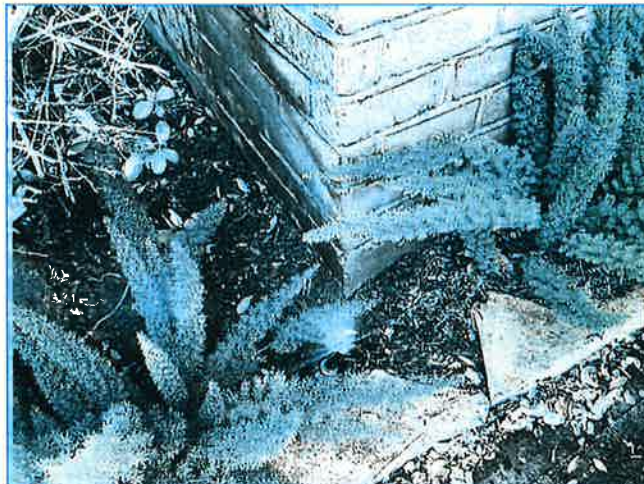
A. Item 2(Picture)

(2) There are several sprinkler heads that are off vertical, are spraying the wrong direction, or not spraying as needed. Recommend a qualified irrigation contractor inspect all heads and make appropriate adjustments. This is a small repair.

*Sprinklers repaired
1-2024*

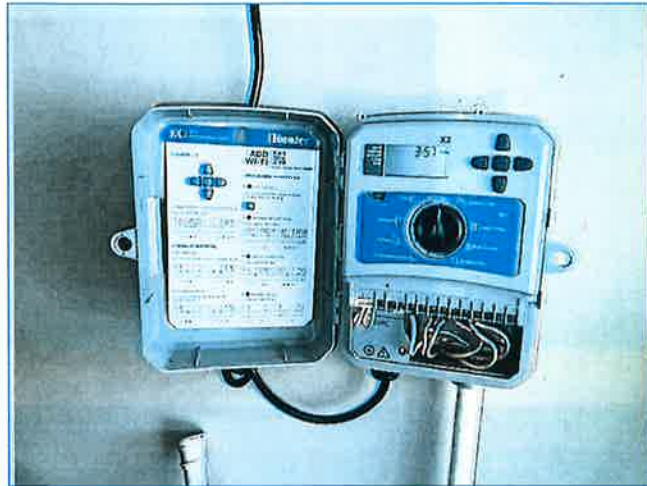
A. Item 7(Picture)

(3) There is no rain sensor installed for sprinkler system. Rain sensor will turn off system during periods of excess rain to conserve water. Recommend installation as desired by a qualified contractor.

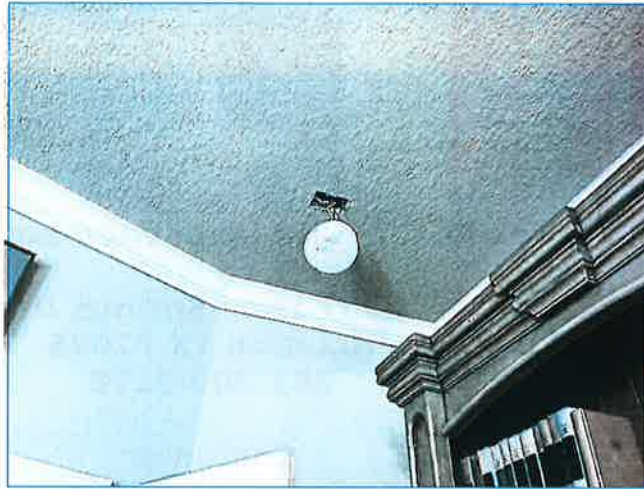
G. Item 1(Picture)

(1) Smoke detector located in office is not mounted to ceiling. Recommend correction by a qualified person or contractor. This is a small repair.
