# Inspection Report

19215 Candlebrook Cir, Spring, TX 77388

## Princess Quality Inspections

# PROPERTY INSPECTION REPORT FORM

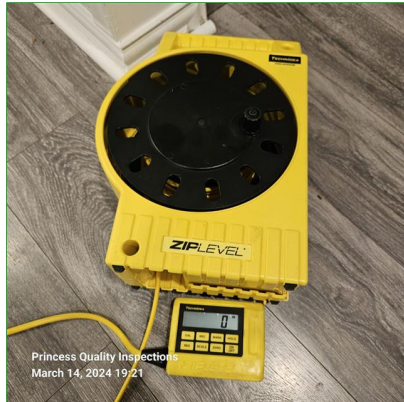
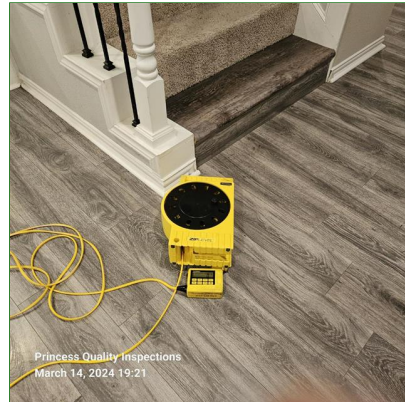
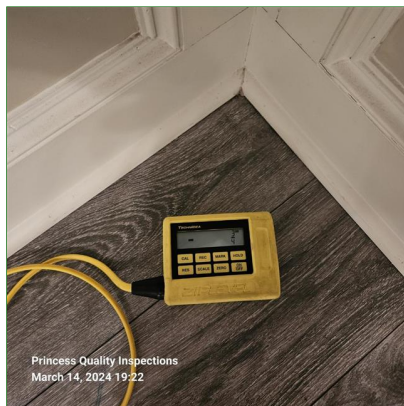
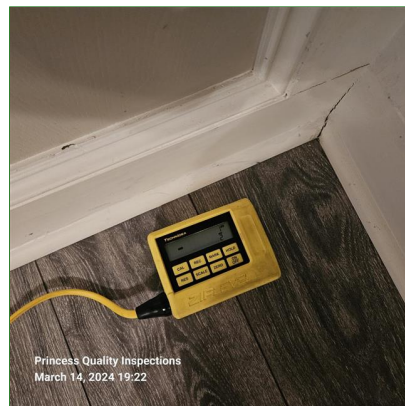
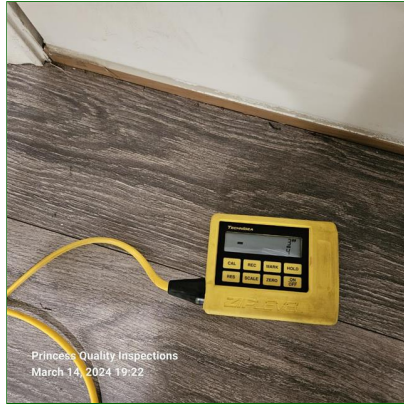
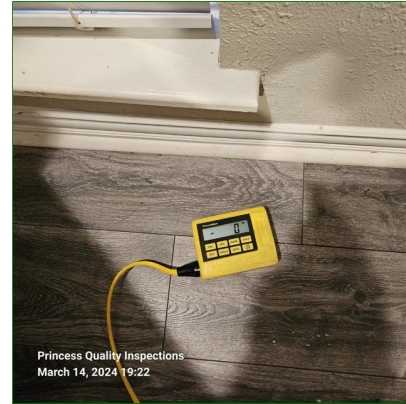
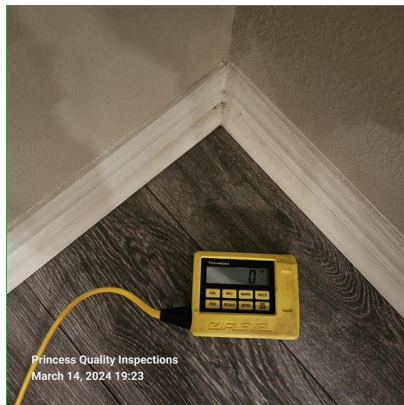
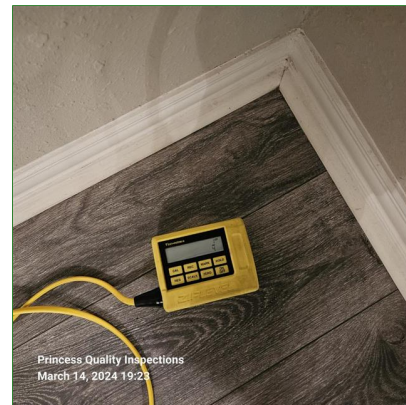
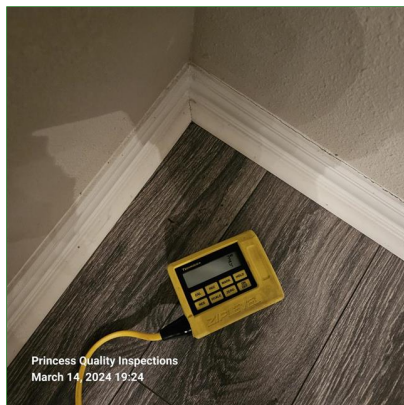
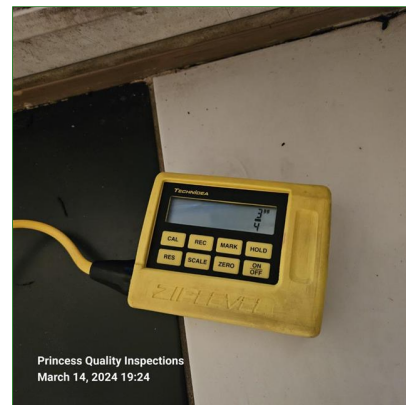
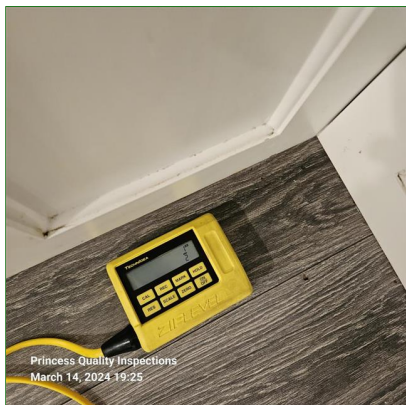
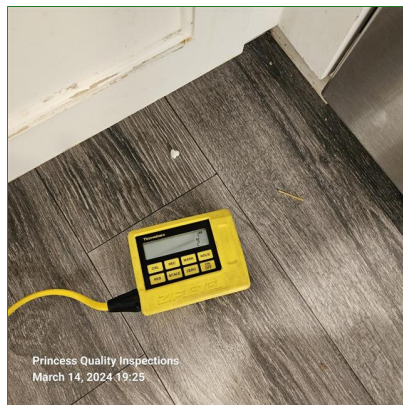
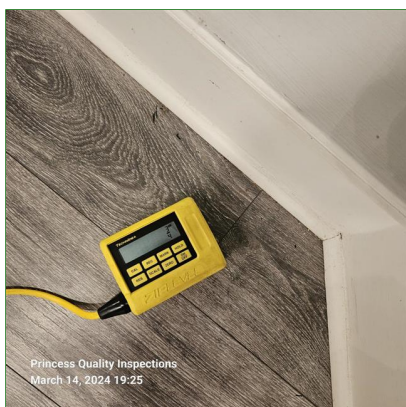
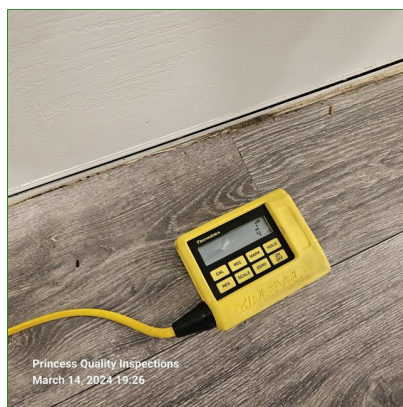
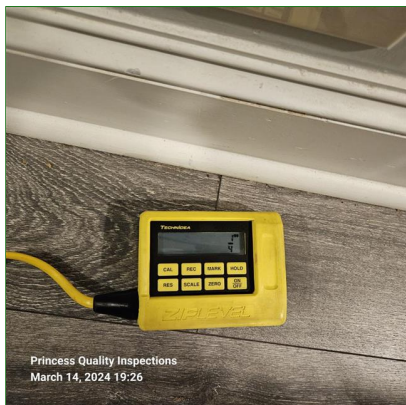
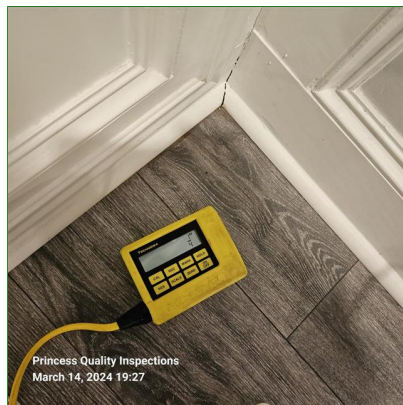
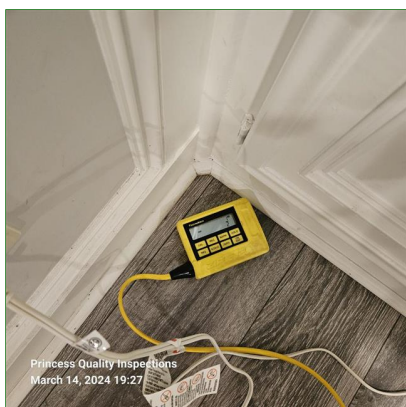
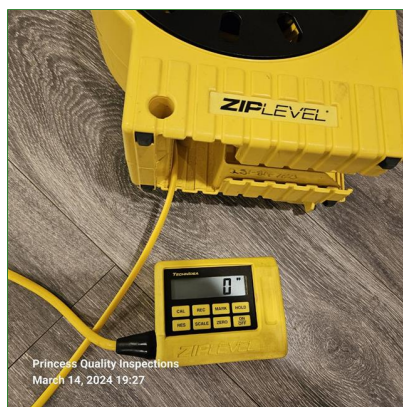
A. Item 1(Picture) Zip level spot check of foundation for level

(1) The foundation is performing it's intended function. No evidence suggesting significant foundation movement at time of inspection.

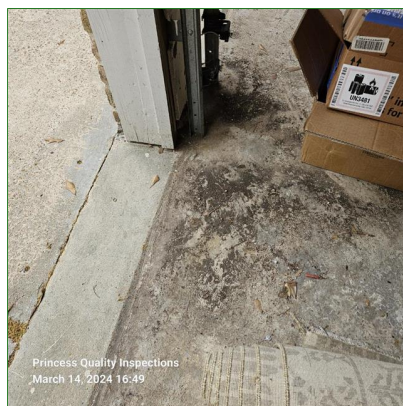
A. Item 20(Picture) Evidence of possible past bonding water observed at two locations along garage openings. FYI

(2) Evidence of possible past bonding water observed at two locations along garage openings. FYI

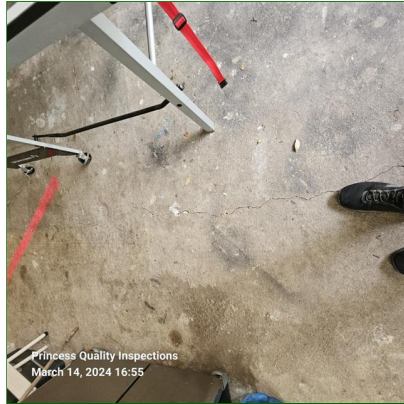
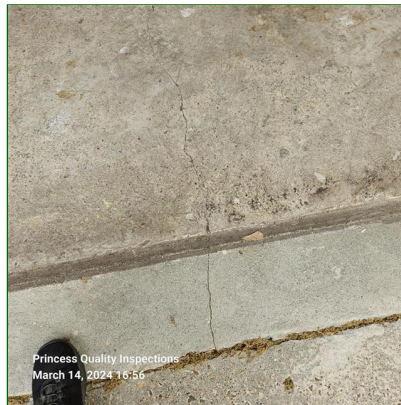
A. Item 21(Picture) Cracks observed in garage floor were cosmetic at the time of inspection and recommend monitoring for changes in size and shape and repair if necessary.

A. Item 23(Picture) Cracks observed in garage floor were cosmetic at the time of inspection and recommend monitoring for changes in size and shape and repair if necessary.

(3) Cracks observed in garage floor were cosmetic at the time of inspection and recommend monitoring for changes in size and shape and repair if necessary.

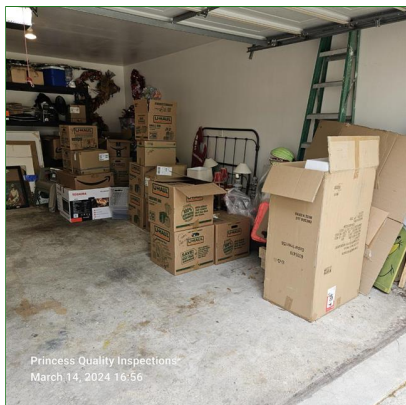
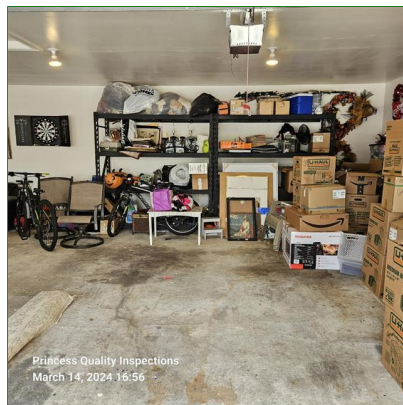
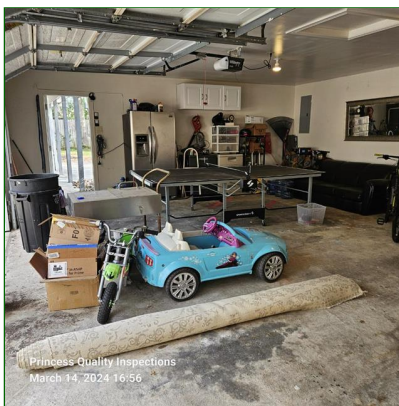
A. Item 24(Picture) Occupant stored items may have obscured defects. FYI

(4) Occupant stored items may have obscured defects. FYI

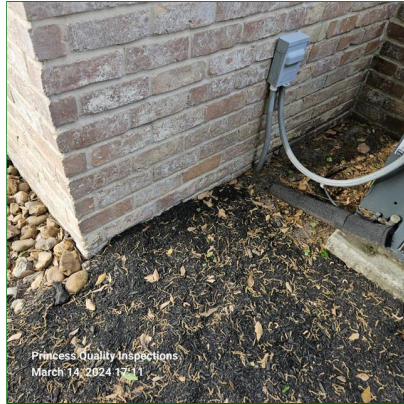
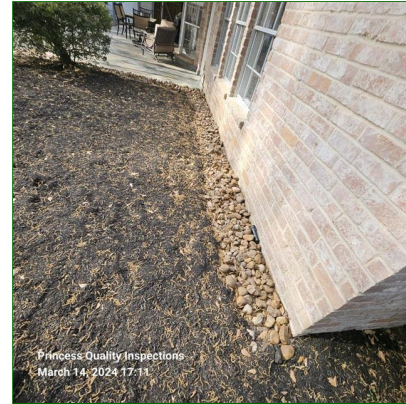
A. Item 27(Picture) Weep holes not visible

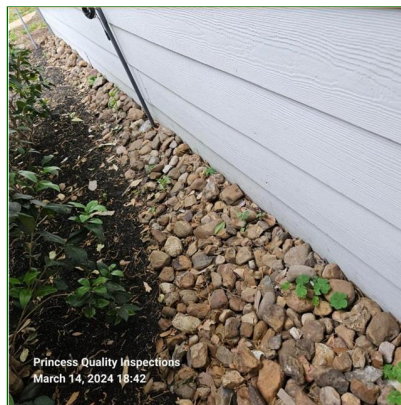
A. Item 31(Picture) Foundation not visible

(5) Soil/Garden level too high around areas with brick or siding. Common industry practice requires a clearance of 4 inches from bottom of brick/siding to soil. High garden or soil level near brick/siding may obscure wood destroying insect activity and may promote moisture intrusions.

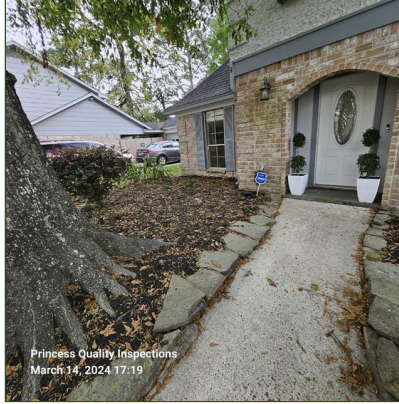
A. Item 32(Picture) Large trees

(6) Tree(s) in close proximity to the foundation were observed. The buyer is encouraged to consider removal of the tree(s) or the installation of a root barrier to reduce the possibility of damage to the foundation from tree roots and moisture removal.

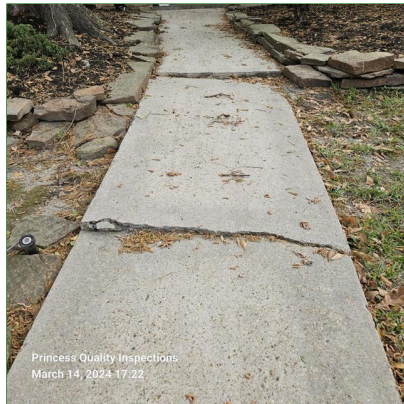
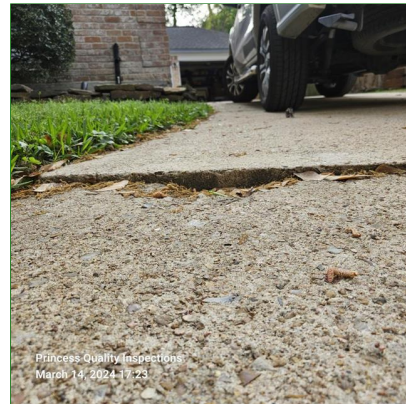
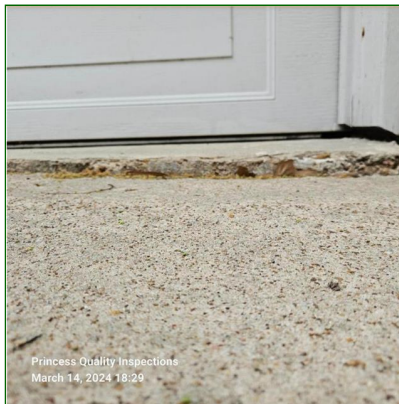
A. Item 33(Picture) Uneven walkways, driveway and or garage apron

A. Item 35(Picture) Garage entry

(7) Tripping Hazard(s), walks and/or driveways and garage entry are uneven and step not level. The inspector recommends repair or replacement of lifted and uneven walkways or driveways by a qualified contractor.

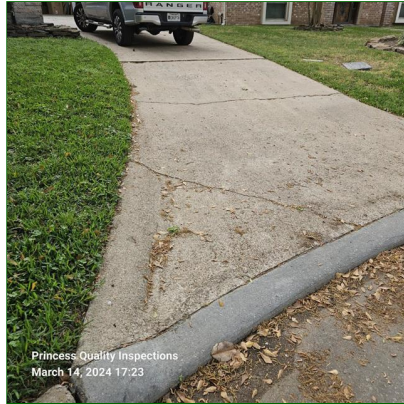
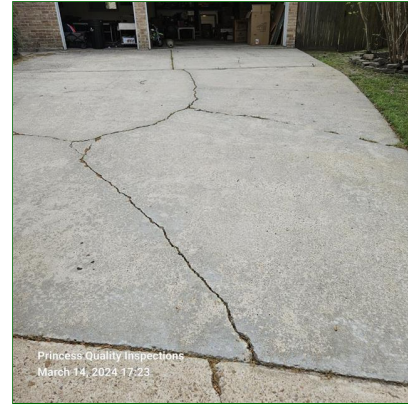
A. Item 36(Picture)

(8) Cracks and or gaps between driveway or sidewalk sections observed and recommend sealing to prevent moisture influenced settlement.

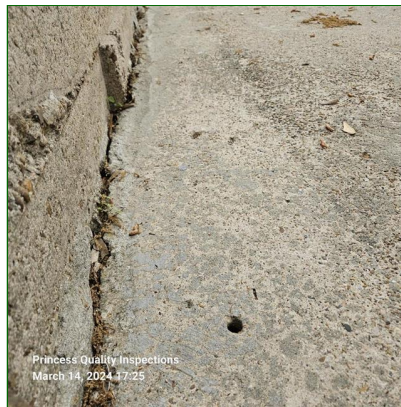
A. Item 38(Picture) Evidence of possible would destroying insect treatment observed through board holes in driveway near the homes Foundation. FYI

(9) Evidence of possible would destroying insect treatment observed through board holes in driveway near the homes Foundation. Continuing termite treatments as a preventative for future infestations is recommended.

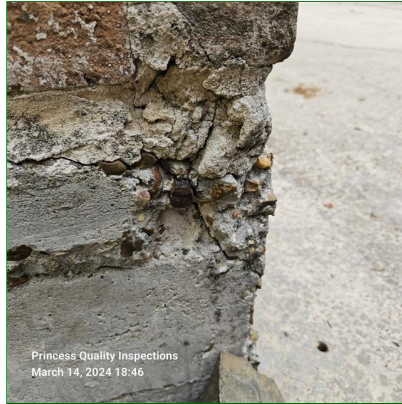
A. Item 39(Picture) Exposed metal Foundation support observed at right front corner and on right side under window with cracked the glass and recommend patching with a high strength concrete patch to prevent premature deterioration of metal Foundation support.

(10) Exposed metal Foundation support observed at right front corner and on right side under window with cracked the glass and recommend patching with a high strength concrete patch to prevent premature deterioration of metal Foundation support.

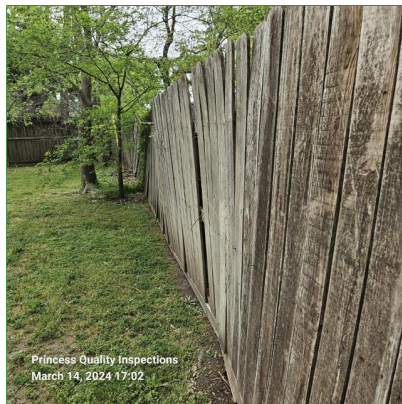
B. Item 1(Picture) Tree branches observed hanging over onto neighboring property

(1) Tree branches observed hanging over onto neighboring property

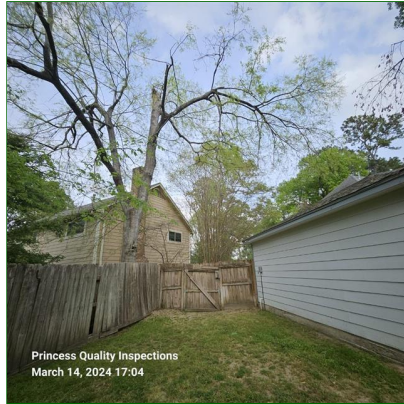
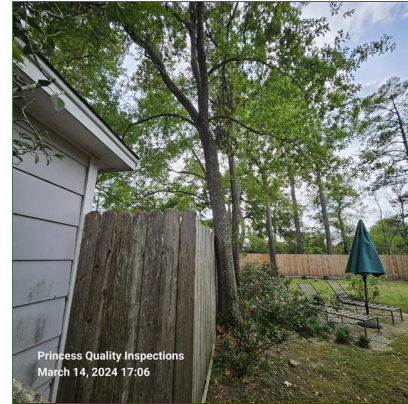
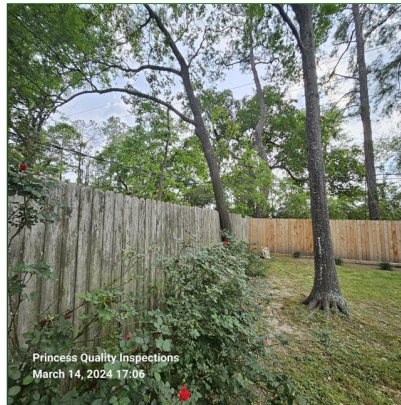
B. Item 3(Picture) Neighbors tree branches observed hanging over onto property

B. Item 4(Picture) Tree branches observed hanging over onto neighboring property

(2) Tree branches observed hanging over onto neighboring property and neighbors tree branches observed hanging over onto property. FYI

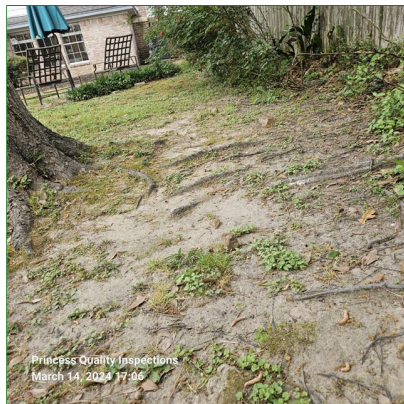
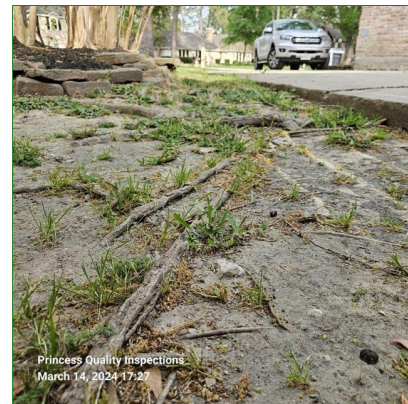
B. Item 6(Picture)

(3) Tree roots above grade observed and recommend backfilling soil over roots or root removal to prevent trip hazards.

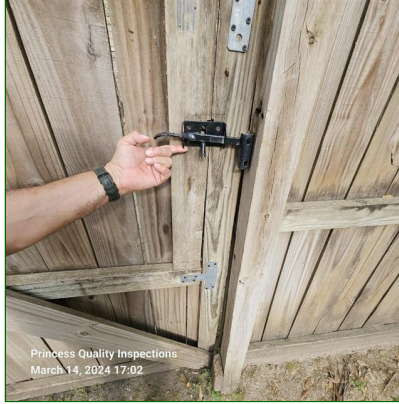
B. Item 8(Picture) Gate at left of the property facing front would not open with moderate force.

(4) Gate at left of the property facing front would not open with moderate force.

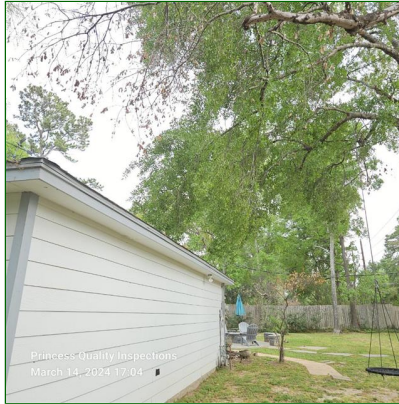
C. Item 1(Picture) Trimming tree branches away from structure is recommended to prevent damage.

(1) Trimming tree branches away from structure is recommended to prevent damage.

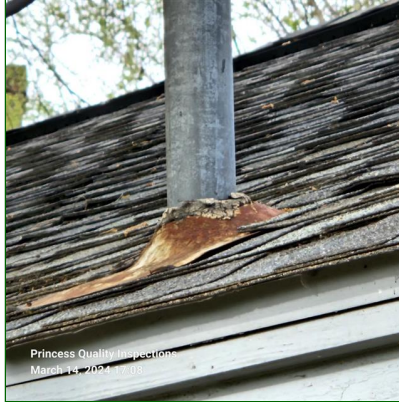
C. Item 2(Picture) The electric service mast boot is missing and recommend repair for long-term performance and to prevent moisture intrusions.

(2) The electric service mast boot is missing at thimble flashing and recommend repair for long-term performance and to prevent moisture intrusions.

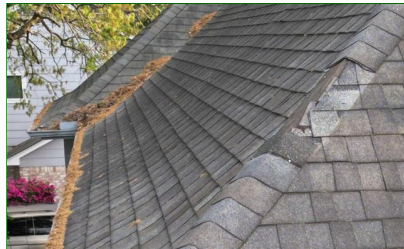
C. Item 3(Picture) Roof covering materials

(3) At the time of the inspection, it was observed that the asphalt composition shingles covering most roof slopes exhibited moderate to severe deterioration and damage with too many locations of damaged/deficient materials to note in the report. Notably, the granules on some shingles were extremely loose, rendering walking on the roof unsafe without safety equipment. Moisture stains were also noted on the second-floor drywall ceilings, potentially indicative of past or present active roof leaks or issues with galvanized piping. Additionally, deficiencies such as lifted flashing and nail pops were evident. The primary cause of granule loss appears to be the age of the roof, as granules are bonded to shingles by asphalt

which weakens over time. Consequently, wear and damage can dislodge these granules. The current condition suggests that the shingles are nearing or at the end of their long-term service life. However, other portions of the roof were found to be in better condition, possibly due to varying exposure to weather patterns or sunlight. A thorough examination by a qualified roofing contractor is recommended to determine whether repairs or a full replacement are necessary. Prompt action is advised to mitigate moisture intrusion and potential damage to attic insulation, drywall, and to prevent mold growth in attic materials.

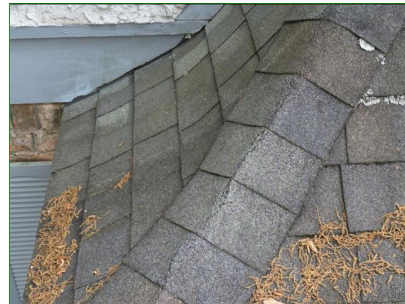
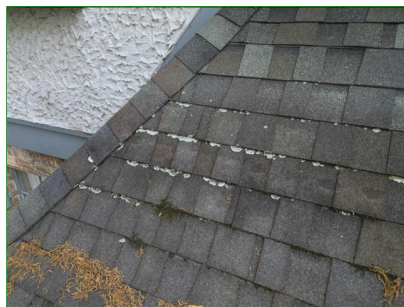
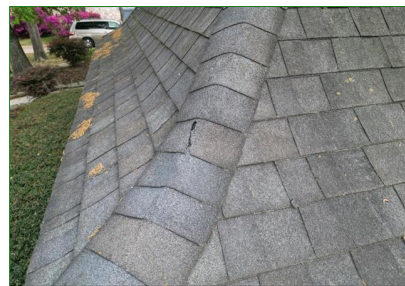
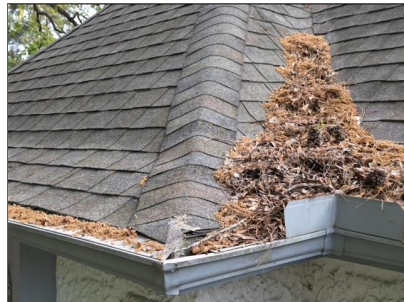
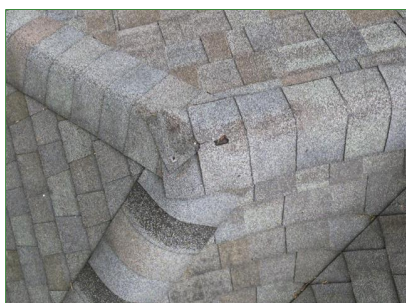
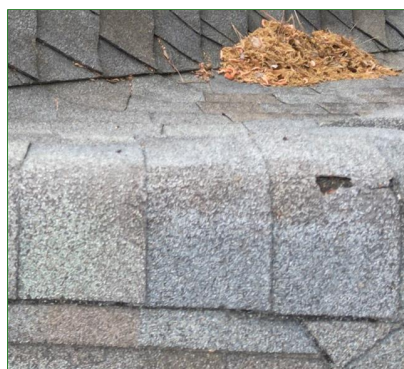
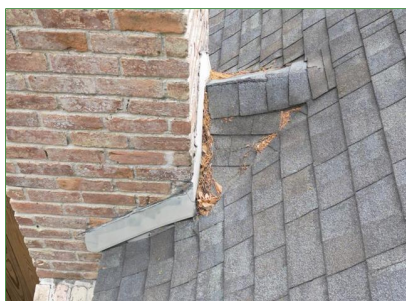
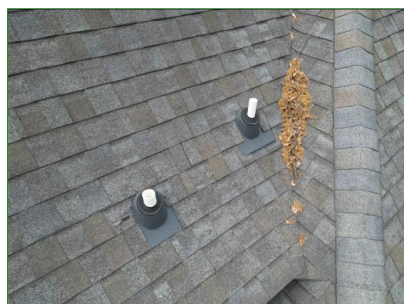
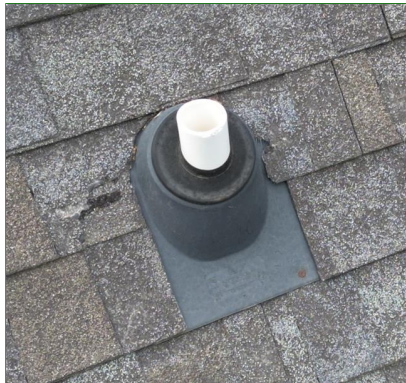
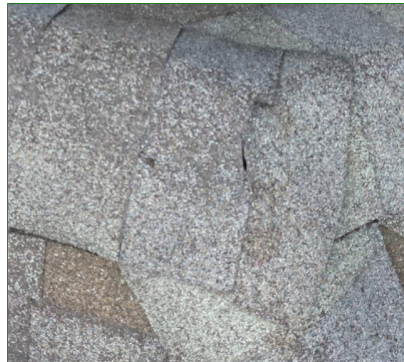
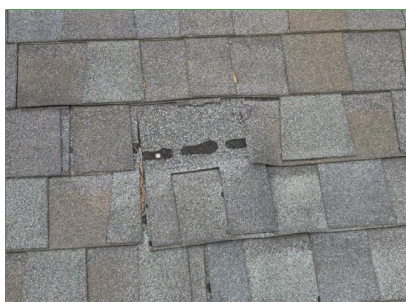
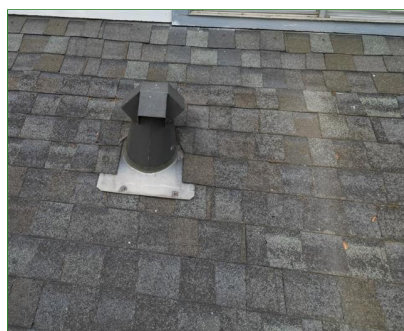
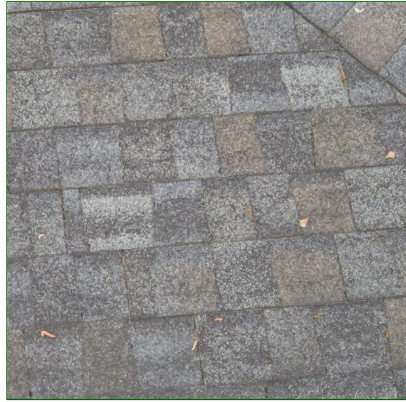
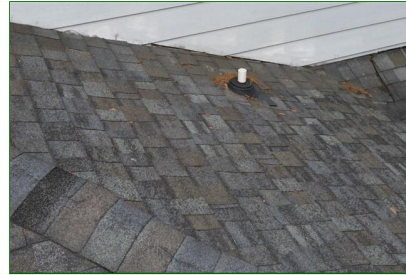
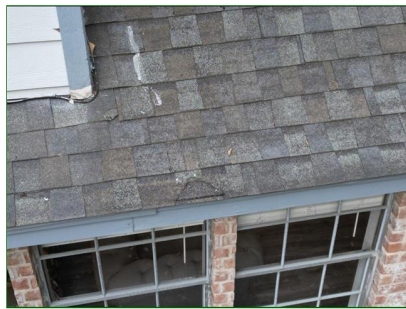
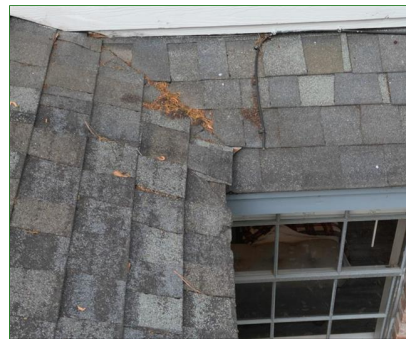
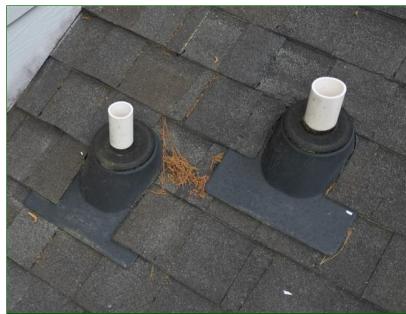
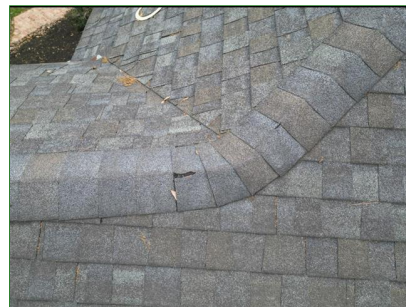
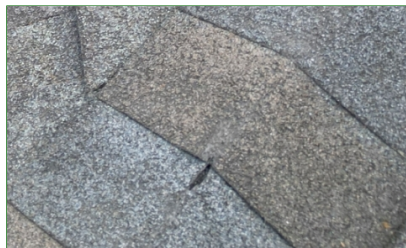
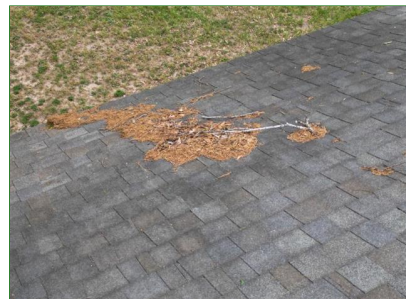
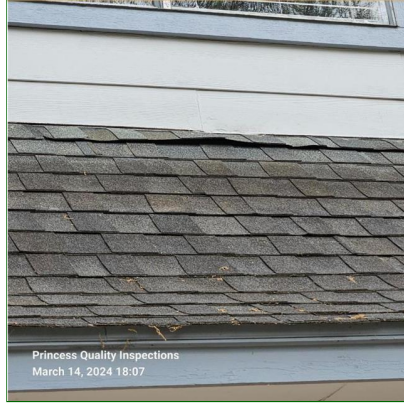
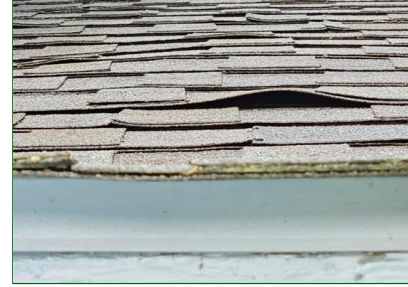
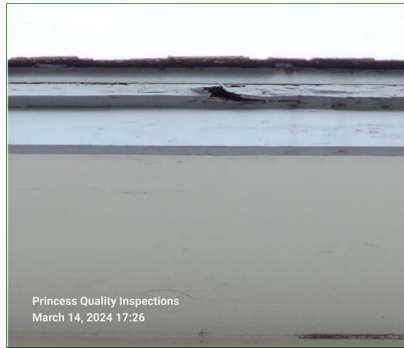
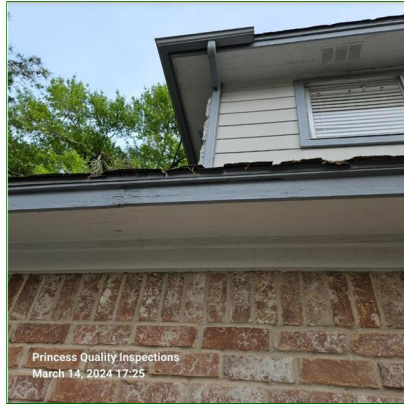
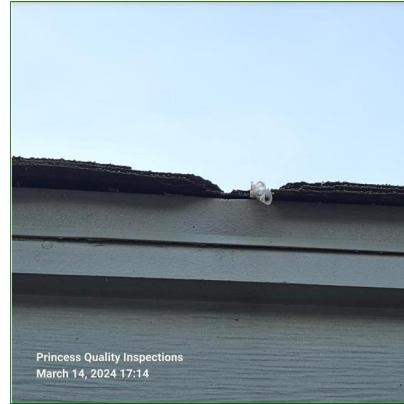
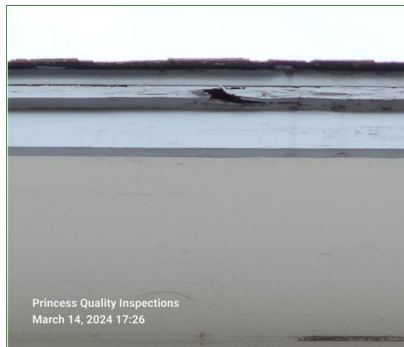
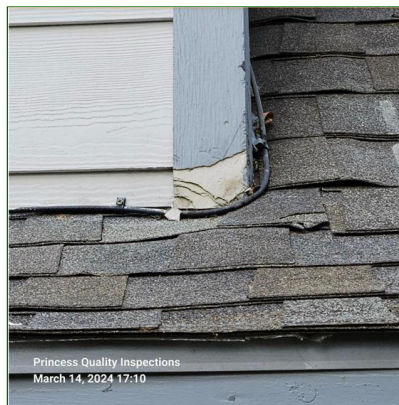
C. Item 4(Picture) Roof covering materials damage

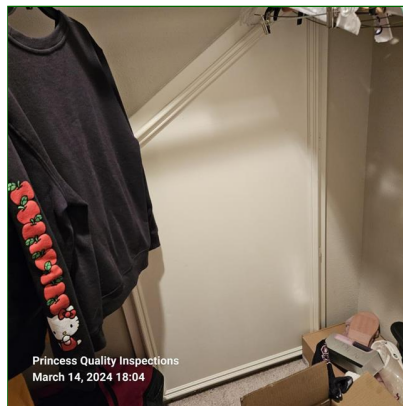
D. Item 2(Picture)

(1) The attic access door at left front second floor closet was locked and therefore not inspected for deficiencies. The inspector was unable to locate another entry into the attic space that is located on the second level. FYI The inspector recommends scheduling a reinspection to inspect these areas for deficiencies.

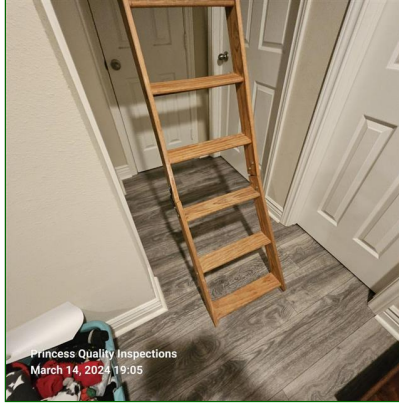
D. Item 3(Picture) The attic pull-down stairs hinges are in need of adjustment or repair to prevent damage and or injuries from falls.

(2) The attic pull-down stairs hinges are in need of adjustment or repair to prevent damage and or injuries from falls.

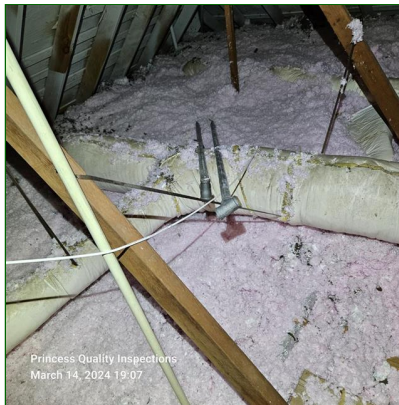
D. Item 4(Picture) Some abandoned replaced galvanized piping observed in attic. the inspector was unable to determine whether all horizontal and vertical galvanized pipes have been replaced due to the added insulation on top of them in attic and recommend asking the seller if any vertical or horizontal galvanized piping remains in use and if so replacement is recommended due to the history of damage caused by bursting pipes. FYI

(3) Some abandoned replaced galvanized piping observed in attic. the inspector was unable to determine whether all horizontal and vertical galvanized pipes have been replaced due to the added insulation on top of them in attic and recommend asking the seller if any vertical or horizontal galvanized piping remains in use and if so replacement is recommended due to the history of damage caused by bursting pipes. FYI

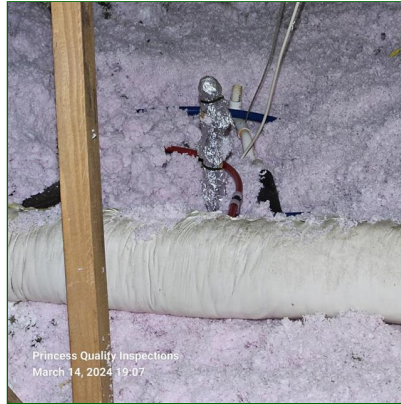
D. Item 5(Picture) Exposed water supply piping in attic space

(4) Exposed water supply piping observed in attic. To prevent the risk of freezing and bursting, any water supply pipes that are exposed to very low temperatures should be adequately insulated or emptied of water. This is especially important for pipes that run outside or in unheated attic of the building. Pex piping performs well in extreme cold temperatures and is freeze resistant but it's not freeze proof to include connectors and clamps. Frozen pipes can cause serious damage and disruption to the water supply system.

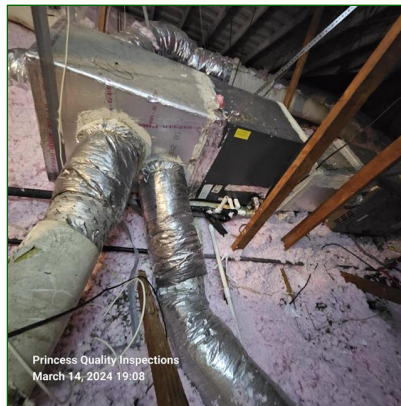
D. Item 6(Picture) A solid pathway to HVAC with a minimum 24 in wide is recommended to safely access HVAC for service and repair service decking to the front of HVAC should be a minimum of 30 in.

(5) A solid pathway to HVAC with a minimum 24 in wide is recommended to safely access HVAC for service and repair service decking to the front of HVAC should be a minimum of 30 in.

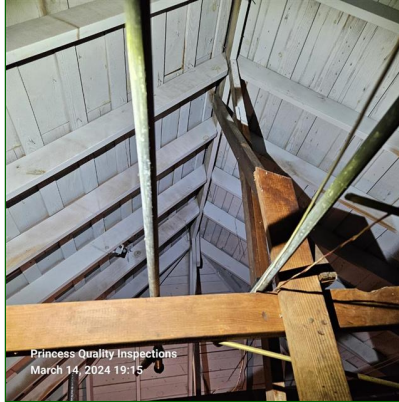
D. Item 7(Picture) The attic structure was performing at the time of inspection with no signs of significant settlement. FYI

(6) The attic structure was performing at the time of inspection with no signs of significant settlement. FYI

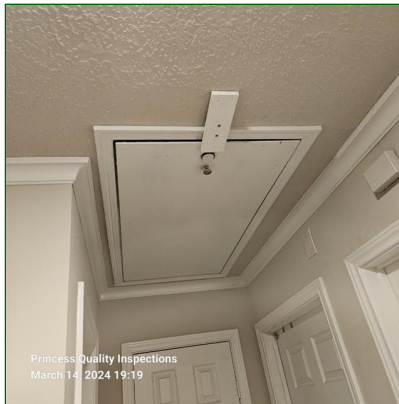
D. Item 8(Picture) Adding weather stripping and insulation to the attic pull-down stairs door is recommended to prevent Heating and Cooling loss.

(7) Adding weather stripping and insulation to the attic pull-down stairs door is recommended to prevent Heating and Cooling loss.

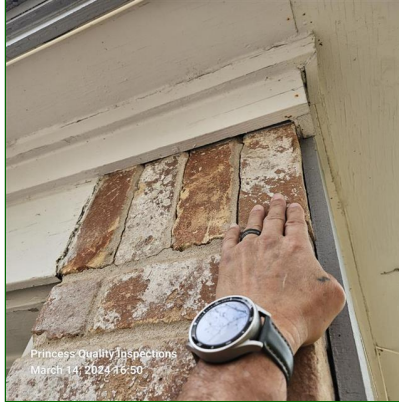
E. Item 1(Picture) A loose brick was observed at Garage right front corner and recommend prepared to prevent separation.

(1) A loose brick was observed at Garage right front corner and recommend prepared to prevent separation.

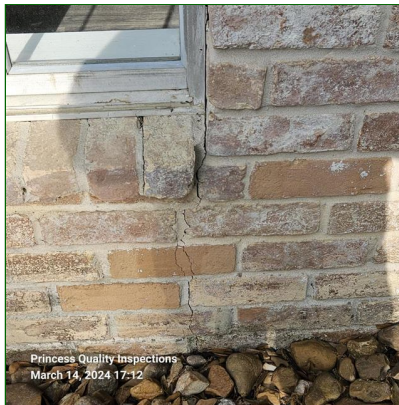
E. Item 2(Picture) Vertical cracks in brick and mortar at rear exterior wall observed and likely caused by settlement. The inspector did not observe any other evidence suggesting significant foundation movement. However, the exterior foundation wall is not visible at this location and recommend further examination by a qualified foundation contractor to identify the the extent and depth of any cracks residing in the exterior foundation walls covered by rocks, soil and flowerbeds and to advise and repair if necessary.

(2) Vertical cracks in brick and mortar at rear exterior wall observed and likely caused by settlement. The inspector did not observe any other evidence suggesting significant foundation movement. However, the exterior foundation wall is not visible at this location and recommend further examination by a qualified

foundation contractor to identify the the extent and depth of any cracks residing in the exterior foundation walls covered by rocks, soil and flowerbeds and to advise and repair if necessary.

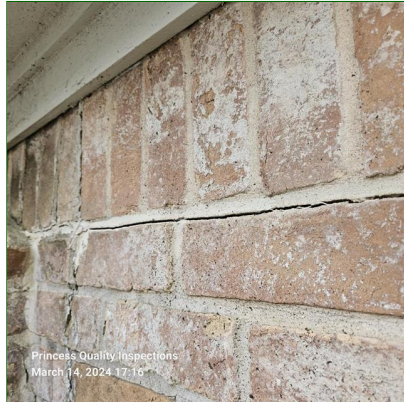
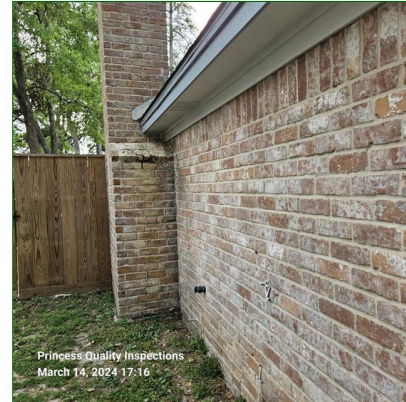
E. Item 3(Picture) A horizontal separation between brick mortar and brick was observed at the left side of home before chimney and likely caused by past settlement and may require repair should the separations worsen. FYI

E. Item 4(Picture) A horizontal separation between brick mortar and brick was observed at the left side of home before chimney and likely caused by past settlement and may require repair should the separations worsen. FYI

(3) A horizontal separation between brick mortar and brick was observed at the left side of home before chimney and likely caused by past settlement and may require repair should the separations worsen. Some repairs has been performed in this area. FYI

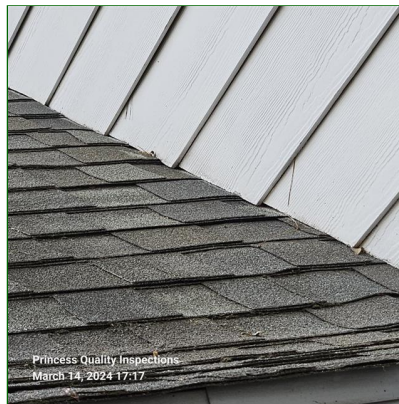
E. Item 5(Picture) Cement fiber siding observed in direct contact with roof coverings at various locations and obscuring from view any metal flashing. Due to the age and condition of roof coverings, the wall flashing will be exposed and can be repaired if needed at the next roof covering change. Cement fiber manufacturers recommend a minimum clearance to roof covering materials of an inch and a half to prevent premature deterioration of cement fiber. FYI

(4) Cement fiber siding observed in direct contact with roof coverings at various locations and obscuring from view any metal flashing. Due to the age and condition of roof coverings, the wall flashing will be exposed and can be repaired if needed at the next roof covering change. Cement fiber manufacturers recommend a minimum clearance to roof covering materials of an inch and a half to prevent premature deterioration of cement fiber. FYI

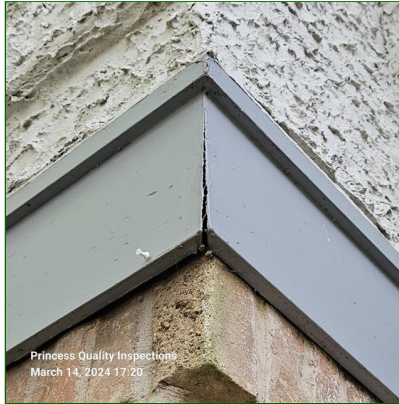
E. Item 6(Picture) uneven gap in frieze board

(5) An inconsistent separation at frieze board Corner observed and commonly caused by some sort of settlement. When a home's foundation settles, it means that all or part of the foundation has moved in a downward direction further into the soil from when it was built. When the foundation settles, the brick wall goes with it. This causes an (out of plumb) condition that stresses the connection between the brick and frieze boards of the home. The settlement was likely caused during the mandatory water restrictions during the past heat wave. FYI

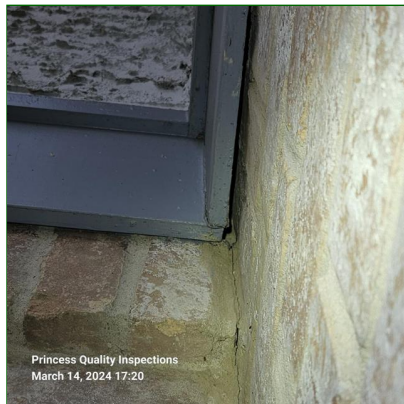
E. Item 7(Picture) Gaps in frieze boards large enough for flying insect entry observed and recommend reducing the size of cracks to prevent flying insect and or Vermin nesting within the structure.

(6) Gaps in frieze boards large enough for flying insect entry observed and recommend reducing the size of cracks to prevent flying insect and or Vermin nesting within the structure.

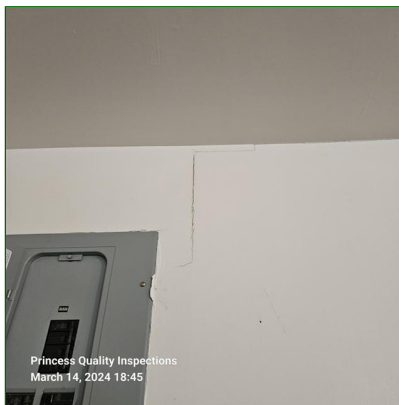
E. Item 9(Picture) The vertical crack near the electrical distribution panel was likely caused by past settlement. It is more common that when a foundation Settles it stops settling and ongoing settlement is continuous movement and is rare.

(7) The vertical crack near the electrical distribution panel was likely caused by past settlement. It is more common that when a foundation Settles it stops settling and ongoing settlement is continuous movement and is rare. FYI

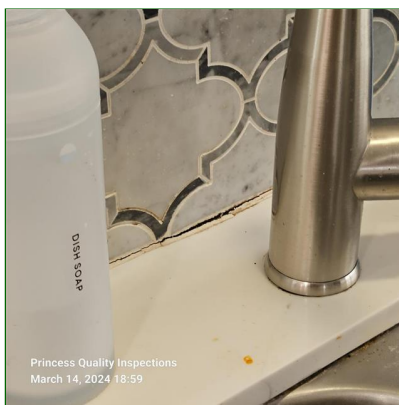
E. Item 10(Picture) Gaps in sealant observed at kitchen counter near kitchen sink and recommend sealant repair to prevent moisture from getting under kitchen counter.

(8) Gaps in sealant observed at kitchen counter near kitchen sink and recommend sealant repair to prevent moisture from getting under kitchen counter.

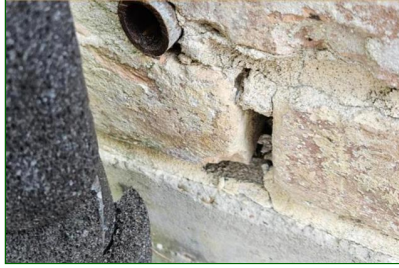
E. Item 11(Picture) Uncommonly large weep holes can be screened to prevent vermin entry. Sealing off weepholes is not recommended as it will prevent ventilation of airspace in wall that is designed to allow moisture to escape and dry. FYI

(9) Uncommonly large weep holes can be screened to prevent vermin entry. Sealing off weepholes is not recommended as it will prevent ventilation of airspace in wall that is designed to allow moisture to escape and dry. FYI

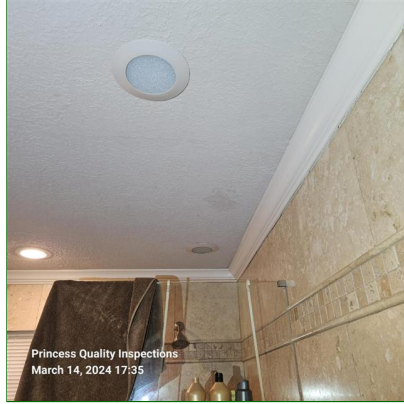
F. Item 3(Picture) Moisture stains observed in drywall ceilings at various locations.

(2) Moisture stains observed in drywall ceilings at various locations. Due to the lack of moisture the inspector was unable to determine whether a active leak is present. However, damaged shingles do exist at various locations of roof and recommend further examination examination of roof covering materials by a qualified roofing contractor to identify and repair or replace any active moisture entry points to prevent moisture damage to materials and fungi growth.

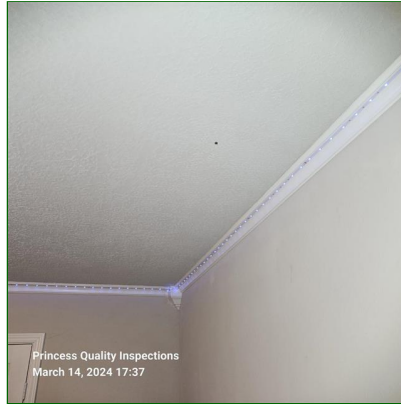
F. Item 7(Picture) Left front bedroom nail pop was observed in ceiling.

(3) Left front bedroom nail pop was observed in ceiling.

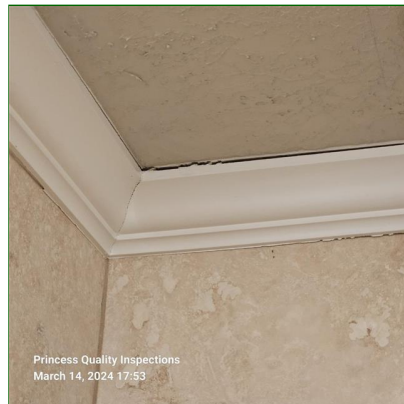
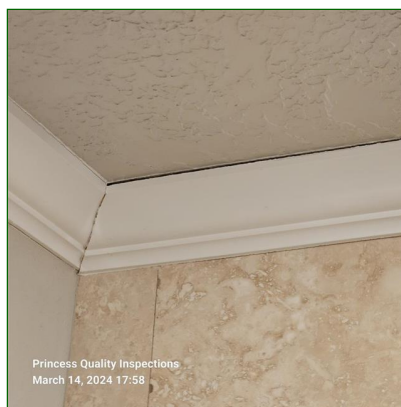
F. Item 8(Picture) Gaps/ separation in crown molding observed at master bathroom.

F. Item 10(Picture) Gaps/ separation in crown molding observed at master bathroom.

(4) Gaps/separation in crown molding observed at master bathroom.

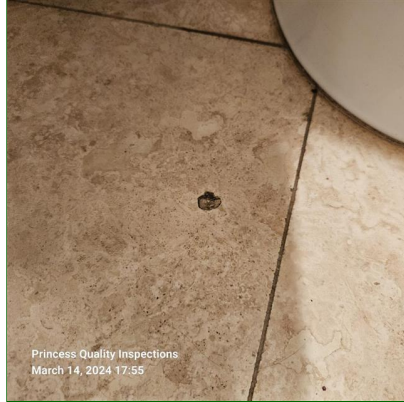
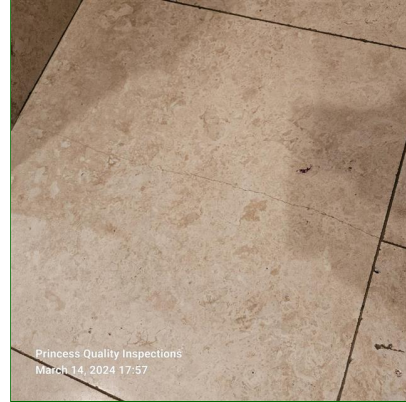
F. Item 11(Picture) Chipped and cracked tiles observe in master bathroom. the inspector did not move floor carpeting to look for more damage. FYI

F. Item 12(Picture) Chipped and cracked tiles observe in master bathroom. the inspector did not move floor carpeting to look for more damage. FYI

(5) Chipped and cracked tiles observe in master bathroom. the inspector did not move floor carpeting to look for more damage. FYI

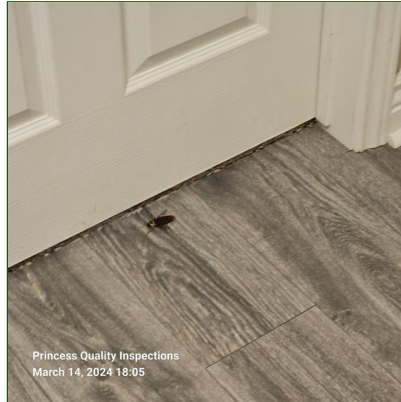
F. Item 15(Picture) Live roaches were observed at 2 locations at second floor and recommend further examination by a qualified pest control contractor to identify and treat as necessary to prevent infestations in the home.

(6) Live roaches were observed at 2 locations at second floor and recommend further examination by a qualified pest control contractor to identify and treat as necessary to prevent infestations in the home.

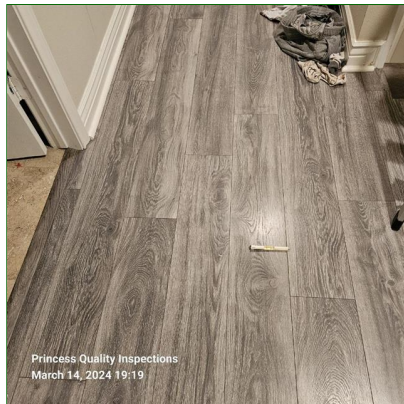
F. Item 16(Picture) Floor slopes down to the front of home at second floor.

(7) The second floor of the home slopes downward towards the front of the home. This is quite common in homes built during this era. There could be several reasons why the second-story floors of your home are uneven. Some of the common causes include: Installation errors: If the floor trusses were not installed correctly, they may be causing the unevenness in the floors. The trusses may not be level or may have been installed at different heights. Deflection: Floor trusses are designed to deflect slightly under load, which can result in some unevenness in the floors. However, if the deflection is excessive, it could indicate a problem with the design or installation of the trusses. Moisture content: Wood trusses can absorb moisture from the environment, which can cause them to warp or twist over time. If the trusses were exposed to excessive moisture during construction, water or roof leaks this could be causing the unevenness in the floors.

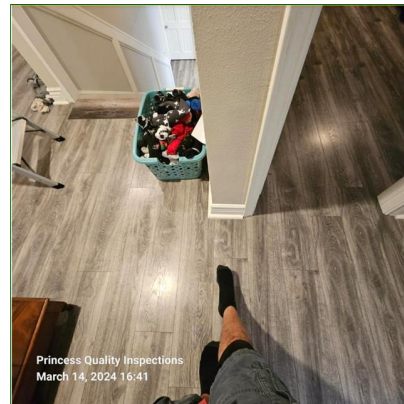
F. Item 17(Picture) A slight rise in floor observed at top of stairs.

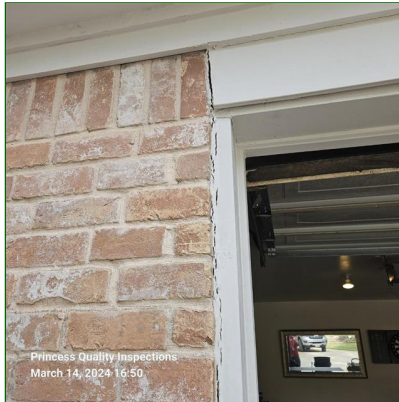
G. Item 1(Picture) Touching up sealant gaps at garage opening is recommended to prevent further separation and or damage.

(1) Touching up sealant gaps at garage opening is recommended to prevent further separation and or damage.

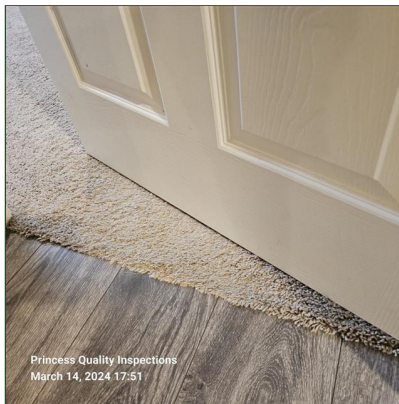
G. Item 2(Picture) Bedroom doors with carpeted bedrooms are too low, and since air returns are not present within the rooms, trimming the door bottoms to allow an inch and a half to the floor is recommended to allow air to return to HVAC for reconditioning.

(2) Bedroom doors with carpeted bedrooms are too low, and since air returns are not present within the rooms, trimming the door bottoms to allow an inch and a half to the floor is recommended to allow air to return to HVAC for reconditioning.

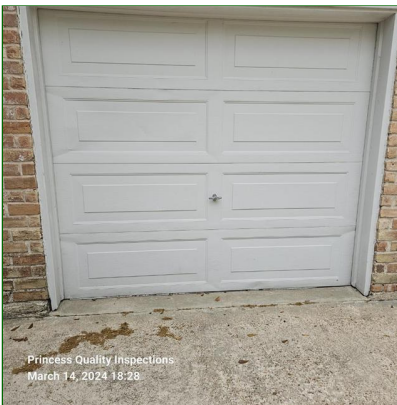
G. Item 3(Picture) One car garage door panels observed to contain creases from buckling but did not hinder the operation of the door. FYI

(3) One car garage door panels observed to contain creases from buckling but did not hinder the operation of the door. FYI

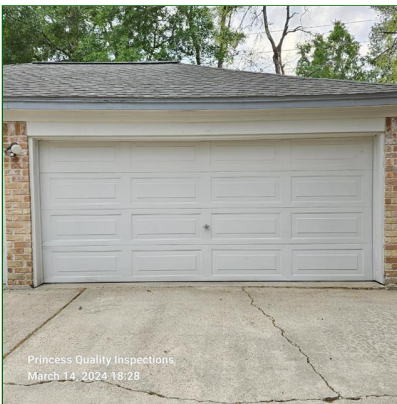
G. Item 4(Picture) A slight sag observed at center of garage opening/header and common in this age of home. The header may need reinforcing in the future if sagging worsens. FYI

(4) A slight sag observed at center of garage opening/header and common in this age of home. The header may need reinforcing in the future if sagging worsens. FYI

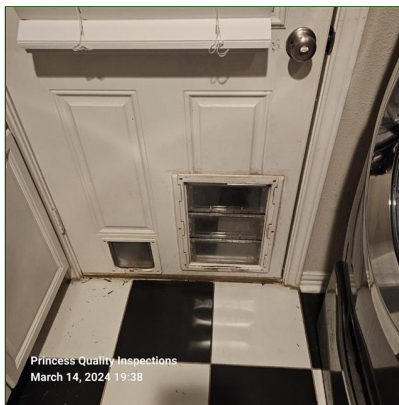
G. Item 5(Picture) Pet access door

(5) Pet access doors have been used by burglars to gain access to the home. FYI

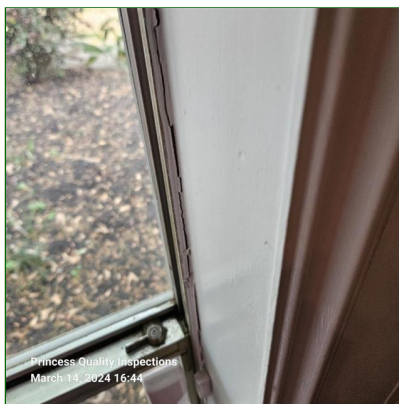
H. Item 1(Picture) Gaps/ separation in sealant observed at various interior window locations and recommend touching up sealant to prevent drafts.

(1) Gaps/separation in sealant observed at various interior window locations and recommend touching up sealant to prevent drafts.

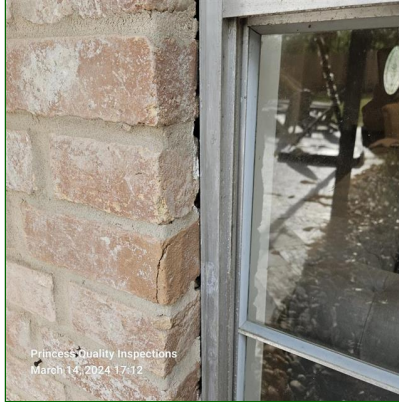
H. Item 2(Picture) Gaps between exterior window frames and brick observed at various locations and recommend repair of gaps to prevent flying insects and or Vermin nesting Within structure.

(2) Gaps between exterior window frames and brick observed at various locations and recommend repair of gaps to prevent flying insects and or Vermin nesting Within structure.

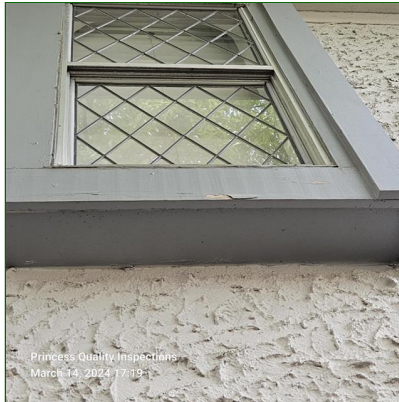
H. Item 3(Picture) Loose paint observed at window protrusion at front of home and may indicate that it's time to repaint paintable surfaces at the exterior of the home. Exterior paint manufacturers recommend painting every 7 to 10 years to prevent premature deterioration of materials.

(3) Loose paint observed at window protrusion at front of home and may indicate that it's time to repaint paintable surfaces at the exterior of the home. Exterior paint manufacturers recommend painting every 7 to 10 years to prevent premature deterioration of materials.

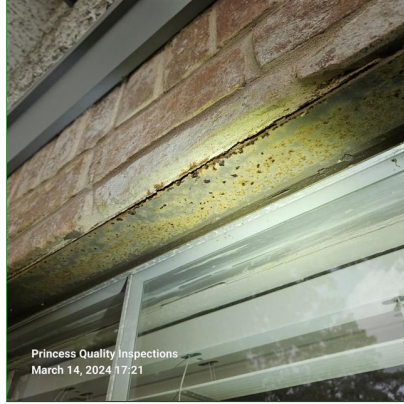
H. Item 4(Picture) Corrosion observed on metal load-bearing lintels above exterior windows and recommend removal of rust and treat with a rust inhibitor to prevent further deterioration of load bearing lintels.

(4) Corrosion observed on metal load-bearing lintels above exterior windows and recommend removal of rust and treat with a rust inhibitor to prevent further deterioration of load bearing lintels.

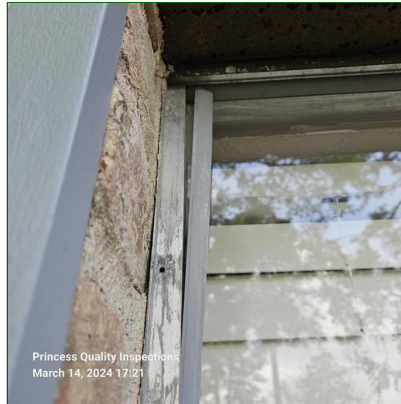
H. Item 6(Picture) Loose blazing bead trim observed at window front of home and recommend repair to prevent damage.

(5) Loose blazing bead trim observed at window front of home and recommend repair to prevent damage.

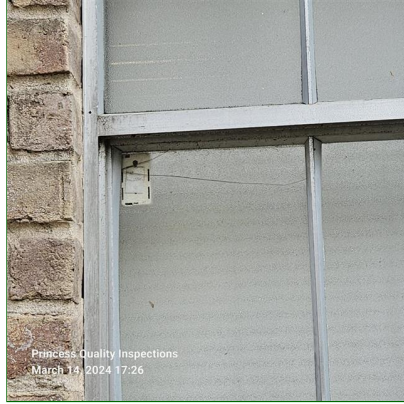
H. Item 7(Picture) Broken glass observed on window at right side of Home facing rear and recommend replacing broken glass.

(6) Broken glass observed on window at right side of Home facing rear and recommend replacing broken glass.

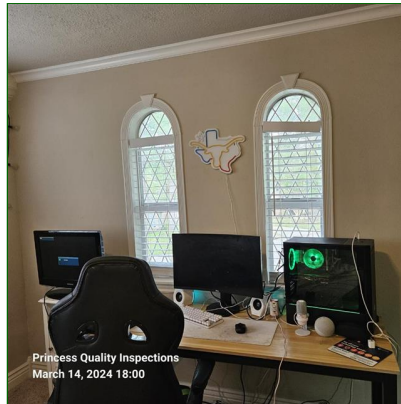
H. Item 9(Picture) Window access blocked by occupant items or not tested for performance. FYI

(7) Window access blocked by occupant items or not tested for performance. FYI
