# Inspection Report

19215 Candlebrook Cir, Spring, TX 77388

## Princess Quality Inspections

# PROPERTY INSPECTION REPORT FORM

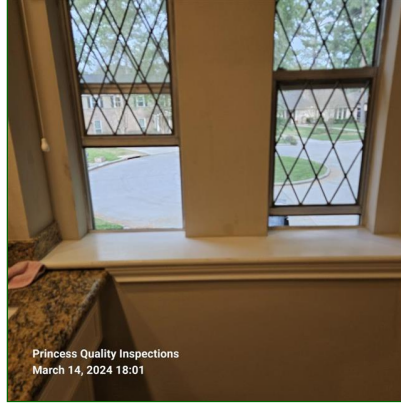
H. Item 10(Picture) One of the windows at the second floor hallway bathroom with only open a few inches with moderate force. FYI

(8) One of the windows at the second floor hallway bathroom with only open a few inches with moderate force. FYI

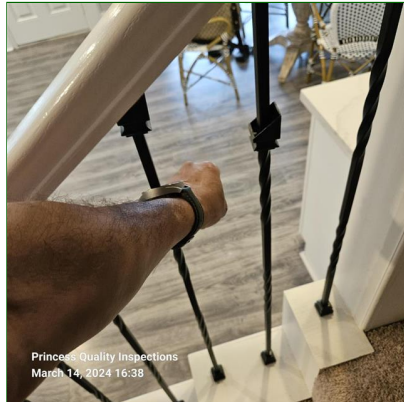
I. Item 1(Picture) The balusters are spaced beyond 4 in and my modern standards would be required to not allow a 4-in sphere pass through. correcting for safety is recommended prevent children from getting their heads stuck. FYI

The balusters are spaced beyond 4 in and my modern standards would be required to not allow a 4-in sphere pass through. correcting for safety is recommended prevent children from getting their heads stuck. FYI

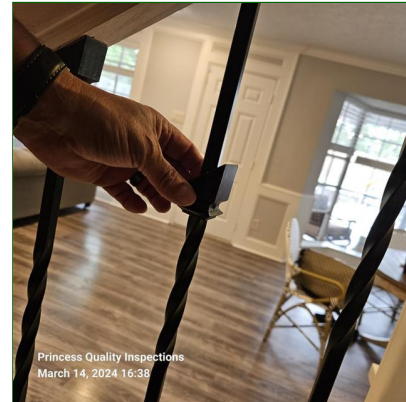
I. Item 2(Picture) Shoes are out of position and should be flush with rail above.

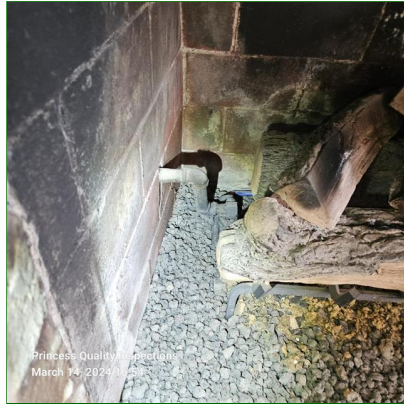
J. Item 1(Picture) Gas logs are present in the fireplace. However, the inspector did not locate a valve that will open gas to the logs and recommends asking the seller for its location and testing for gas pressure. If necessary, repair it.

(1) Gas logs are present in the fireplace. However, the inspector did not locate a valve that will open gas to the logs and recommends asking the seller for its location and testing for gas pressure. If necessary, repair it.

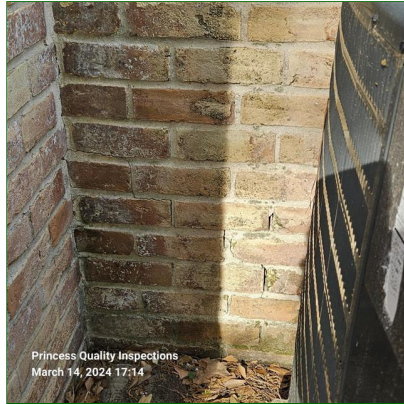
J. Item 5(Picture) Gaps in brick and mortar observed on chimney exterior and recommend repair of all gaps and cracks to prevent moisture seepage.

(2) Gaps in brick and mortar observed on chimney exterior and recommend repair of all gaps and cracks to prevent moisture seepage.

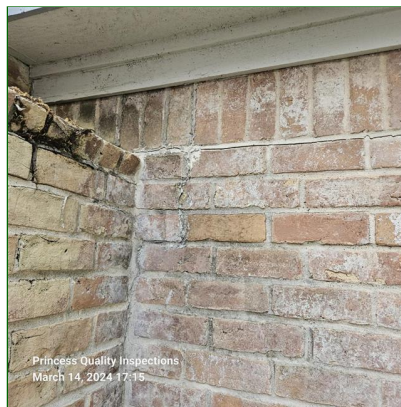
J. Item 9(Picture) Some mortar repairs observed.

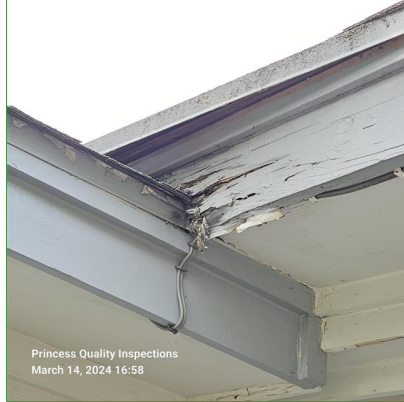
K. Item 1(Picture) Moisture damage observed at rear patio structure and mostly at fascia and recommend repair to prevent from creating an environment conducive to wood destroying insect activity.

(1) Moisture damage observed at rear patio structure and mostly at fascia and recommend repair to prevent from creating an environment conducive to wood destroying insect activity.

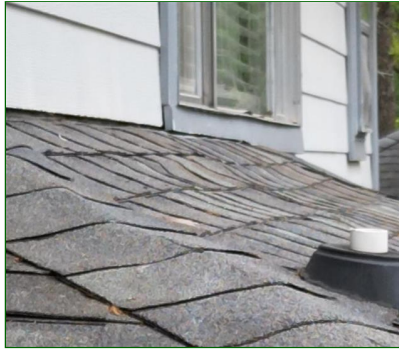
K. Item 5(Picture) Un uncommon dip in roof surface over rear patio structure observed and recommend further examination by a qualified roofing contractor to identify the cause and repair as necessary to prevent moisture intrusions and damage to materials.

(2) Un uncommon dip in roof surface over rear patio structure observed and recommend further examination by a qualified roofing contractor to identify the cause and repair as necessary to prevent moisture intrusions and damage to materials.

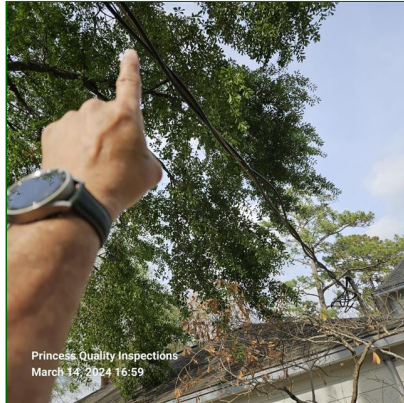
A. Item 1(Picture) The electrical service drop appears to be than the required 10" to grade. Due to the inherent danger, the inspector did not place his medal tape measure close enough to get the precise reading of height

(1) The electrical service drop appears to be lower than the required 10" to grade. Due to the inherent danger, the inspector did not place his metal tape measure close enough to get the precise reading of height, and the electrical service wires pass close enough for a child to grab from the top of the roof.

The inspector recommends contacting the electric service provider regarding clearances to the ground of the electrical service drop, as well as transmission and distribution power lines. If they see fit, they will perform repairs free of charge. FYI

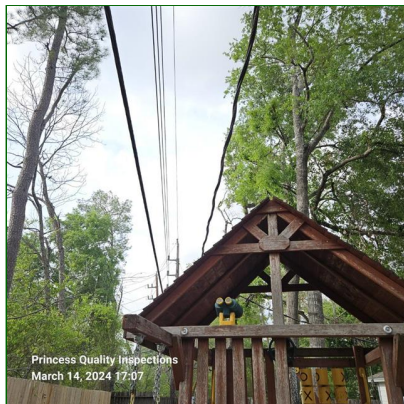
A. Item 3(Picture) Electrical transmission and distribution power lines are close enough to the Fort roof for a child to grab while standing on the roof. FYI

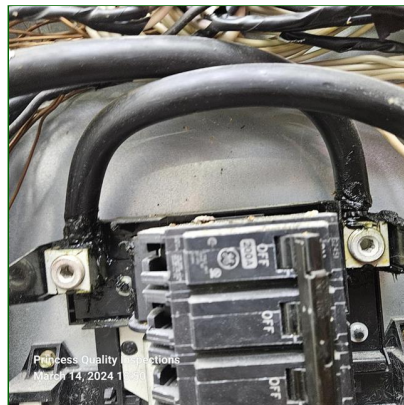
A. Item 7(Picture) Antioxidant paste was present on the aluminum strand service conductors at connections as required. FYI

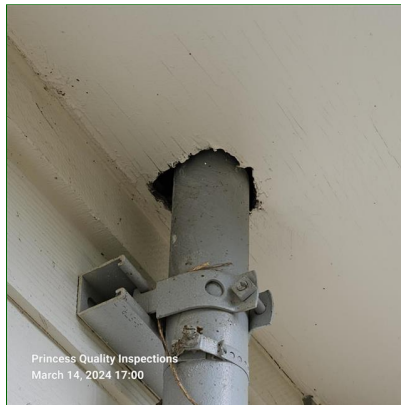
A. Item 11(Picture) Sealing off gap in soffit at electrical service mask penetration at rear of garages recommended to prevent flying insect and Vermin nesting Within structure.

(2) Sealing off gap in soffit at electrical service mask penetration at rear of garages recommended to prevent flying insect and Vermin nesting Within structure.

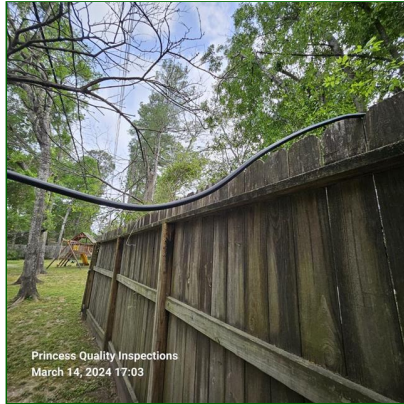
A. Item 12(Picture) A loose cable observed at the right rear corner of property and recommend further examination to identify the cable and correct as necessary.

(3) A loose cable observed at the right rear corner of property and recommend further examination to identify the cable and correct as necessary for safety.

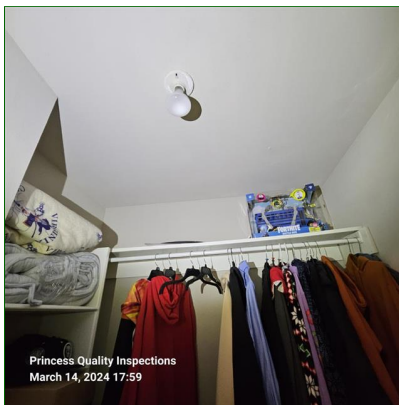
B. Item 2(Picture) Globes/covers are not present on light bulbs in closets.

(2) Observed open incandescent type light fixtures in one or more closets and recommend replacing incandescent bulbs with low wattage LED bulbs.

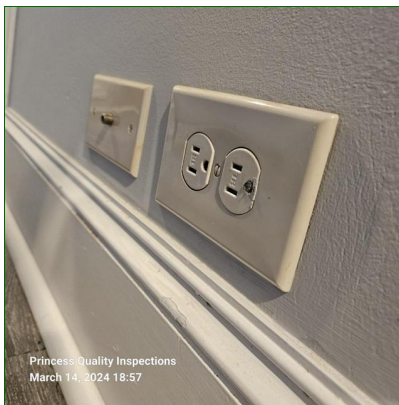
B. Item 3(Picture) A damaged prong what's observed stuck in a living room receptacle on exterior wall and recommend repair or replacement by a qualified electrical contractor for safety.

(3) A damaged prong what's observed stuck in a living room receptacle on exterior wall and recommend repair or replacement by a qualified electrical contractor for safety.

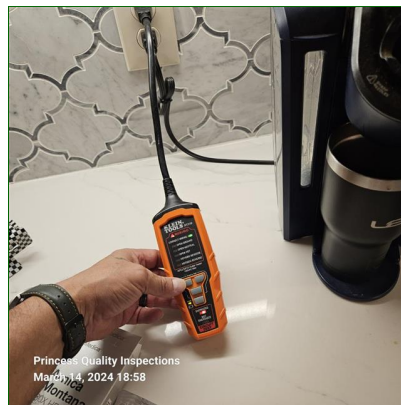
B. Item 6(Picture) The electrical receptacle at Coffee station did not respond to GFCI testing at the time of inspection and updating for safety is recommended. FYI

(5) The electrical receptacle at Coffee station did not respond to GFCI testing at the time of inspection and updating for safety is recommended. FYI

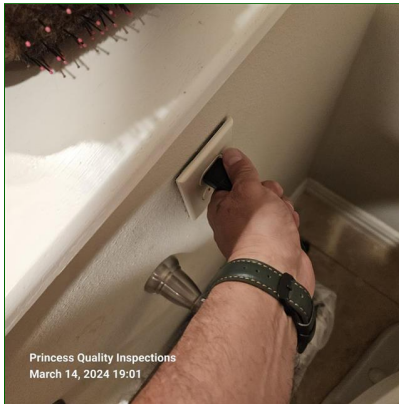
B. Item 7(Picture) The electrical receptacle next to the master toilet is loose and recommend adjustment or repair by qualified electrical contractor for safety.

(6) The electrical receptacle next to the master toilet is loose and recommend adjustment or repair by qualified electrical contractor for safety.

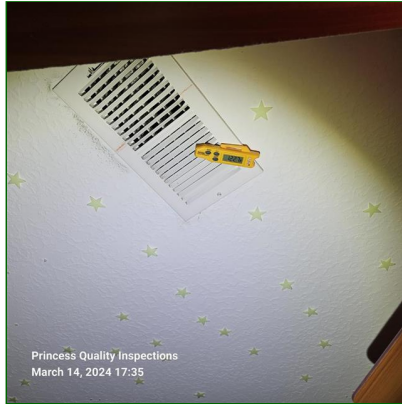
A. Item 1(Picture) The gas furnace was performing at the time of inspection.

(1) The gas furnace was performing at the time of inspection. However, a service platform that extends 30 in to the front of the appliance was not present and should have been installed at the time of last Appliance replacement installation of a service platform with a solid path to the Attic entry of no less than 24 in is recommended for safety. FYI

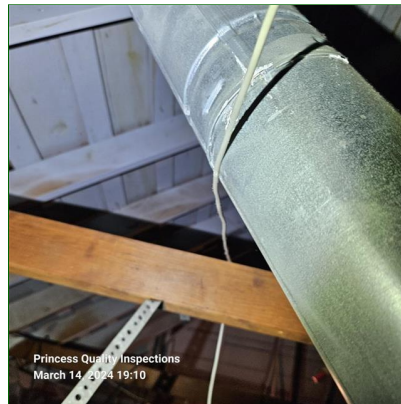
A. Item 3(Picture) The furnace exhaust Class B vent requires a 1-in clearance to combustible materials and recommend adjustment or relocating of signal wire that is in direct contact with furnace vent for safety.

(2) The furnace exhaust Class B vent requires a 1-in clearance to combustible materials and recommend adjustment or relocating of signal wire that is in direct contact with furnace vent for safety.

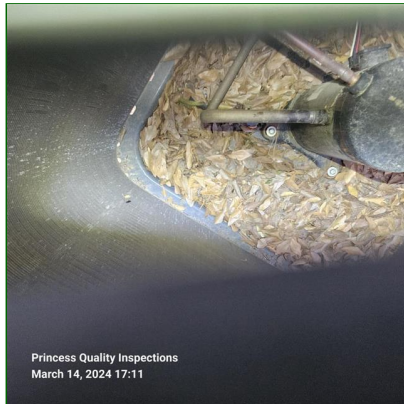
B. Item 5(Picture) Debris observed inside condenser housing and service or repair by a qualified HVAC contractor to prevent reductions inefficiency from debris blockages.

(2) Debris observed inside condenser housing and service or repair by a qualified HVAC contractor to prevent reductions inefficiency from debris blockages.

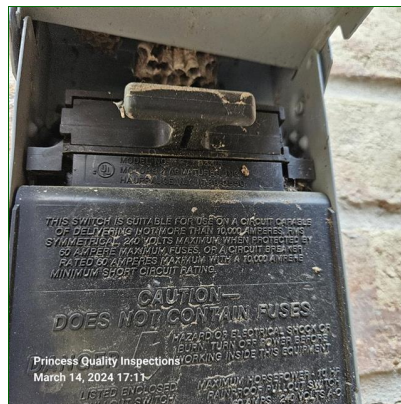
B. Item 7(Picture) Wasp nests observed inside of the condenser service disconnect panel and recommend removal by qualified HVAC or electrical contractor for safety.

(3) Wasp nests observed inside of the condenser service disconnect panel and recommend removal by qualified HVAC or electrical contractor for safety.

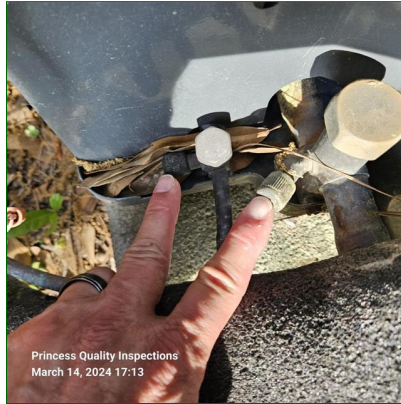
B. Item 8(Picture) The condenser service ports do not have the necessary tamper resistant caps installed.

(4) Condenser refrigerant circuit access ports (which carries the refrigerant to and from your outdoor AC, and indoor cold coil) are commonly fitted with locking type tamper-resistant caps to prevent unauthorized access and recommend correcting and are not present and by modern standards are required.

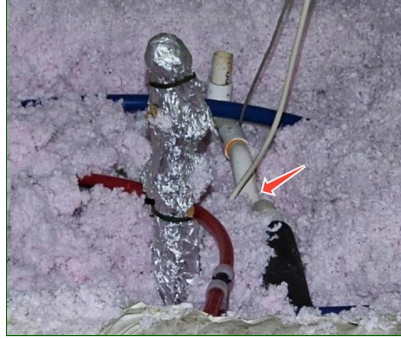
B. Item 11(Picture) The primary condensate drain line trap is not insulated. Insulating the Trap is recommended to prevent condensation and moisture damage.

(6) The primary condensate drain line trap is not insulated. Insulating the Trap is recommended to prevent condensation and moisture damage.

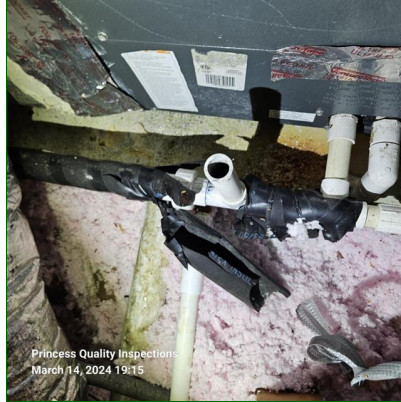
B. Item 14(Picture) Gaps/separation in foam insulation observed on the primary condensate drain line at evaporator and recommend insulating all exposed primary condensate drain line in attic space to prevent condensation and moisture damage..

(8) Gaps/separation in foam insulation observed on the primary condensate drain line at evaporator and recommend insulating all exposed primary condensate drain line in attic space to prevent condensation and moisture damage..

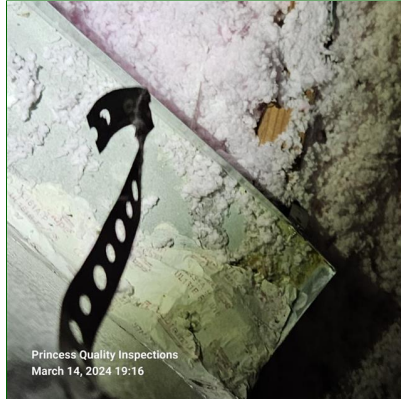
B. Item 15(Picture) Removal of all debris from evaporator drip pan is recommended to prevent clogging of drain line.

(9) Removal of all debris from evaporator drip pan is recommended to prevent clogging of drain line.

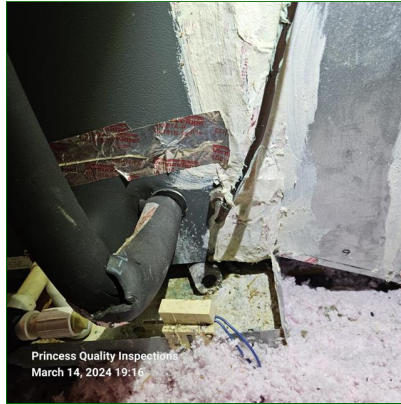
B. Item 16(Picture) The air handler is resting on top of drip pan vertical wall and is uncommon the inspector recommends further examination of the air handler installation and repair is necessary to prevent condensation and moisture damage.

(10) The air handler is resting on top of drip pan vertical wall and is uncommon the inspector recommends further examination of the air handler installation and repair is necessary to prevent condensation and moisture damage.

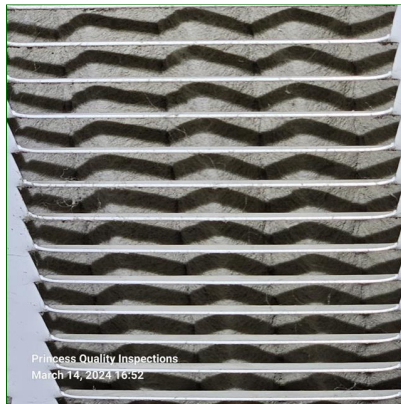
C. Item 1(Picture) Dirty filters observed and recommend replacement and return duct cleaning part of routine maintenance as recommended by the HVAC manufacturer for long-term performance of equipment.

Dirty filters observed and recommend replacement and return duct cleaning part of routine maintenance as recommended by the HVAC manufacturer for long-term performance of equipment.

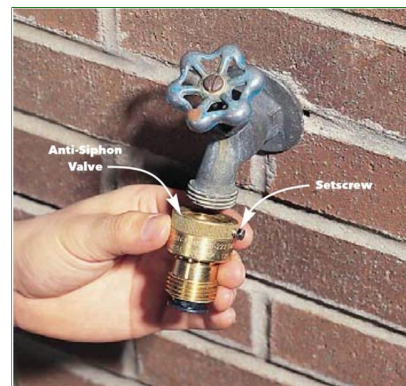
A. Item 4(Picture) Anti-siphon devices were not present and recommend installing anti-siphon devices.

(2) The exterior hose bibs are missing anti-siphon devices and recommend installing anti-siphon/vacuum breaker devices. A hose connection vacuum breaker should be installed on each faucet or hose bibb that is connected to the potable water supply to prevent backflow to the water supply.

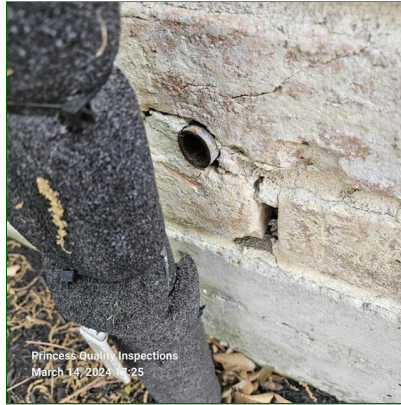
A. Item 6(Picture) The old abandoned galvanized pipe at water service entrance is open and recommend sealing off to prevent insect and or Vermin entry.

(3) The old abandoned galvanized pipe at water service entrance is open and recommend sealing off to prevent insect and or Vermin entry.

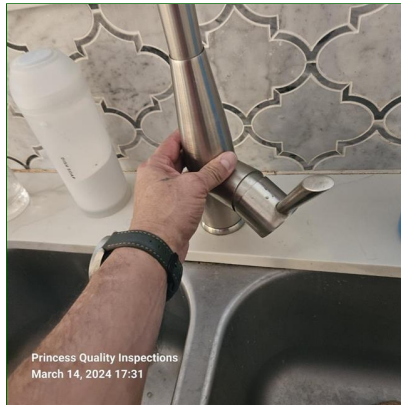
A. Item 7(Picture) The kitchen sink fixture was loose and recommend adjustment or repair.

(4) The kitchen sink fixture was loose and recommend adjustment or repair.

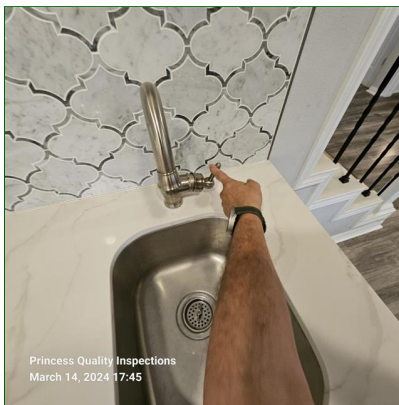
A. Item 8(Picture) The smaller sink fixture water supply may have been cut off and was not working at the time of inspection.

(5) The smaller sink fixture water supply may have been cut off and was not working at the time of inspection. FYI

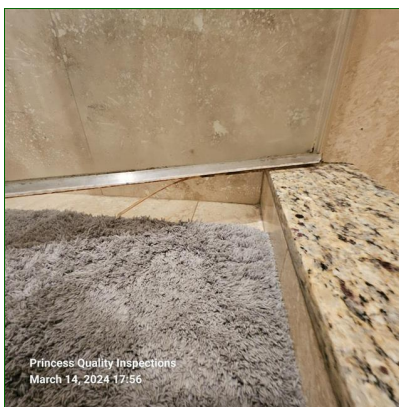
A. Item 9(Picture) The Master shower door bottom seal is damaged and recommend replacement to prevent moisture from leaving shower enclosure.

(6) The Master shower door bottom seal is damaged and recommend replacement to prevent moisture from leaving shower enclosure.

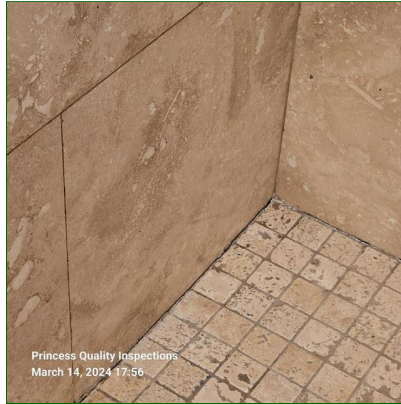
A. Item 10(Picture) Gaps/ separation in tile grout observed at Master shower tile and recommend touching up grout for sealant application.

(7) Gaps/separation in tile grout observed at Master shower tile and recommend touching up grout for sealant application.

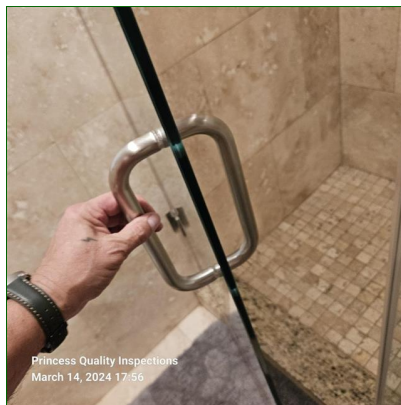
A. Item 11(Picture) The shower door handle was observed loose.  
FYI

(8) The shower door handle was observed loose. FYI

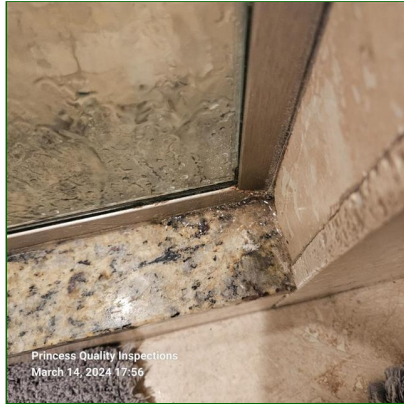
A. Item 12(Picture) Shower enclosure leaks observed at 2 or locations of Master shower and recommend repairing leaks to prevent moisture damage to materials.

(9) Shower enclosure leaks observed at 2 or locations of Master shower and recommend repairing leaks to prevent moisture damage to materials.

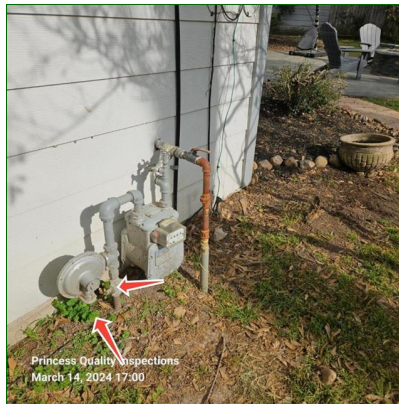
A. Item 14(Picture) The gas meter regulator/vent is closer to ground than the common 18" and the gas cut off valve is closer to the ground than the common 8 in. Any repairs to these items would be performed by the gas service provider with no charge. FYI

(10) The gas meter regulator/vent is closer to ground than the common 18" and the gas cut off valve is closer to the ground than the common 8 in. Any repairs to these items would be performed by the gas service provider with no charge. FYI

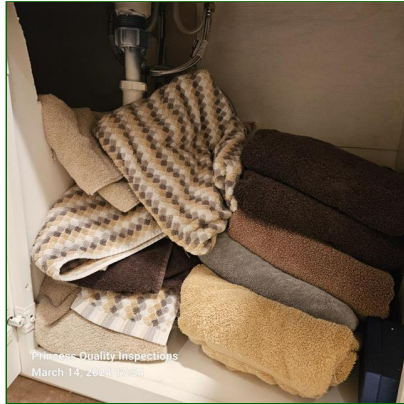
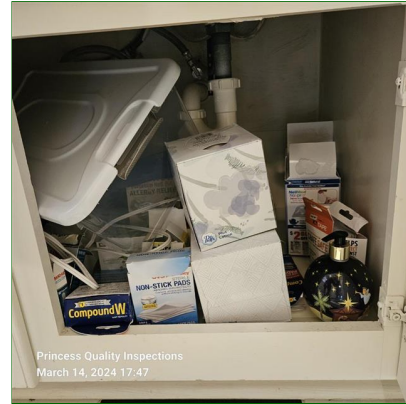
B. Item 1(Picture) Occupant stored items under sinks obscured items to be inspected

Occupant stored items under sinks obscured items to be inspected. Plumbing supply, drainage piping, attic spaces and electrical panels are important items that are inspected during a home inspection and should be made readily available and visible. The inspector recommends scheduling a reinspection of water supply piping and drainage under cabinets that were obscured by occupants stored items and the locked attic space at the second floor left side with access through left front bedroom closet to determine if any deficiencies are present at these areas.

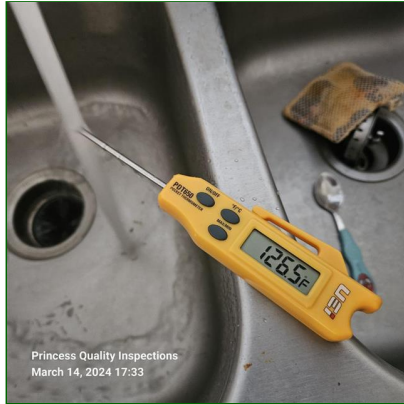
C. Item 1(Picture) Water heating temperature ok

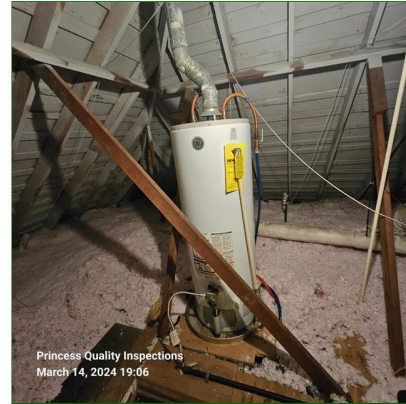
C. Item 2(Picture) The water heater is located in the high attic

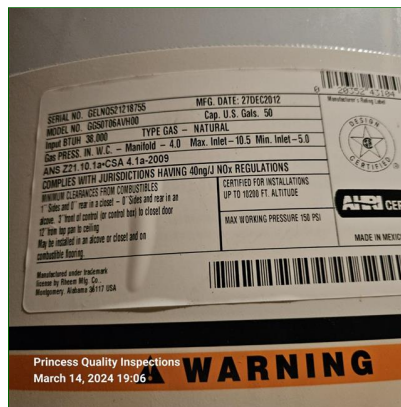
C. Item 3(Picture) The water heater was manufactured in 2012 and is over 11years old. Well maintained gas water heaters normal service life is between 10 and 15 years and recommend budgeting for replacement in the near future based on the history of damage caused by bursting water heater tank.

The water heater was manufactured in 2012 and is over 11years old. Well maintained gas water heaters normal service life is between 10 and 15 years and recommend budgeting for replacement in the near future based on the history of damage caused by bursting water heater tank.

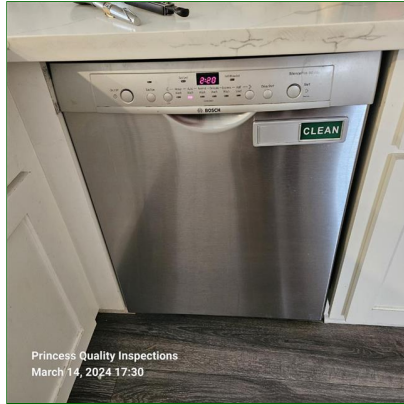
A. Item 1(Picture) The dishwasher was performing at the time of inspection.

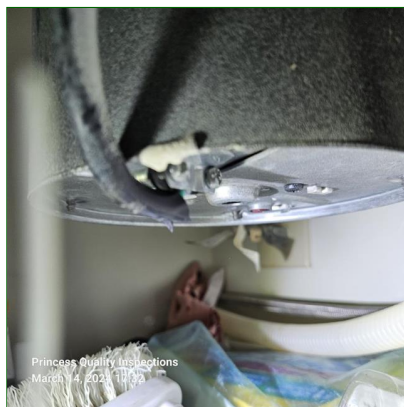
B. Item 1(Picture) The garbage disposal power supply sheathing was removed exposing the individual sheathed wires the outer sheathing should remain intact beyond unit entry. FYI

(1) The garbage disposal power supply sheathing was removed exposing the individual sheathed wires the outer sheathing should remain intact beyond unit entry. FYI

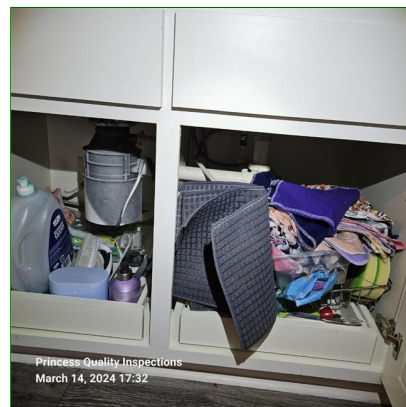
B. Item 2(Picture) Occupant stored items prevent full view under cabinets. FYI

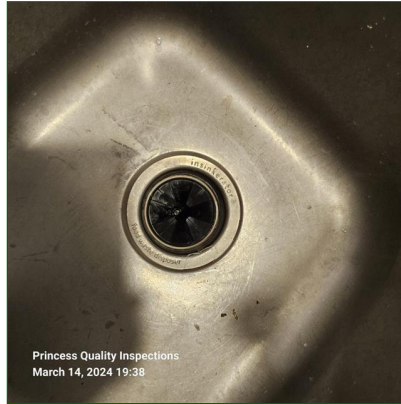
B. Item 3(Picture) The garbage disposal was noisy and appeared to have an item trapped in the unit. FYI

(2) The garbage disposal was noisy and appeared to have an item trapped in the unit. FYI

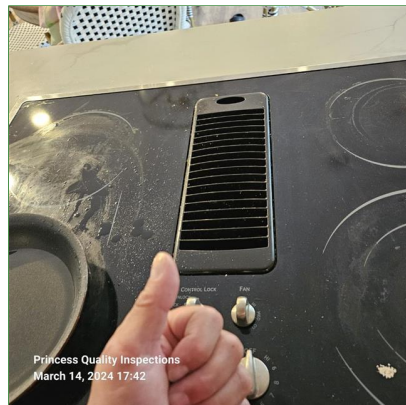
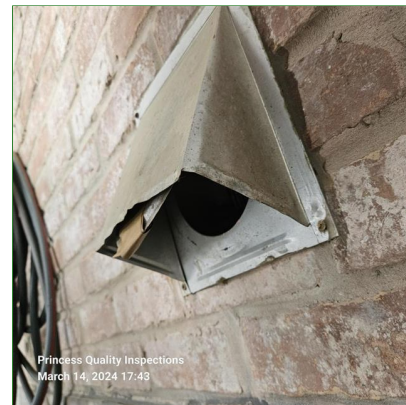
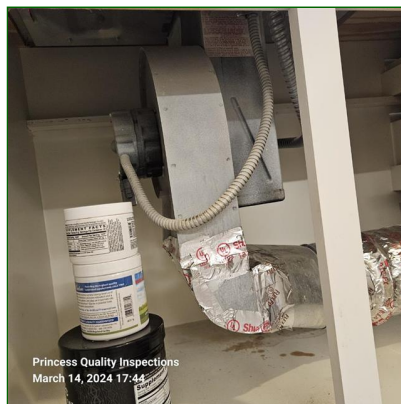
C. Item 1(Picture) The downdraft ventilation was performing at the time of inspection.

(1) The downdraft ventilation was performing at the time of inspection.

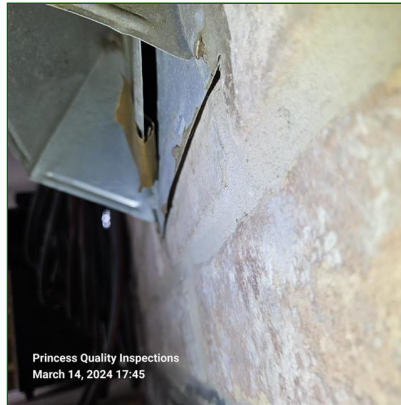
C. Item 4(Picture) The downdraft termination damper would not close fully and maybe caused by the cardboard for paper attached to damper and recommend further examination and correct as necessary to prevent Vermin entry through open damper.

(2) The downdraft termination damper would not close fully and maybe caused by the cardboard for paper attached to damper and recommend further examination and correct as necessary to prevent Vermin entry through open damper.

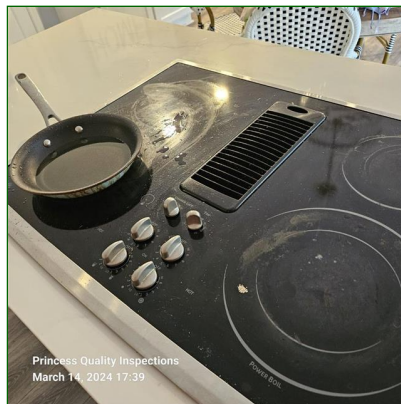
D. Item 1(Picture) The cooktop contained grease on cooking areas and therefore was not tested for performance and recommend testing cooktop for performance and repair if necessary.

(1) The cooktop contained grease on cooking areas and therefore was not tested for performance and recommend testing cooktop for performance and repair if necessary.

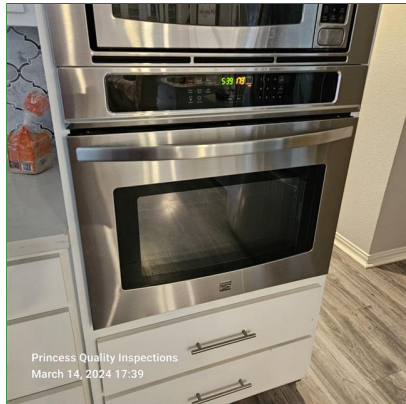
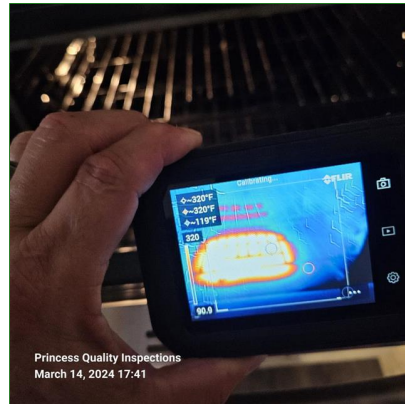
D. Item 2(Picture) The built-in oven was performing at the time of inspection.

(2) The built-in oven was performing at the time of inspection.

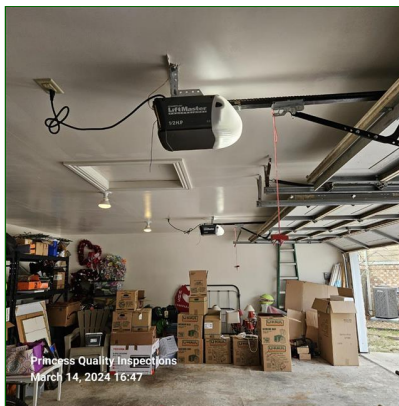
G. Item 1(Picture) Garage door operators

The garage door will reverse when met with resistance. The sensors are in place for garage door(s) and will reverse the door. The garage door(s) were performing as intended at the time of inspection.

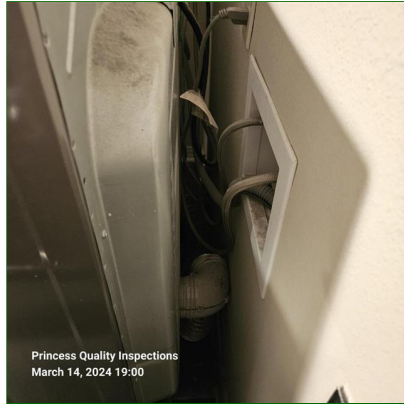
H. Item 1(Picture) The dryer was connected to the dryer exhaust system at the time of inspection and recommend disconnecting dryer from vent , clean all the way to the point of termination and then at least once per year to prevent the accumulation of clothes lint and potential fire hazards.

The dryer was connected to the dryer exhaust system at the time of inspection and recommend disconnecting dryer from vent , clean all the way to the point of termination and then at least once per year to prevent the accumulation of clothes lint and potential fire hazards. One of the most important but often overlooked maintenance tasks for your home is cleaning the dryer exhaust system. This includes the duct that runs from the dryer to the outside vent, as well as the vent itself. Why is this so important? Because lint buildup in the dryer exhaust system can reduce the efficiency of your dryer, increase your energy bills, and create a serious fire hazard. According to the NFPA, dryers and washing machines are responsible for nearly 16,000 fires every year in the U.S., with dryers accounting for 92% of them. These fires result in an average of \$200 million in property damage, as well as injuries and deaths. The leading cause of these fires is failure to clean the dryer exhaust system. To prevent this from happening, you should clean your dryer exhaust system at least once a year, or more often if you notice any signs of lint accumulation, such as longer drying times, overheating, or a burning smell. You can hire a professional service to do this for you, or you can do it yourself with some basic tools and safety precautions.

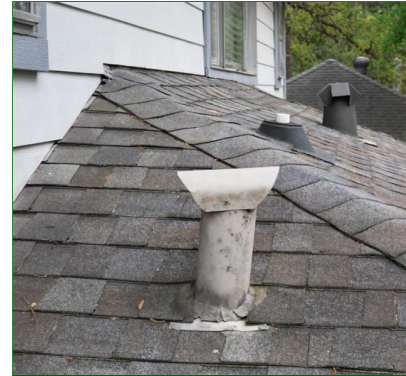
H. Item 2(Picture) The old dryer exhaust system termination above roof does not contain a backdraft damper to prevent flying insect or vermin entry and recommend replacing the dryer vent termination with a termination containing a backdraft damper at next roof covering change. FYI

The old dryer exhaust system termination above roof does not contain a backdraft damper to prevent flying insect or vermin entry and recommend replacing the dryer vent termination with a termination containing a backdraft damper at next roof covering change. FYI

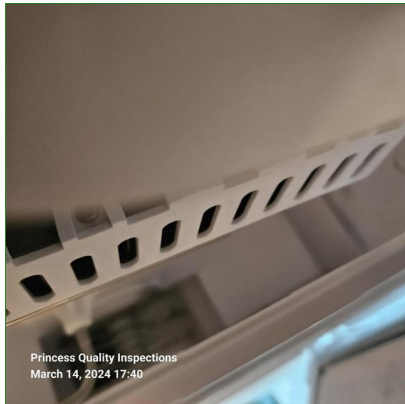
I. Item 2(Picture) No ice in ice bin
