STRUCTURAL REPORT

9743 Rockwell Dr
Willis, TX 77318

JANUARY 17, 2024

REF: CONDITION OF PROPERTY SURVEY

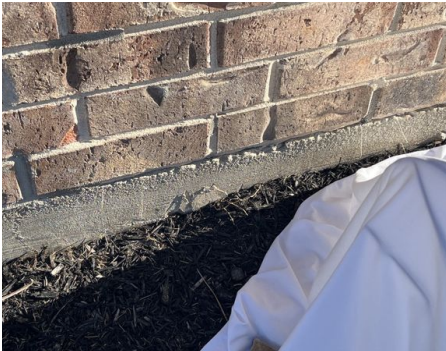
Description: Concrete PT slab

The foundation was a concrete slab on grade, and was reinforced with post tensioned cables.

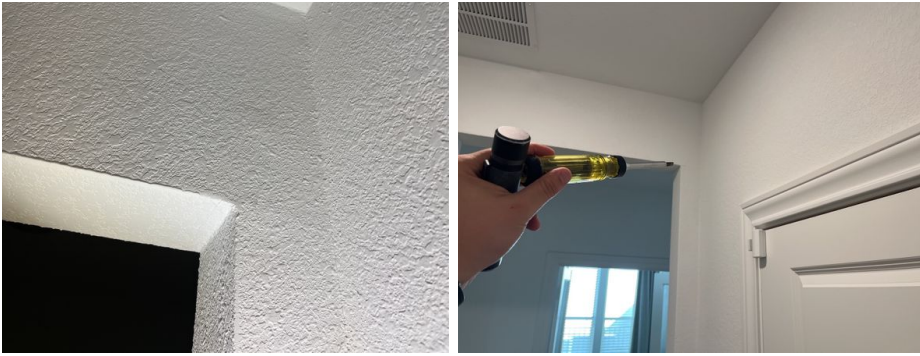
Differential Movement: Veneer Cracks - Minimal

We observed that cracks in the exterior veneer were minimal in number and degree at the time of the inspection.

Differential Movement: Sheetrock Cracks - Minimal

We observed that sheetrock cracks were minimal in number and degree at the time of the inspection.

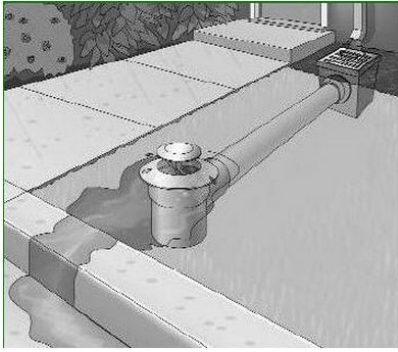
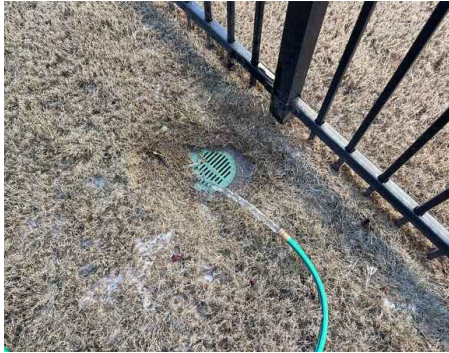
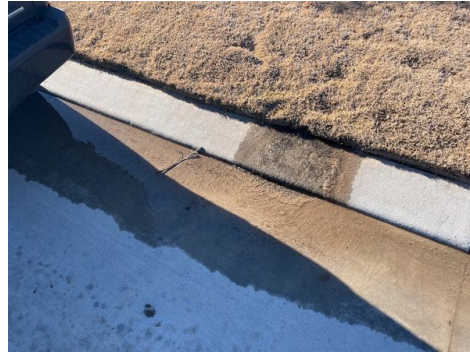
Perimeter Grading/Drainage: Underground drainage to pop-up emitter

The underground drainage system at the rear of the house was checked by running water into the drain for approximately 15 minutes, and the system was observed to be draining properly to the pop-up emitter.

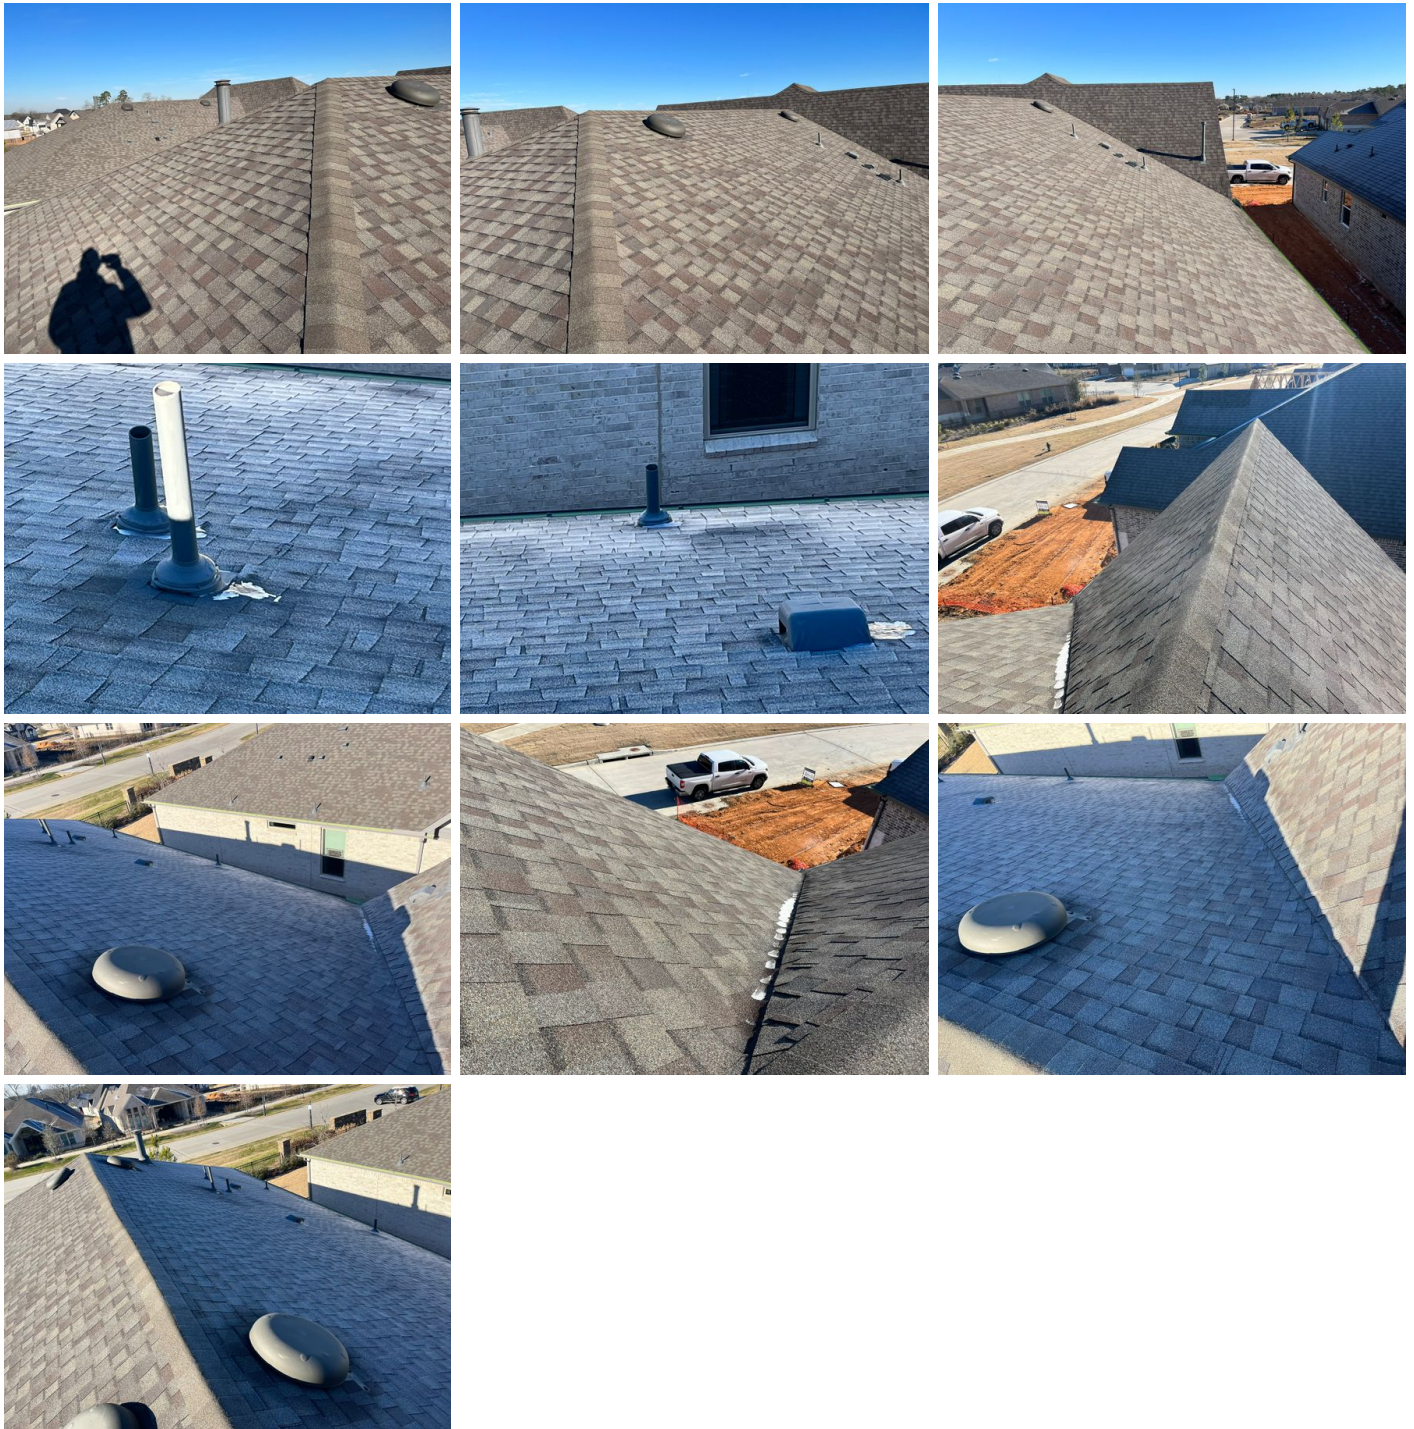
Roof Description: Composition Shingles

The pitched roof surface was constructed of composition shingles. The life expectancy of a composition shingle roof has been observed to vary from 15 to 20 years, with most requiring replacement at about 17-20 years.

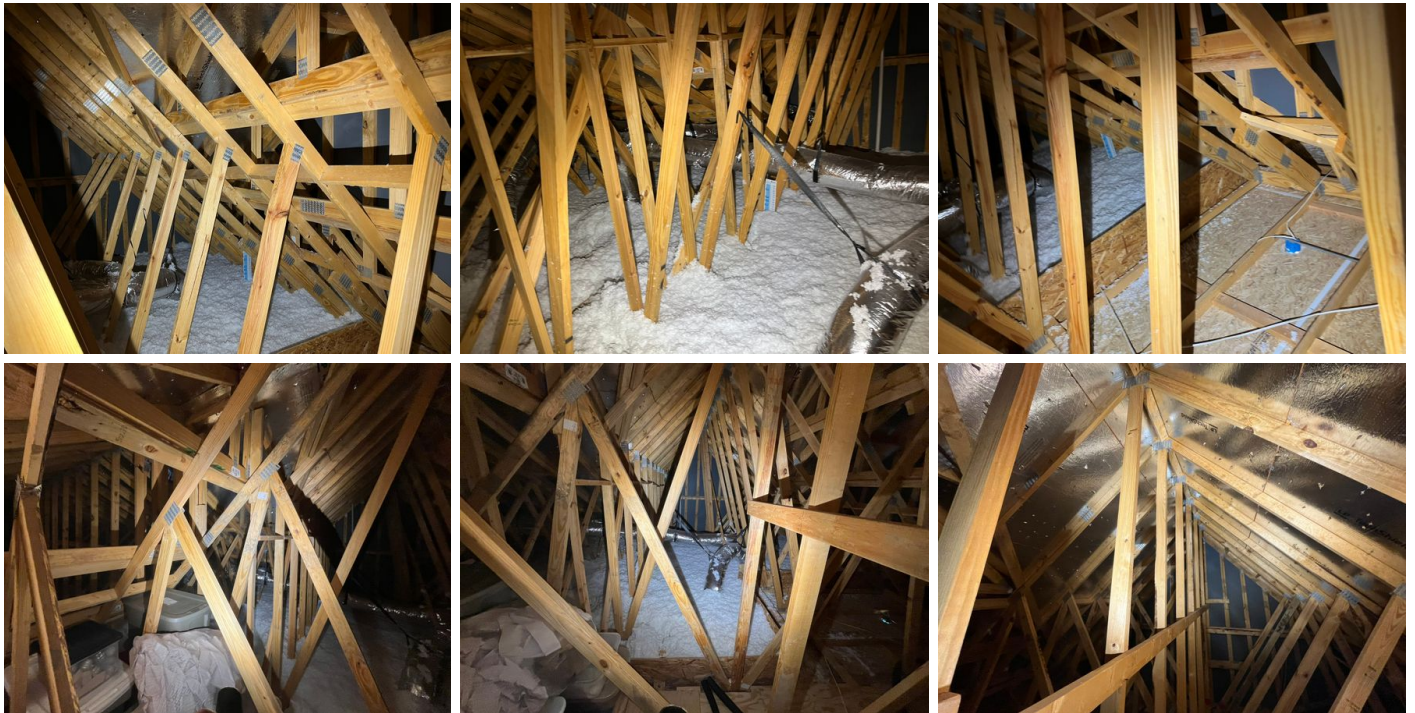
Framing Description: Prefabricated trusses in attic

The roof framing members in the attic were constructed of prefabricated trusses connected with metal gusset plates pressed into the wood at the joints.

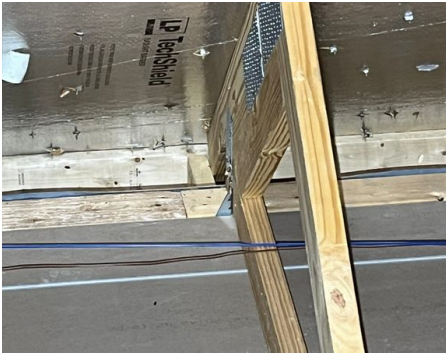
Hurricane Clips/Straps: Clips at roof/wall

Wind uplift or hurricane clips were observed to be installed at the bottom of the roof framing, connecting the roof rafters to the top of the wall framing. This provides a stronger structure and will be more resistant to wind uplift from hurricane and tornadoes.

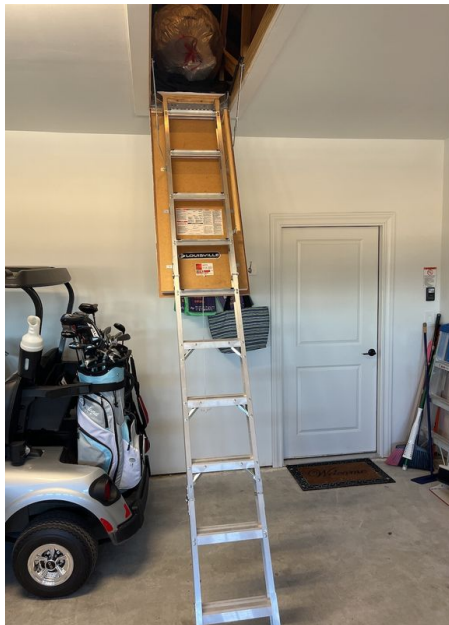
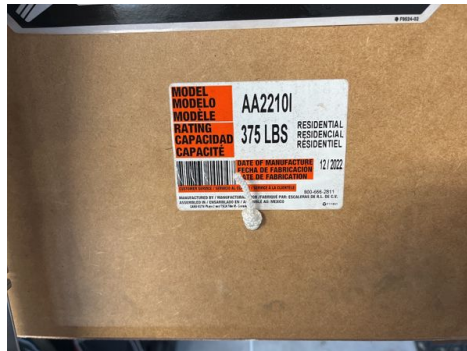
Ladder: 375 pound capacity

The access ladder was observed to be rated at 375 pound capacity.
