HEDDERMAN SERVICES

MECHANICAL REPORT

9743 Rockwell Dr
Willis, TX 77318

PROPERTY INSPECTION REPORT FORM

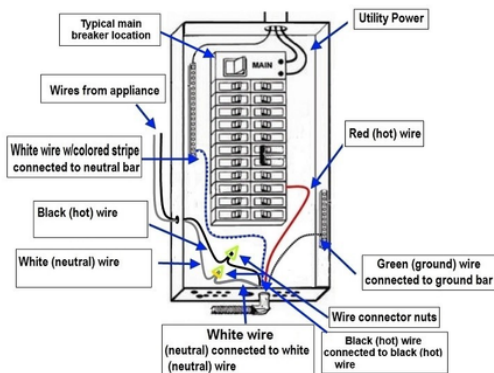
Circuit Breaker Wiring Diagram

The interior of the breaker panel equipment was inspected and the breakers were all properly sized for the circuits they were protecting, the grounding and bonding were properly connected, no knockout clips were missing, and the wiring appeared to be in acceptable condition at the time of the inspection.

It is a general recommendation that all circuit breakers be tripped off and on at least once a year to ensure that they are still physically able to trip off. Occasionally, the points on a breaker will fuse to the main bus in the panel, preventing the breaker from tripping off, even if there is an overload on the circuit. If this condition occurs, it can be a fire hazard.

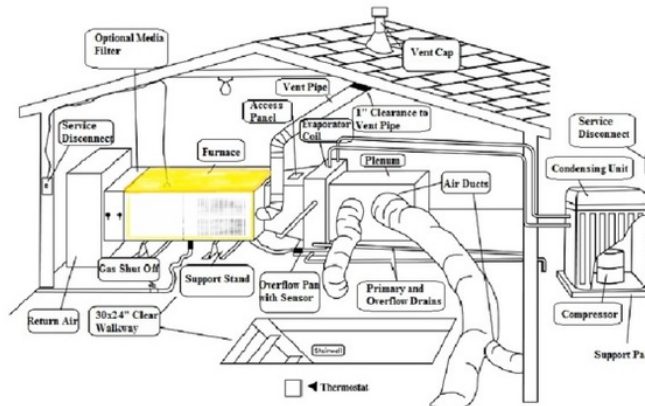
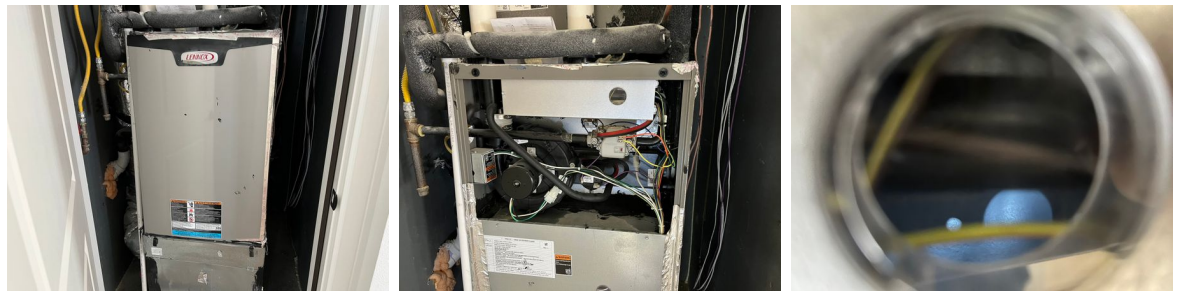
The heating for the property was provided the following natural gas-fired equipment:

<u>ZONE</u>	<u>BRAND</u>	<u>BTU</u>	<u>DATE</u>	<u>LOCATION</u>
House	Lennox	88,000	2022	Utility Closet

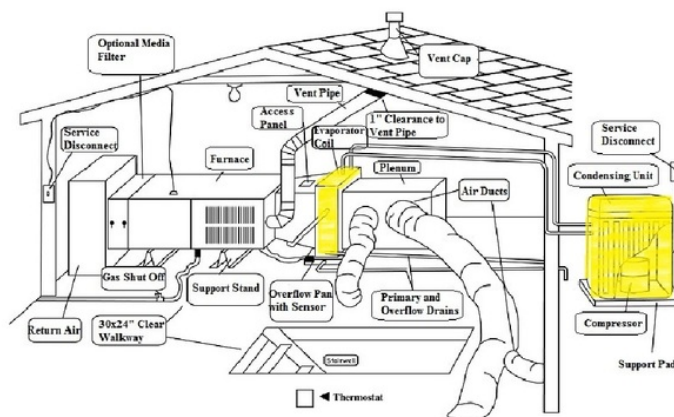
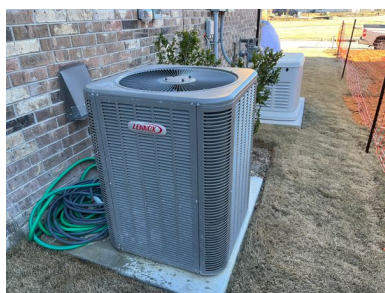
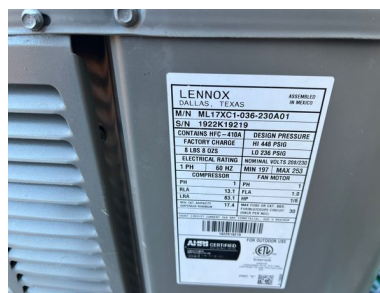
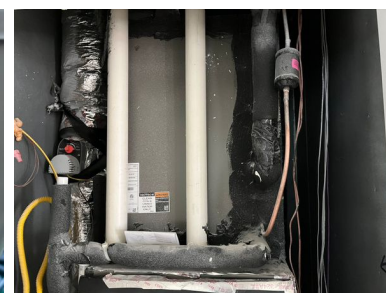
Overflow Pan - Water sensor present:

The overflow pan under the evaporator coil was equipped with a water sensor that is intended to shut off the air conditioning equipment if the pan fills with water.

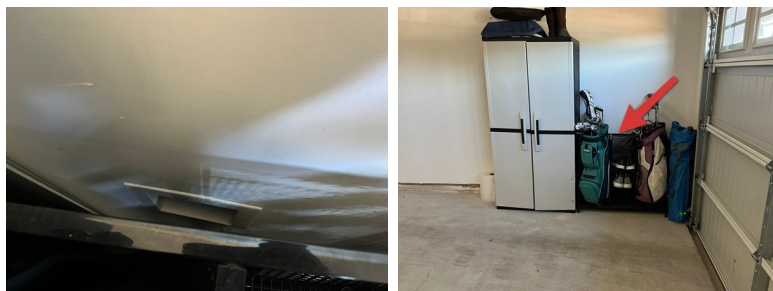
Main Water Shut Off Valve Location: Inside garage -

The main shut-off valve for the water line service piping is intended to provide a means to disconnect the water service to the structure/property.

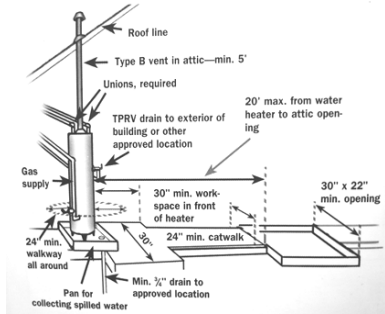
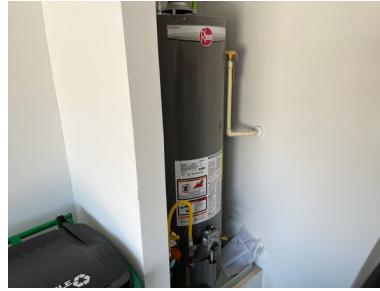
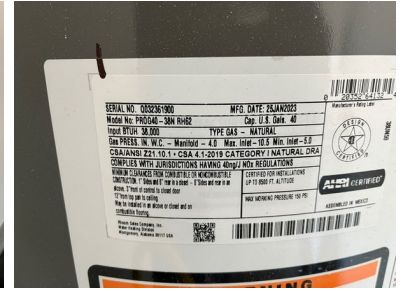
Location	Brand	Capacity	Age	Energy Type
Garage	Rheem	40 gallons	2023	Gas

Water Heater Equipment - Functional:

The water heater equipment was functional at the time of the inspection and providing hot water to the applicable plumbing fixtures.

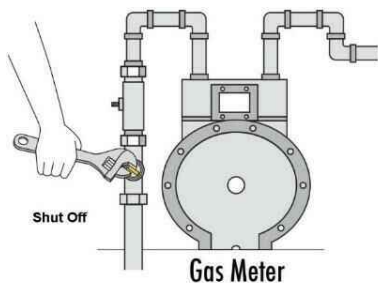
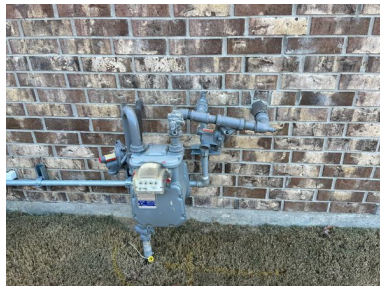
Gas System - No repairs noted:

No items were observed that were in need of repair at the time of the inspection for the visible gas supply piping.

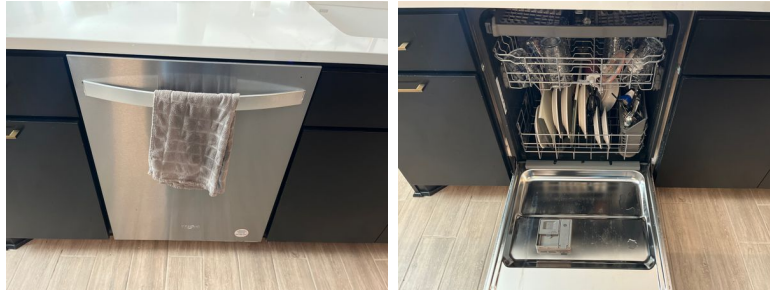
Functional:

The dishwasher was functioning and responded to the controls. The unit was run through a cycle at the time of the inspection and appeared to be operating properly.

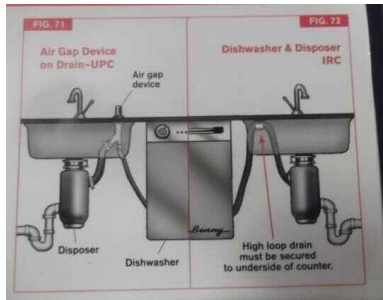
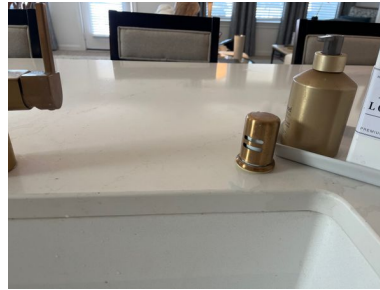
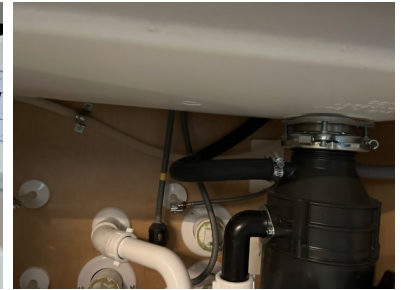
Anti-siphon Present:

The dishwasher drain line was connected to an anti-siphon device at the kitchen sink, which was functional at the time of the inspection.

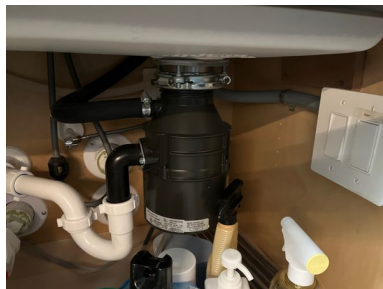
Functional:

The disposal was operating and responded to the controls at the time of the inspection.

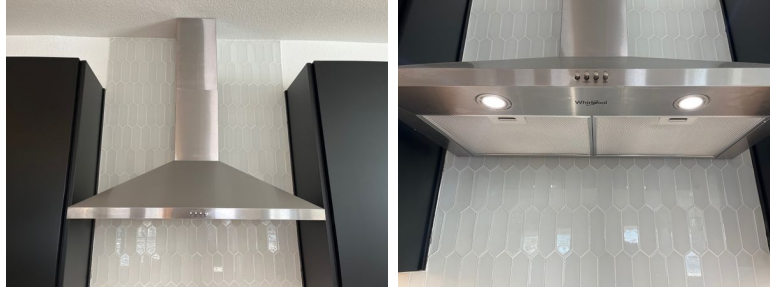
Range Vent - Functional:

No items requiring repair were visible at the time of the inspection to the operation of the range vent. The vent fan was observed to be venting properly at the time of the inspection.

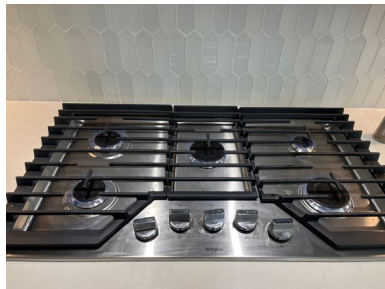
Gas Cooktop - Functional:

The gas cooktop was functioning and responded to the controls when they were operated. All of the burners and controls were operating properly at the time of the inspection.

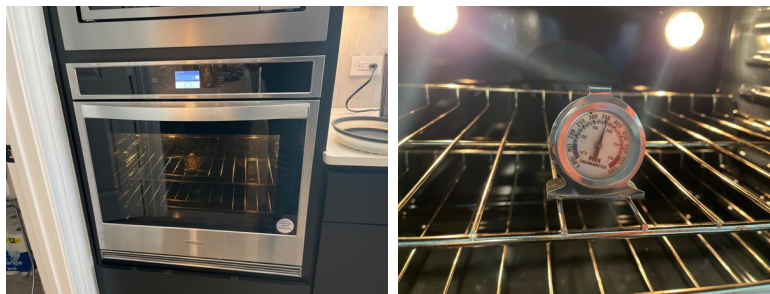
Electric Oven - Functional:

The electric oven was observed to be functioning and no items requiring repair were visible at the time of the inspection.

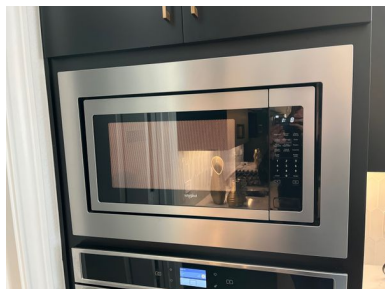
microwave. A cup of water was placed in the unit, and the microwave heated the water adequately. It is pointed out that the unit was not checked for microwave leakage.

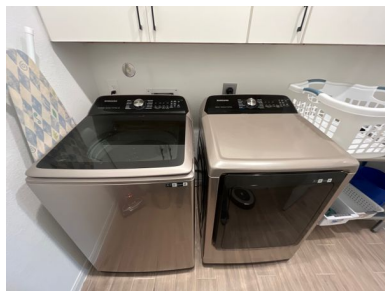
Dryer vent - Dryer present:

The vent was connected to the dryer but was not tested. It is recommended that the vent be checked for an excess of lint and that it be cleaned if necessary. (Information)

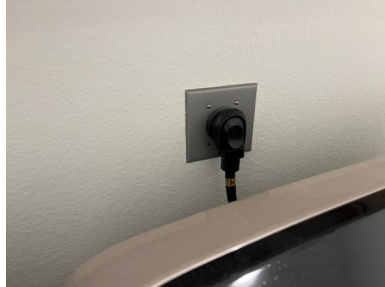
Dryer Connection - No Gas - Electric 4 prong:

The 240-volt outlet for the electric dryer connections was observed to be the newer style 4-prong outlet rather than the older 3-prong outlet. You may want to check your clothes dryer to determine if you have the correct power cord for this outlet. A gas connection was not installed.

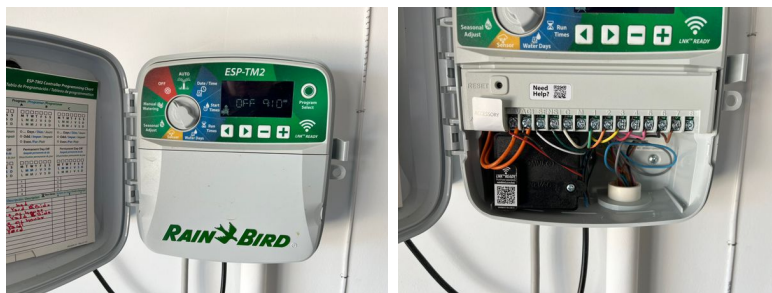
Sprinkler System: Rainbird, Located inside garage, 7 zones -

An automatic sprinkler system was installed. The system included a control panel, one or more solenoid valves, underground water lines and with sprinkler heads.

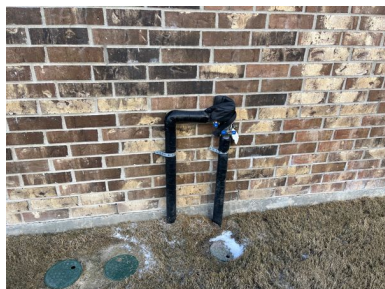
Backflow Prevention Device - present:

A backflow prevention device was present and was equipped with the two water shut off valves on the water supply line to the sprinkler system.
