PROPERTY INSPECTION REPORT

23502 Greenwood Springs Place, Katy Texas 77493

February 23, 2024

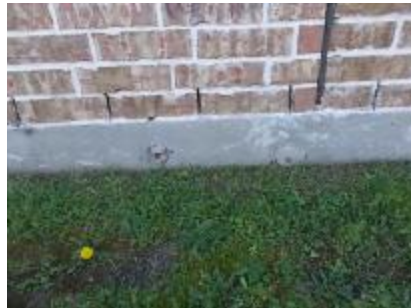
Comments: corner pops/cracks at front left, right rear, right rear, rear left. exposed cable ends at rear and left. have contractor seal corner pops and exposed cables.

exposed cable ends rear

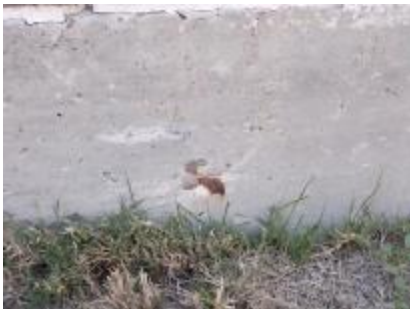
Exposed cable end left
