RESIDENTIAL INSPECTION REPORT

8526 Stones Throw Ln
Missouri City, TX 77459

PROPERTY INSPECTION REPORT FORM

8526 Stones Throw Ln, Missouri City, TX 77459
Address of Inspected Property

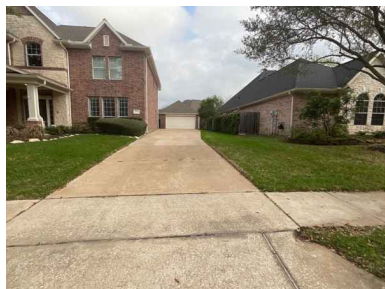
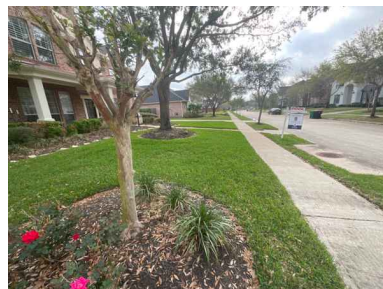
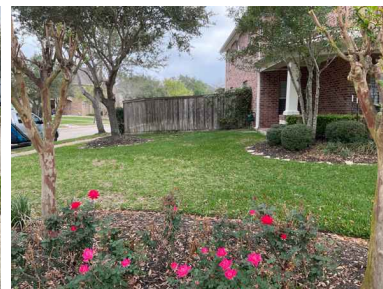
Drainage Adequate: Right Side, Front, Left Side, Rear -

The general slope, swales and underground drainage (if installed) around the structure appeared adequate to sufficiently drain storm water away from the foundation on the above listed sides. In general, water should not stand within 10' of the foundation for more than 24 hours. While some deficiencies may be noted in this report, the overall grading appeared adequate to provide proper drainage on these sides of the home.

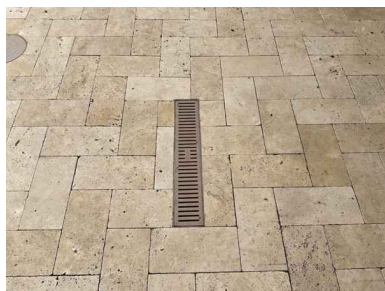
Rear

Surface Drainage Installed:

There is an underground and/or surface drainage system in place and appeared to terminate in an appropriate location. While I am not able to verify the operation, sizing, efficiency or adequacy of the system, no apparent drainage issues were noted at the time of the inspection.

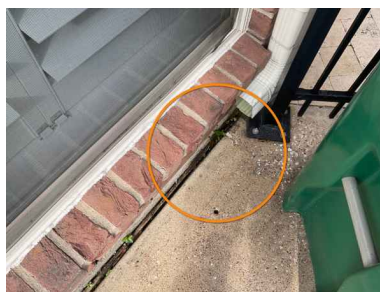
Right Side

The downspout is loose and not secured to the wall. During heavy rains, a large amount of water is drained through the downspouts and could cause an unsecured downspout to move. This movement could cause damage to the downspout itself as well as the gutters, fascia, soffit or siding. The downspout should be secured to prevent potential damage.

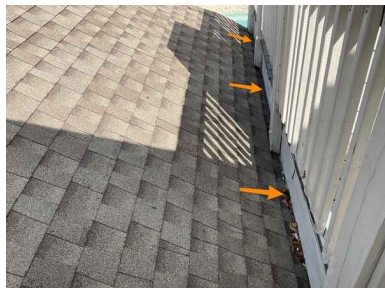
Rear

The installed second-story balcony prevents proper drainage from roof coverings. The installation should be further assessed by a knowledgeable contractor.

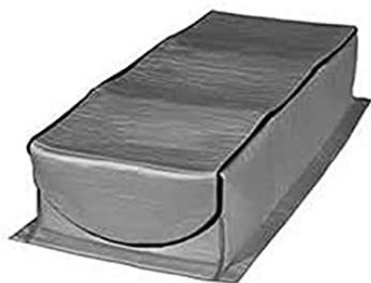
Attic Tent

The pull down attic access stair is not insulated or sealed effectively. This can cause some heat loss in the winter and the loss of cool air in the summer if not corrected. The easiest correction is the installation of weatherstripping and an attic stair insulator kit, also known as an attic tent.

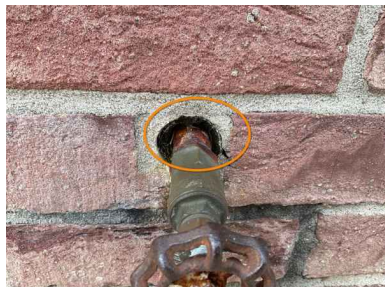
Right Side

The gaps around the exterior cladding and the fixtures/penetrations are not sealed. Areas such as utility connections, hose bibbs, lighting fixtures, receptacles, etc should be properly sealed. Unsealed gaps or holes can allow insects, moisture and weather to enter the wall cavity and cause damage. I also recommend the gaps be sealed with an appropriate exterior grade elastomeric caulk which is designed to last longer and remain flexible than interior grade caulk.

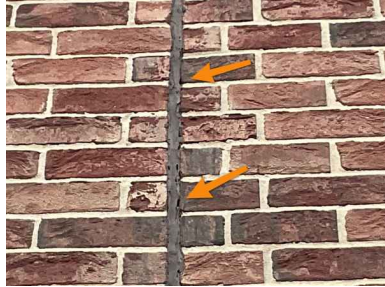
Left Side

The exterior expansion joint sealant is missing or deteriorated in places. Missing or deteriorated sealant can allow water to enter the wall structure and cause internal damage and further deterioration. I recommend any aged caulk be removed and the seam be sealed with the appropriate exterior grade elastomeric caulk to prevent infiltration by insects, moisture and weather.

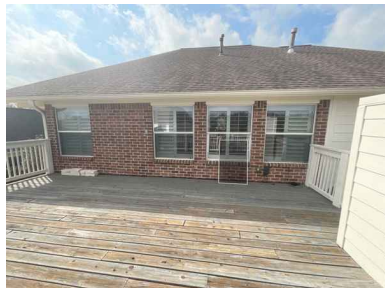
Rear

No Access to Balcony:

There is no access to the second story balcony at the rear of the home. This is provided for your information.

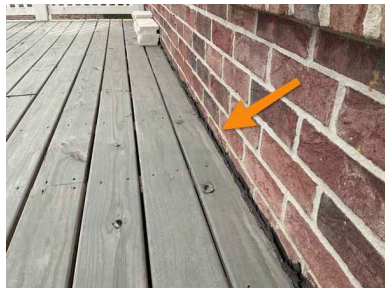
2nd Floor Deck

1: Balcony - Inadequate Flashing

The balcony floor joists did not appear to be flashed correctly. Flashing is critical at the connection to the structure to keep water from entering the house as well as to protect the integrity of the cantilevered joist. A qualified contractor should further assess and determine corrective action if needed.

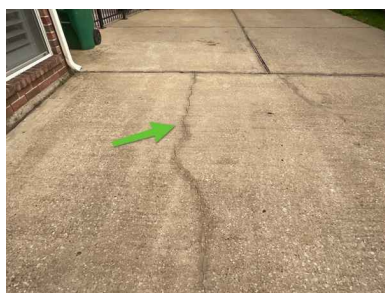
Right Side

Driveway - Cosmetic Cracks: Curing or settlement cracks were noted in the concrete driveway. These are considered cosmetic in nature unless they continue to expand or heave vertically. I recommend that the cracks be monitored for any future movement and if significant movement occurs, to consult a concrete contractor for repair options.

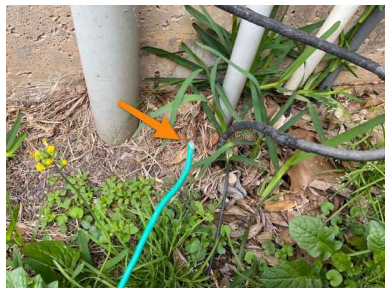
Low Voltage

The low voltage system (cable, internet, phone) did not appear to be properly grounded/bonded. This is considered unsafe. A grounding wire should be installed.

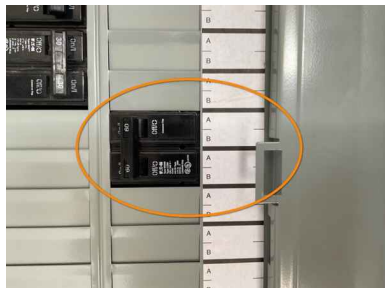
Panel Box

4: Panel - Inadequate Labeling

The panel labeling is missing, illegible or confusing. This should be corrected for ease of use and safety reasons.

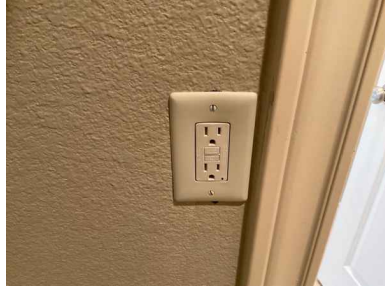
Master Bathroom HydroTub

One or more of the Ground Fault Circuit Interrupter (GFCI) receptacles did not appear to function properly at the time of the inspection. The GFCI receptacle should be replaced to ensure protection.

it should be noted that the Hydro tub operated correctly, but when GFCI was tested it would not reset.

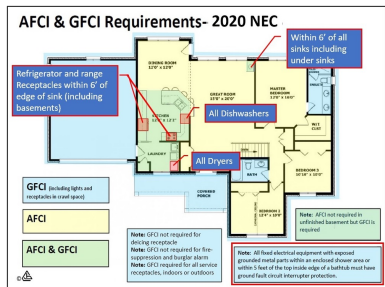
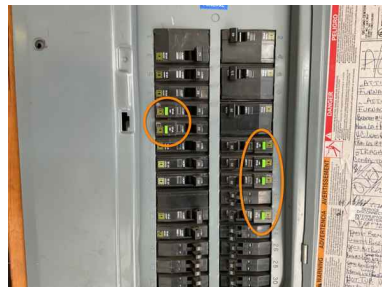
AFCI & GFCI Requirements

3: AFCI Missing

Kitchen, Dining Room, Office/Library, Closets, Laundry Room, Living Room, Family room, Hallways - One or more of the branch circuits in the listed area (above) were noted to not have Arc-Fault Protection Interrupter (AFCI) protection. Current requirements are that AFCI protection should be used for all 120 volt, single phase, 15 and 20 amp circuits installed in kitchens, family rooms, dining rooms, living rooms, parlors, libraries, dens, bedrooms, sunrooms, recreation rooms, closets, hallways and laundry rooms. While this may not have been required when the home was built, lack of AFCI protection is a safety concern and required to be noted as deficient by TREC standards of practice. This is generally accomplished by installing an AFCI breaker in the panelbox.

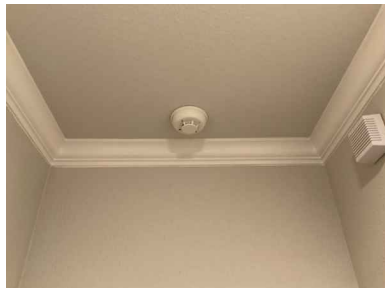
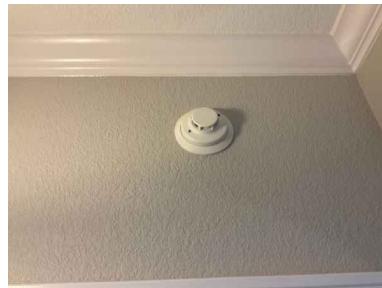
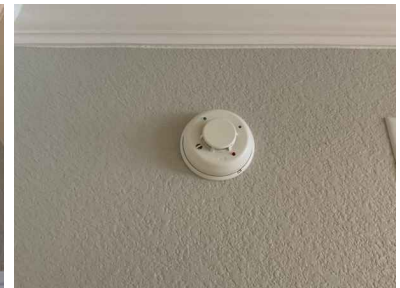
1st Floor Hallway

4: CO Detectors - Not Marked

I was unable to determine if the installed detectors were dual smoke and carbon monoxide capable. As carbon monoxide (CO) detectors are generally marked as such, I have to assume they are not CO capable. CO detectors are required outside all sleeping areas and every level in dwellings with fuel fired appliances or with attached garages.

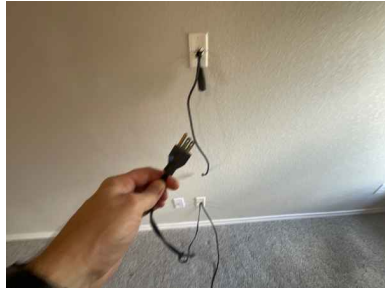
2nd Floor Media Room

Electrical flexible extension cords should not be used for permanent wiring and should not be run behind building materials. Permanent wiring should be installed.

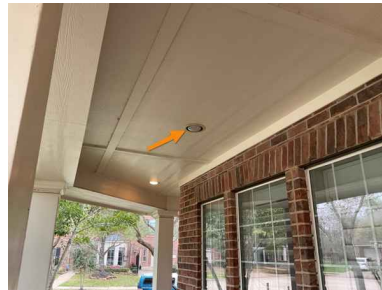
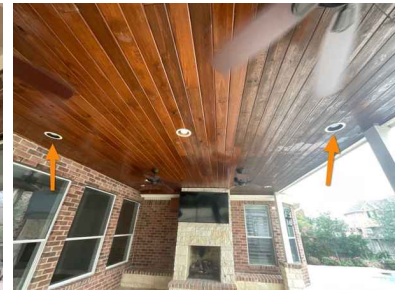
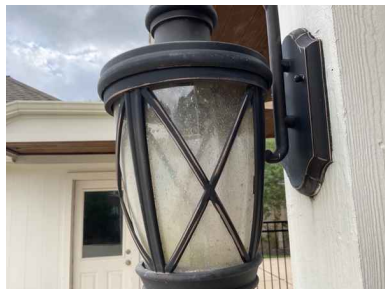
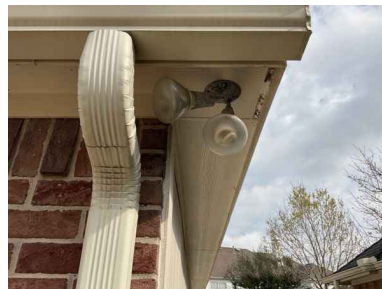
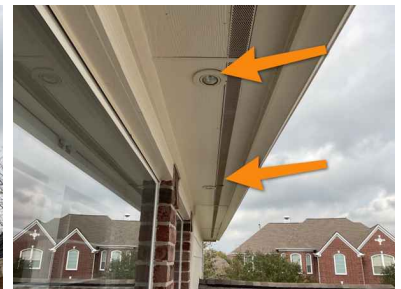
6: Light - Non-Functioning

One or more of the light fixtures did not appear to function properly at the time of the inspection. I am unable to determine if this is a wiring issue, a fixture issue or simply a burnt out or missing bulb. I recommend the bulb be replaced first as it is the simplest and cheapest possible repair.

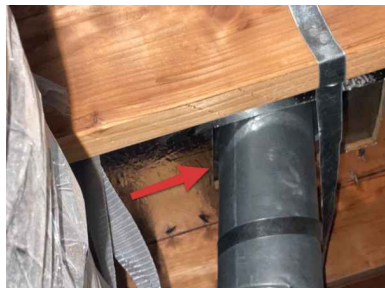
Furnace # 2

1: Flue - Inadequate Clearance

The furnace flue vent pipe was installed with inadequate clearance to combustible materials. Double walled, also known as B-Vent, pipes should have at least a 1" clearance and single walled vent pipes should have at

least 6" clearance. The clearance applies to any combustible material to include roof sheathing. This is a safety hazard and should be corrected.

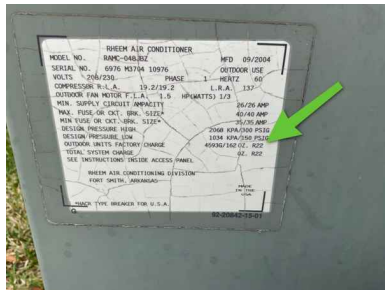
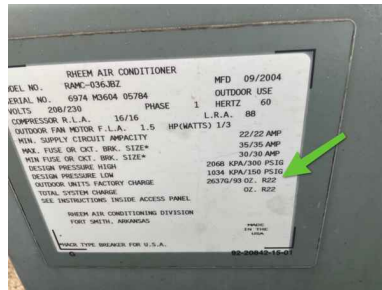
1: AC - Mismatched Components

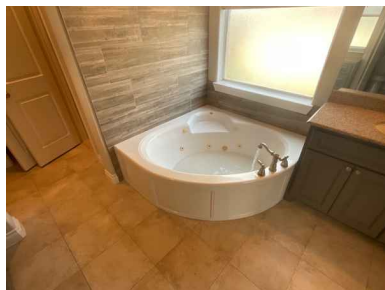
Master Bathroom

Access Panel - Inaccessible:

I was unable to open the hydro-massage tub panel and inspect the internal components. An appropriately sized panel is required that would allow access to the concealed hydro-massage tub equipment for inspection, service, repair or replacement without removing permanent construction materials. While it did appear that a panel was installed, it was not openable without removing construction materials. I could not verify proper installation, piping, motor or grounding of the concealed equipment.

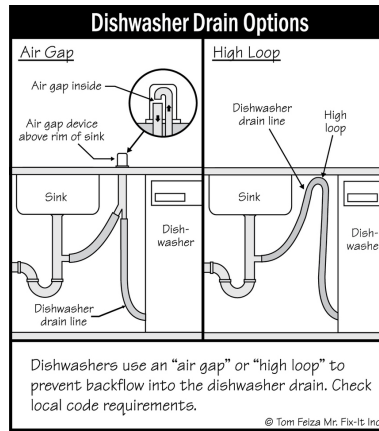
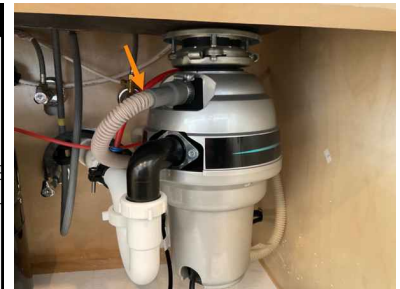
1: Dishwasher - Missing Backflow Prevention

The dishwasher drain hose does not have backflow prevention installed. An air-gap, or high-loop, provides backflow prevention to protect the potable water supply. The simplest repair is to create a high-loop by securing the dishwasher drain hose to the underside of the cabinet.

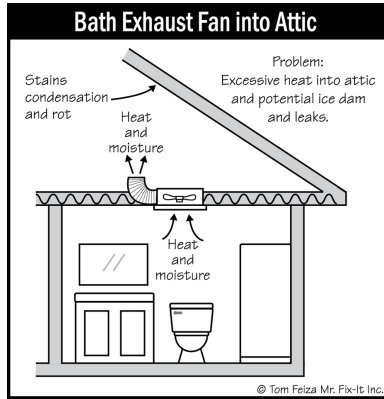
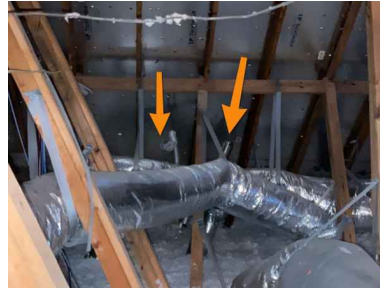
Attic

One or more of the bath and/or laundry mechanical exhaust fans do not vent to the outside of the structure but rather, terminate inside the attic. Under current building standards, all mechanical exhaust vents should exhaust to the exterior of the structure. Bath or laundry mechanical exhaust piping that terminates in the attic space can cause excessive moisture in that area and the attic as a whole depending on the ventilation. Excessive moisture is conducive to mold growth and accelerated deterioration of building materials. Many older homes have their mechanical exhaust pipes vented into the attic as it was common practice when this home was built. It is up to you to determine whether or not this is a concern or needs further consideration

from a general contractor. I generally recommend that exterior vents and connections be installed at the next roof replacement.

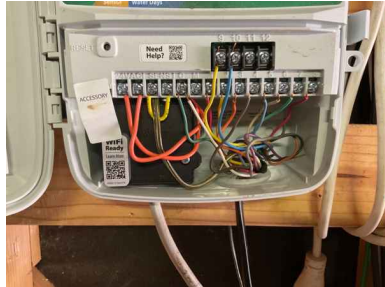
Rain/Moisture Sensor: Not Installed/Observed

1: Rain Sensor Missing

An installed rain sensor was not located. Rain sensors are required by the Texas Commission on Environmental Quality (TCEQ) on every lawn sprinkler system. They also conserve water by preventing automatic irrigation systems from operating when the lawn has received sufficient rain. While the system will operate without a sensor, TREC standards of practice requires the lack of a sensor to be reported as deficient.

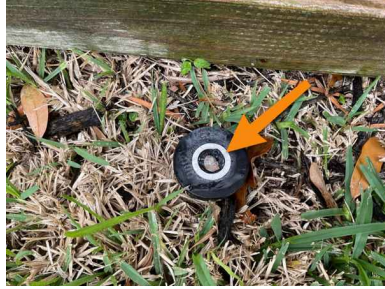
Zone 9

2: Sprinkler Head - Damaged

A damaged sprinkler head was noted and should be repaired or replaced.
