Total Home Inspection

Property Inspection Report

13322 Southshore Dr, Conroe, TX 77304
Inspection prepared for: Brook Mead
Real Estate Agent: -

Date of Inspection: 3/14/2024 Time: 9:00-11:30AM
Age of Home: 1968 Size: 1792
Weather: 70's clear
Order ID: 3696
Pre listing inspection. Home was occupied.

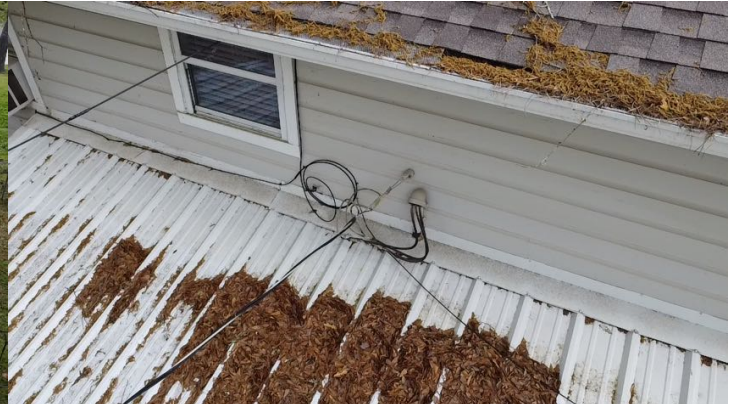
Pine needles and tree debris should be cleared from valleys and walls, to allow unimpeded flow of rain water.

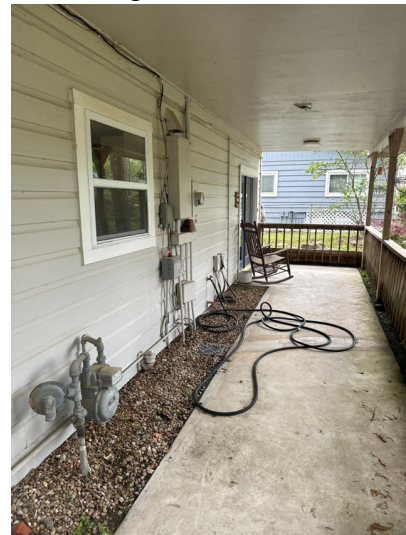
Wood deterioration was noted at some areas of siding including the left side of the garage and the right side wall.

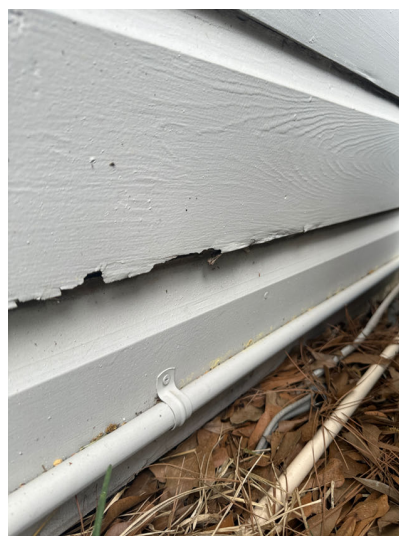
Wood deterioration was noted at some areas of siding including the left side of the garage and the right side wall.

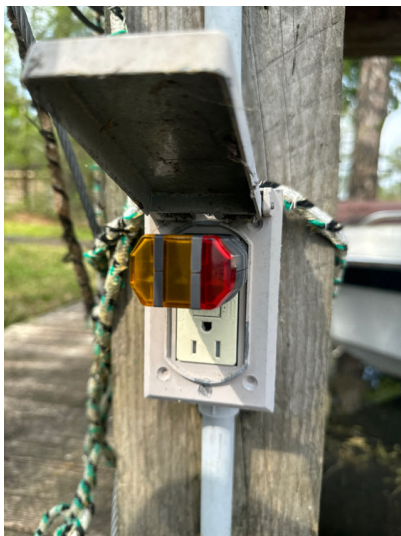
The boat dock electrical receptacles and motors did not appear to be GFI protected.

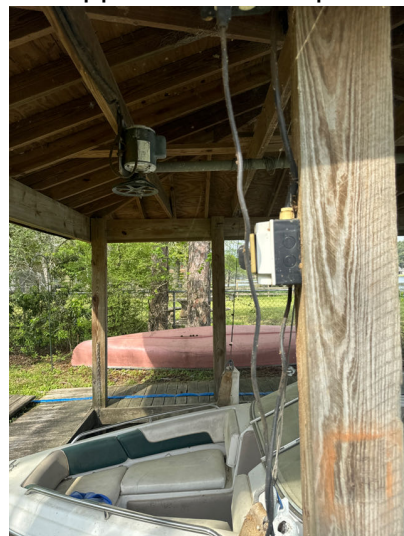
The boat dock electrical receptacles and motors did not appear to be GFI protected.

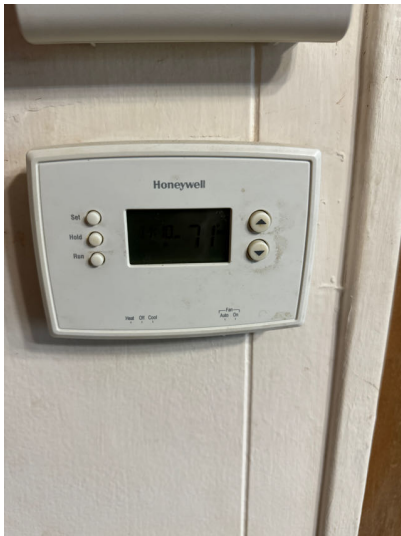
Thermostats were Honeywell type digital programmable located in the upper and lower levels.

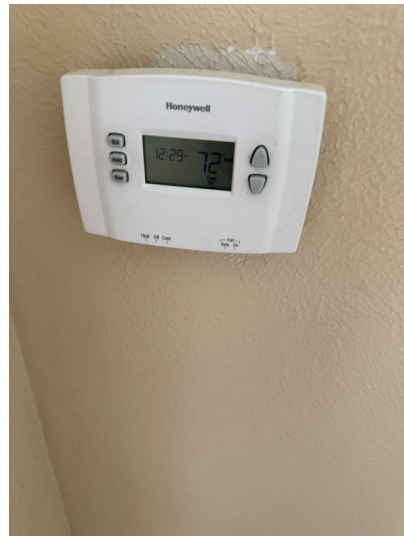
Thermostats were Honeywell type digital programmable located in the upper and lower levels.

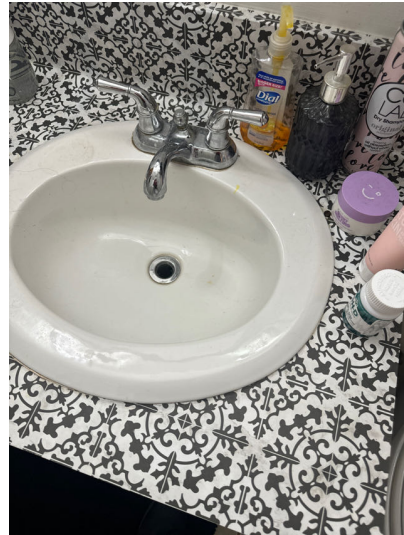
Sink stopper were not present in the upper bathrooms.

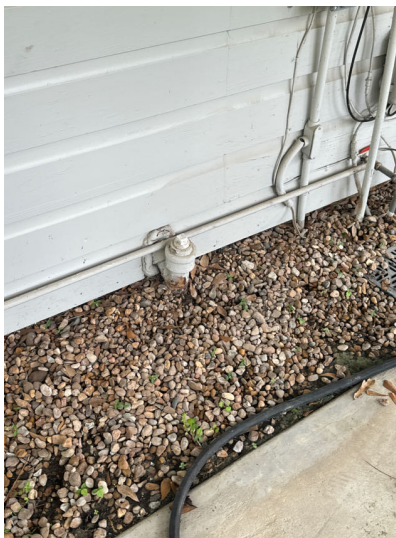
Cast iron drain pipe was observed. Hydrostatic pressure testing and/or video camera testing of drain pipe is recommended due the age and type of piping.

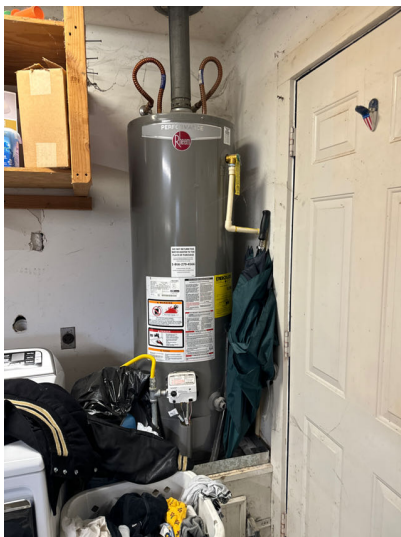
• Flue vent did not fully penetrate the roof deck and was not terminated with a B type vent.

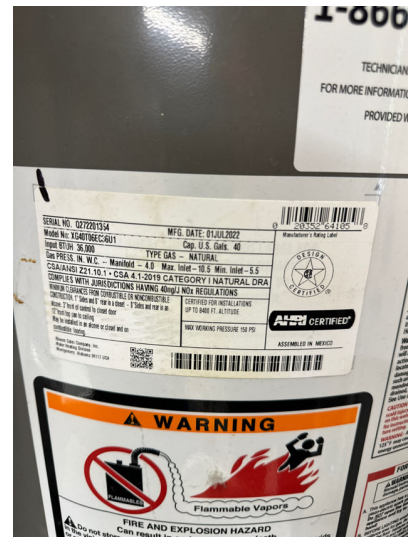
Water heater was gas powered and appeared to be manufactured by Rheem in 2022.

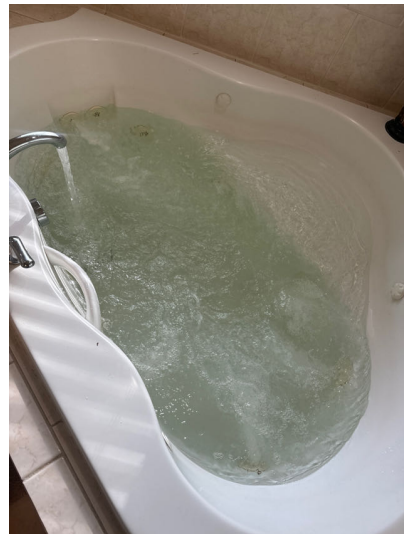
Hydro-massage unit in master bathroom appears to be operating normally.

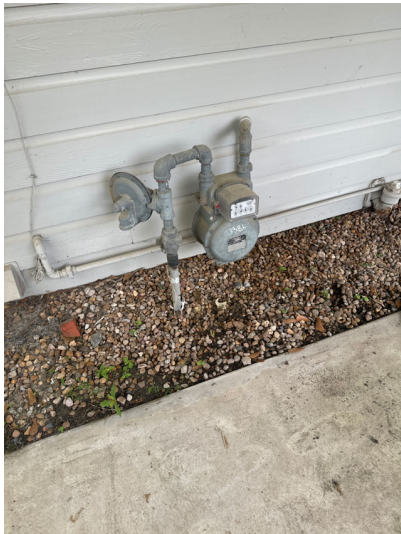
Gas meter was at the front of the home.

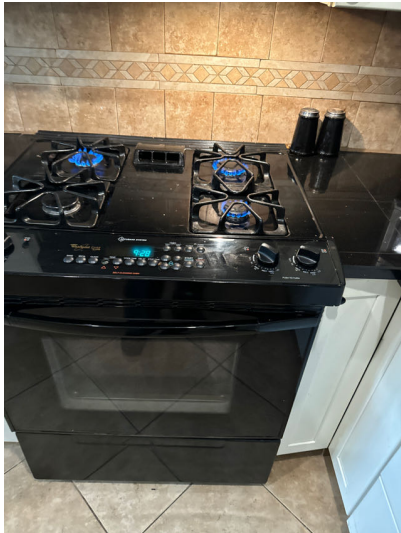
The ignition for the two burners on the right side of the cook top was inoperative. Burners can be lit with a lighter.

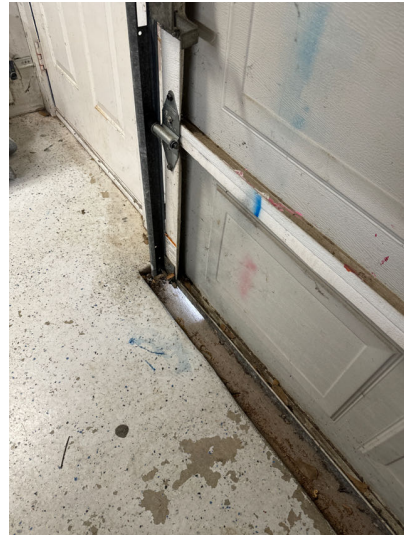
Electronic sensor was not present. This is a safety issue.

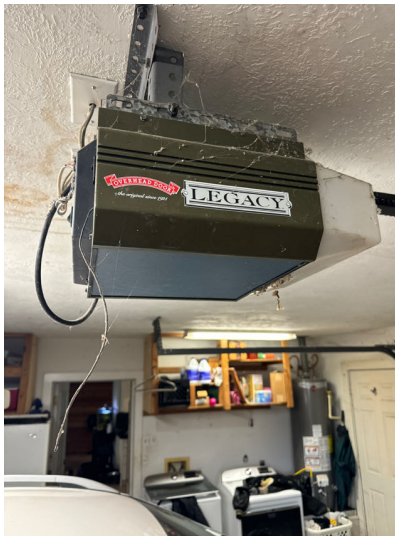
Garage door opener was an Overhead Door type chain drive without sensors.

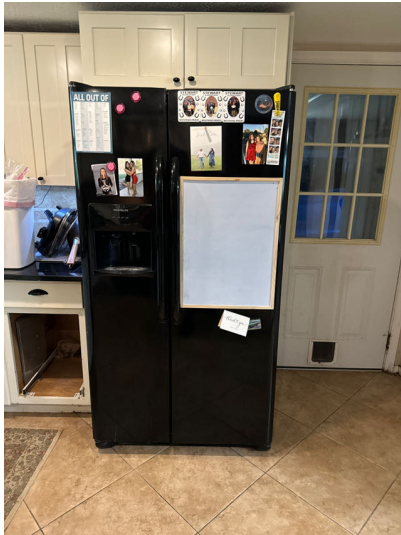
Frigidaire refrigerator with functioning ice maker was observed in the kitchen.

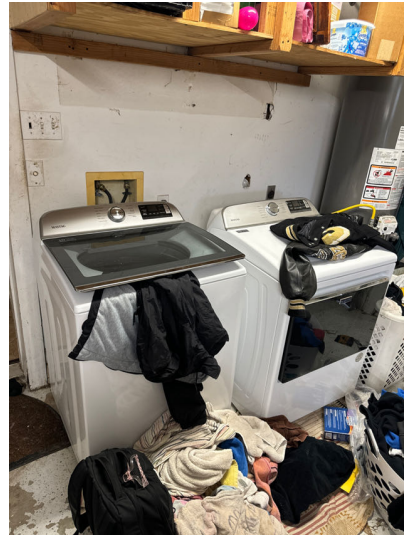
Maytag side by side washer dryer was noted in the laundry area.
