# PROPERTY INSPECTION REPORT FORM

VISTA PROPERTY INSPECTION GROUP LLC  
 3430 County Road 89, Pearland, TX 77584  
 281-642-1516, vista.insp@gmail.com

<u>Alfredo Rosales</u>	<u>03/28/2024</u>
<i>Name of client</i>	<i>Date of Inspection</i>
<u>6638 Carly Park Way, Houston, TX 77084</u>	
<i>Address of Inspected Property</i>	
<u>Felix D. Angel</u>	<u>20185</u>
<i>Name of Inspector</i>	<i>TREC License #:</i>
<u>N/A</u>	<u>N/A</u>
<i>Name of Sponsor (If applicable)</i>	<i>TREC License #:</i>

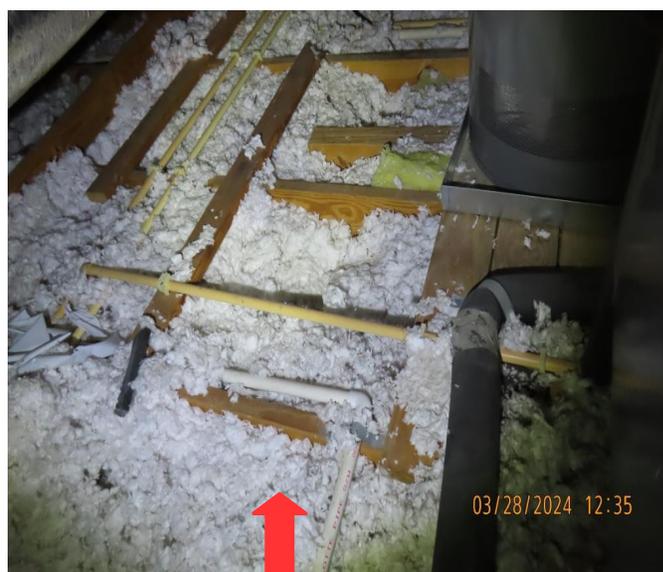
- Install sufficient insulation where shallow for insulating value

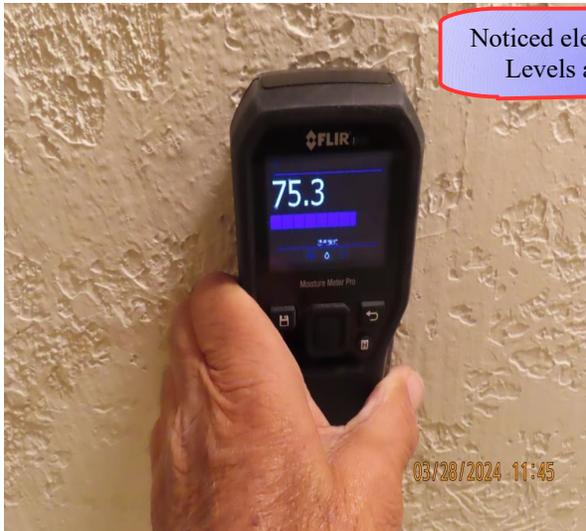
- Evidence of waster damage inside the master bedroom closet. Possibly associated with the various water infiltration locations located in the roof deck. Confirm that root cause and all affected areas such as but not limited to: drywall, insulation, lumber, etc have been properly repaired and or treated by a qualified contractor. If not properly repaired/treated, it can lead to microbial growth.

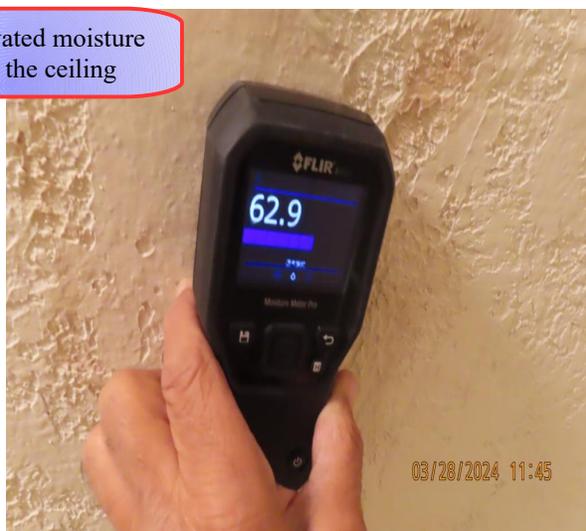
Noticed elevated moisture levels at the ceiling

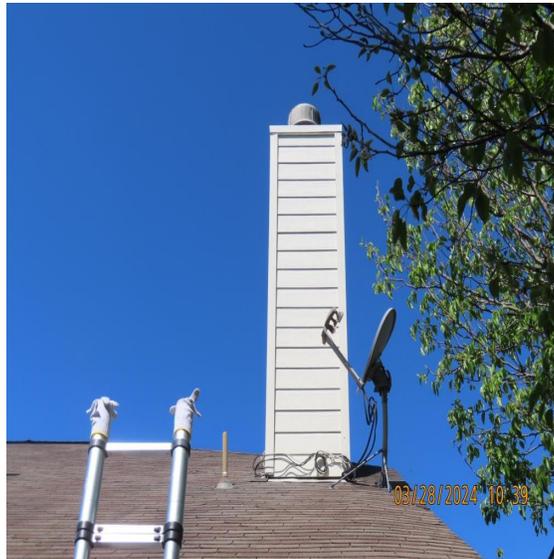
- Bracing may be required for chimneys that extend high above the roof line. Lateral support may be required to tie a chimney to the building structure. When these supports are missing, even a chimney set on a solid foundation may tip, wobble, or separate from the building it serves.

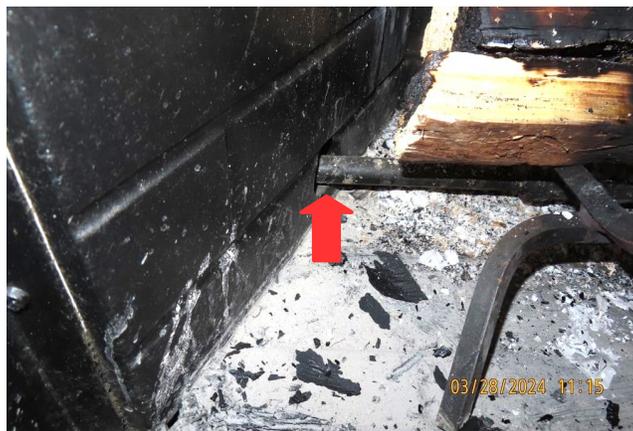
- Note: The annular space between the gas line and refractory panel was not sealed. The manufacturer's installation instructions should be followed typically require that the annular space be sealed with insulation, high-temp caulk or medium duty refractory mortar to prevent heated gases from entering into the wood framed wall. We recommend sealing this area for fire and personal safety.

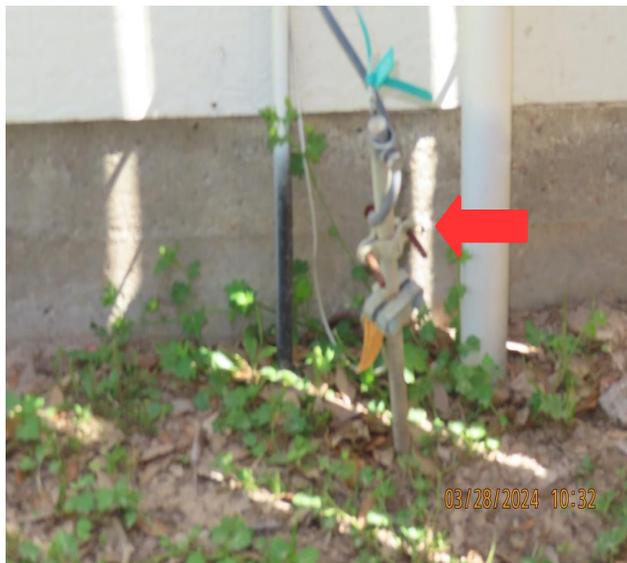
- Grounding electrode/rod length should be 8ft and entire bar should be into the earth.

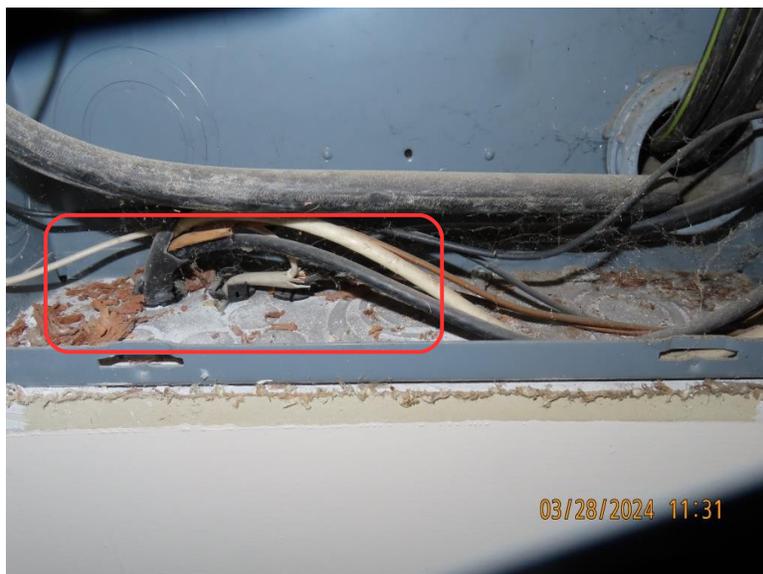
- Routinely, remove the debris inside the enclosure,

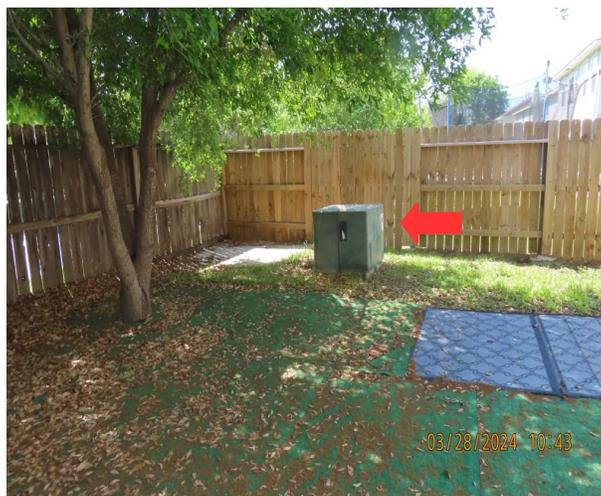
- Information: Noticed what appeared to be a power transformer in the back yard. Investigate further as needed

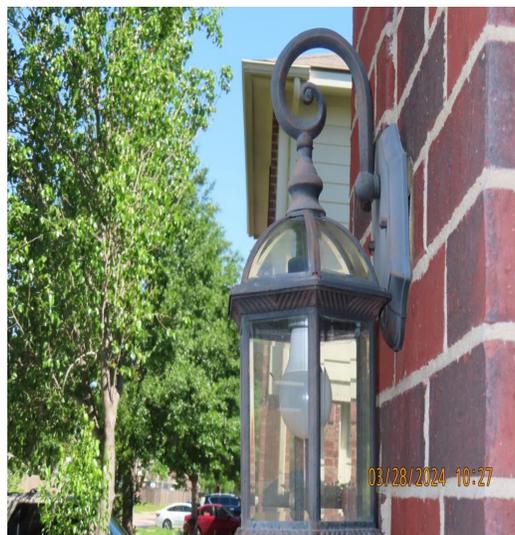
- Properly secure loose light fixtures on the front wall. Also, seal around the flange to prevent water intrusion

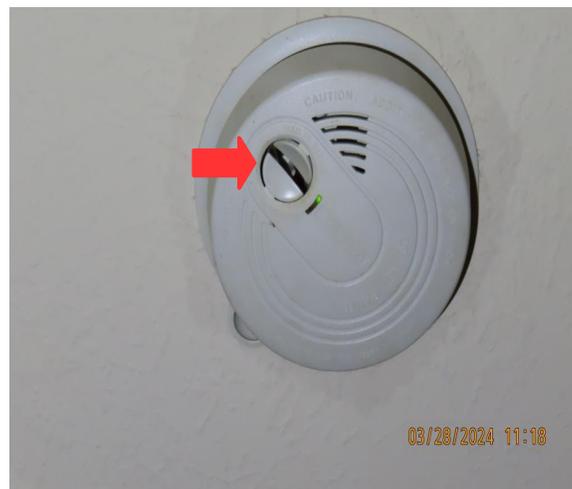
- The upstairs hallway Co alarm reset button appeared to be damaged. In need of repair

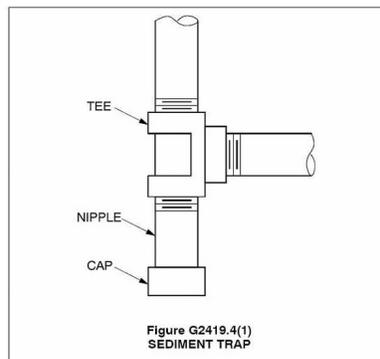
- The sediment trap on the furnace gas line is not evident. Note: The sediment trap shall be either a tee fitting having a capped nipple of any length installed vertically in the bottom most opening of the tee or other device approved as an effective sediment trap

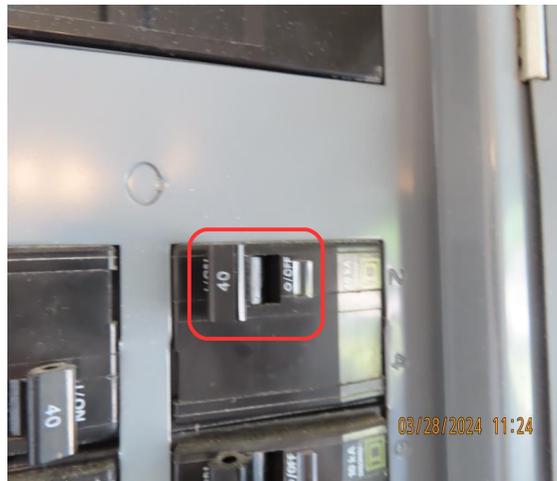
- Note: The maximum AC c. breaker capacity recommended by the manufacturer is 35 amp (on data plate). The actual capacity installed is a 40 amp c. breaker. Repair as needed

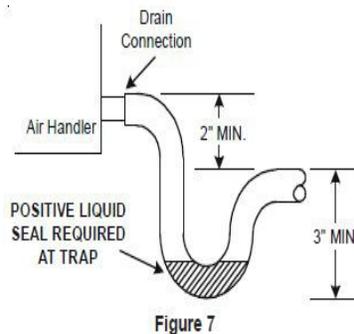
- There was no *visible* trap within the primary condensate drain line. Both the international Plumbing Code (IPC) and the Uniform Plumbing Code (UPC) require that the condensate piping, as an indirect drain line, be trapped.

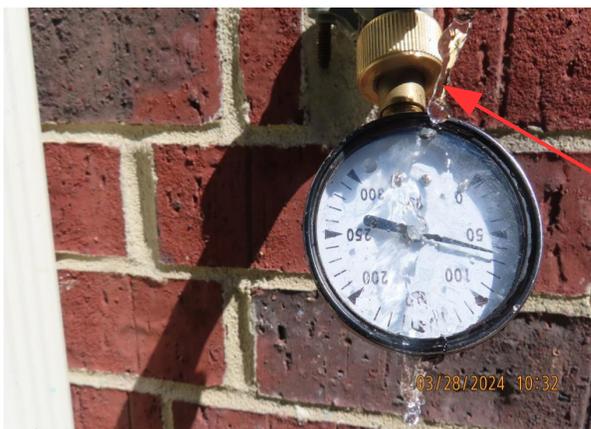
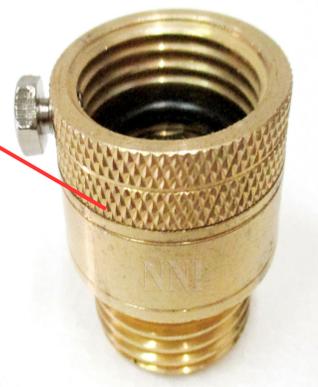
- Noted missing “Back Flow Prevention” device on hose bibs. This prevents contaminants such as sewage etc from being siphoned into the water supply. Recommend installation of device for safety

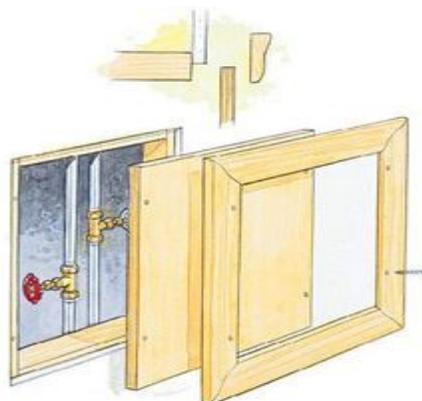
- Note: We strongly recommend the installation of a “plumbing access” (ex: 12”x12” opening) at each shower, bathtub/whirlpool to confirm for possible defective plumbing and or water leaks.

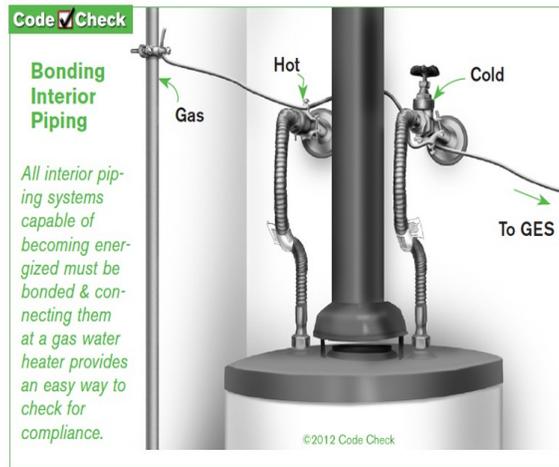
- The electrical equipment bonding on the water piping is not evident.  
Note: The Hot and Cold water, supplying the water heater gas or electric, must have a #6 copper "Bonding Jumper" Installed from one water pipe to the other water pipe

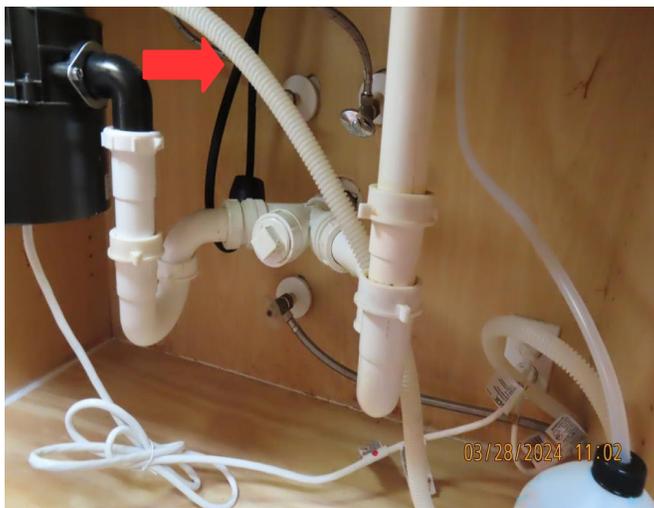
- Note: Drain line should loop to the highest point of under the sink, then down to the drain line at the disposal to prevent back siphoning of dirty dishwasher back into the dishwasher.

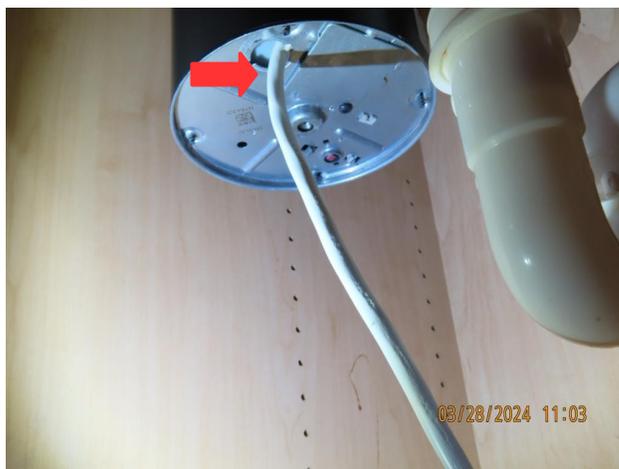
- Install missing clamp to protect the power cord from damage

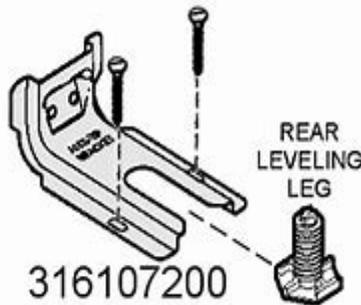
- Oven standard: 350° F +/- 25° F, **Actual: 340° F** (approx).
- The anti-tip bracket appeared to be missing or not properly installed. Recommend installation for child safety

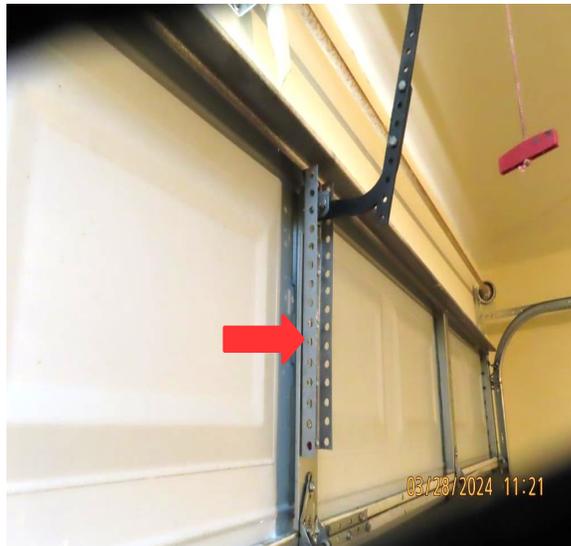
- Evidence of repair. Investigate further as needed
