## Home Inspection - TREC

**Inspection Date:** 2/22/2024

**Transferee / Property Information:** Russ Armstrong  
2095 Savannah Trce  
Beaumont, TX 77706

# PROPERTY INSPECTION REPORT FORM

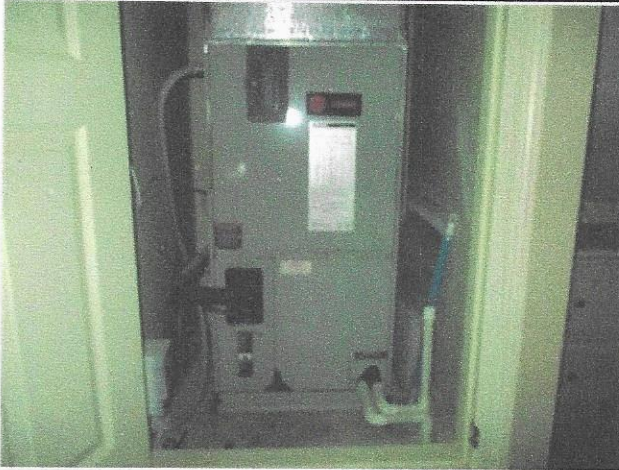
Upper Level Heating Equipment

<b>HVAC Systems</b>	<p><b>Type #1 Heating Equipment</b>  <b>Problem:</b> A flexible fuel line improperly penetrates the furnace cabinet. Please Note: The heating equipment was functional at the time of assessment, however; the unit is aged beyond its estimated useful life. No warranties are expressed or implied as to the future performance of the heating equipment.  <b>Corrective Action:</b> Heating technician to replace the flexible fuel line with rigid piping.</p> <p><b>Type #2 Heating Equipment</b>  <b>Remarks:</b> The upper level heating equipment was functional at the time of assessment, however; the unit is aged beyond its estimated useful life. No warranties are expressed or implied as to the future performance of the electric heating equipment.</p> <p><b>Type #1 Cooling Equipment</b>  <b>Problem:</b> The electric disconnect is improperly mounted behind the unit and the insulation is damaged on the exterior refrigerant line. Please Note: The main level A/C unit was functional at the time of assessment, however; the unit is aged beyond its estimated useful life. No warranties are expressed or implied as to the future performance of the main level A/C unit.  <b>Corrective Action:</b> HVAC technician to relocate the electric disconnect and repair / replace the insulation on the refrigerant line.</p> <p><b>Type #2 Cooling Equipment</b>  <b>Problem:</b> The electric disconnect is improperly mounted behind the unit and the insulation is damaged on the exterior refrigerant line. Corrosion was noted on the interior HVAC cabinet.  <b>Corrective Action:</b> HVAC technician relocate the electric disconnect and repair / replace the upper level HVAC equipment and any necessary components. Obtain a cost estimate from a qualified and insured contractor.</p>

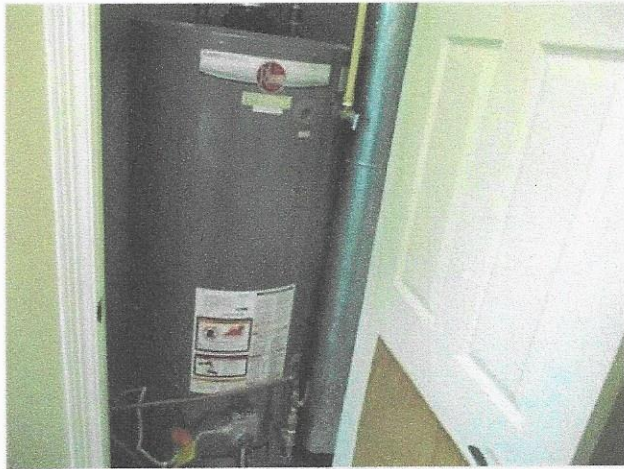
Water Heater

<b>Plumbing Systems</b>	<p><b>Water Heaters</b>  <b>Problem:</b> The water heater TPR valve extension improperly runs up hill and a drain pan is missing below the unit. Please Note: The water heater was functional at the time of assessment, however; the unit is aged well beyond its estimated useful life. No warranties are expressed or implied as to the future performance of the water heater.  <b>Corrective Action:</b> Plumber to repair / correct the water heater TPR valve extension and install a drain pan.</p>
