## RESIDENTIAL HOME INSPECTION

15335 Poplar Grove Dr,  
Houston, TX 77068

# PROPERTY INSPECTION REPORT FORM

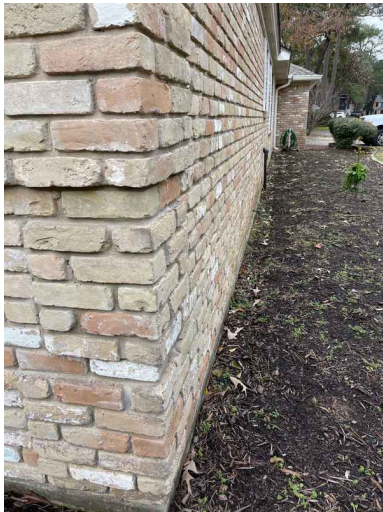
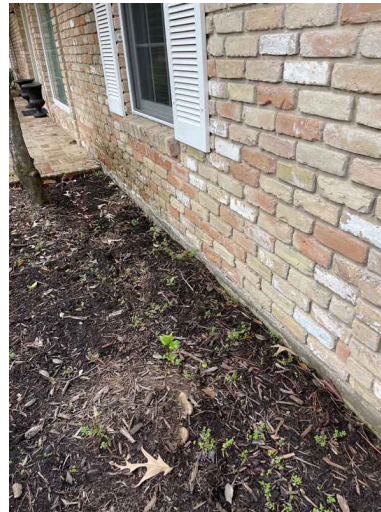
away from the house and off the lot. The ground should slope away from the house at a rate of one inch per foot for at least the first ten feet. Ideally, at least 4-6 inches of clearance should be maintained between soil level and the top of the foundation walls.

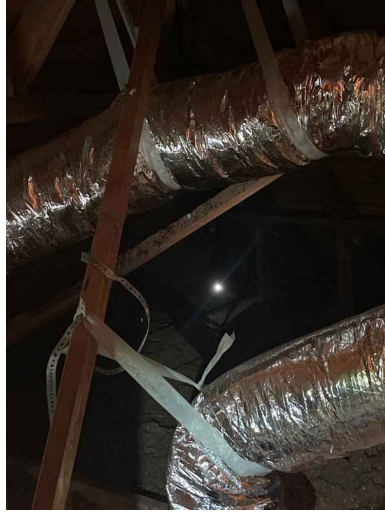
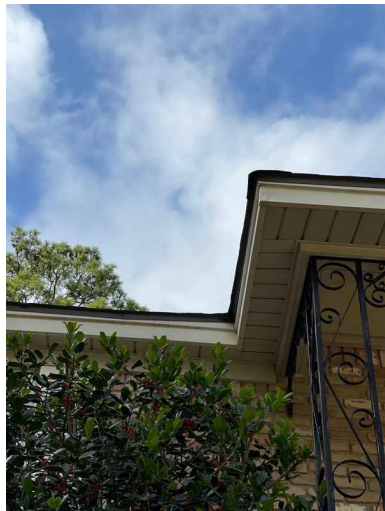
#### 4: Missing Kickout Flashing

Kickout flashing was not present in area(s) where guttering and/or fascia abutted a sidewall. The installation of kickout flashing is recommended to be performed by a roofing contractor at any areas where gutters or fascia meet a sidewall, preventing rain water from infiltrating between the end of the gutter/fascia and the wall. Hidden damage may exist in areas where kickout flashing is missing and this should be investigated during the installation of kick-out flashing

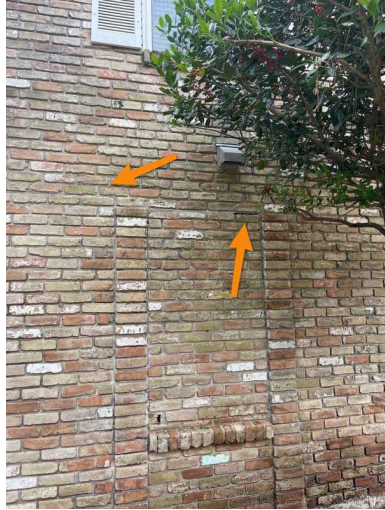
Front Left Side

There were gaps in the mortar joint/Grout at several locations around the home. I recommend sealing these areas with appropriate mortar sealant.

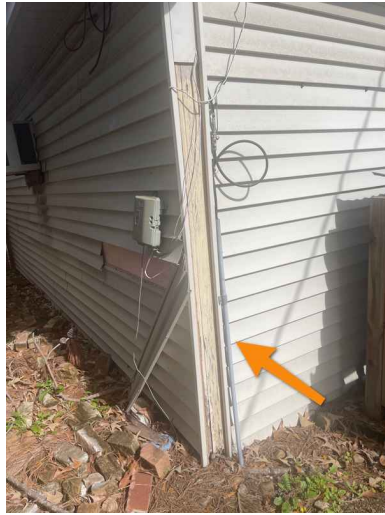
Garage

## 3: Exterior Trim Damaged

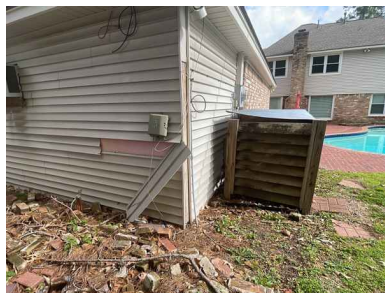
#### 4: Deteriorated/Missing Siding

Deteriorated and missing siding was observed on the following locations around the exterior wall. I recommend repairing these deficient sections of siding.

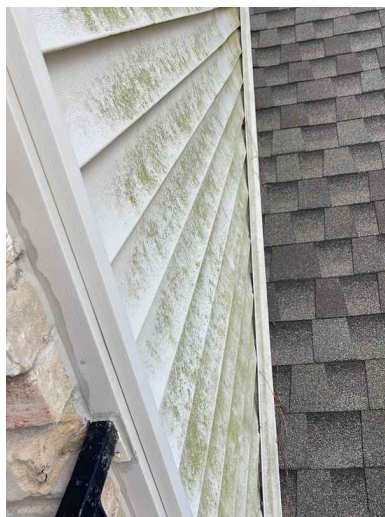
#### 5: Algae Growth - Exterior Wall

**Note:** North facing sections of homes in the Northern Hemisphere are in the sun's shadow for a longer period during the year. This promotes damper conditions and are conducive to algae growth.

**Note:** The causes of these unsightly stains are either or a combination of: moisture, shade, and from the stain pattern. Several conditions might invite this Algae growth and staining 1. Gutter overflow making the eave and wood beam and wall below wetter than otherwise. 2. Shade 3. Algae-friendly coatings that lack a fungicidal ingredient

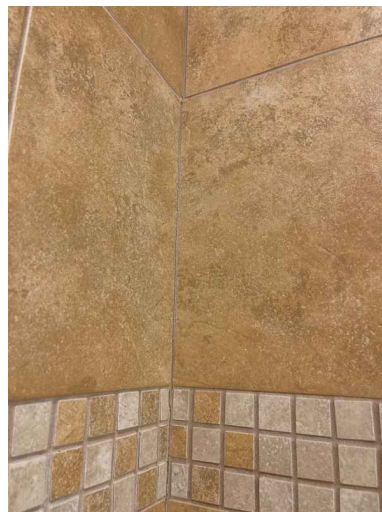
Primary Bathroom

#### 6: Caulk/Grout - Shower/Bath

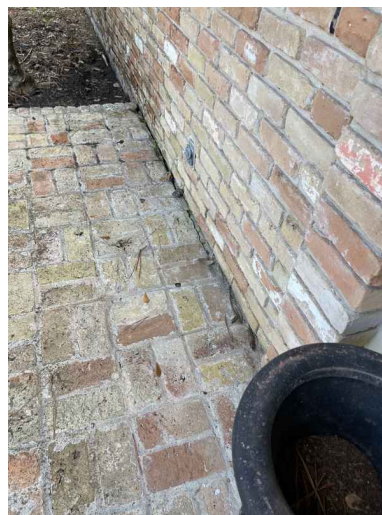
During the inspection of the property, it was observed that there were missing caulking and gaps at several areas around the floor of the home. Proper sealing of these areas is crucial to prevent issues such as moisture intrusion, air leaks, and potential damage to the property. I recommend having a qualified profession to address these deficiencies by properly sealing and caulking the identified areas.

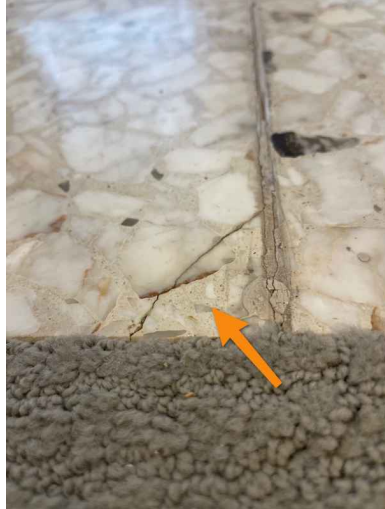
2nd Floor Jack & Jill Bathroom

Floors have evidence of general surface wear and damage in several areas. Recommend a qualified flooring contractor evaluate & remedy.

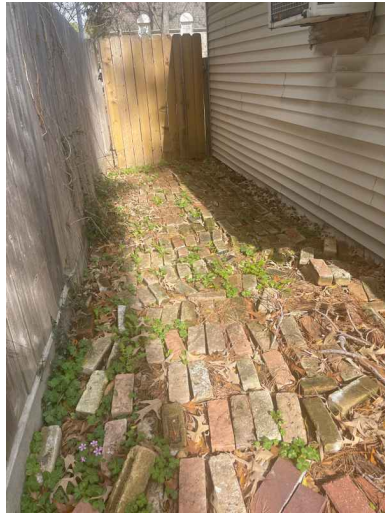
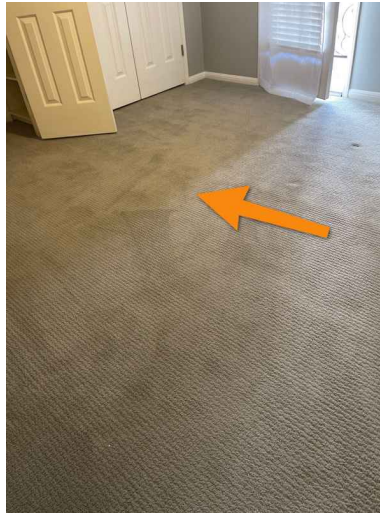
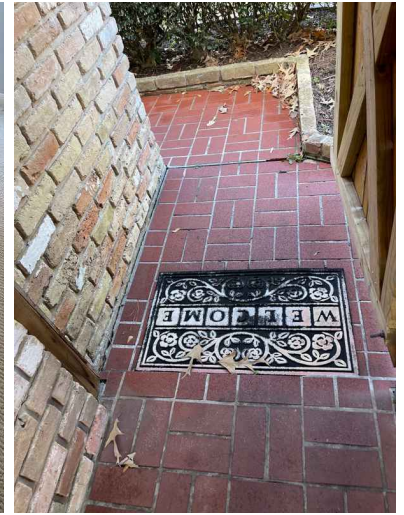
2nd Floor Front Right Corner Bedroom

### 3: Flooring Uneven

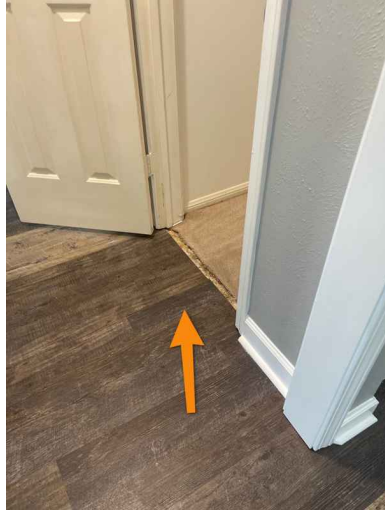
1st Floor Primary Hallway

**4: Flooring is not finished**

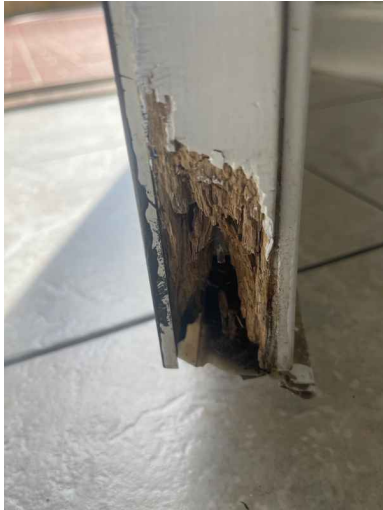
Breakfast Area

The following door/s is damaged. I recommend repairing/replacing the damaged door(s).

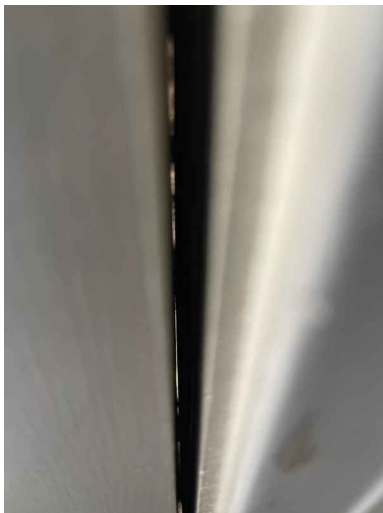
2nd Floor balcony

The weather stripping on the following exterior door is deficient. This can result in significant energy loss and moisture intrusion. Recommend installation of standard weatherstripping, or adjusting the closure space of the door in its frame.

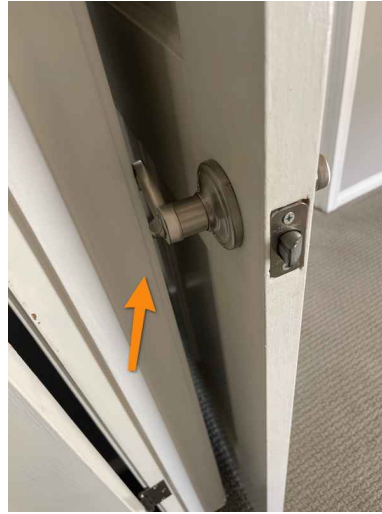
2nd Floor Front Right Side Bedroom

There were missing doorstops on several doors in the home. I recommend installation of door stops to prevent doors from striking the wall therefore damaging the adjacent wall.

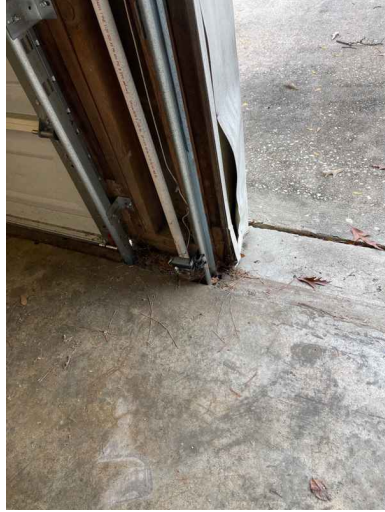
During the home inspection, it was observed that the garage door trim installation was incomplete and not properly sealed. The trim had gaps and uneven edges, This incomplete sealing could potentially lead to air leakage, which may result in energy inefficiency and increased utility costs for the homeowner. Additionally, the gaps in the trim could allow moisture to seep in, potentially leading to water damage or the growth of mold and mildew. Immediate attention and proper sealing of the door trim are recommended to ensure a secure and energy-efficient home.

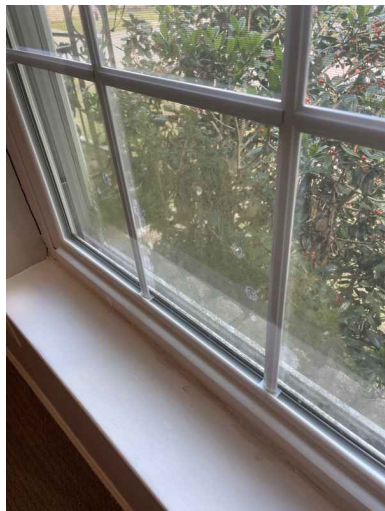
2nd Floor Front Left Corner Bedroom

Discoloration/condensation between the window panes of following window/s was observed which may indicate a failed seal. Recommend qualified window contractor evaluate & replace.

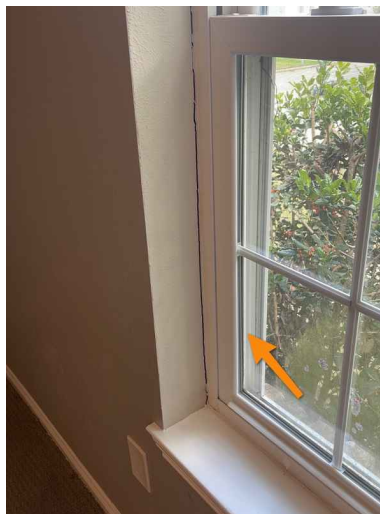
2nd Floor Front Left Corner Bedroom

There were gaps between the window frame and the window openings around several windows at the time of the inspection. I recommend sealing these areas with caulking to prevent moisture and possible pest penetration into the home.

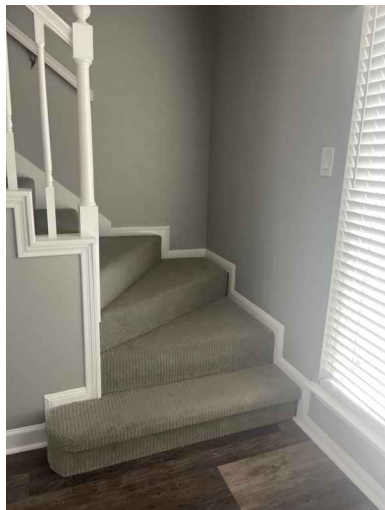
During the inspection, it was noted that there is no stairs or handrail present in the following location. This poses a safety issue, particularly for those with mobility concerns. It is recommended to install a handrail anywhere there is three or more steps to ensure safety.

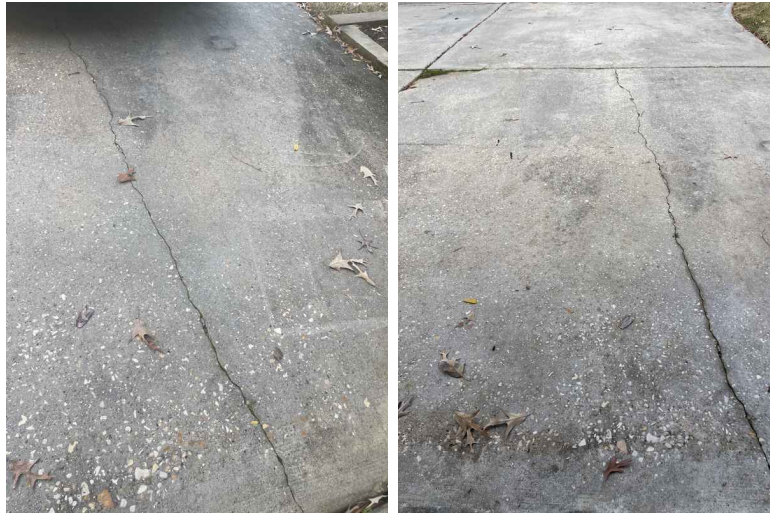
The driveway had cracks at the time of the inspection. I recommend sealing all cracks with an appropriate sealant to prevent water penetration below the slab.

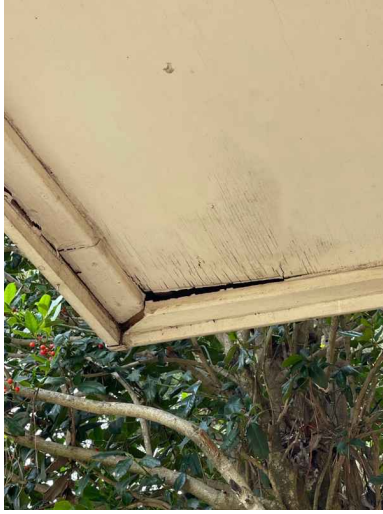
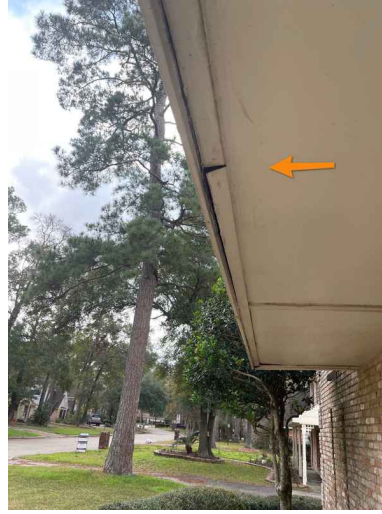
The patio ceiling trim needs to be repaired in the following location.

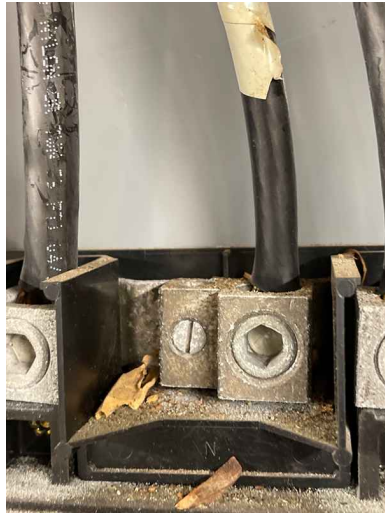
**Note:** While this was not a requirement in older homes, the installation of non-conductive plastic cap/covers over the service terminals is recommended.

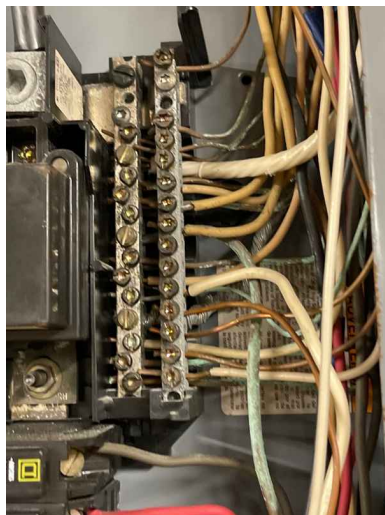
**Note:** A 'double tapped neutral or ground' is when one of the screws on the neutral/grounding bus bar in the panelboard has more than one wire feeding to it. Double tapped can expand and contract enough to the point where the connection becomes loose. The loose connection could overheat and cause a fire. Should this happen to a grounding wire, it means that circuit will not have grounding protection.

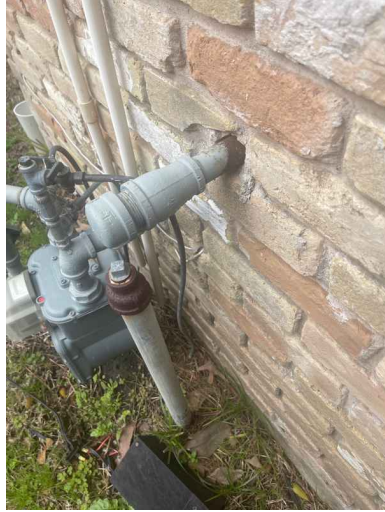
The gas meter is not properly bonded to the remainder of the electrical system. The clamp and bond wire are required to be firmly attached in a location that is visible and accessible for inspection. I recommend that a qualified electrician evaluate and repair the bonding necessary.

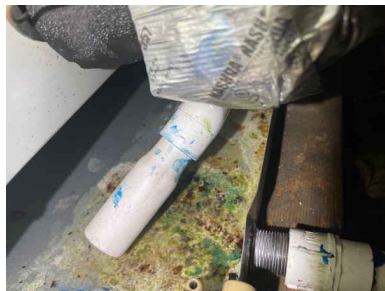
**1: Condensation Pan - Debris/Rust**

There was debris and/or rusting in the A/C condensation pan. I recommend cleaning of the condensation pan by a qualified HVAC contractor.

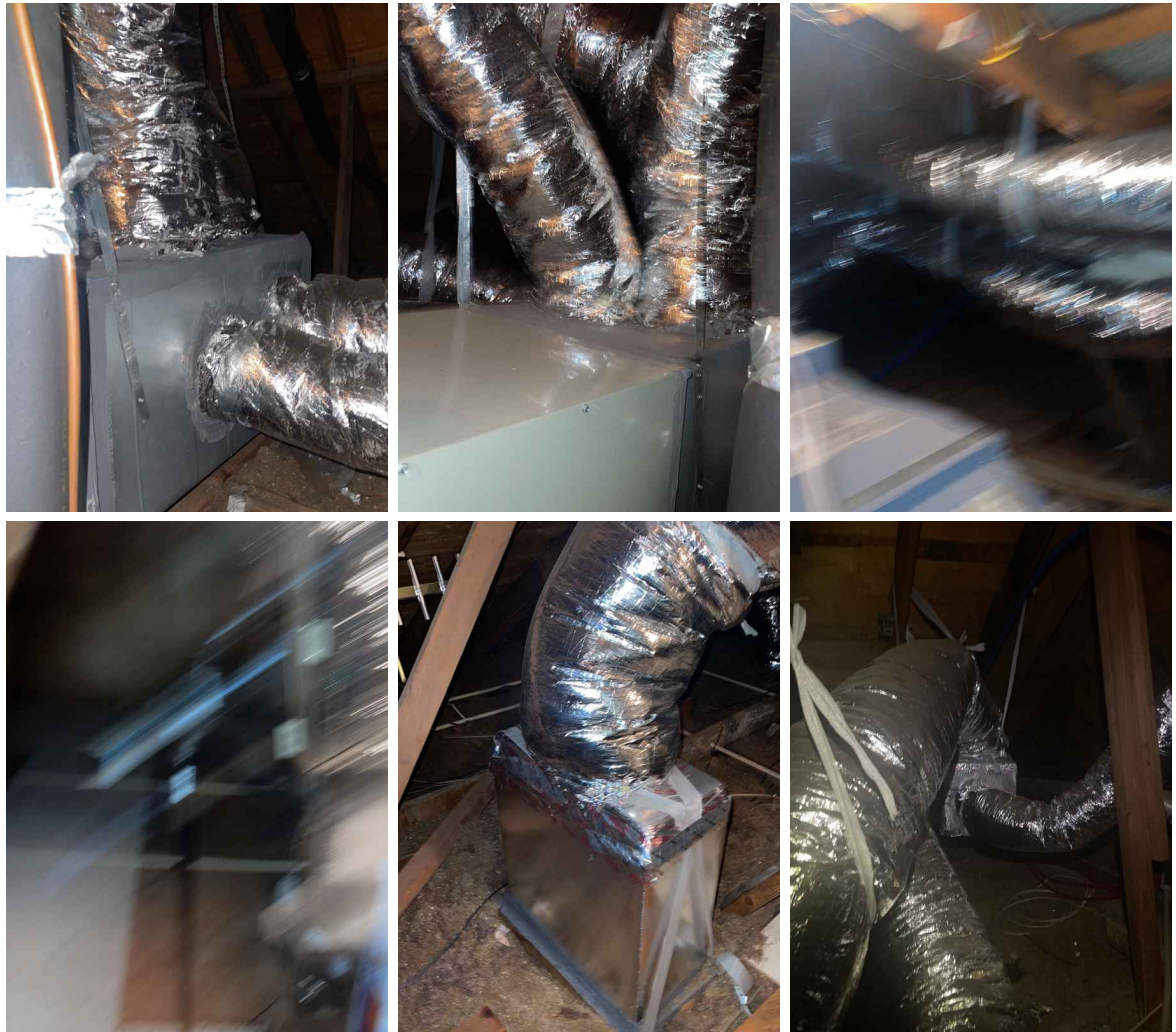
The duct-work in the attic were generally well supported and installed at the time of the inspection. Thermal imaging showed no leaks in the accessible and visible duct work at the time of the inspection.

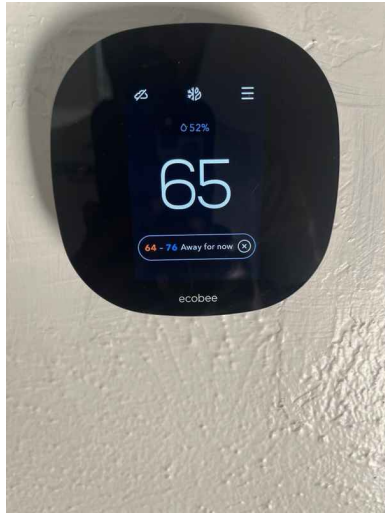
*Temperature of the home when the inspection began: 65*

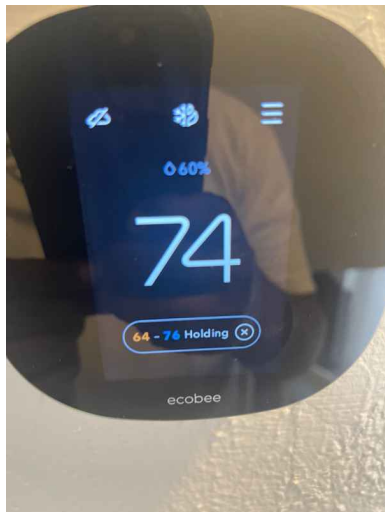
*Temperature of the home when the inspection finished: 74*

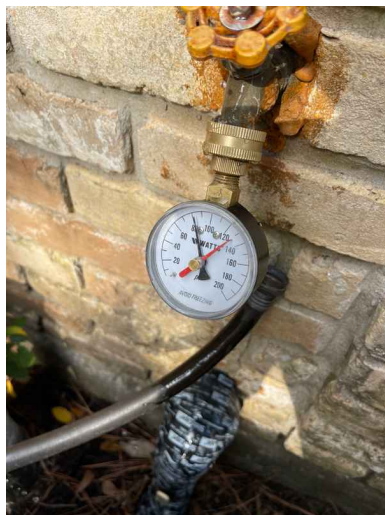
*Static Water Pressure Reading:* 80 -  
The static water pressure was within the recommended water pressure of 40 - 80 PSI.

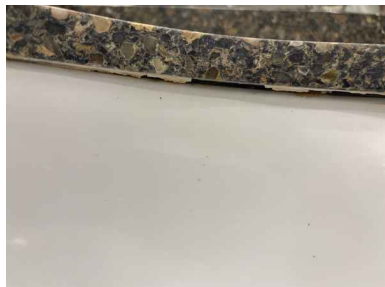
There are gaps in caulking on the following sinks. These under-mounted sinks need to be properly sealed to prevent water intrusion into the cabinets.

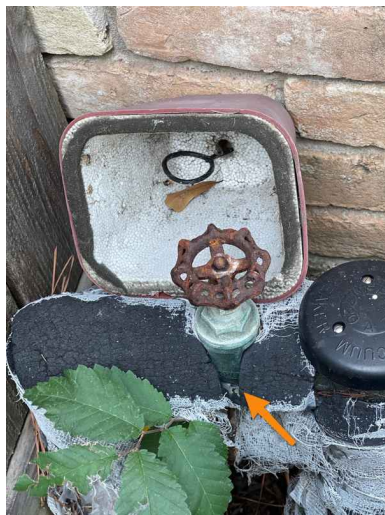
### 2: Oxidation on the plumbing

Oxidation on plumbing can be a common problem, especially in older homes with pipes made of metal such as copper, brass, or iron. Oxidation occurs when the metal in the plumbing reacts with oxygen in the air or water and forms a layer of corrosion on the surface.

While a small amount of oxidation may not be a major issue, excessive corrosion can weaken the pipes, cause leaks, and result in costly repairs. In addition, oxidation can cause the water to have an unpleasant taste, odor, or discoloration.

If the pipes are already corroded, it may be necessary to replace them. This can involve replacing individual sections of piping or, in some cases, replacing the entire plumbing system. A licensed plumber can help assess the extent of the damage and recommend the best course of action.

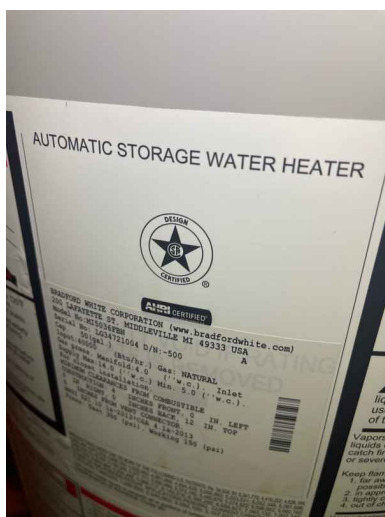
**1: Water temperature too hot**

**Note:** The acceptable tolerance for hot water and below the maximum recommended temperature of 120 Degrees F. High hot water temperatures can cause scalding and burns particularly in small children. If high water temperatures over 120 degrees F are being discharged from a faucet, I recommend lowering the temperature setting on the water heater.

**Note:** High hot water temperatures can cause scalding and burns particularly in small children. If high water temperatures over 120 degrees F are being discharged from a faucet, I recommend lowering the temperature

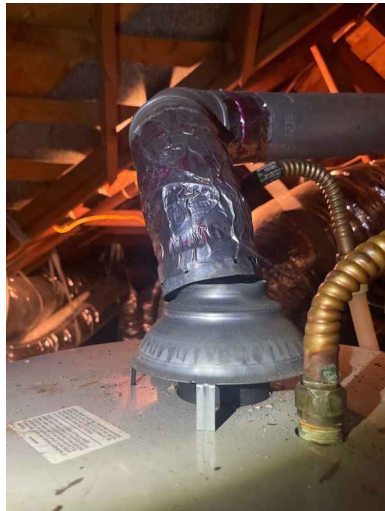
**▲ Safety Hazard**

The B-vent above the water heater was slightly misaligned over the top of the water heater unit. The vent is designed to remove exhaust fumes from the unit to the outside. I recommend proper alignment of the B-vent.

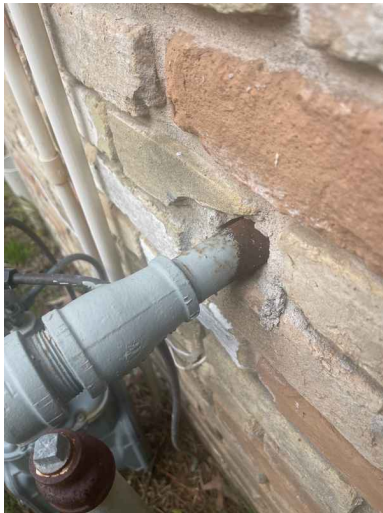
**1: Rusted gas line**

The gas line was rushed in the following location. I recommend evaluation and repair by a qualified Plumbing Professional.

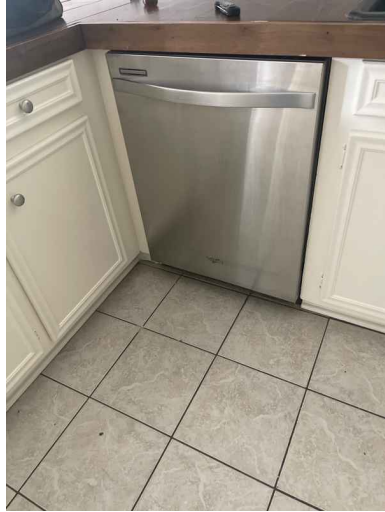
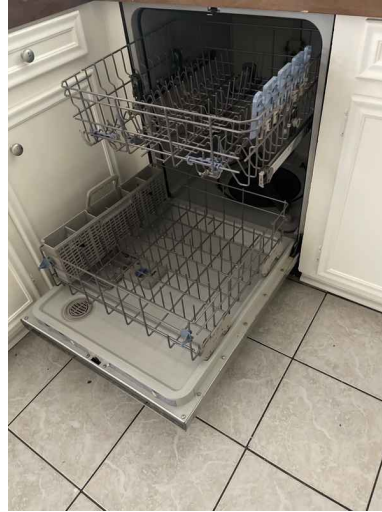
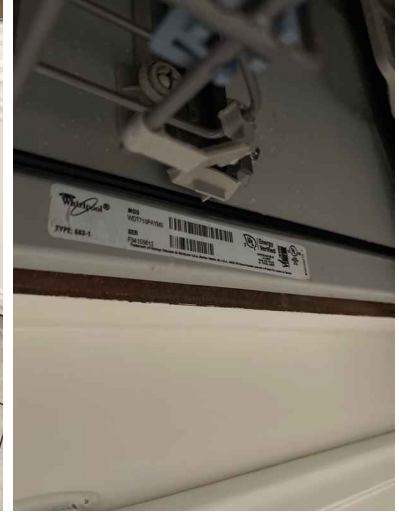
The dishwasher was functional at the time of the inspection. Air gaps are the most effective means of preventing your drain from cross-contaminating your dishwasher with waste.

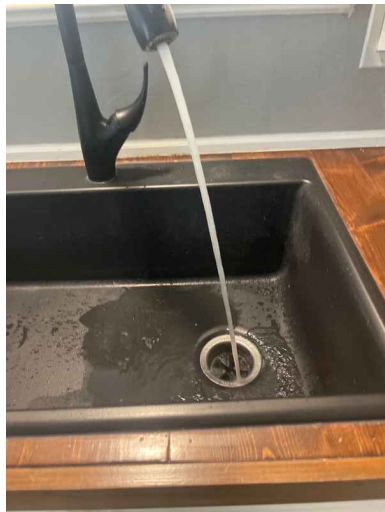
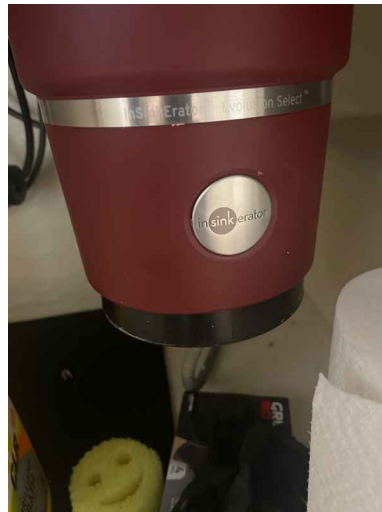
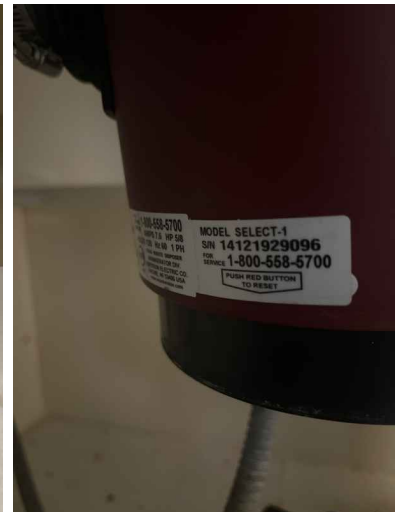
The food waste disposer was functional at the time of the inspection. No excessive noise was heard, no leaking, and proper mounting of the unit was observed.

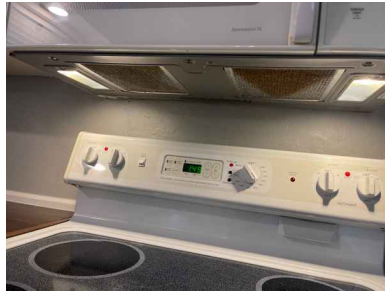
The range hood and exhaust system was functional at the time of the inspection. No excessive noise was heard, and the unit was properly vented over the range.

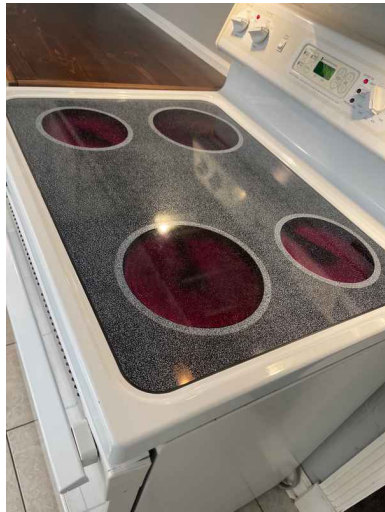
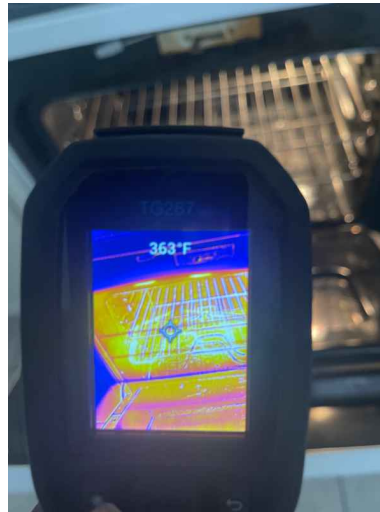
The range was functional at the time of the inspection. All burners lit properly.

The oven was functional at the time of the inspection. Oven was set at 350 degrees F and produced a baking temperature of 360-365 degrees F. This was within the accepted temperature range of +/- 25 degrees F.

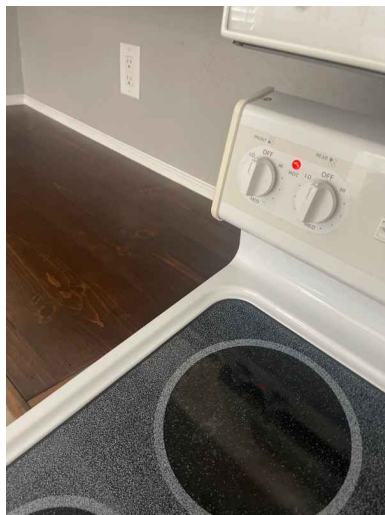
**1: Missing Anti-tip Device**

Range was not fastened with an anti-tip device. This poses a safety hazard to children. Recommend a qualified contractor secure range so it cannot tip over.

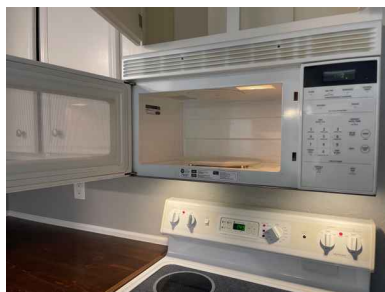
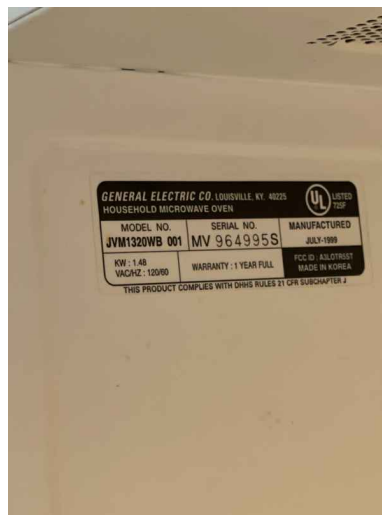
The microwave oven was functional at the time of the inspection.

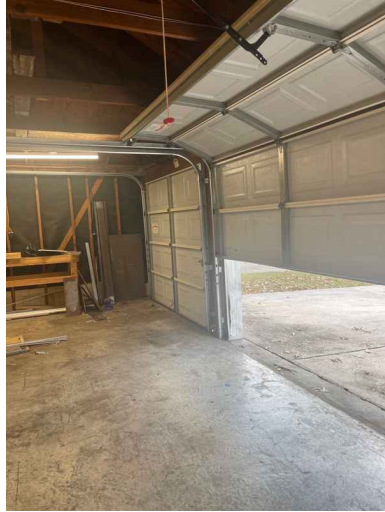
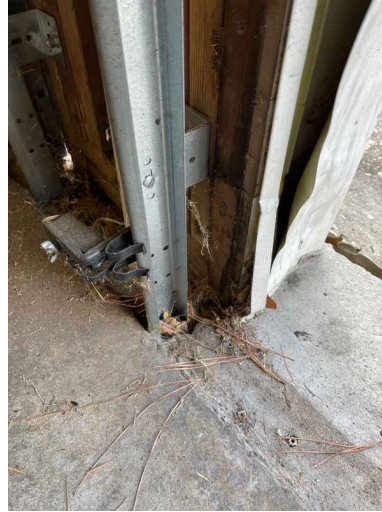
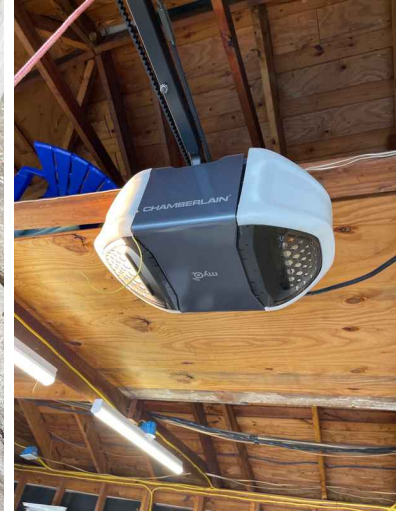
The garage door was functional at the time of the inspection. No excessive noise was heard from the garage opener and the door and tracks appeared to be properly mounted. The garage door automatic reversing feature performed satisfactorily.

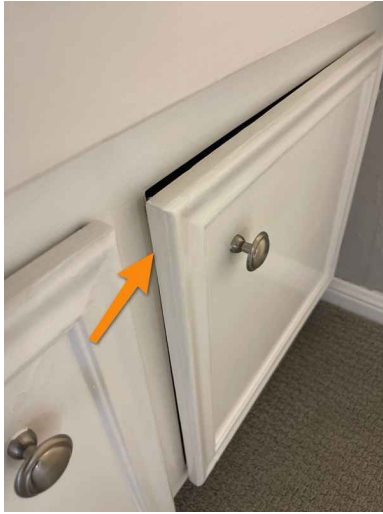
2nd Floor Jack & Jill

**1: Improper installation**

The following cabinet door is Not installed correctly. Normal use will cause deterioration. I recommend further evaluation and repair.
