DualCheck Inspections LLC
Effective.Efficient.Everytime

03/31/2022

PROPERTY INSPECTION REPORT FORM

Address of Inspected Property: 29002 Dryander Forest Ct. Katy, Texas

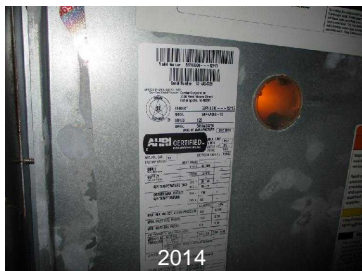
Approx. age: 2014 (8 years)

- The heating equipment appears to be performing as intended at the time of the inspection.
