## PROPERTY INSPECTION REPORT

10102 TRIBECA TRAIL, MISSOURI CITY, TX 77459

HAO WANG

4/7/2022

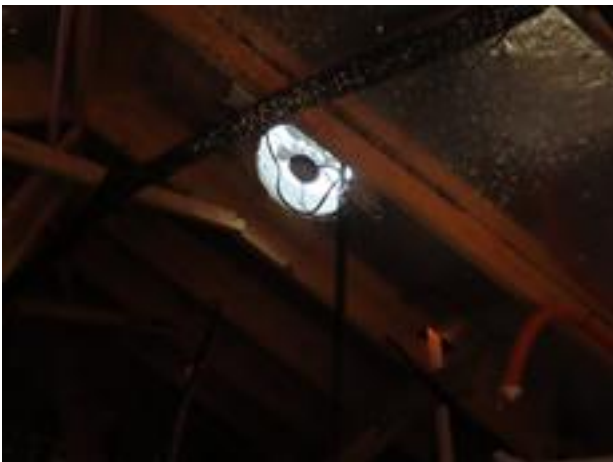
Support needs at one overlapped rafter in left back walk-in attic on second floor

Soft walking board needs to be strengthened in ceiling attic

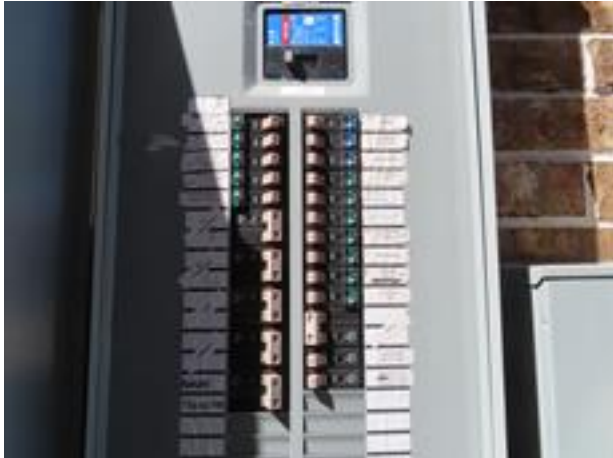
The panel locates on the left exterior wall of the house.

The AFCI (arc fault circuit interrupters) needs to be tested at least once a year.

No test on AFCI due to house occupied.

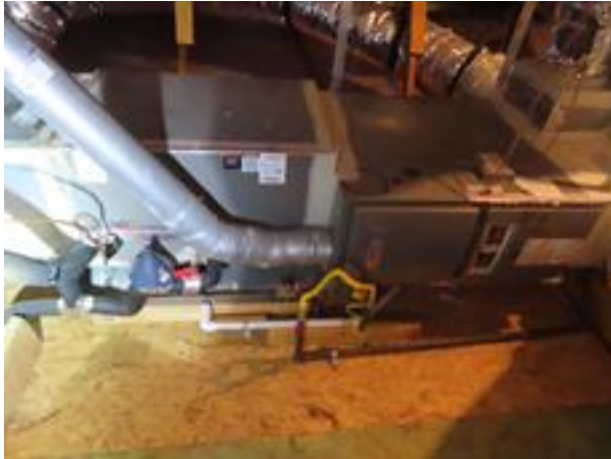
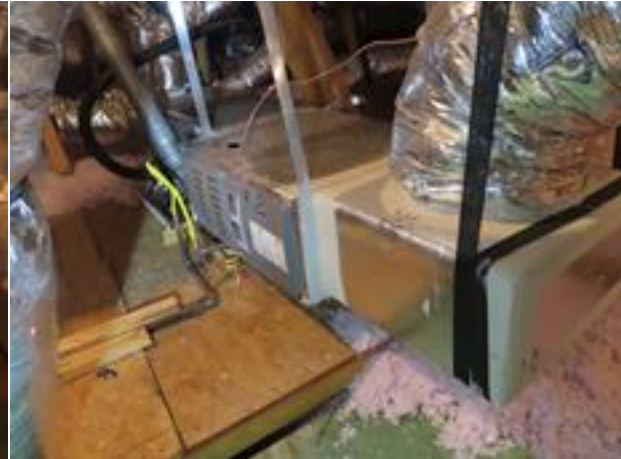
Info: Two LENNOX furnaces locate in the attic

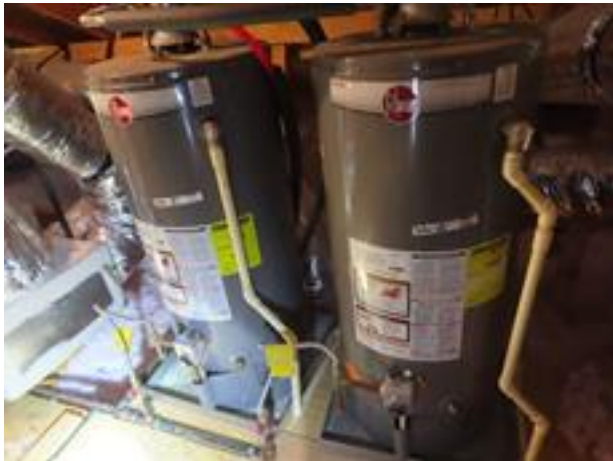
Info: Two water heaters locate in the attic

Functioning as intended
