Lone Star Stucco, LLC

Moisture Assessment Report

1316 Peden Street, Unit B

Houston, TX 77006

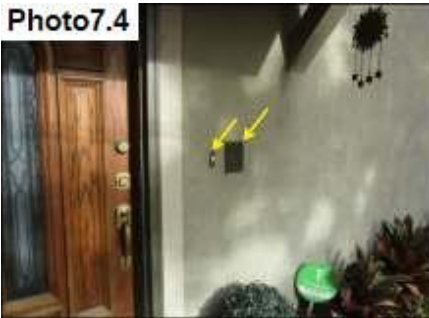
Photo7.4

Penetration Sealants / Seal

- The penetration sealants are missing in these locations. The inspector suggests to have a qualified waterproofing contractor seal these areas with a low modulus sealant in an effort to prevent moisture intrusion. These types of sealants are of high quality and compatible with stucco and other termination points. Please refer to photos #7.2, #7.3, #7.4, #7.5 and #7.6 for more detail.

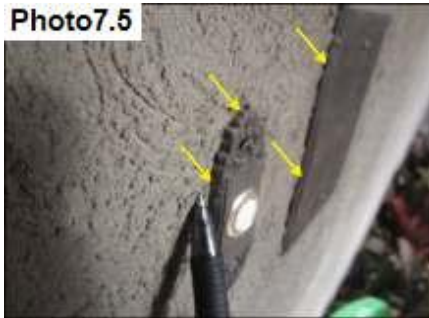
Photo7.5

Penetration Sealants / Seal

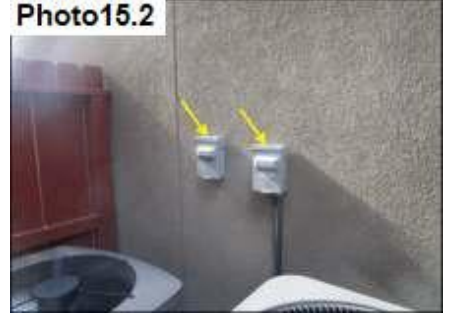
Photo15.2

Penetration Sealants / Seal

- The penetration sealants are aged, separated or missing in these locations. The inspector suggests to have a qualified waterproofing contractor seal these areas with a low modulus sealant in an effort to prevent moisture intrusion. These types of sealants are of high quality and compatible with stucco and other termination points. Please refer to photos #15.2, #15.3, #15.4, #15.5 and #15.6 for more detail.

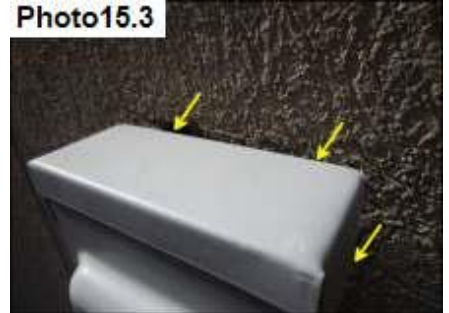
Photo15.3

Penetration Sealants / Seal

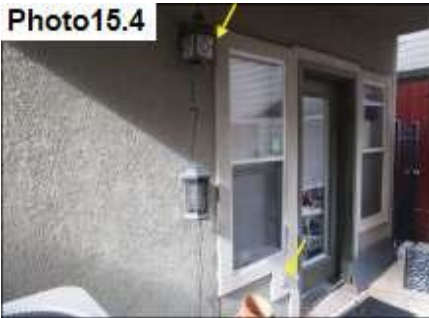
Photo15.4

Penetration Sealants / Seal

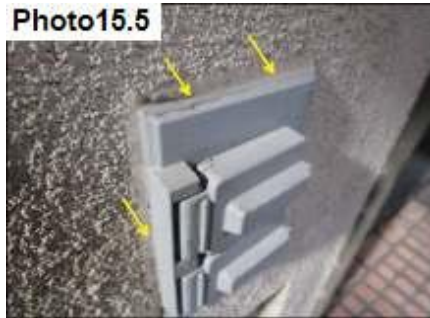
Photo15.5

Penetration Sealants / Seal

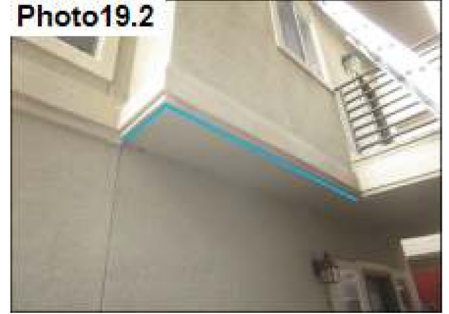
Photo19.2

No Relief / No Modification but Maintain Sealants Above

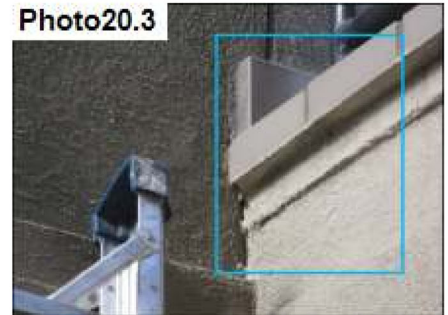
Balcony Flashing / Seal

Grid Location	Item Description	Moisture Readings	Substrate Condition	Observations
Blue Box	Balcony Flashing			The second floor balcony flashing sealants are aged or separated at this location. The inspector suggests to have a qualified waterproofing contractor further assess and seal this area with a low modulus sealant in an effort to prevent moisture intrusion. These types of sealants are of high quality and compatible with stucco and other termination points. Please refer to photos #20.2, #20.3, #20.4 and #20.5 for more detail.
F5	Bottom Balcony	14%	Firm	A moisture probe was taken at the bottom of the balcony. The substrate was firm with no damage noted at this time
G4	Bottom Balcony	16%	Firm	A moisture probe was taken at the bottom of the balcony. The substrate was firm with no damage noted at this time
I5	Bottom Balcony	28%	Semi-Firm	A moisture probe was taken at the bottom of the balcony. An elevated moisture reading was noted with a semi-firm substrate.

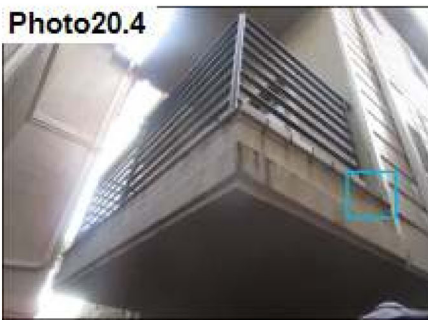
Balcony Flashing / Seal

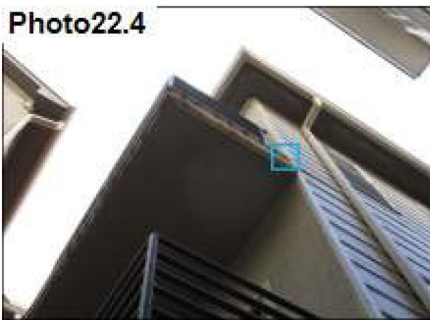
Balcony Flashing / Seal

Grid Location	Item Description	Moisture Readings	Substrate Condition	Observations
Blue Box	Balcony Flashing			The third floor balcony flashing sealants are aged or separated at this location. The inspector suggests to have a qualified waterproofing contractor further assess and seal this area with a low modulus sealant in an effort to prevent moisture intrusion. These types of sealants are of high quality and compatible with stucco and other termination points. Please refer to photos #22.2, #22.3, #22.4 and #22.5 for more detail.
F2	Bottom Balcony	12%	Firm	A moisture probe was taken at the bottom of the balcony. The substrate was firm with no damage noted at this time
F1	Bottom Balcony	14%	Firm	A moisture probe was taken at the bottom of the balcony. The substrate was firm with no damage noted at this time
G2	Bottom Balcony	20%	Firm	A moisture probe was taken at the bottom of the balcony. An elevated moisture reading was noted with a firm substrate.
