Inspection Report

Property Address:
8011 Serenity Ct
Houston TX 77025

Houspecx Inspection Service

PROPERTY INSPECTION REPORT FORM

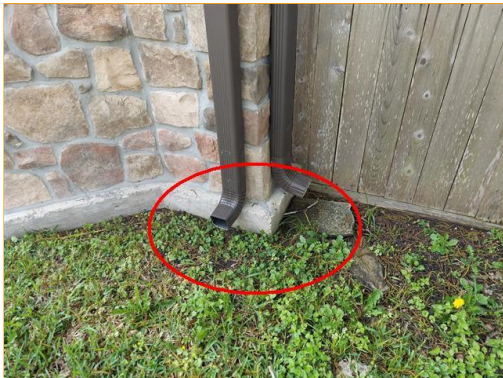
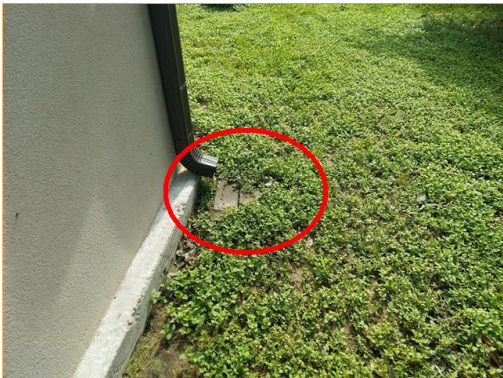
Downspouts Extensions

(2) One or more downspouts lacked extensions or splash blocks which are recommended to move runoff water away from the foundation and to prevent erosion and to help protect the home structure and occupants. ([CHN](#))

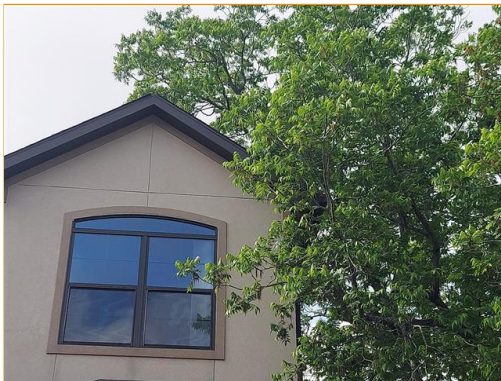
(4) Large tree limbs were growing overhang the roof covering and may lead to damage to the roof covering or restrict the roof drainage; Consider having these limbs trimmed away by a qualified arborist. [\(CHN\)](#)

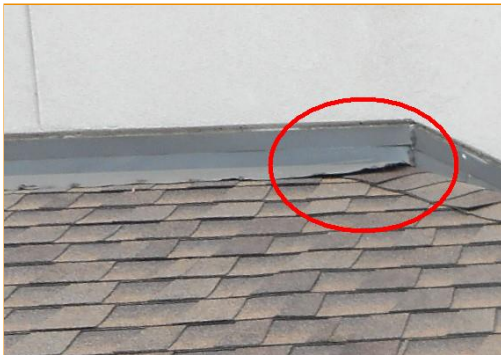
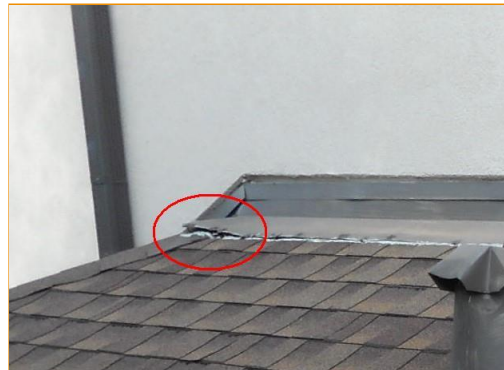
(5) Roof covering flashings were observed to be lifting, damaged, or improperly installed and were in need of repair or replacement; Lifting, damaged, or improperly installed flashings may allow water penetration; to fully evaluate the insurability and condition of the roofing materials; repair is recommended. [\(CHN\)](#)

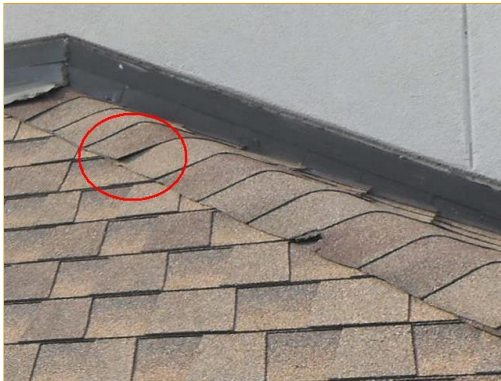
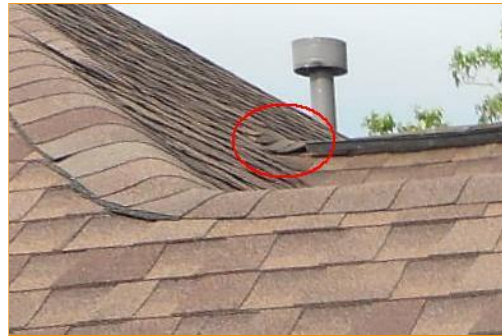
(6) Loose shingles were observed at the ridge cap during the inspection due to malfunctioning adhesion of the back strip on the shingles; this may lead to roof leakage; repair is recommended.

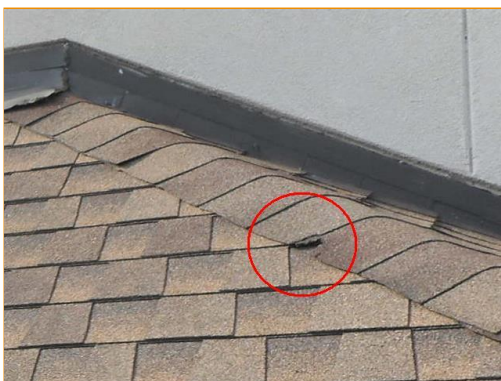
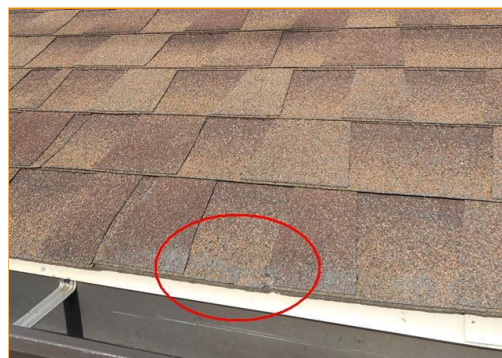
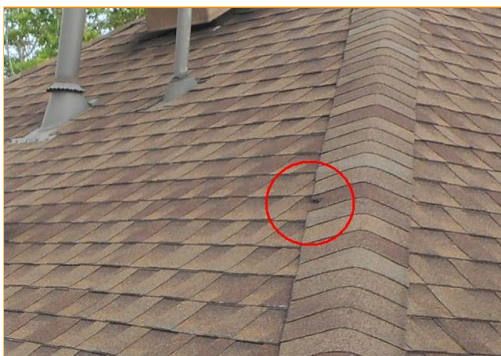
(7) Damaged roof covering materials were observed during the inspection; a full evaluation of the insurability and condition of the roofing material is recommended; repair as needed.

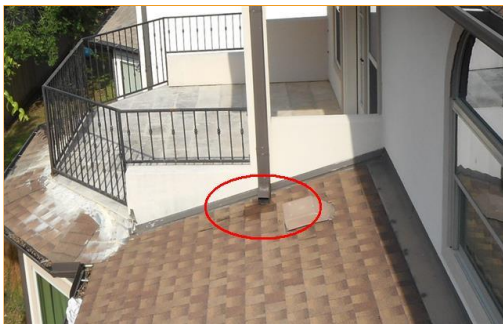
(8) The gutters or downspouts were found to discharge rain water directly onto roof shingles. The secondary roof rain gutter lacks a downspout; lack of a downspout at secondary roof rain gutters may allow localized deterioration and premature wear of the roof covering materials; the condition should be evaluated and corrected as needed by a qualified roofing contractor. [\(CHN\)](#)

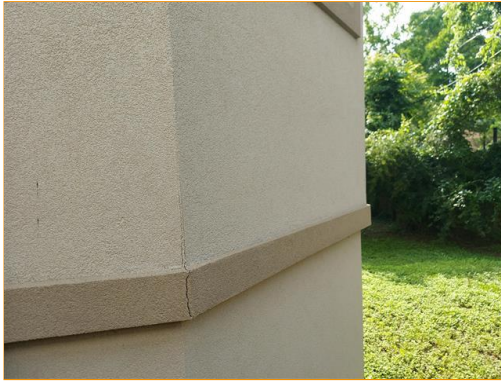
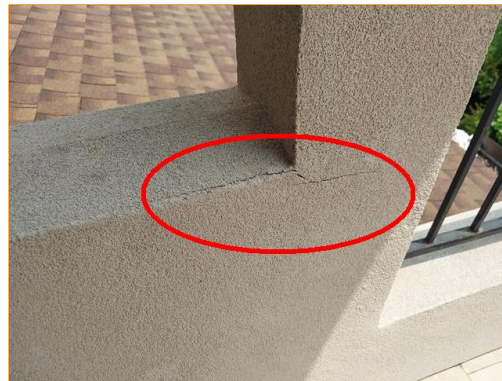
(6) **Mortar was observed to be damaged, separated or missing in one or more areas.** Missing, separated or damaged exterior masonry mortar may allow moisture penetration and should be repaired (repointing).

Mortar improvements are recommended for the exterior masonry veneer.

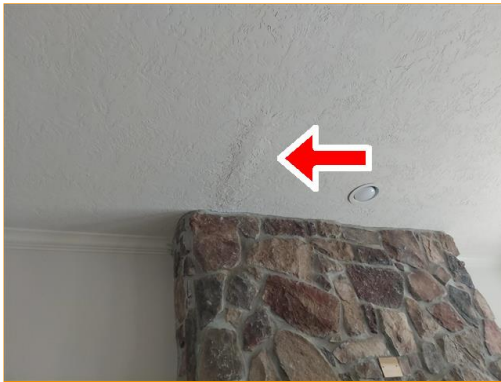
(3) Improper previous repair was noted in the family room during the inspection; further evaluation by a qualified contractor is recommended and repair as needed.

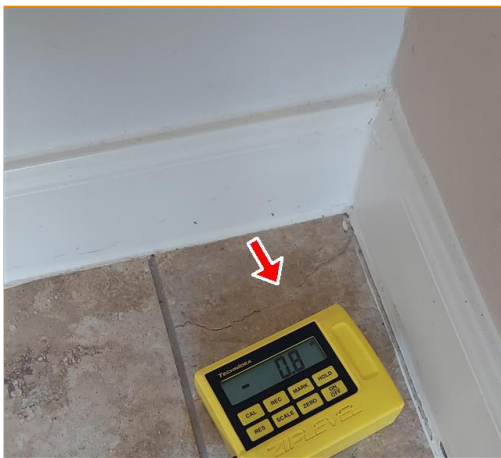
(4) Cracked floor tiles were observed during the inspection; further evaluation and repair as needed.

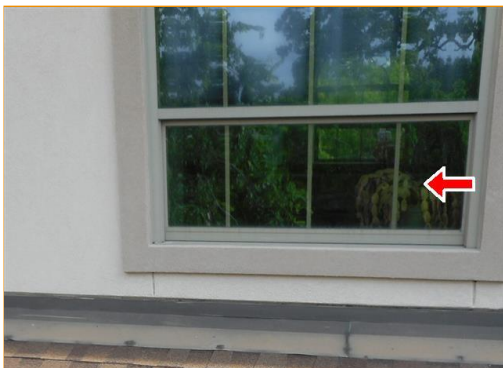
(5) The window exterior screens were observed to be missing and/or damaged. The condition may result in pest entry and should be corrected by a qualified professional.

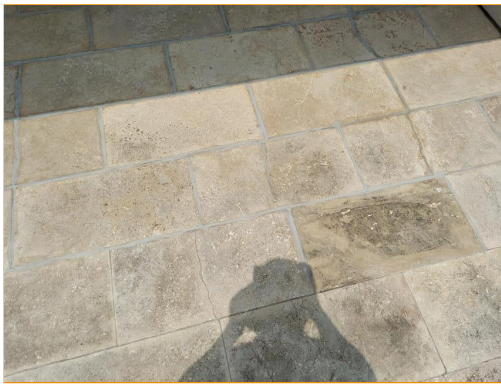
The balcony components appeared to be in generally serviceable condition at the time of the inspection.

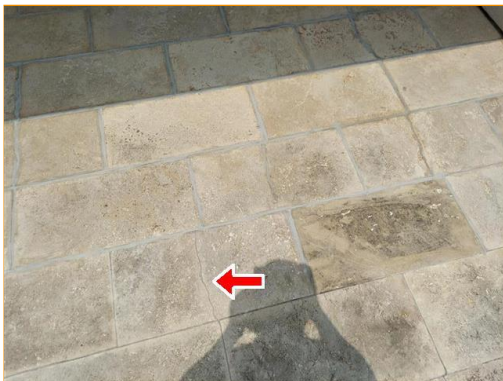
(2) Common cracks (1/4-inch or less) were noted in the concrete porch floor at the time of the inspection. Cracks exceeding 1/4-inch should be filled with an appropriate sealant to avoid continued damage to the concrete porch floor surface from freezing moisture.

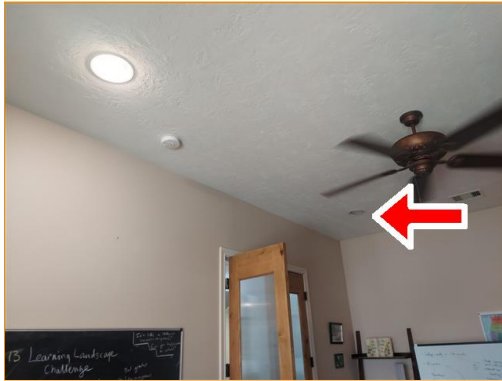
(3) Light Fixture Not Response

One or more light fixtures in this home had one or more light bulbs that did not respond to the switch. The bulb may need to be replaced or there may be a problem with the switch, wiring, or light fixture. If after the bulb is replaced this light still fails to respond to the switch, this condition may be a potential fire hazard and the Inspector recommends that an evaluation and any necessary repairs be performed by a qualified electrical contractor. [\(CHN\)](#)

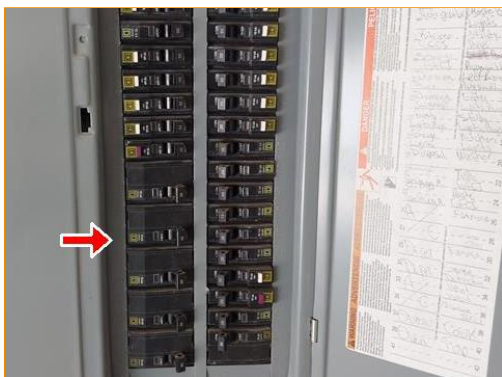
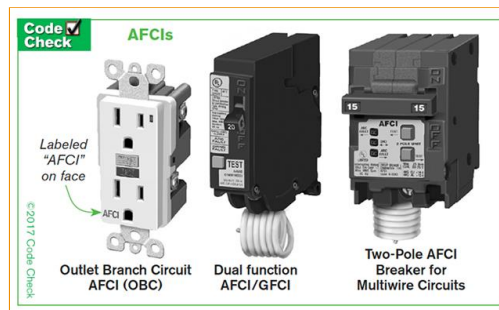
(4) During the inspection, it was discovered that the appliances lacked AFCI protection. Furthermore, current recommendations indicate that dishwashers, garbage disposals, washing machines, and dryers should have combination GFCI/Arc-Fault protection, while microwaves should specifically be Arc-Fault protected. Therefore, it is strongly advised that the necessary corrections be made to ensure the safety of these appliances. The installation of AFCI protection will help prevent arc faults, which can potentially lead to electrical fires. To address this issue, it is recommended to hire a professional to install the appropriate protection mechanisms for each appliance, ensuring compliance with safety standards and reducing potential hazards. [\(CHN\)](#)

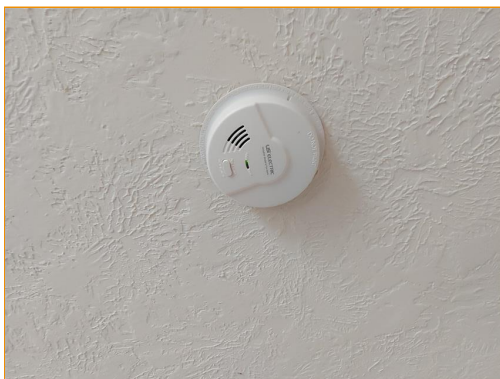
(4) No CO detectors provided

The home lacks carbon monoxide detectors, posing a safety concern. The Inspector advises immediate installation in key areas. Proper placement is crucial. Ideally, position one near the sleeping quarters to awaken occupants during sleep, per the CPSC's recommendation. For enhanced safety, consider adding detectors on every floor and in each bedroom. Avoid installing near-fuel-burning appliances to prevent false alarms from appliance emissions. Keep detectors at least 15 feet away from heating or cooking devices and avoid humid spaces like bathrooms. Safeguard your home and family by adhering to these vital carbon monoxide detector placement guidelines. [\(CHN\)](#)

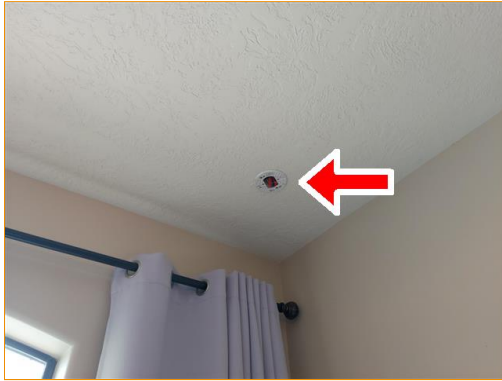
(5) Missing smoke detector in one or more sleeping room at the time of the inspection. The Inspector recommends installing a smoke detector in each sleeping room to provide improved fire protection.

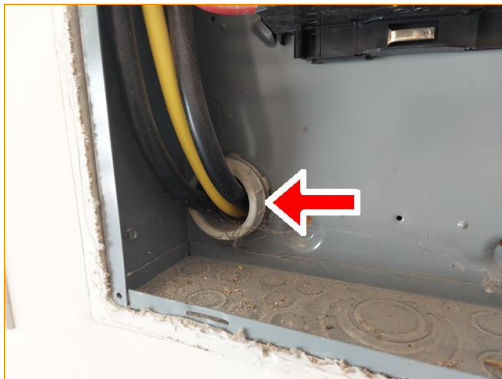
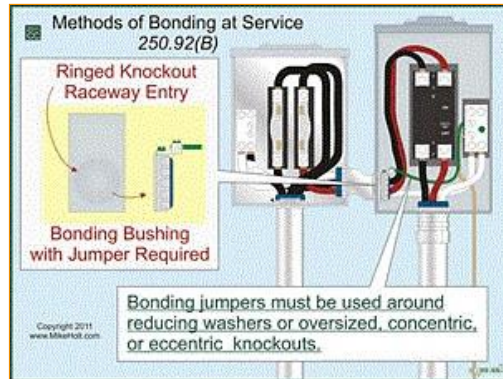
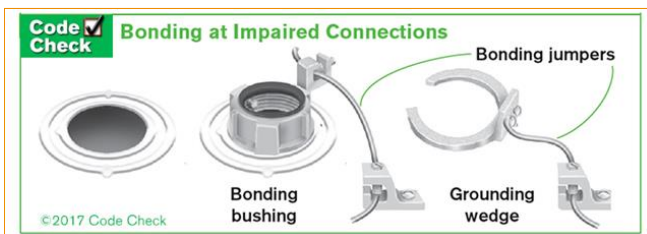
Missing Bonding Jumper

The inspection, conducted in strict accordance with TREC SOPs, highlighted a critical electrical safety consideration regarding bonding jumpers. It is now imperative, per NEC 250.92(A) & (B), that raceways entering service enclosures through concentric or eccentric knockouts include bonding jumpers. These jumpers are crucial for ensuring proper electrical bonding, which is essential for maintaining safe electrical systems.

Notably, knockouts designed for larger conduits often lack sufficient bonding, making standard locknuts and bushings inadequate for NEC compliance. Therefore, to meet bonding requirements, it is highly recommended that a licensed electrician installs a bonding jumper wire during the next panel service. This proactive measure enhances electrical safety and aligns with industry standards and regulations. [\(CHN\)](#)

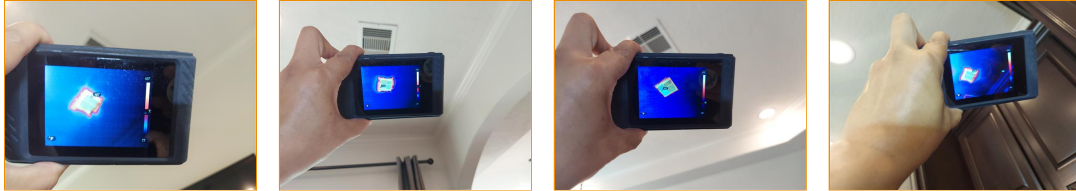
(3) Temperature readings in the main floor when the furnace operating during the inspection.

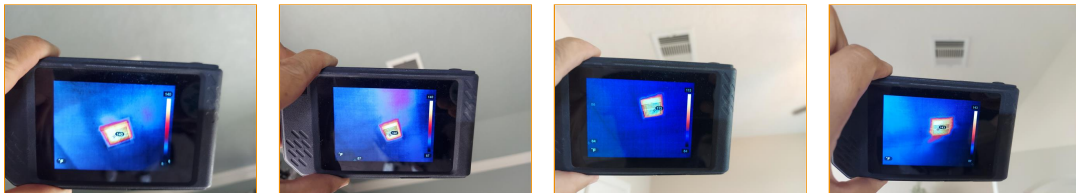
(4) Temperature readings in the main floor when the furnace operating during the inspection.

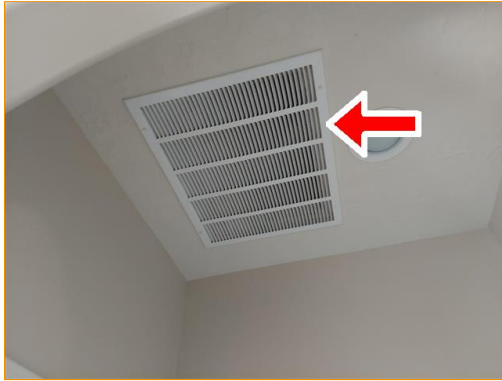
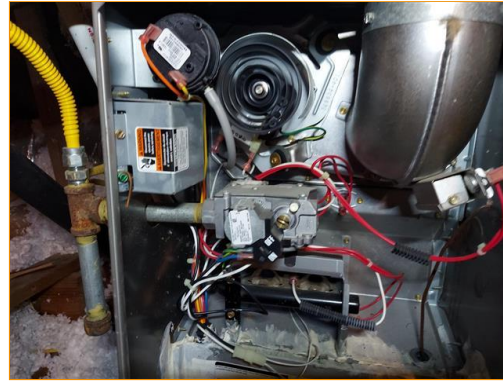
(5) At the time of the inspection, the blower failed to shut down the blower when the thermostat turn the system OFF. This condition should be evaluated by a qualified HVAC contractor.

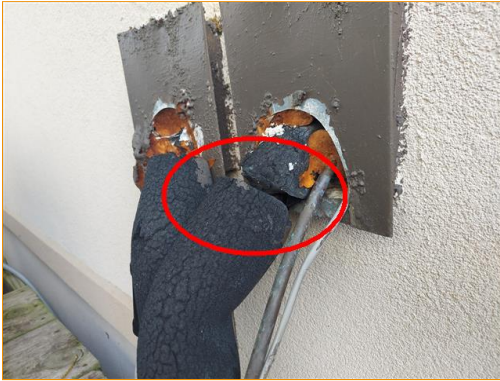
(6) Missing or damaged insulation

The foam sleeve on the suction line was missing, damaged, or, deteriorated foam sleeve in the area(s) at the outside unit; a defective foam on the suction line can cause energy loss and condensation; recommends service or repair as needed. [\(CHN\)](#)

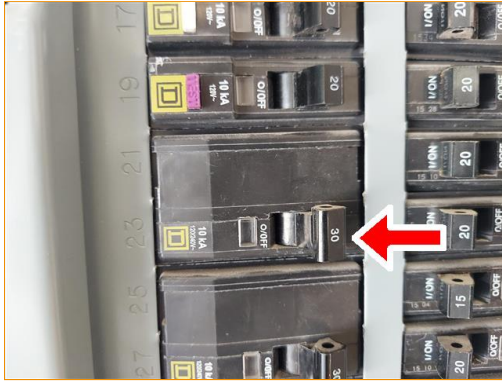
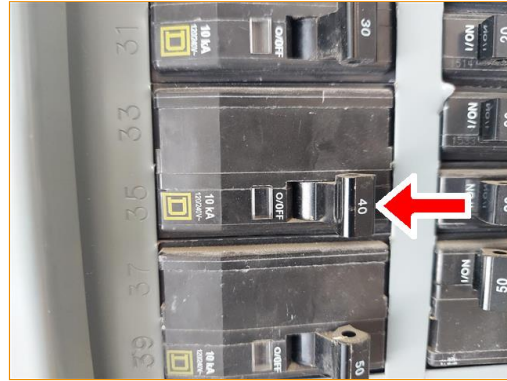
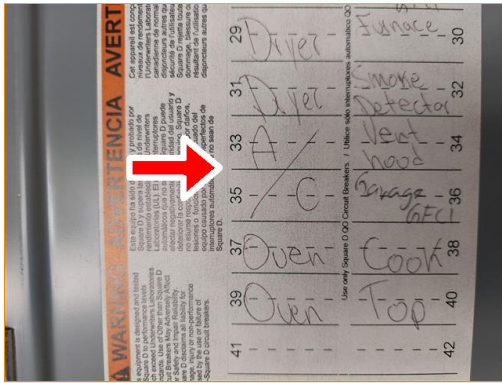
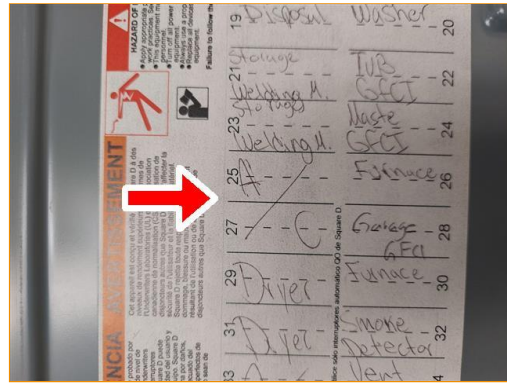
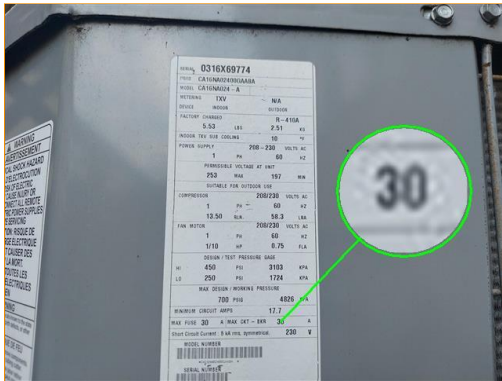
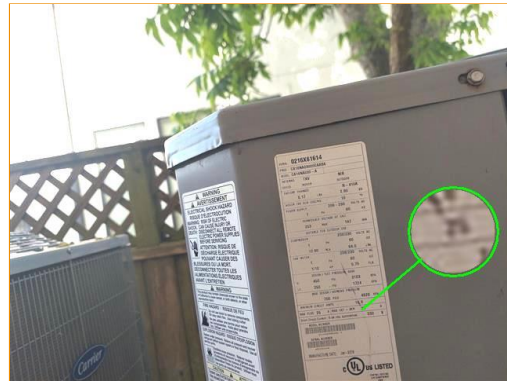
Mismatched breaker sizes between exterior cooling equipment (Max./Min. Amperage), or the electrical service panel breakers were observed; Mismatched electrical components may affect performance or damage the HVAC equipment; further evaluation and correction as needed by a qualified HVAC specialist.

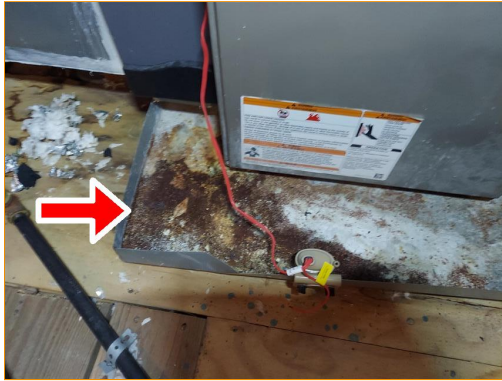
(10) The air conditioning system condensate overflow tray shows evidence of leaks; condensate falling into the condensate overflow drip tray is not a normal event; if we see evidence of leaks in the condensate tray, the air conditioning system service technician should investigate the cause of this condition. ([Right-click to view the detail](#))

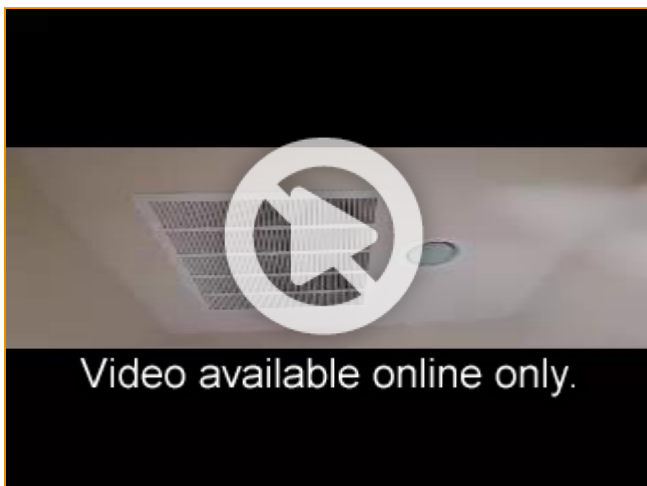
(2) The air conditioning system produces excessive noise from the return air chase during operation. To address this issue, it is advised to seek assistance from a qualified HVAC contractor for a thorough evaluation and necessary corrective measures. This step will ensure optimal functioning and a quieter environment for your comfort. [\(CHN\)](#)

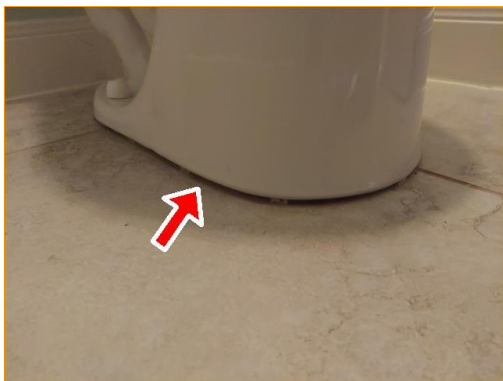
(4) Missing caulking at the floor and toilet during the inspection; correction performed by a qualified contractor is recommended.

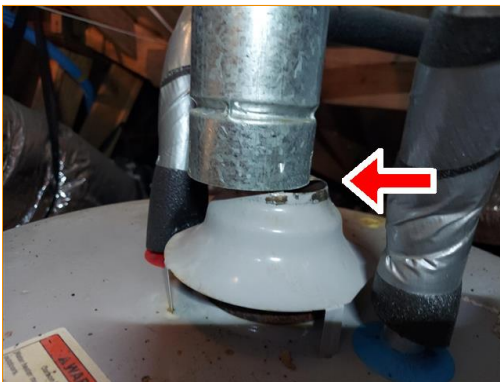
(4) The draft diverter of the gas-fired water heater had been displaced, was improperly aligned and may allow the toxic products of combustion to leak into the living space. Excessive human exposure to these products of combustion can result in injury or death. The Inspector recommends correction by a qualified HVAC or plumbing contractor.

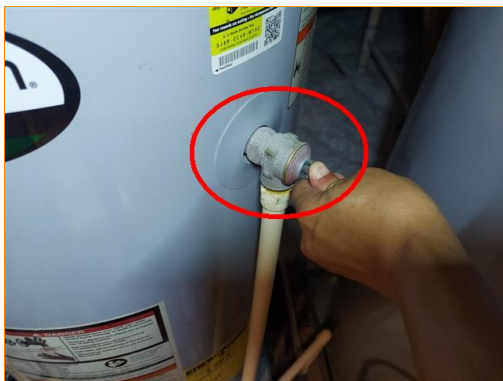
(5) The pressure relief valve was inoperable when tested during the inspection and should be replaced by a qualified HVAC technician or plumbing contractor.

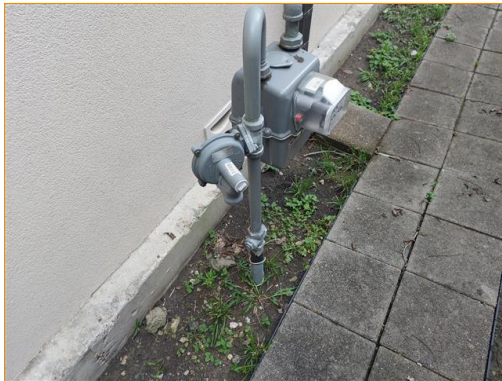
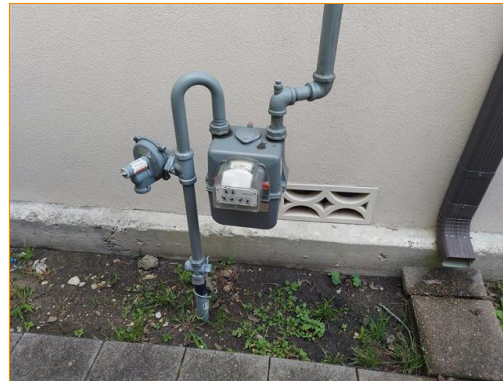
(1) *Gas smell at the gas meter at the time of the inspection.* It may be a leak at the regulator or a leak at one of the pipe connections.

The inspector recommends evaluation by the gas service provider and repair as needed.

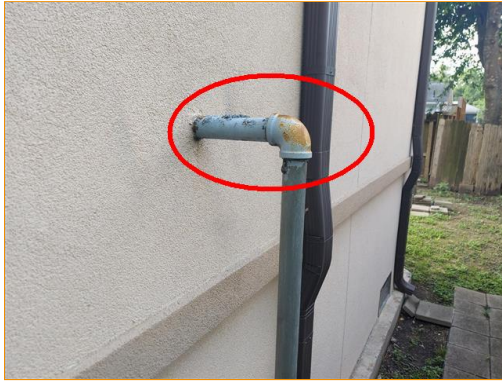
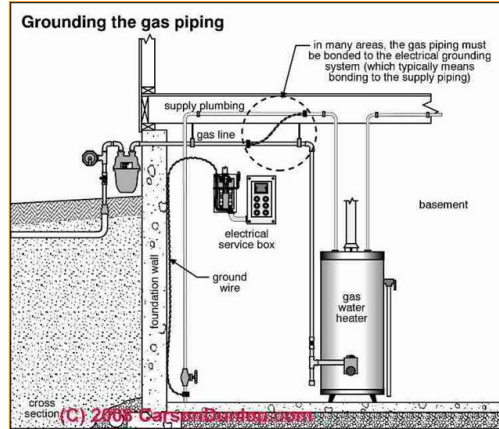
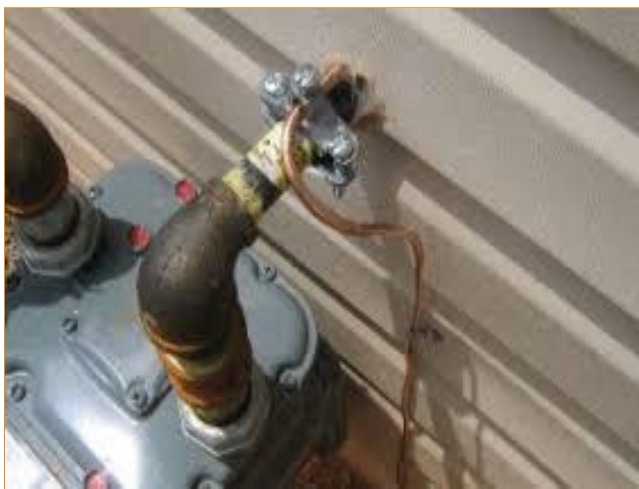
(2) EQUIPOTENTIAL BONDING Wire Not Found

EQUIPOTENTIAL BONDING wire was not found at the time of the inspection; Metal gas (including corrugated stainless steel tubing (CSST)) and water supply pipes & other equipment such as stoves, ovens, furnaces, air conditioners, water heaters & metallic electrical panel boards, that may become electrically energized, are required to be electrically bonded together. If, a bonding component has come loose, appears deficient, or is missing/not visible, it will be noted in this report as required by the TEXAS REAL ESTATE CONSUMER NOTICE CONCERNING HAZARDS OR DEFICIENCIES. It is often not possible to tell during this type of inspection if all bonding has been properly done. The lack of bonding may allow metallic parts, in a home, to become electrically energized due to a number of electrical events not normal to an electrical system, such as a lightning event; A Master Electrician should be consulted to verify all bonding has been installed in accordance with the proper current Electrical Standard. [\(CHN\)](#)

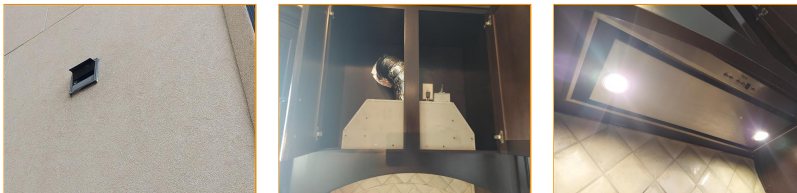
(2) The exhaust fan appeared to be inoperable at the time of the inspection. Repairs should be made by a qualified technician.

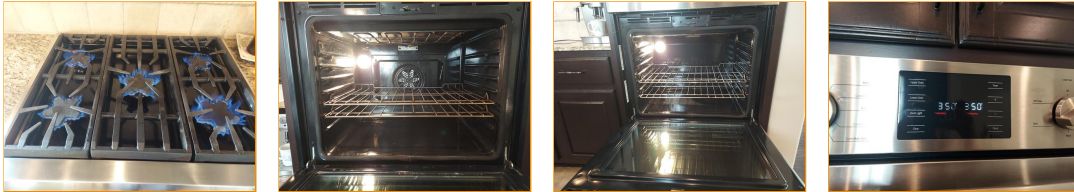
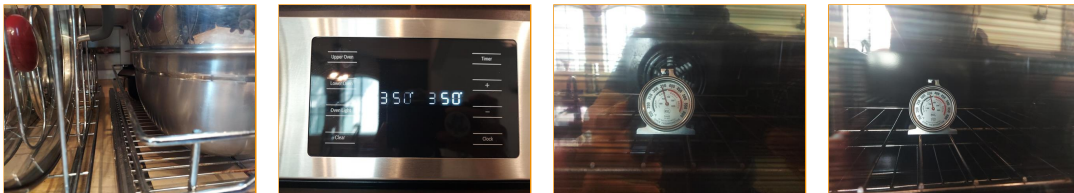
(2) Improper burner flame color observed; fluctuates between orange, yellow, and red with wavering. The color indicates carbon soot particles from incomplete methane combustion—servicing required by qualified technicians.

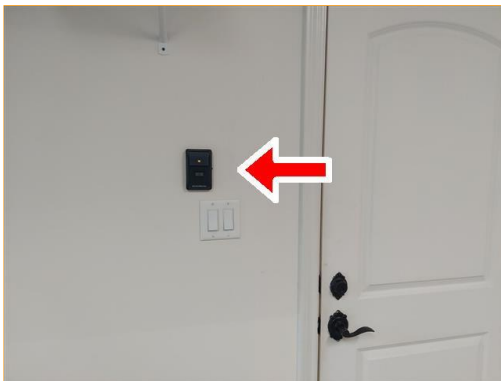
No Warning Label next to wall button as required by manufacturer's installation instructions. Warning information for child safety.
