REDSTAR PROFESSIONAL HOME INSPECTION, INC

REDSTAR RESIDENTIAL INSPECTION REI 7-6

24327 Palomino Sage Trl
Katy, TX 77493

PROPERTY INSPECTION REPORT FORM

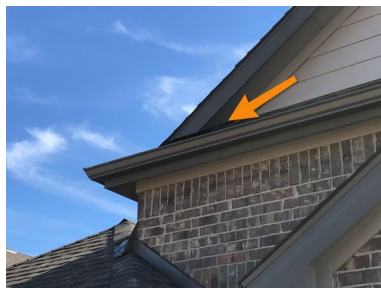
Front Multiple Locations

Observed buckled/lifted shingles on the roof covering. This condition is where the shingles are lifted or are not laying flat due to wrinkling of the underlayment or a shingle issue. High humidity and moisture issues at decking can also contribute to this condition. Recommend further evaluation by a roofing contractor to determine the extent of necessary repair.

Recommendation: Contact a qualified roofing professional.

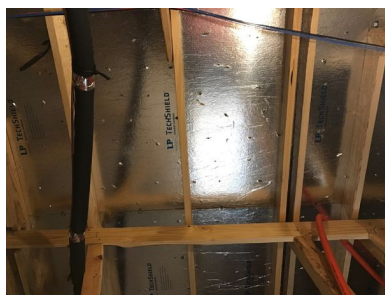
A radiant barrier was installed at the attic space. While these barriers are great for reflecting radiant heat and improving energy efficiency, they can conceal possible evidence of water penetration and limit evaluation of the decking material. Recommend regular monitoring of the attic space. More information may be contained in the report.

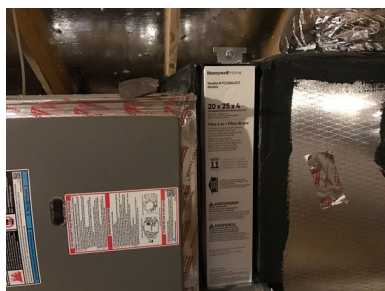
Attic

Media filter is located at the air handler in the attic. This should be changed out every 6-8 months.
