21418 Park Rock Ln
Katy, TX 77450
Kachi Osuorji

06/27/2024

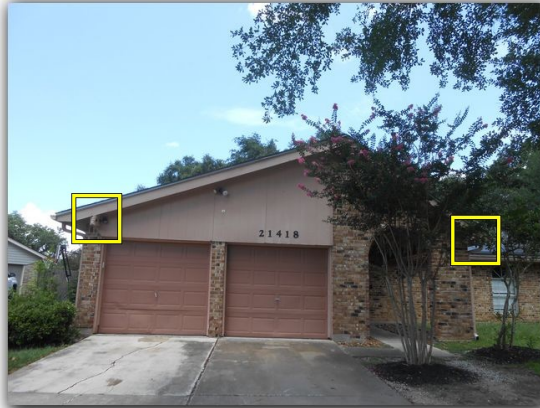
The decorative beam is missing at the peak at the front of the home exposing an opening into the attic space. This is an entry point of water and pests.
