FIG Services LLC d/b/a FOX INSPECTION GROUP  
 Property Inspection Report #220113JO-102 Phanturn Lane  
 8616 Daffodil St. Houston, TX 77063  
 (Office)713.723-3330 (Email) [office@foxinspectiongroup.com](mailto:office@foxinspectiongroup.com)

## ***PROPERTY INSPECTION REPORT***

**Prepared For:** Xiao Han  
(Name of Client)

**Concerning:** 102 Phanturn Lane, Bellaire, TX 77401  
(Address of Inspected Property)

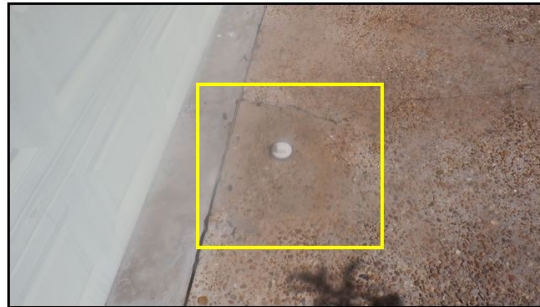
*Evidence suggests foundation MAY have been repaired, recommend that buyer review paperwork regarding the scope of work done and steps necessary to transfer a warranty if any.*

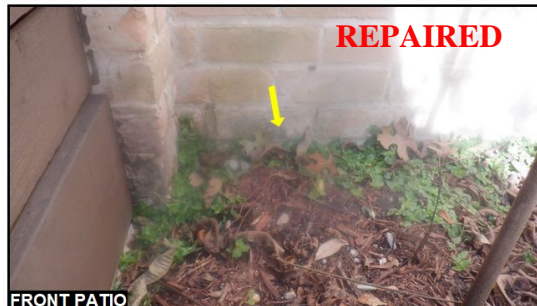
Soil level too high around areas including, but not limited to, multiple areas around house and garage. Common industry practice requires a clearance of at least 4 inches from the bottom of the siding to the soil. High soil level near the siding promotes wood rot and is considered a conducive condition to termite activity and water penetration.

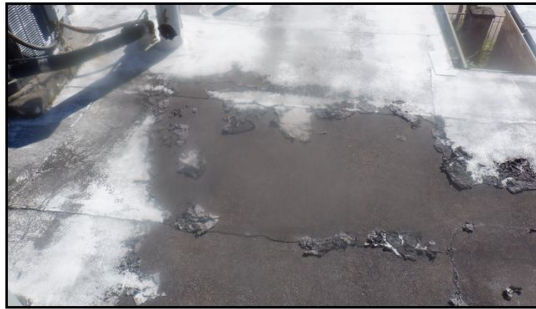
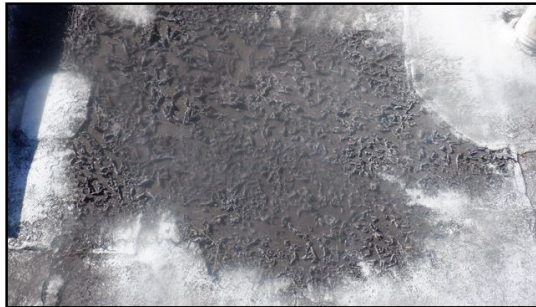
Both roof surfaces appears older. Observed deterioration / blistering of roll roof surface and brittle, cracked, curled ends and/or excessive granular loss of shingles. Recommend further evaluation by a qualified roofing specialist.

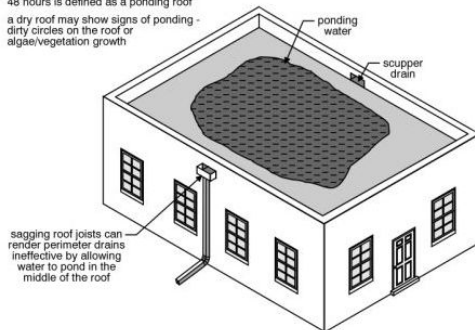
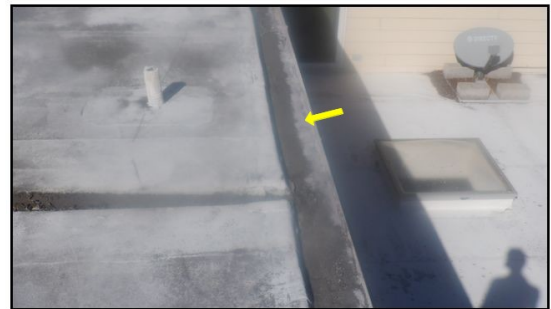
Standing water and/or stains from previous standing water observed on the flat roof. This condition is conducive to water penetration. Recommend roofer be consulted regarding the ability to correct drainage on the roof to prevent/reduce standing water.

**Ponding on flat roofs**

any roof that still has water on it after 48 hours is defined as a ponding roof  
a dry roof may show signs of ponding - dirty circles on the roof or algae/vegetation growth

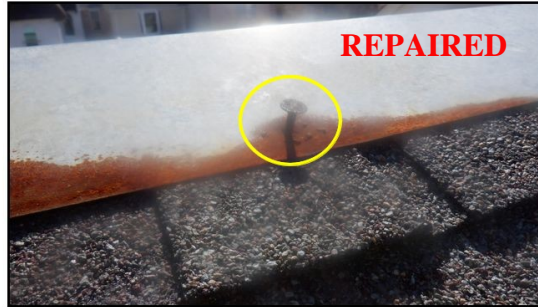
Exposed staples/nail-heads/fasteners observed on the roof are not properly sealed. Water entry possible.

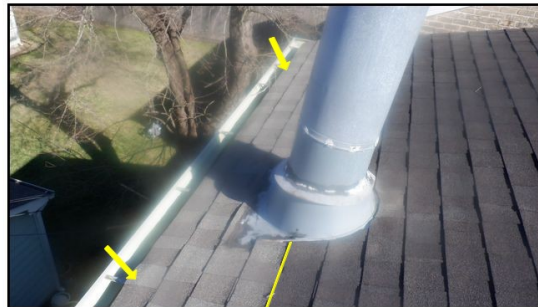
Observed spot repairs to the roof surface; possible water penetration area.

**Repaired in Oct 2020**

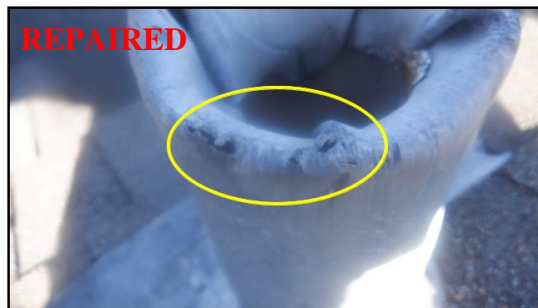
Not all lead flashing of drain waste vents are properly rolled down interior of plumbing vent pipes and/or are damaged by squirrels, which may allow some rainwater entry.

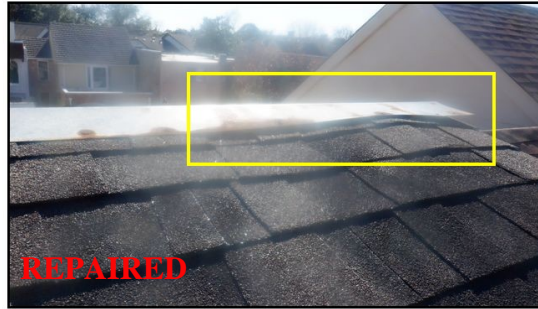
Lower side of flashing is not sealed down, wind-driven rains can cause water penetration.

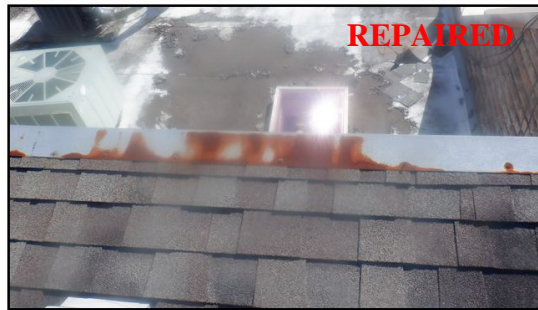
Observed rusted flashing at one or more locations. Recommend painting all exposed metal above roof line to prevent rusting and extend service life.

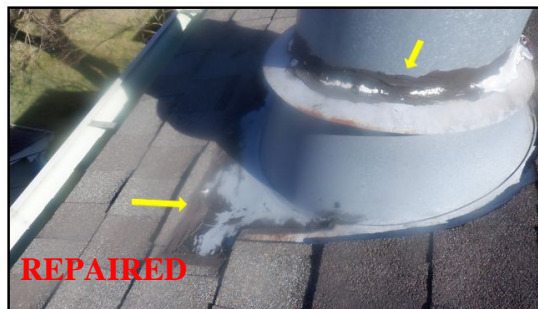
Observed improper use of roof tar as a sealant around the chimney vent. Roof tar is not an approved sealant around hot vent piping. Roof tar repairs observed around chimney.

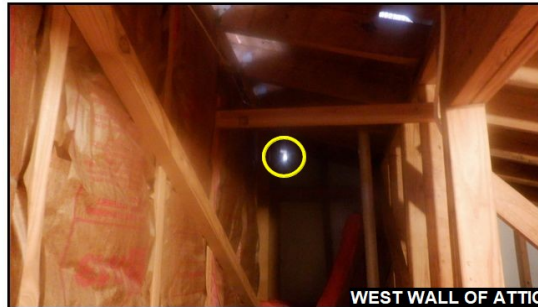
Daylight is visible from interior of attic at one or more locations. Recommend sealing these areas to prevent potential pest / rodent / water entry.

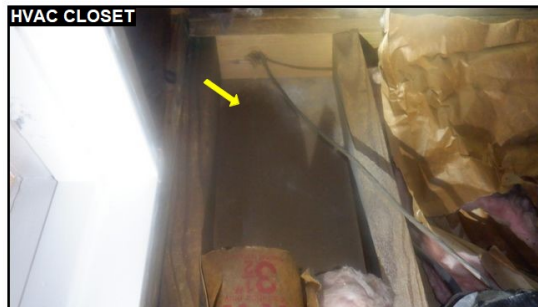
Vertical sections of insulation observed to be missing / displaced on interior walls in attic.

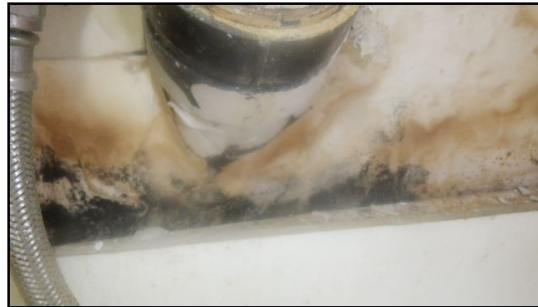
**Moisture meter registers water stains as active; kitchen cabinet below sink. Source of moisture is unknown. Recommend inquiry of seller and further investigation to determine root cause / possible remedy.**

Observed possible micro-organism growth (kitchen cabinet below sink) which may be a concern due to increased awareness of environmental issues associated with molds. Recommend removal of all sheetrock containing visible mold growth plus an additional 2 feet surrounding area. This inspector does not inspect for and is not qualified to render opinions on any type of environmental or other biohazards. If this is a concern or potential concern, Fox Inspections recommends contacting our company or a qualified professional of your choice for further information/investigation.

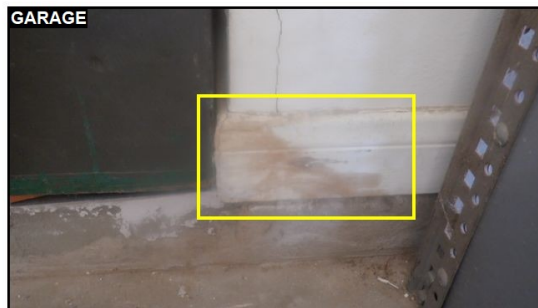
Water stains, damage or repairs observed, moisture meter indicated that stains are not active (wet) at the time of inspection; garage, powder bath.

**REPAIRED**

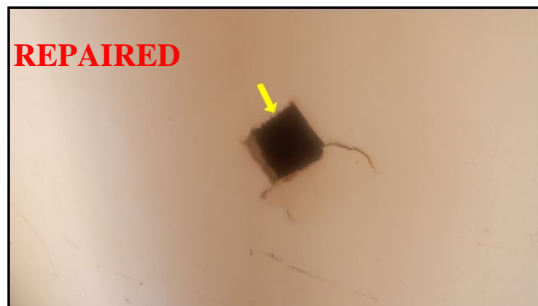
Recommend buyer consider installing sheetrock on unfinished garage walls / ceiling to serve as fire stopping to comply with current code and help protect the house.

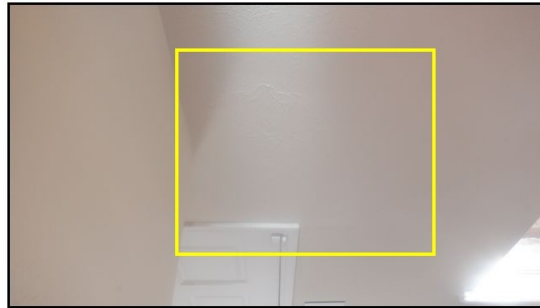
Cracks and/or previously repaired cracks in the sheetrock observed over some/many doors, windows, and/or corners, possibly due to house settlement.

*Patch / repairs noted at entry over front door; This inspection does not rate the substance or adequacy of these repairs.*

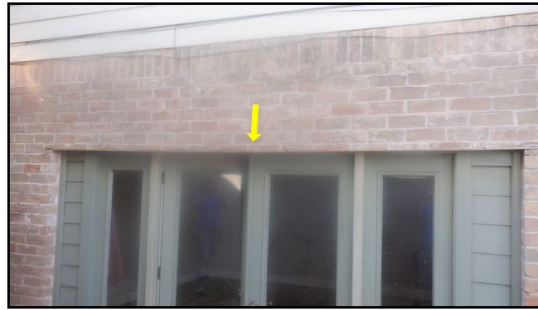
Sag observed in the lintel over the back door. Possible indication of improper/inadequate framing and/or foundation settlement.

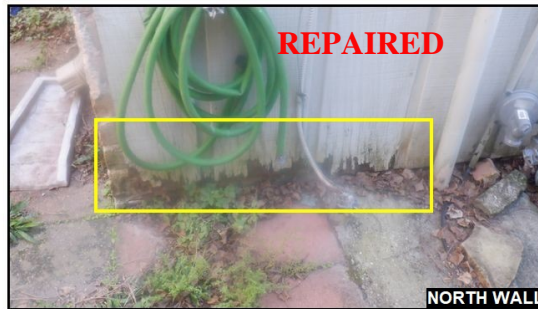
Wood rot observed on areas of house/garage.

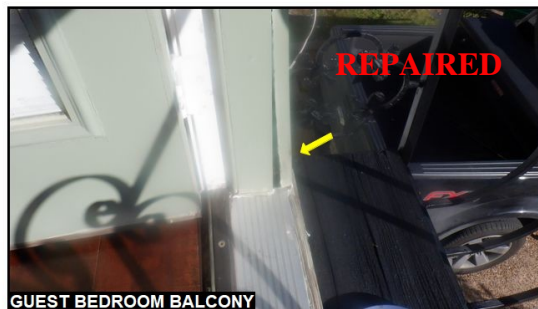
Trim / siding observed to be not secured down at one or more areas of house/garage.

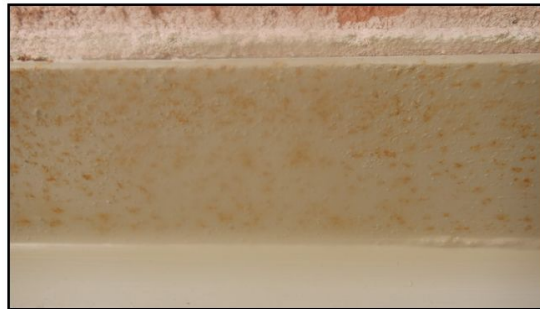
Metal lintel(s) over window/door openings need paint.

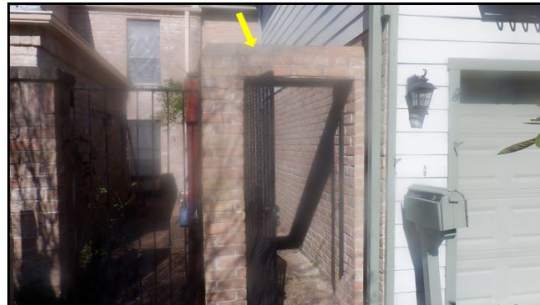
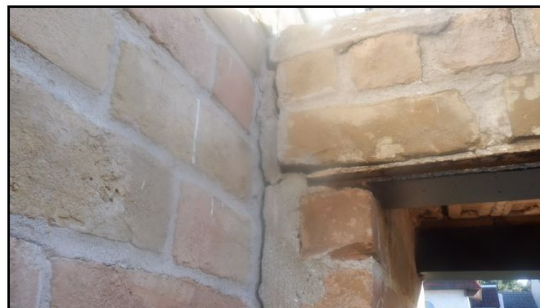
Cracks in the brick arch were observed. Loose bricks are hazardous.

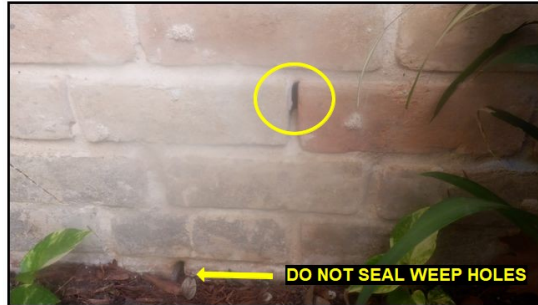
Mortar joints between brick ends are deficient in areas. This is an indication the brick-layer might not have properly "struck" the bricks (used enough mortar) - recommend re-pointing areas where voids in mortar are present.

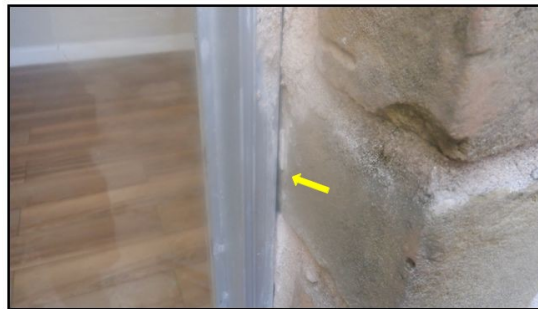
Caulking missing and/or deficient around windows / doors / vertical trim / joints in siding. May allow wind driven rain entry.

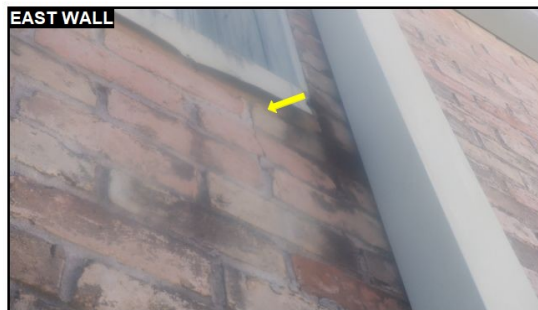
Cracks in brick / stone veneer and/or repairs, one or more locations, Recommend buyer take photographs of cracks, their location, and width [ruler across the crack] with a high-resolution camera that has a date stamp for future reference.

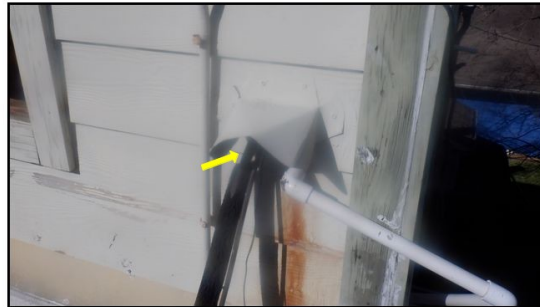
Recommend sealing / foaming exterior where AC lines enter the house. A weatherproof hood can be added for maximum prevention of water penetration.

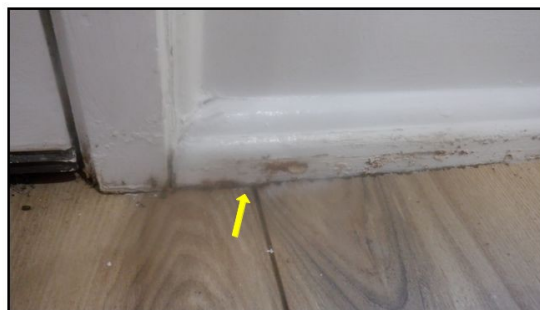
<b>Water penetration detected at back door. Could not confirm presence of door pan flashing or built-in water channel on door threshold (see Exterior Doors section below). Recommend further investigation / repair by a qualified professional.</b>
---

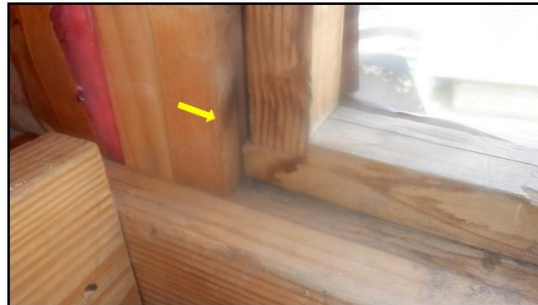
Water stains/damage to the interior of rooftop door jamb. Moisture meter indicated that the stains were not active (wet) at the time of inspection.

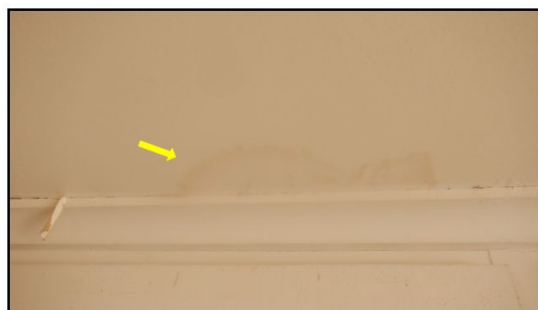
Water stains, damage or repairs observed, moisture meter indicated that stains are not active (wet) at the time of inspection; garage.

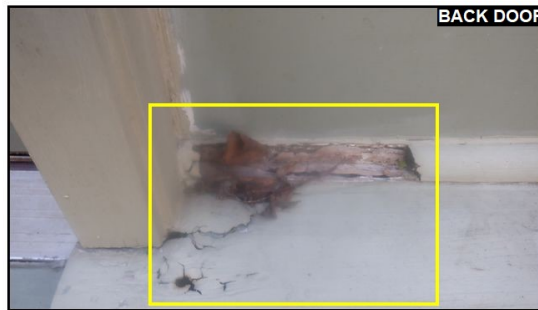
Wood rot of lower door and/or jamb; front and back doors.

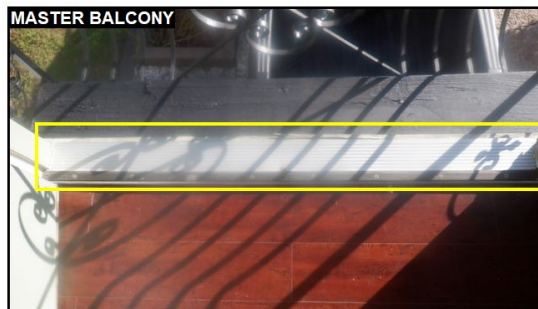
Improper threshold used on exterior doors without roof overhang protection from wind-driven rains can result in water damage from intermittent water entry.

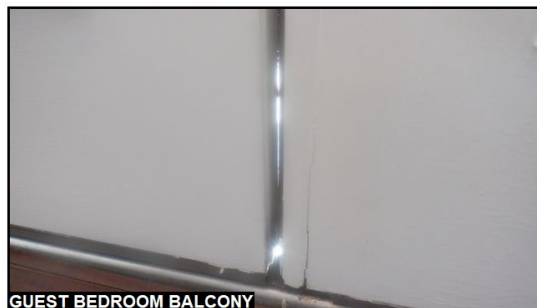
The lock set/deadbolt does not hold the door tight against the weather-stripping. Adjust striker plates or weather-stripping for proper seal.

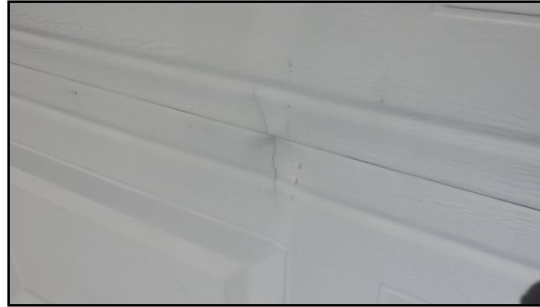
Section of steel garage door is damaged / bent.

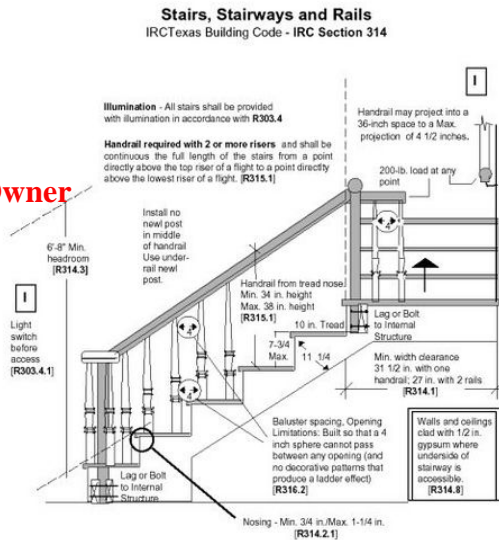
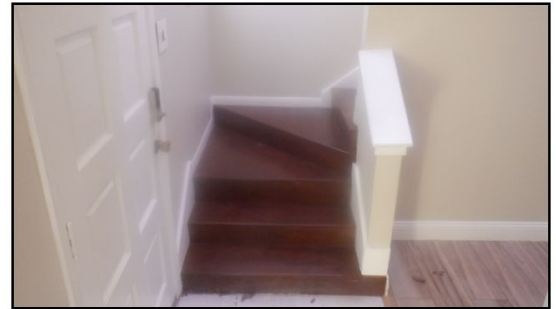
Steps/stairway do not comply with code due to one or more of the following; Inadequate headroom clearance, risers are not the same height, handrail is missing, stairway is too steep or narrow, railing not high enough, etc.

**Installed by Previous Owner**

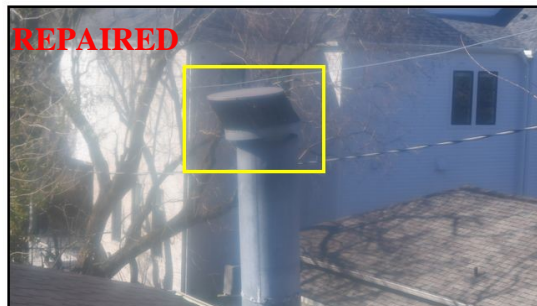
Chimney vent cap is loose / damaged on top of the chimney. Recommend repair by a qualified professional.

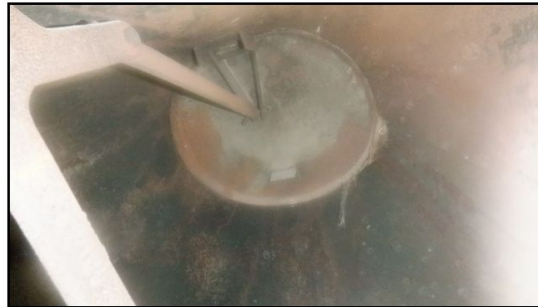
Apparent water entry at chimney/flue, resulting in water/rust stains around base of flue/damper area, water (effervescent) stained hearth bricks, and/or weak mortar. The condition should be addressed by a qualified chimney sweep.

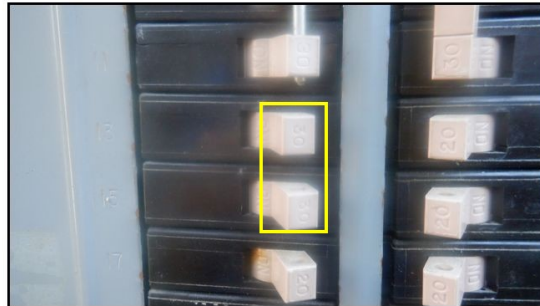
Missing tie-bar(s); 220-volt circuit breakers should be mechanically connected so that if one leg trips off it will trip the second leg of the 220-volt circuit.

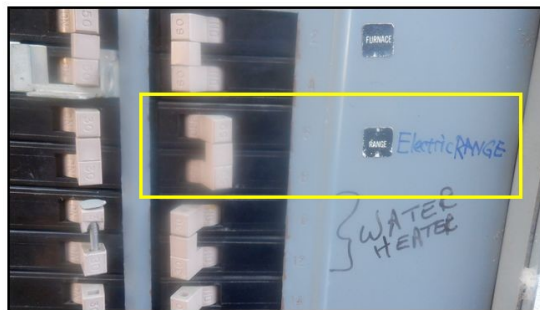
One or more breaker(s) were off at the time of inspection. Inspector does not turn on breakers found in off position due to potential short/electrical problem. Recommend inquiring seller regarding information regarding any/all breaker(s) found in off position.

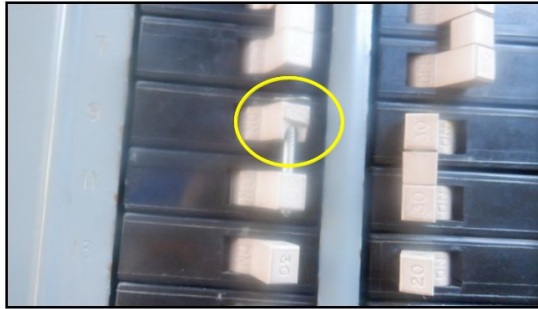
Damaged breaker observed in panel.

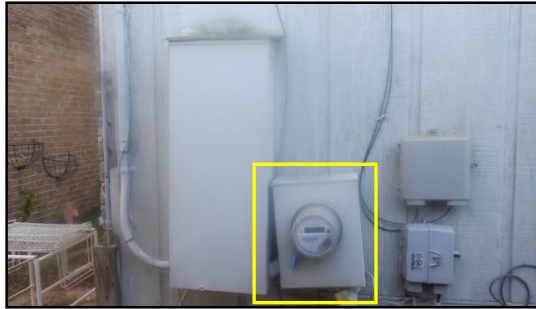
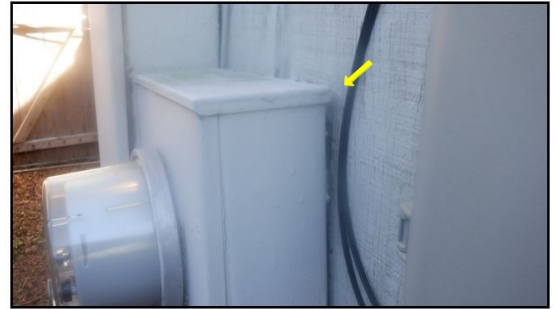
The electrical service meter is not properly secured to the structure.

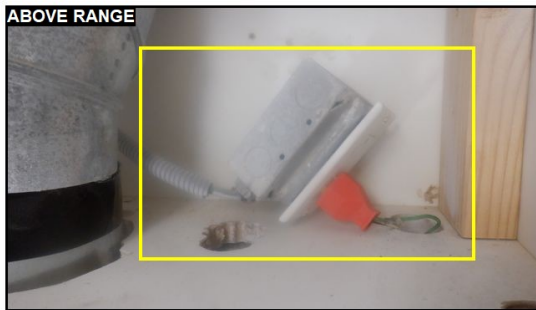
Handyman (amateurish) wiring observed, including but not limited to; multiple locations in kitchen cabinetry.

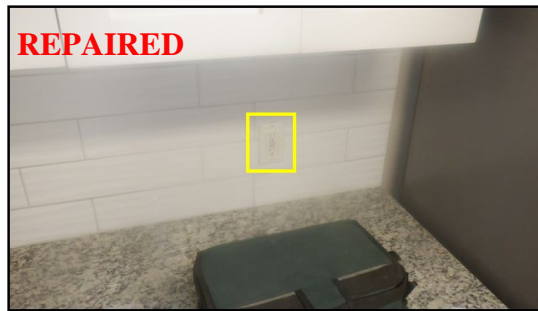
**GFCI outlet did not operate properly when tested with test button; kitchen counter.**

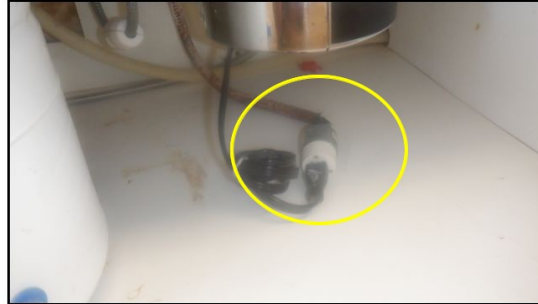
Outlet under kitchen sink is not properly mounted to framing to prevent water entry in the event of a leak.

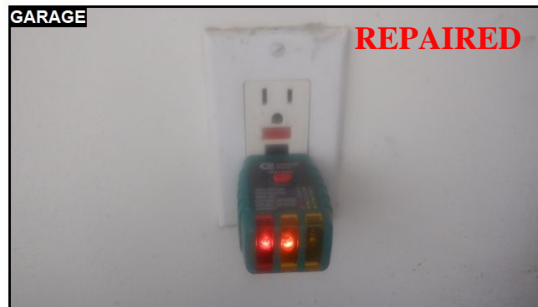
Improperly wired, 3 prong outlet not grounded or polarity reversed, including but not limited to; garage. powder bath.

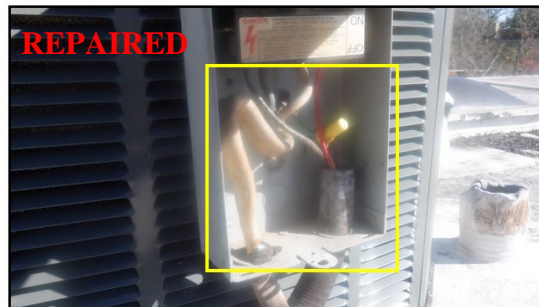
The electrical service disconnect is missing the dead front cover; main AC condenser. Protective bushing not present around electrical wire as it passes through metal box.

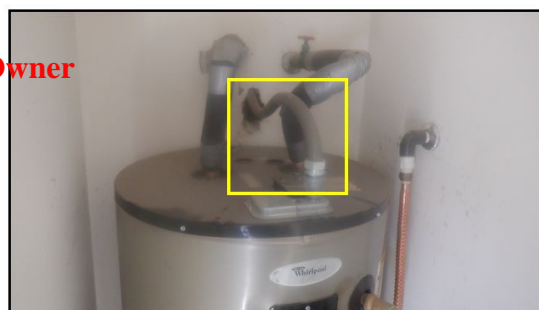
No electrical disconnect for electric water heater observed within sight. This does not comply with the current National Electric Code (NEC) minimum standards.

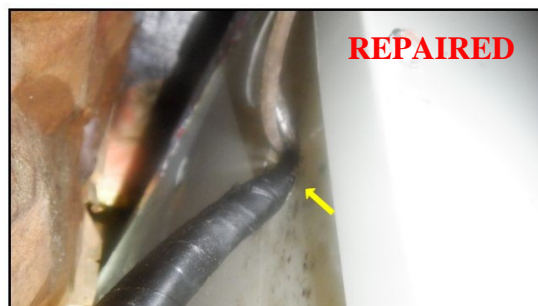
Electrical wiring not secured, the unit is missing a small fitting that secures the electrical line to the cabinet of the heater unit.

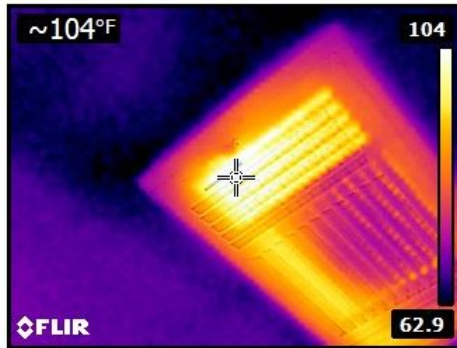
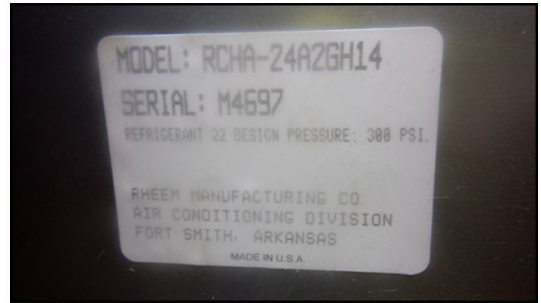
HEATING UNIT - GYM: (1997) RHEEM

**The furnace has exceeded its normal serviceable life; budget for repair or replacement.**

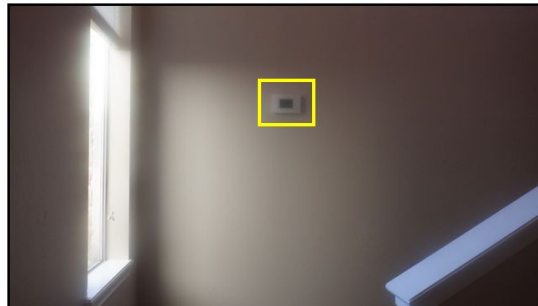
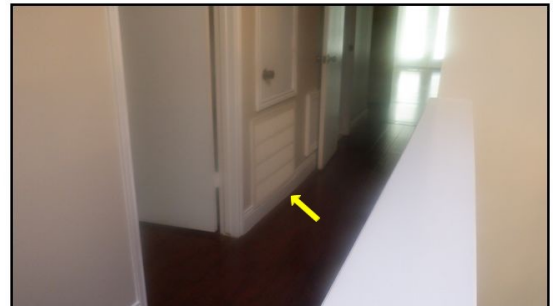
Improperly located, thermostats are supposed to be located near the return air chase.

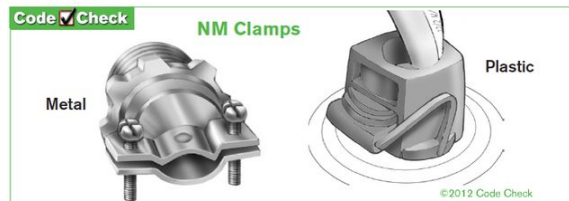
Thermostat wiring not secured to attic unit(s), missing small fitting that secures wiring to the cabinet to prevent pulling loose by service personnel or homeowner.

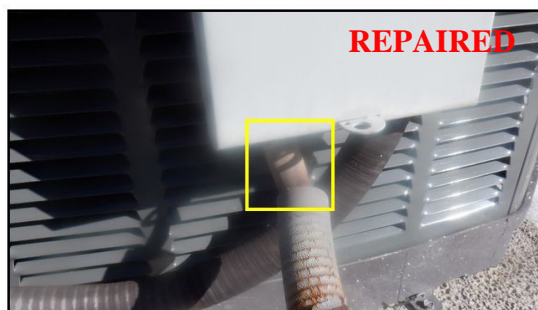
Electrical line supplying power to A/C outside is not fully enclosed in protective conduit.

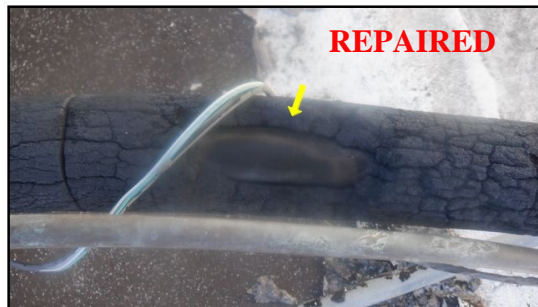
Section of suction line insulation missing or deteriorated near the condenser.

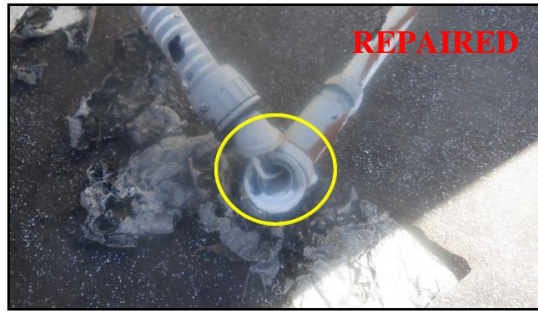
Electrical line supplying power to A/C outside is not fully enclosed in protective conduit.

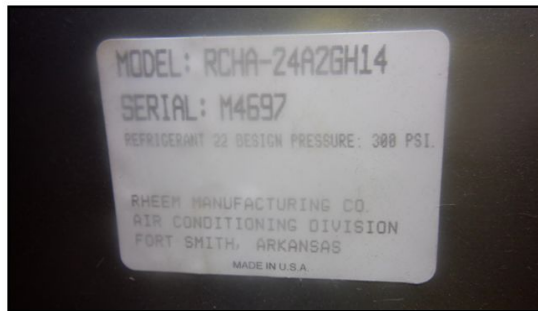
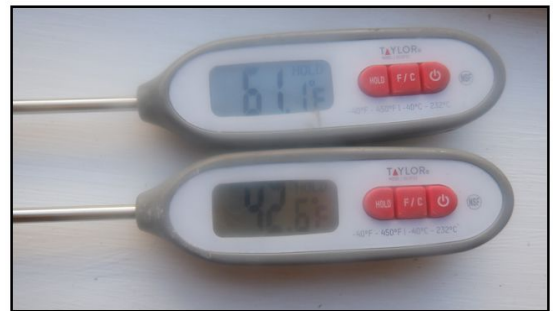
EVAPORATOR COIL - GYM: (1997) RHEEM 2 TON

**The e-coil has exceeded its normal serviceable life; budget for repair or replacement.**

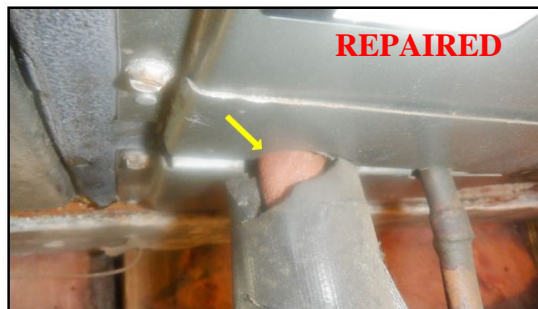
Section(s) of suction line insulation missing in the attic near the coil. Warm attic air condenses on cold suction line/expansion valve and drips condensation.

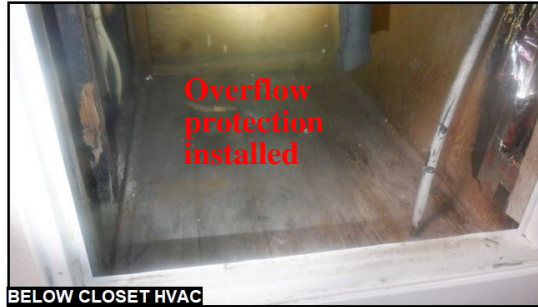
**No drain pan observed below closet HVAC unit. If unit should leak / drip condensation, interior finishes could be damaged.**

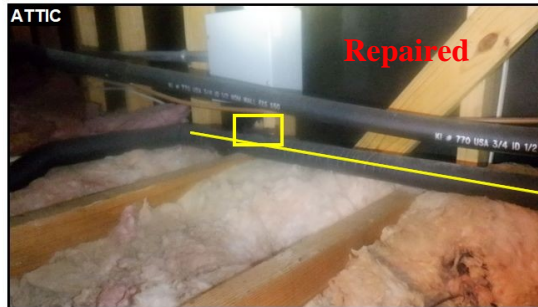
Primary drain line elevation improper, repair; attic unit.

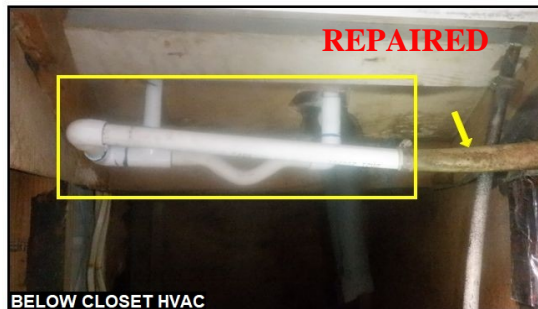
The primary drain line should be insulated along the entire length to prevent warm air condensing on the cool drain line and dripping condensation. Observed flexible drain line, these drain lines are easily routed up-hill and / or kinked / clogged. Recommend replacing with hard pipe.

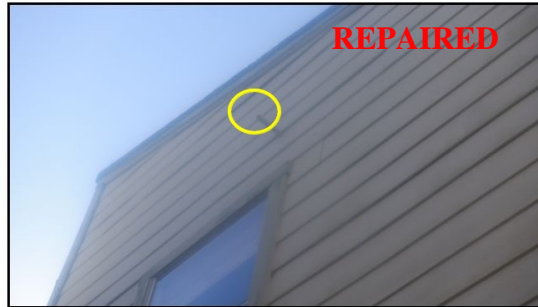
Missing 90° elbow fitting on end of emergency drain line to prevent condensation dripping back onto the exterior wall; back patio east wall of house.

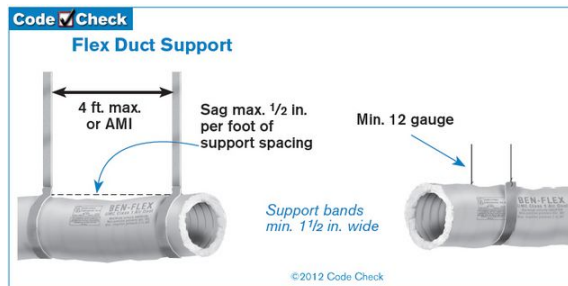
Some flex duct observed to be routed improperly, not to manufacturer's installation instructions. Recommend additional support and/or routing ducts to eliminate “snaking” drooping or crimping of flex duct more than 1” per foot which adds unnecessary additional resistance.

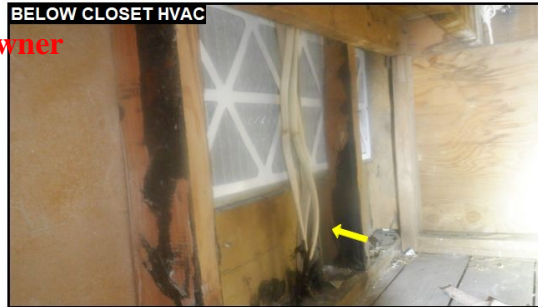
120 volt electrical wiring improperly located in return air chase. This does not comply with the current industry standard/code. Ref. NEC 300-22(c).

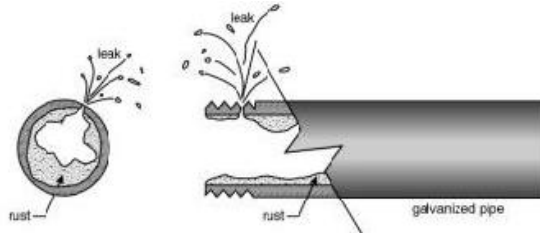
Water supply piping observed to be a mix of copper and galvanized.

Rusting of galvanized pipes can greatly reduce water pressure and will eventually cause leaks as rust creates holes in the pipe walls. Problems are likely to occur soonest on pipes carrying hot water, horizontal pipes and at threaded (thinner) sections.

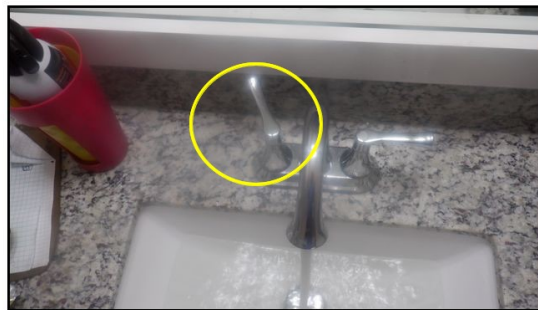
Faucet stop broken, [turns 360°]; upstairs hall bath sink hot water handle.

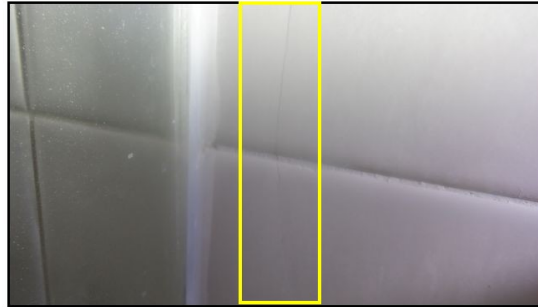
Observed cracked tiles; master bath.

Grout/caulking needed at vertical tile corners, cracks in tile and/or mortar between tiles, to prevent water entry behind the wall.

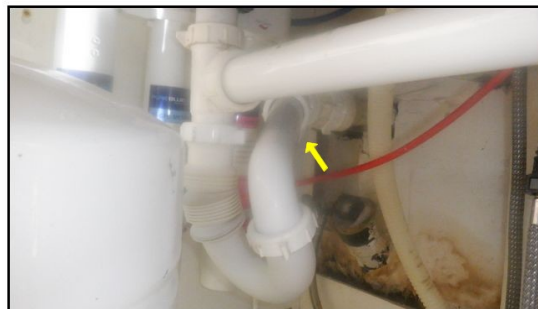
Reverse slope of drain line - does not tilt towards downhill for proper drainage; kitchen.

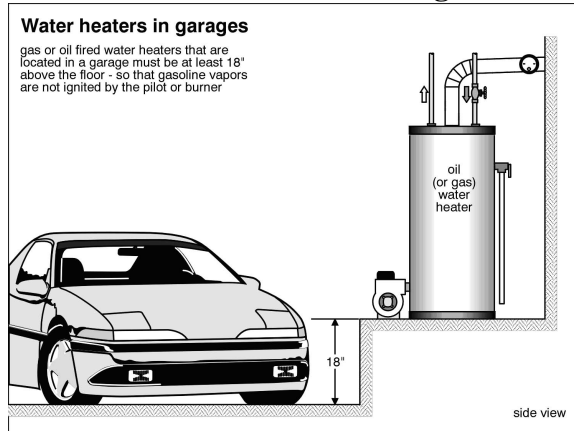
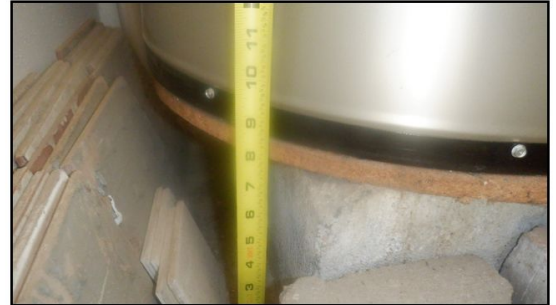
**Located in garage or room opening directly into garage and source of ignition (burner/electrical connection) is not elevated a minimum of 18 inches above the floor. This is considered a recognized safety hazard and needs repair.**

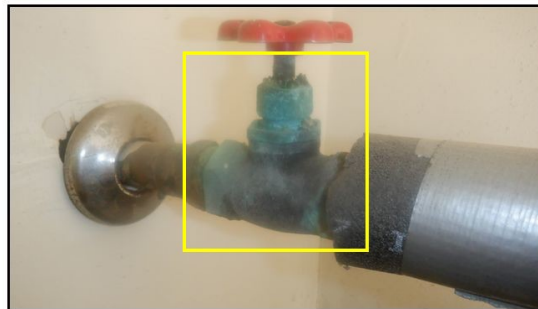
Corrosion observed at shut off valve and/or connections on top of the water heater.

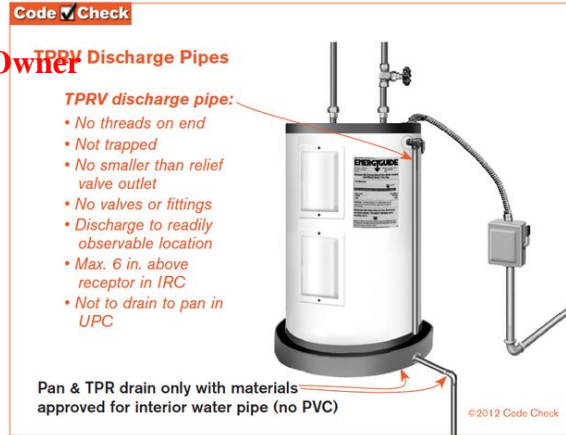
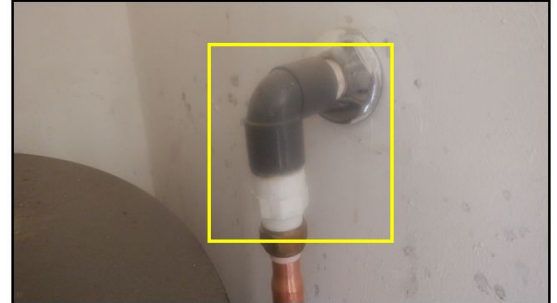
The drain line is improper PVC material not rated for use as a TPR drain line. Recommend replacement with the proper material to meet code.

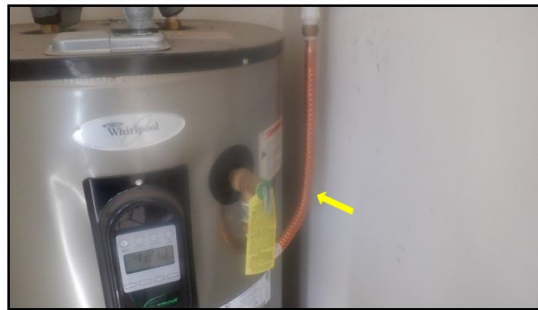
Drain line improperly reduced in size using a flexible connector, considered a recognized safety hazard; REF.: 1991 Standard Plumbing Code 1213.7.4 IRC 2803.6.1.

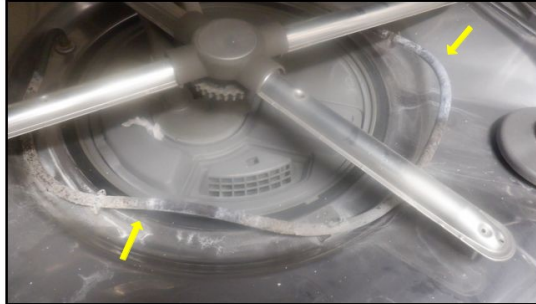
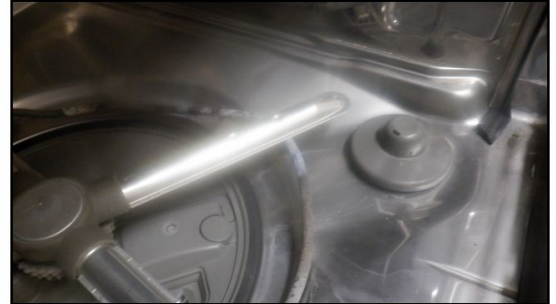
**The lower heating element was bent / warped / distorted at time of inspection. Unit was not operational when tested, recommend repair / replacement.**

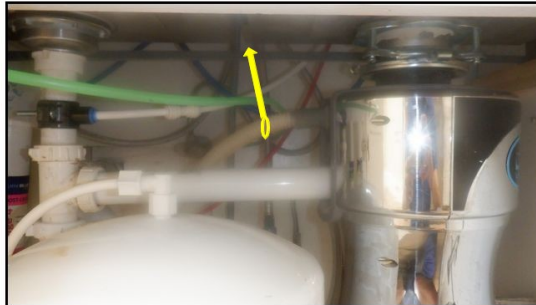
Drain line needs to be better elevated and secured above side inlet of disposal to prevent debris and gray water from draining down line from disposal and back into dishwasher.

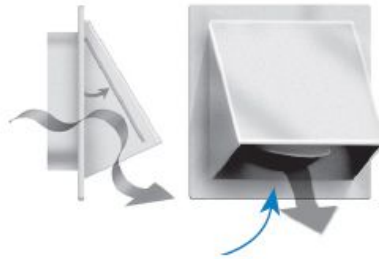
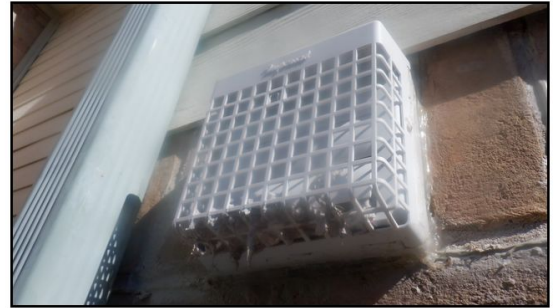
Improper dryer vent termination observed. Screens shall not be installed at the vent termination. Per IRC 1502.2.

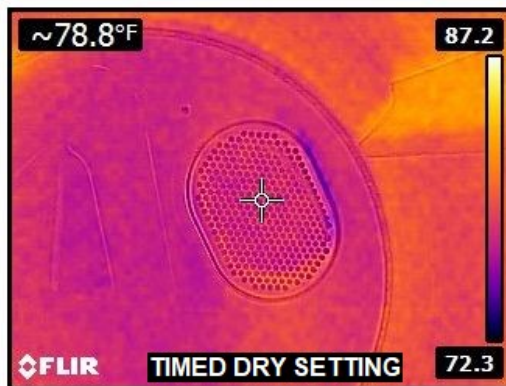
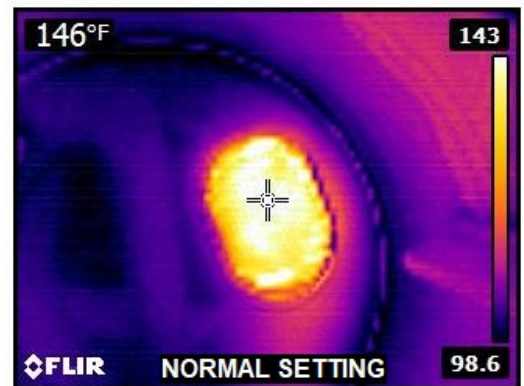
Unit did not function properly when tested on "Timed Dry" cycle. Unit was set to high heat but did not heat properly. Unit functioned normally under "Normal" setting.
