## Moisture Inspection Report

Inspected for  
Kenya Bosso  
4241 Bettis Dr  
Houston, TX 77027  
02/10/2021

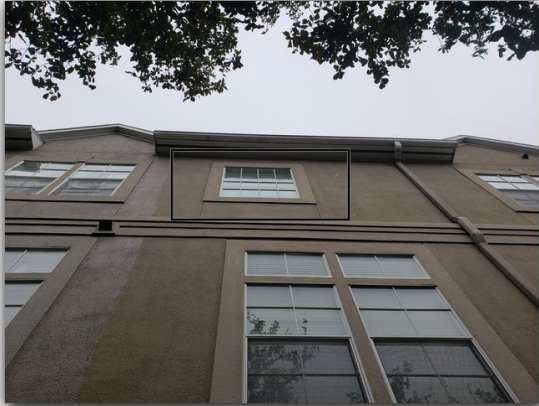
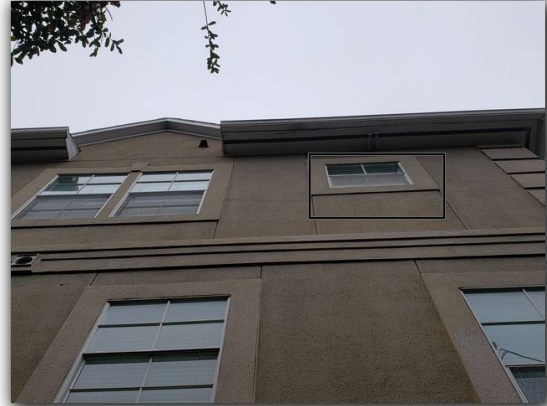
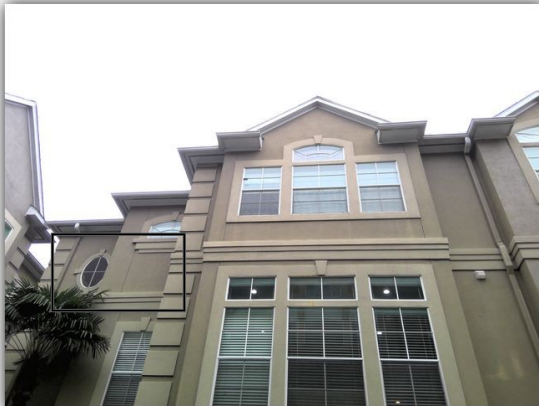
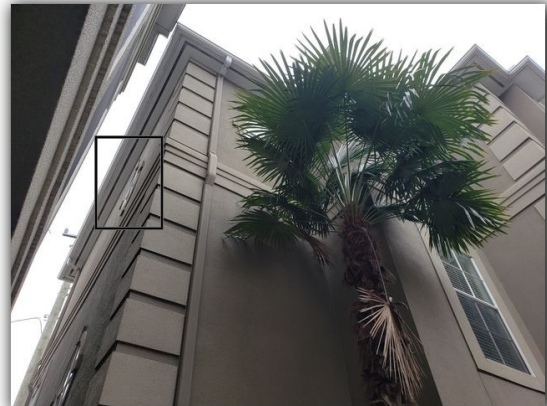
The inspector will make every effort to test all potentially vulnerable locations by use of a 2-story ladder or exterior openings. Some areas of the structure were inaccessible for invasive moisture testing. This could be due to safety concerns, height, windows do not open, windows blocked by furniture, the type of roof covering, roof pitch, neighboring house / fencing / outdoor furniture restricting safe ladder use, or other reasons limiting access. These areas were visually inspected during the inspection. If you have any questions regarding whether moisture testing was performed on a certain location, please contact us. Examples of these locations are provided below:

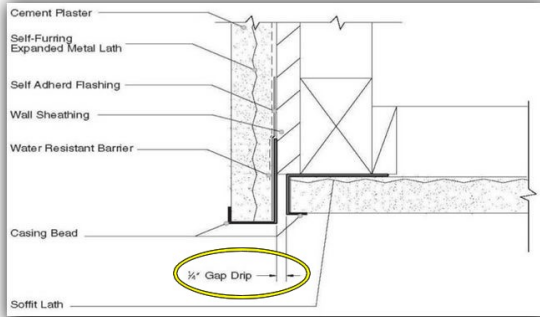
**2.1 Location: Front Overhang**

**2. Missing Drainage Openings:** Drainage openings missing at the stucco walls. Drainage openings assist with allowing incidental moisture to escape. When moisture becomes trapped, the wood can hold the moisture commonly referred to as a "stucco bucket". Recommend installation of drainage openings during repairs.

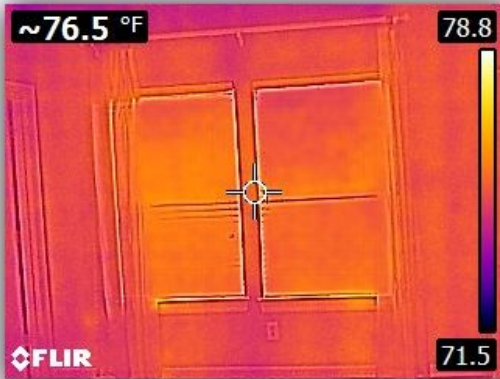
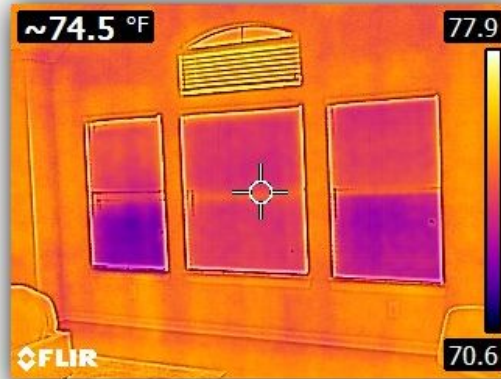
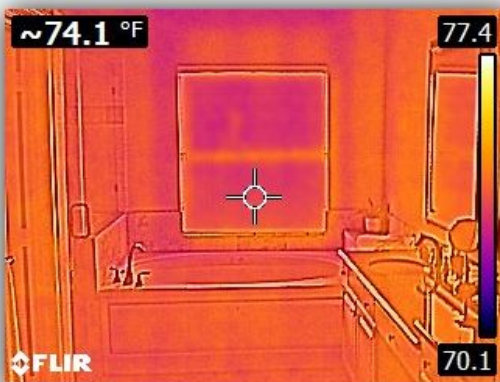
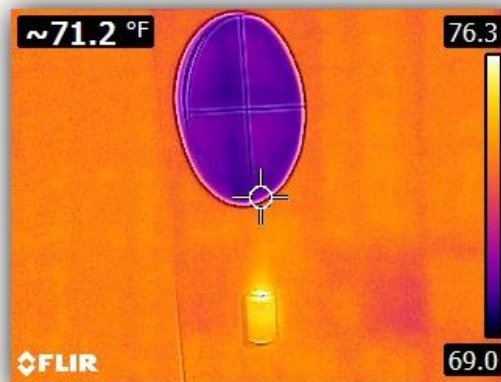
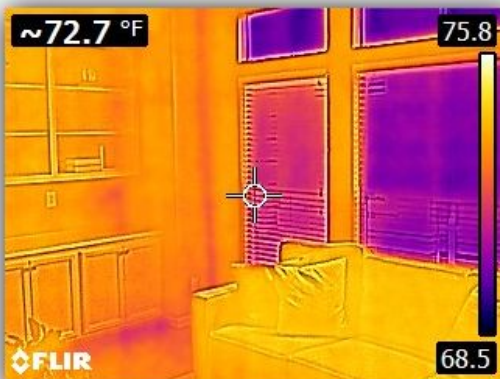
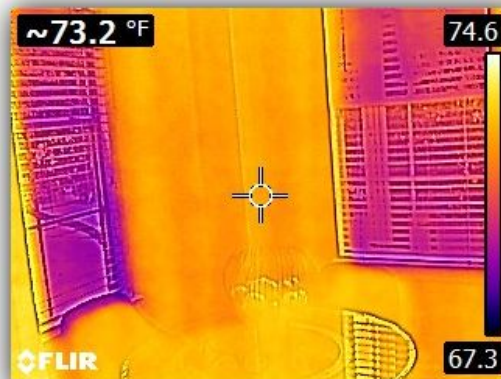
During the inspection, an infrared (thermal) camera was used to help identify areas of possible moisture penetrations. The camera was used from within the home, on the exterior walls with stucco cladding only. No abnormalities were discovered with the infrared camera at the time of the inspection. Photos from the inspection are provided below:
