TREC REI 7-6 SUPER INSPECTOR RESIDENTIAL INSPECTION*

2506 Huckleberry Ln
Pasadena, TX 77502

PROPERTY INSPECTION REPORT FORM

Cristina Gutierrez <i>Name of Client</i>	03/09/2024 9:00 am <i>Date of Inspection</i>
2506 Huckleberry Ln, Pasadena, TX 77502 <i>Address of Inspected Property</i>	
Robert Dillin <i>Name of Inspector</i>	TREC #21702 <i>TREC License #</i>
<i>Name of Sponsor (if applicable)</i>	<i>TREC License #</i>

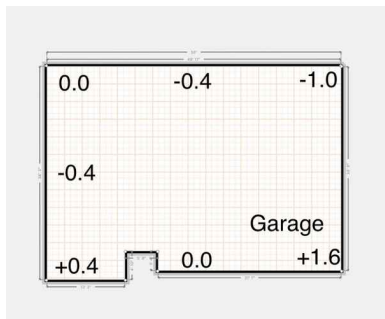
Signs of Structural Movement or Settling: Floors not level, Cracks in brick stone or stucco, Separations in joined materials, Cracks in walls and/ or ceilings

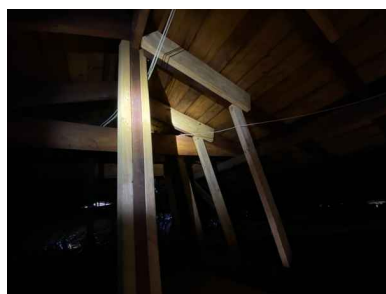
Previous repair in attic space :

There is evidence of previous repairs in the attic space. The cause or extent of repairs are unknown. Contact seller for more information.

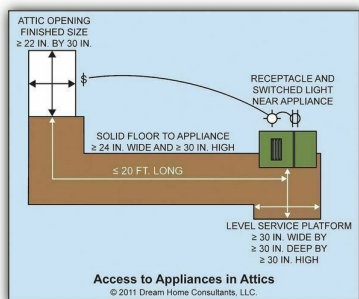
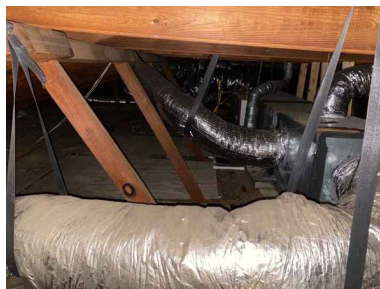
from the opening to the appliance. The passageway shall have continuous solid flooring in accordance with Chapter 5 not less than 24 inches (610 mm) wide. A level service space at least 30 inches (762 mm) deep and 30 inches (762 mm) wide shall be present along all sides of the appliance where access is required. The clear access opening dimensions shall be a minimum of 20 inches by 30 inches (508 mm by 762 mm), and large enough to allow removal of the largest appliance.

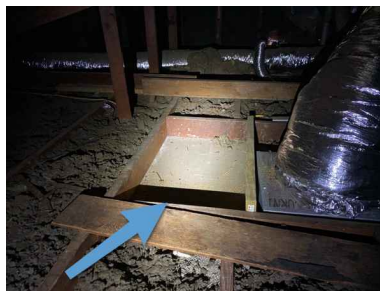
2: Missing attic insulation

There is missing attic insulation at one or more locations. Additional insulation may need to be installed to help prevent heat transfer through the ceiling in those areas.

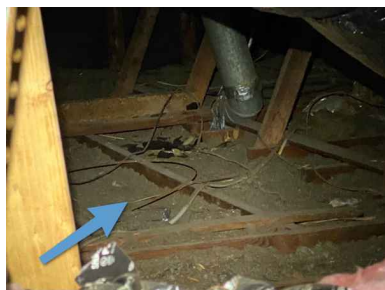
3: Compressed blown insulation

The blown attic insulation is compressed at one or more locations. Compressing blown insulation can significantly reduce the R Value. Additional insulation may need to be installed in those areas to help prevent heat infiltration from the attic.

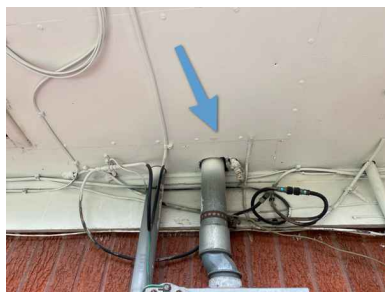
West side

There are unsealed soffit board penetrations at one or more locations. Soffit board penetrations should be sealed to help prevent pest entry in those areas.

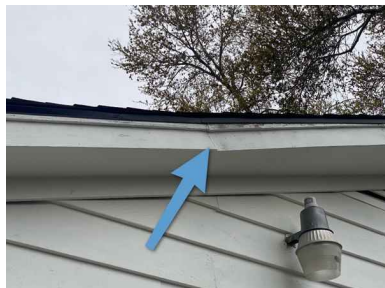
The paint is peeling or missing from the fascia / soffit boards at one or more locations. The fascia boards should be properly painted to help prevent moisture absorption and/or deterioration.

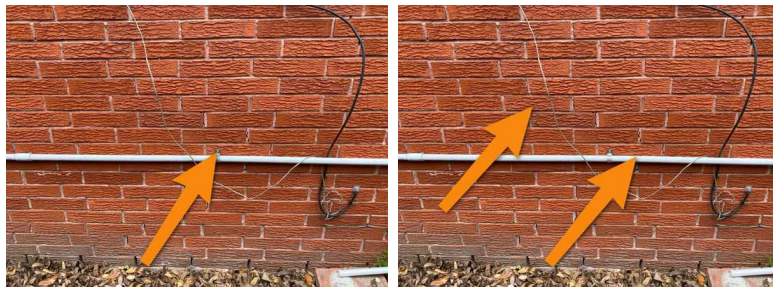
The exterior brick, stone or stucco is fractured at one or more locations. This may indicate movement in those areas. This alone does not conclude the failure of a foundation. Monitoring these locations for further separation is advised. Having the cracks sealed by a professional contractor is recommended.

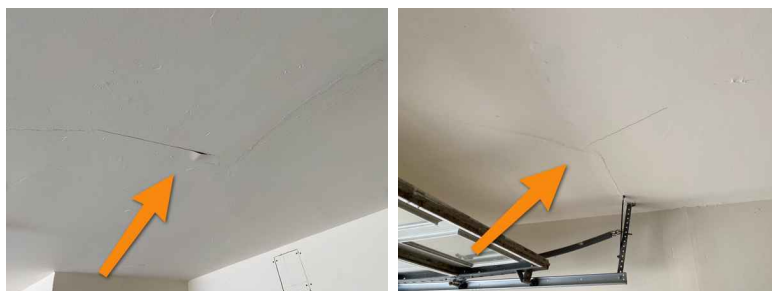
Fractures were observed on the ceiling in one or more areas throughout the house. This may correlate with or indicate structural movement. The fracture(s) should be monitored over time for further separation and evaluated as necessary.

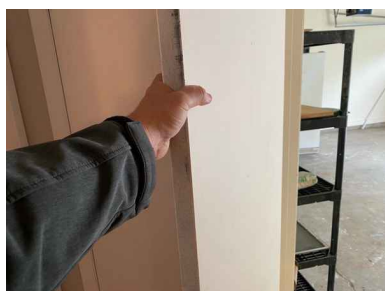
The door to the garage is a hollow core door. It should be replaced with a solid core or fire rated door to establish a proper fire partition between the house and garage.

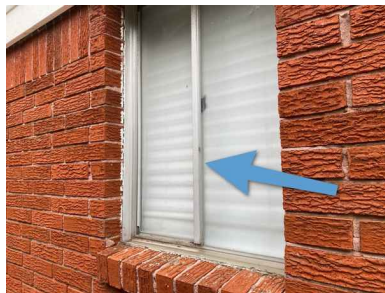
One or more windows are missing screens. It is not uncommon for the screens to be stored in the attic or garage. It is a good idea to ask the home owner before purchasing new ones. Recommend replacement.

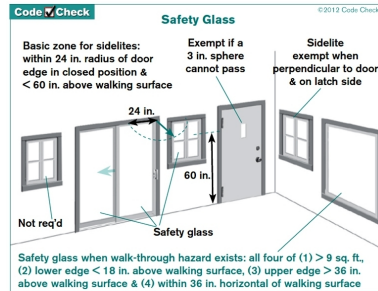
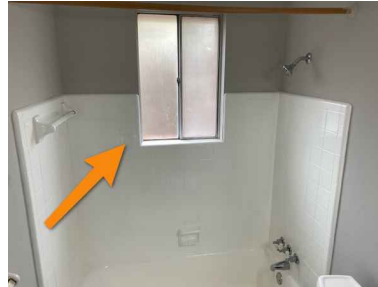
R308.4.5 Glazing and wet surfaces.

Glazing in walls, enclosures or fences containing or facing hot tubs, spas, whirlpools, saunas, steam rooms, bathtubs, showers and indoor or outdoor swimming pools where the bottom exposed edge of the glazing is less than 60 inches (1524 mm) measured vertically above any standing or walking surface shall be considered a hazardous location. This shall apply to single glazing and all panes in multiple glazing.

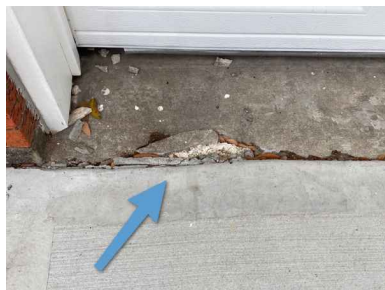
The driveway and garage rebar dowels are chipped. This usually indicates settling of the driveway or garage. A qualified masonry contractor should be contacted for possible repairs to this area if desired.

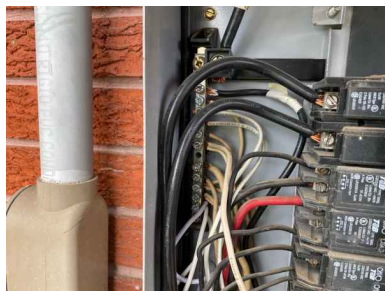
circuit. Also, the neutral assemblies are not evaluated with multiple neutral conductors in the same terminal. 2002 NEC Art. 408-21 Grounded Conductor Terminations. Each grounded conductor shall terminate within the panel board in an individual terminal that is not also used for another conductor.

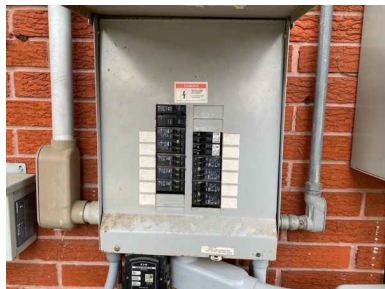
2: Panel not properly labeled

The breakers in the panel are not properly labeled. The breakers should be individually labeled for identification purposes.

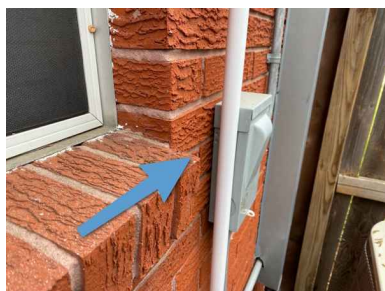
One or more exterior electrical panels are not sealed to the wall. The panels should be sealed to prevent moisture intrusion in the opening behind the panel.

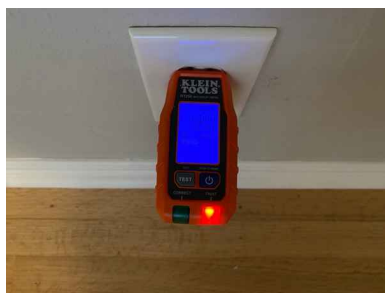
Throughout the house

One or more outlets in the house tested as Open Ground. This may indicate the ground conductor is loose, disconnected, or not present. Further evaluation and / or repair by a licensed electrician is advised.

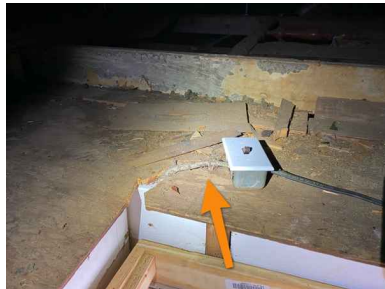
Attic

It appears the house was originally wired with cloth covered electric cabling. This product was widely used at the time of construction. The cloth covering is known to become brittle and deteriorate over time and is currently frayed at one or more locations. This can result in improper protection for the electrical conductors. The cabling should be inspected by a licensed electrician and repaired or replaced, if necessary.

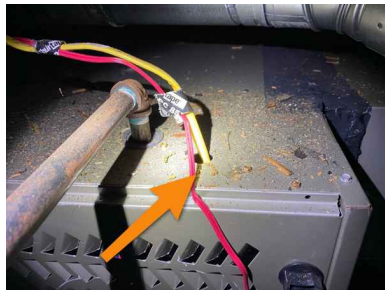
There are unprotected conductors at the furnace housing. The conductors should be protected from the sharp edges of the furnace cabinet using a rubber grommet. Repairs are advised.

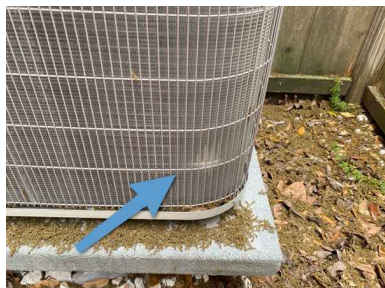
1: Condenser coils damaged

The condenser coil is damaged. This can result in refrigerant leaks. It is recommended the coil be examined by a licensed HVAC technician to determine if leaks are present.

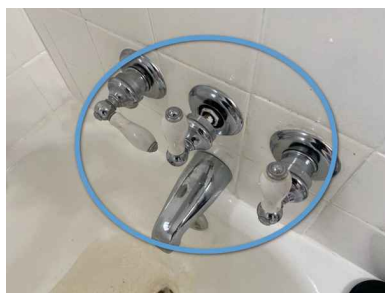
4: Faulty Faucet Valve Stop

The valve stop for the temperature control knob at the **sink/bathtub/shower** is damaged or missing. This may also allow the valve handle to rotate 360 degrees. A valve stop should be installed to prevent confusion when setting the water temperature. Further evaluation by a licensed plumber is recommended.

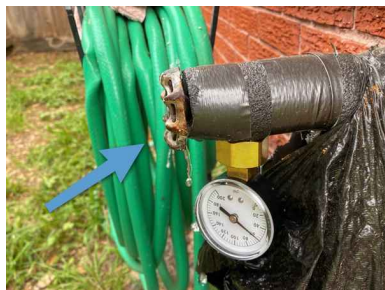
9: Water Meter Drip Indicator Not Stable

The water meter flow indicator continued to move when all valves in the house were closed at the time of the inspection. This may indicate a hidden leak. Further evaluation and/or repair by a licensed plumber is advised.

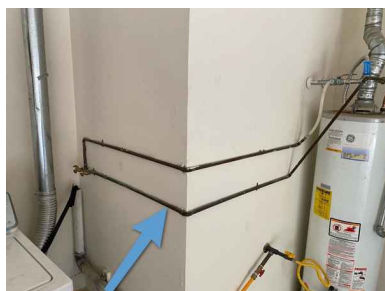
11: Galvanized water pipe

The house is equipped with galvanized iron water supply pipes. Galvanized iron pipes are known to deteriorate and leak overtime. It is beyond the scope of this inspection to determine if there are breaks in the pipes in non visible areas. For a more detailed analysis of the pipes a licensed plumber should be consulted.

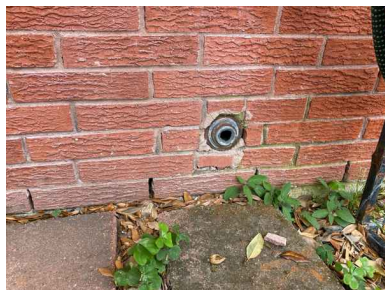
2: Missing / Damaged cleanout cap

There is a missing / damaged cleanout cap. The cap should be replaced to help keep debris out of the waste lines and to help prevent sewer gases from escaping from the drain cleanouts.

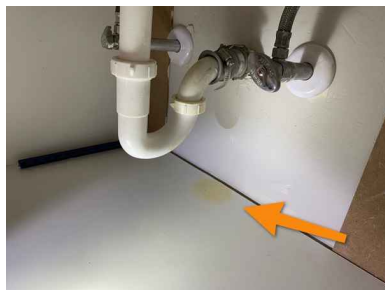
3: Drain leaked evidence

A drain leak evidence was observed at one or more locations when plumbing was tested. Further evaluation and/or repair by a licensed plumber is advised.

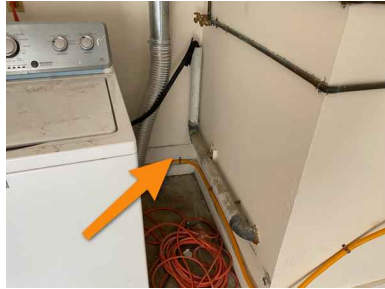
5: Washing Machine Drain

The drain for the washing machine did not appear to be properly configured. This drain should have at least an 18 inch drop with a p-trap at the bottom. This configuration may allow sewage gases to enter the house. Repair by licensed plumber is recommended.

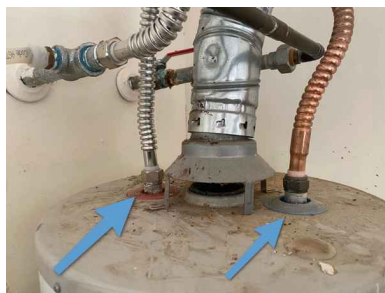
1: Rust/Galvanic corrosion at water heater fittings

Rust and corrosion were observed at the water heater fittings. This can indicate moisture seepage at the joints and/or galvanic corrosion. Galvanic corrosion can occur in piping and equipment systems when two dissimilar metals are joined together. Galvanic corrosion occurs due to an electrochemical process in which one metal corrodes preferentially to another. Installing dielectric unions at pipe joints where dissimilar metals are connected can help prevent this process. Further evaluation and/or repair by a licensed plumber is advised.

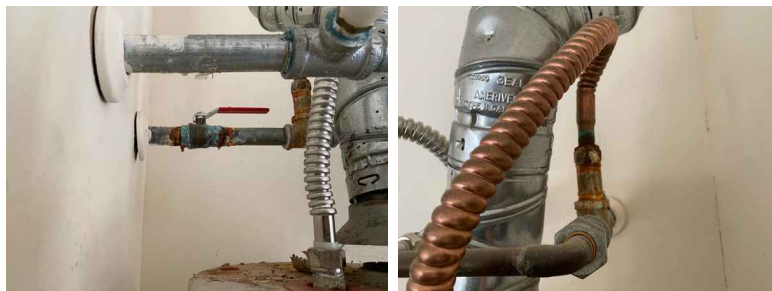
2: Rust at pipe fittings

Rust and corrosion were observed at the water heater pipe fittings. This can indicate the unit is aging and the tank is beginning to rust. The unit should be monitored for leakage and replaced at the next opportunity.

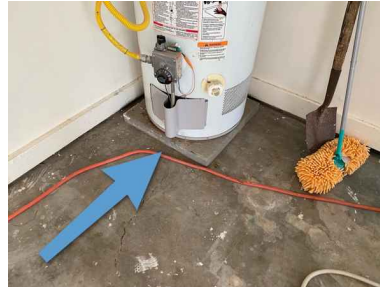
The water heater has been installed in the garage in a location that could be damaged by a vehicle. Due to the location of the water heater, bollard's should be installed to help prevent damage. This is reflected in the 2012 IRC 1307.3.1. Installation of bollard's is recommended.

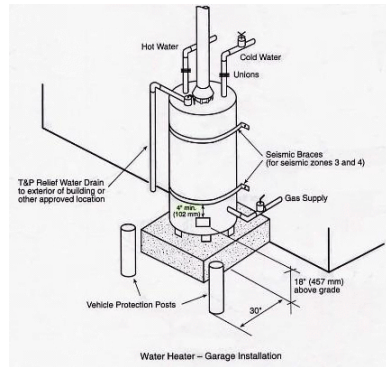
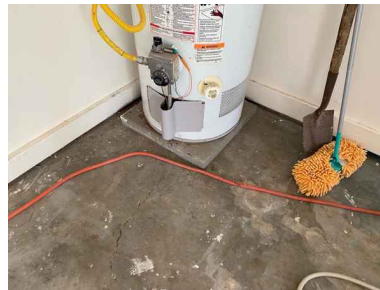
4: Inadequate garage water heater floor clearance

The water heater does not have adequate floor clearance. Garage water heaters should have 18 inches of floor clearance to ensure the ignition source (electric or gas) is clear of any flammable gas fumes that may be present as a result of storing flammable gases in the garage. 2012 IRC: P2801.6 Water heaters installed in garages: Water heaters having an ignition source shall be elevated such that the source of ignition is not less than 18 inches (457 mm) above the garage floor.

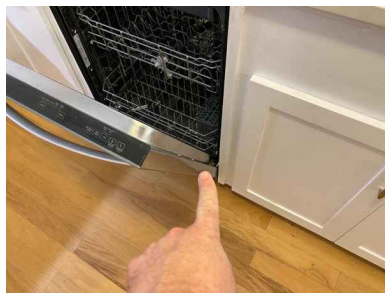
The dishwasher door rubbed the frame of the dishwasher went opening and closing. This may indicate the door is off, centered or damaged. Repair as needed.

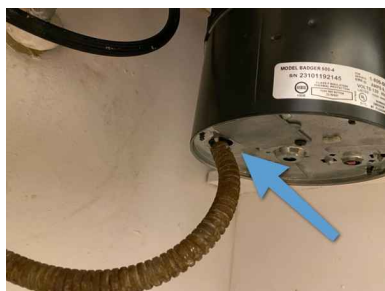
The conductors feeding the food waste disposer are not properly protected from the food waste disposer housing. A bushing with a clamp should be installed to help prevent the housing cutting into the conductor casing. Further evaluation and/or repair by a licensed electrician is advised.

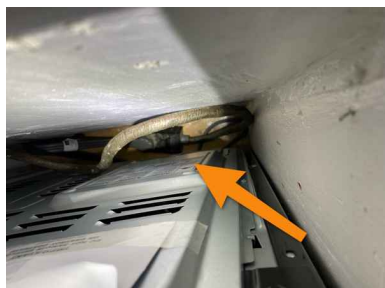
The oven plug was laying on the floor behind the oven. It is recommended that the oven plug be properly secured to the wall to prevent accidental damage of the plug.

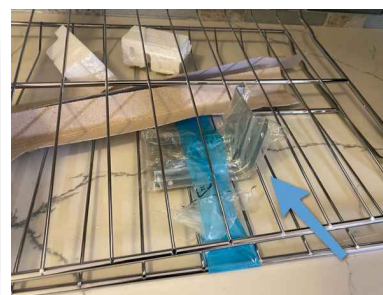
2: No anti tip device installed

There is no-anti tipping device installed for the oven/range. It is recommended that one be installed for safety.
