Moisture Assessment Report

Nishant Shah and Mita Das

2629 Westgate Street, Unit A

Project Information

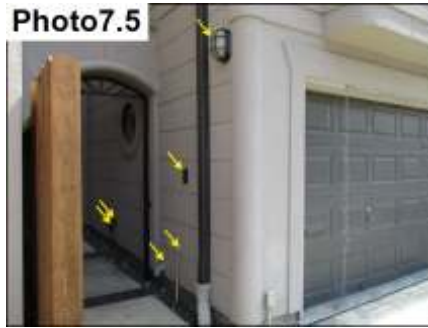
Photo7.5

- The penetration sealants are aged, separated or missing in these locations. The inspector suggests to have a qualified waterproofing contractor seal these areas with a low modulus sealant in an effort to prevent moisture intrusion. These types of sealants are of high quality and compatible with stucco and other termination points. Please refer to photos #7.2, #7.3, #7.4, #7.5 and #7.6 for more detail.

Penetration Sealants / Seal

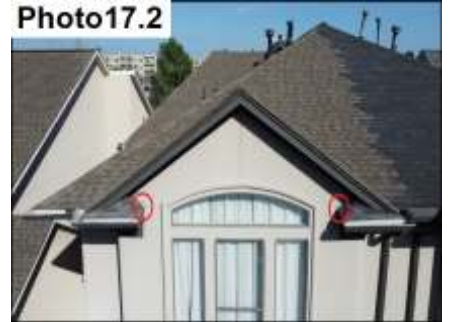
Photo17.2

- The roof and stucco termination is aged or separated at these locations. The inspector suggests to have a qualified waterproofing contractor further assess and seal these areas with a low modulus sealant in an effort to prevent moisture intrusion. These types of sealants are of high quality and compatible with stucco and other termination points. Please refer to photos #17.2, #17.3, #17.4, #17.5 and #17.6 for more detail.

Roof Termination / Seal

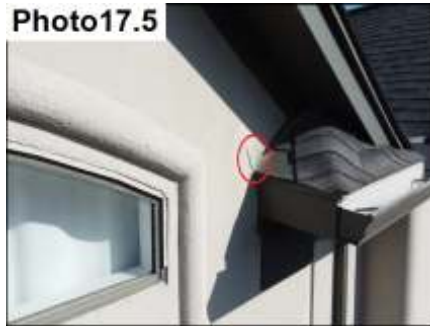
Photo17.5

Roof Termination / Seal

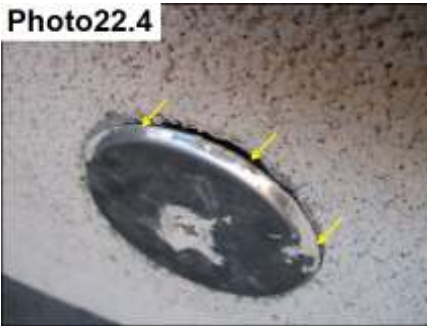
Photo22.4

Penetration Sealants / Seal

Grid Location	Item Description	Moisture Readings	Substrate Condition	Observations
Yellow Arrows	Penetrations			The penetration sealants are aged, thin, separated or missing in these locations. The inspector suggests to have a qualified waterproofing contractor seal these areas with a low modulus sealant in an effort to prevent moisture intrusion. These types of sealants are of high quality and compatible with stucco and other termination points. Please refer to photos #22.2, #22.3, #22.4, #22.5 and #22.6 for more detail.

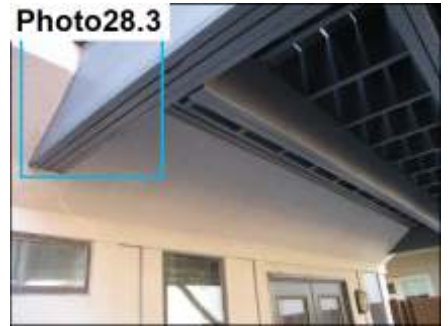
Photo28.3

Balcony & Stucco Termination / Seal

Grid Location	Item Description	Moisture Readings	Substrate Condition	Observations
Blue Boxes	Balcony & Stucco Termination			Balcony/stucco termination sealants are aged or separated at this location. The inspector suggests to have a qualified waterproofing contractor further assess and seal this area with a low modulus sealant in an effort to prevent moisture intrusion. These types of sealants are of high quality and compatible with stucco and other termination points. Please refer to photos #28.2, #28.3, #28.4, #28.5 and #28.6 for more detail.

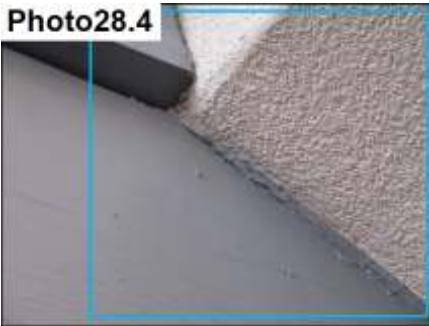
Photo28.4

Balcony & Stucco Termination / Seal

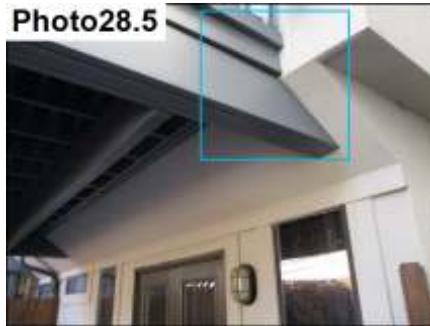
Photo28.5

Balcony & Stucco Termination / Seal

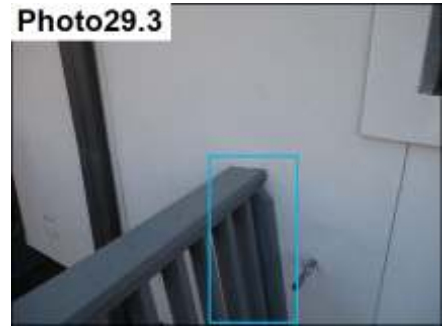
Railing & Stucco Termination / Seal

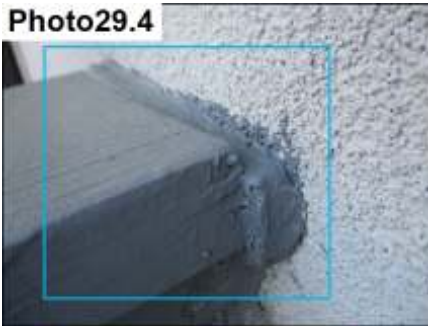
Railing & Stucco Termination / Seal

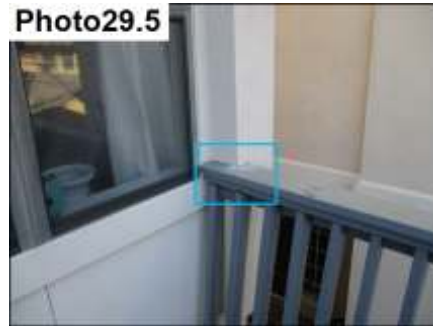
Railing & Stucco Termination / Seal

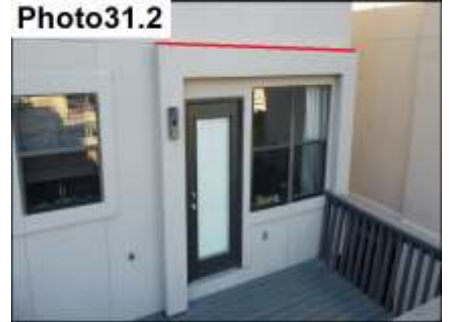
Photo31.2

Flat Accent / Install Metal Cap or Apply Elastomeric Coating

Grid Location	Item Description	Moisture Readings	Substrate Condition	Observations
Red Line	Flat Accent			A flat accent has been noted in this area. Although the moisture levels were acceptable the inspector suggests to have a waterproofing contractor further assess and to apply elastomeric coating or install a metal cap as needed, in an effort to prevent moisture intrusion. Please refer to photos #31.2, #21.3, #31.4, #31.5 and #31.6 for more detail.
