Lone Star Stucco, LLC

Moisture Assessment Report

2629 Westgate Street, Unit A

Project Information

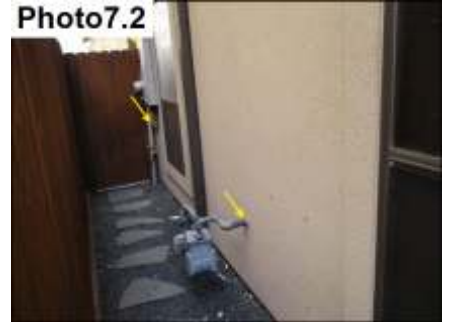
Photo7.2

- The penetration sealants are aged, separated or missing in these locations. The inspector suggests to have a qualified waterproofing contractor seal these areas with a low modulus sealant in an effort to prevent moisture intrusion. These types of sealants are of high quality and compatible with stucco and other termination points. Please refer to photos #7.2, #7.3, #7.4, #7.5 and #7.6 for more detail.

Penetration Sealants / Seal

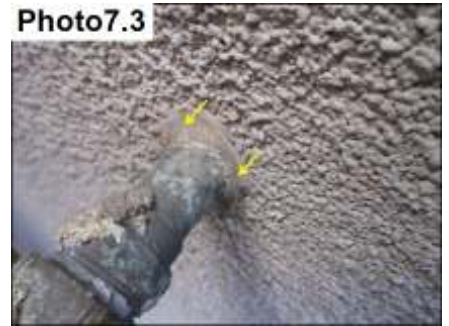
Photo7.3

Penetration Sealants / Seal

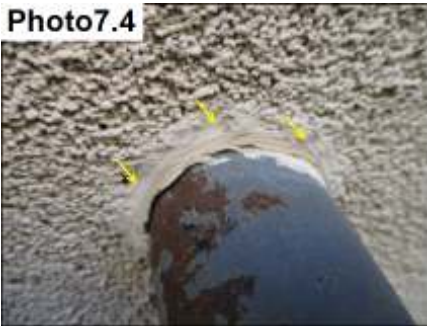
Photo7.4

Penetration Sealants / Seal

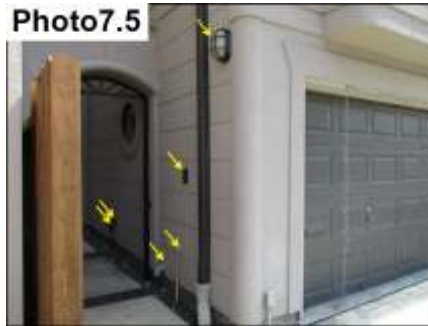
Photo7.5

Penetration Sealants / Seal

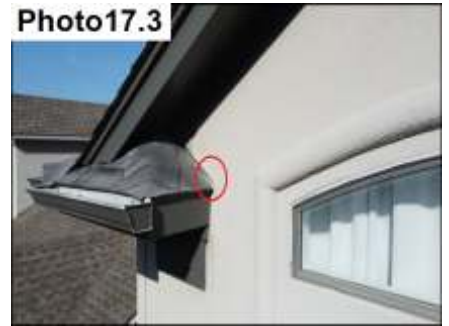
Photo17.3

Roof Termination / Seal

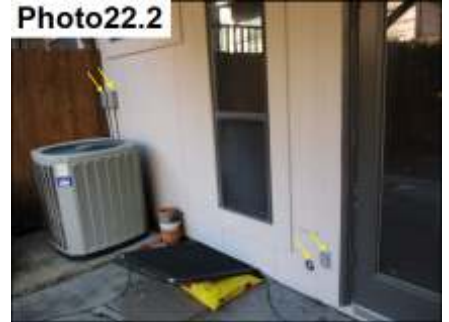
Photo22.2

Penetration Sealants / Seal

Grid Location	Item Description	Moisture Readings	Substrate Condition	Observations
Yellow Arrows	Penetrations			The penetration sealants are aged, thin, separated or missing in these locations. The inspector suggests to have a qualified waterproofing contractor seal these areas with a low modulus sealant in an effort to prevent moisture intrusion. These types of sealants are of high quality and compatible with stucco and other termination points. Please refer to photos #22.2, #22.3, #22.4, #22.5 and #22.6 for more detail.

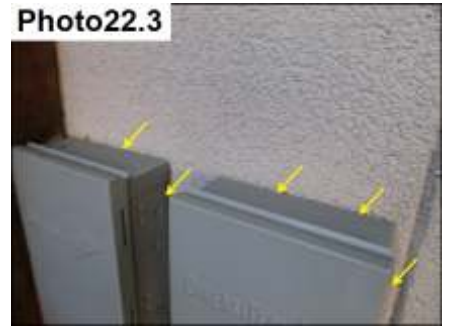
Photo22.3

Penetration Sealants / Seal

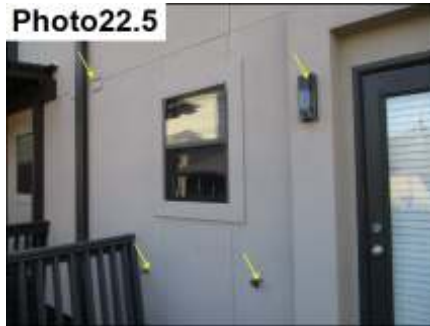
Photo22.5

Penetration Sealants / Seal

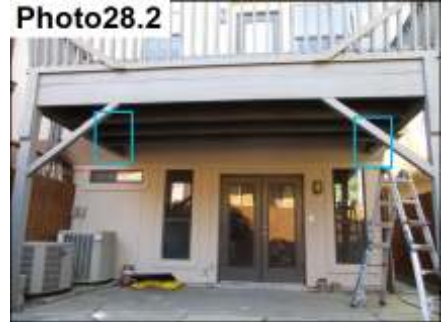
Photo28.2

Balcony & Stucco Termination / Seal

Grid Location	Item Description	Moisture Readings	Substrate Condition	Observations
Blue Boxes	Balcony & Stucco Termination			Balcony/stucco termination sealants are aged or separated at this location. The inspector suggests to have a qualified waterproofing contractor further assess and seal this area with a low modulus sealant in an effort to prevent moisture intrusion. These types of sealants are of high quality and compatible with stucco and other termination points. Please refer to photos #28.2, #28.3, #28.4, #28.5 and #28.6 for more detail.

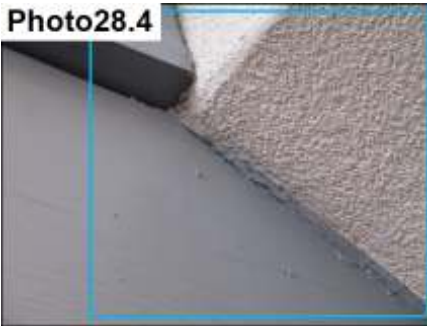
Photo28.4

Balcony & Stucco Termination / Seal

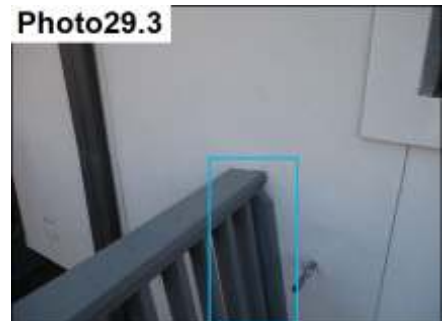
Railing & Stucco Termination / Seal

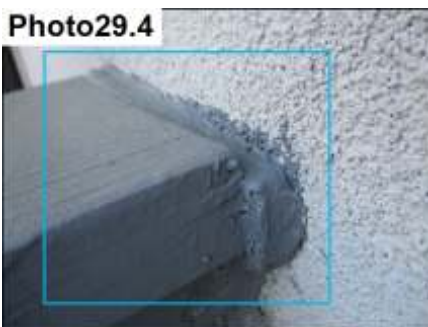
Railing & Stucco Termination / Seal

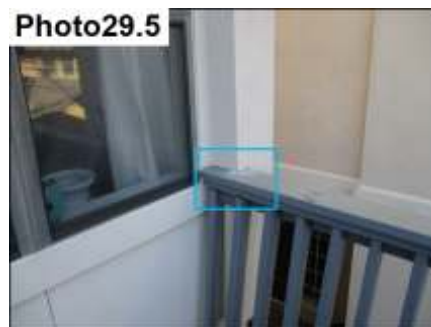
Railing & Stucco Termination / Seal

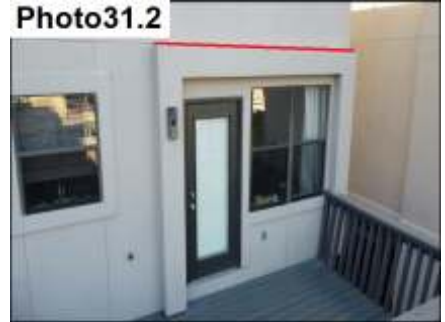
Photo31.2

Flat Accent / Install Metal Cap or Apply Elastomeric Coating

Grid Location	Item Description	Moisture Readings	Substrate Condition	Observations
Red Line	Flat Accent			A flat accent has been noted in this area. Although the moisture levels were acceptable the inspector suggests to have a waterproofing contractor further assess and to apply elastomeric coating or install a metal cap as needed, in an effort to prevent moisture intrusion. Please refer to photos #31.2, #21.3, #31.4, #31.5 and #31.6 for more detail.
