# **Property Inspection Report**

Horsley Home Inspection

238 Birch St
Inspection Prepared For: Kara Gresslin
Agent: -

Date of Inspection: 1/2/2023

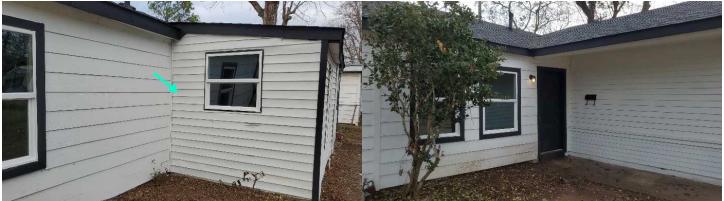
• The house primarily has cement board siding with vinyl siding on the rear addition.

Vinyl sid	ding on the rear addition.	Cement siding.
X	F. Ceilings and Floors	
x	Ceiling and Floor Materials: Comments: No immediate evidence of a Deficiency was obs G. Doors (Interior and Exterior)	erved.
	Comments: • No immediate evidence of a Deficiency was obs	erved.
$X \square \square X$	H. Windows	
	Window Types: Comments: One or more of the window screens were observed missing.	ved to be damaged and/or
	I. Stairways (Interior and Exterior)	
	Comments:	
	J. Fireplaces and Chimneys	
	Locations: Types: Comments:	
	K. Porches, Balconies, Decks, and Carports	
	Comments: • No immediate evidence of a deficiency at time of	of inspection.

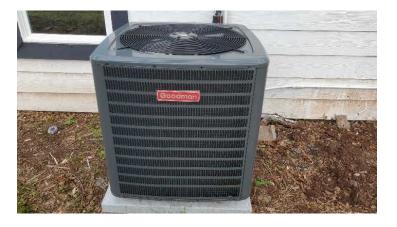
• The outdoor compressor was manufactured in 2022.

• The system measured as having a 22 degree temperature differential. Proper functioning systems should have a temperature drop between 15-22 degrees. Systems that produce a low temperature differential are recommended for service as it may be a sign of the system not functioning properly. The temperature is measured at the main air return and at the supply vents around the house.

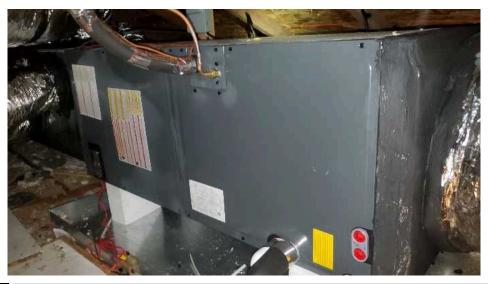
X	C. Duct Systems, Chases, and Vents
	Comments:  • No immediate evidence of a Deficiency was observed.  • The rear add-on and utility rooms do not have ducting for HVAC.  • The hallway bathroom does not have ducting for HVAC.
	D. Other
	Comments:

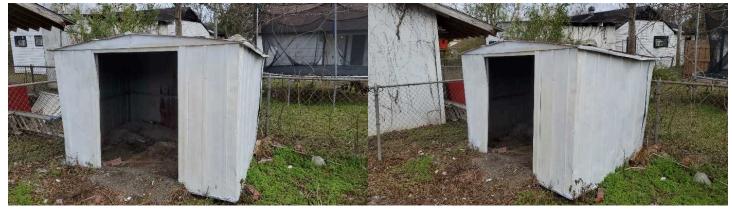
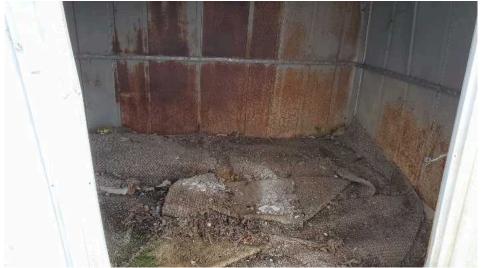
I=Inspected	NI=Not Inspected	NP=Not Present	D=Deficient
I NI NP D	)		
	VI.	OPTIONAL SYSTEMS	3
	A. Landscape Irrigation	n (Sprinkler) Systems	
	Comments:		
B. Swimming Pools, Spas, Hot Tubs, and Equipment			
	Type of Construction: Comments:		
$X \square \square X$	C. Outbuildings		
	Materials: Comments: Small metal shed in t	he backyard of the hou	se.
