RESIDENTIAL INSPECTION

217 Cresta Cove Ct
Montgomery, TX 77356

PROPERTY INSPECTION REPORT FORM

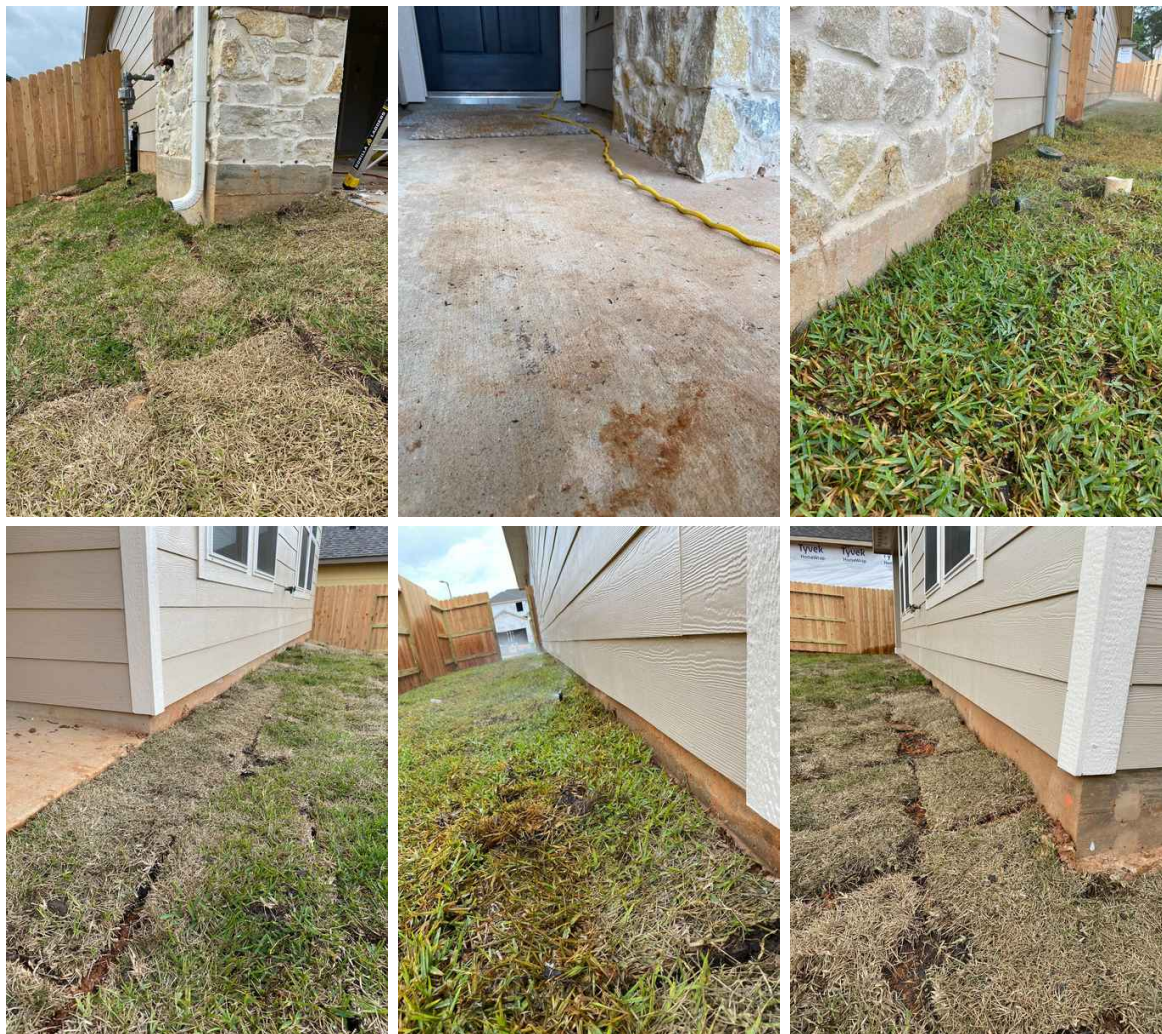
The foundation performance was adequate, with only minor cosmetic damage at the concrete exterior slab.

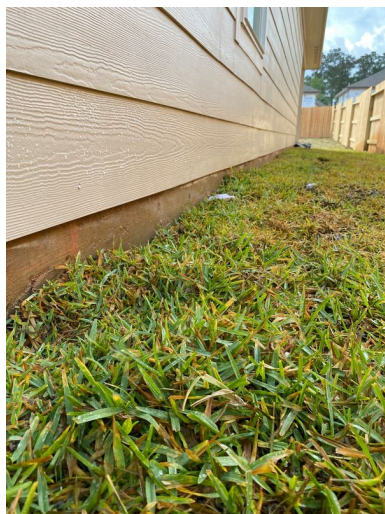
The right side sprinkler system was spraying onto the siding and potentially the sheathing underneath. Redirect spray heads to avoid damage to wall structure.

Recommendation: Contact a qualified structural engineer.

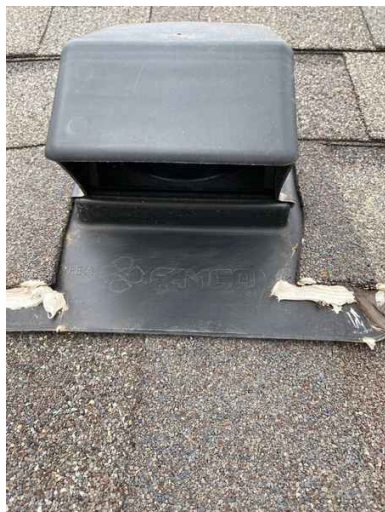
This is your dryer vent

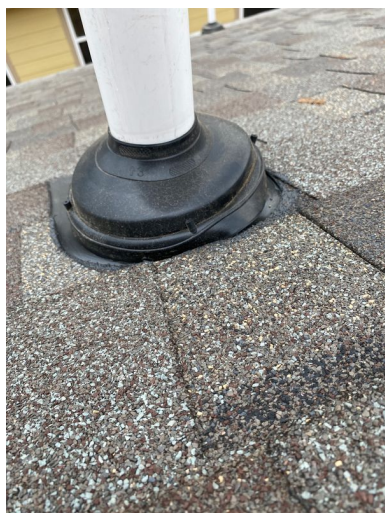
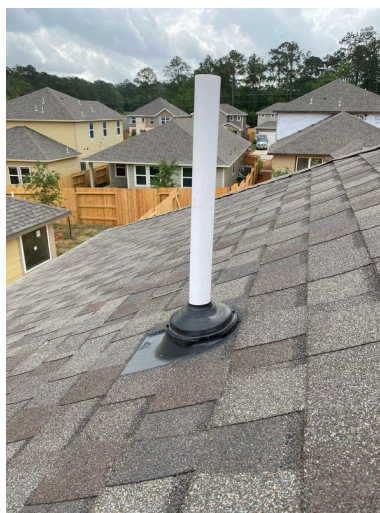
The plumbing vents needed final adjustments and to be cut down to size. They will still be functional as they are not, but the excess height is abnormal for a finished home.

Recommendation: Contact a qualified roofing professional.

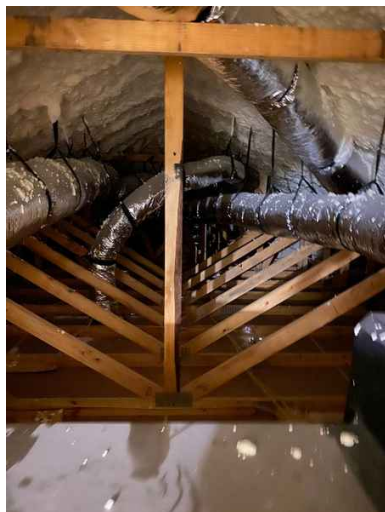
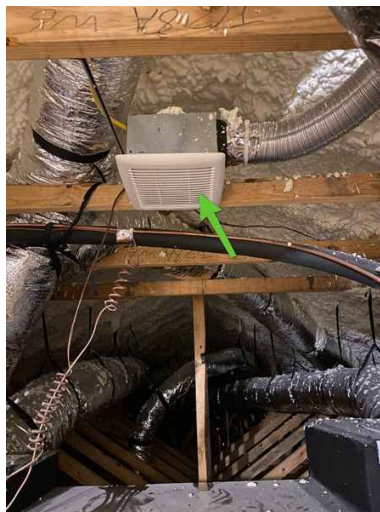
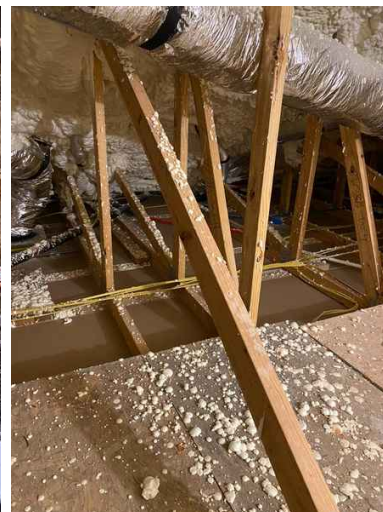
This is the continuously running attic ventilation fan to keep moisture down since this is a ventless, conditioned space. It exhausts along the right side wall under the eaves.

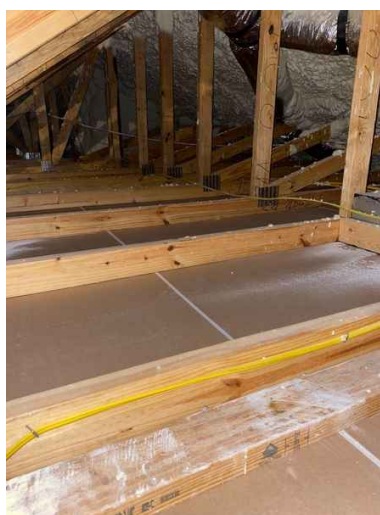
1: Damaged Insulation

Minor damage to spray foam insulation in two spots in the attic.

Recommendation: Contact a qualified insulation contractor.

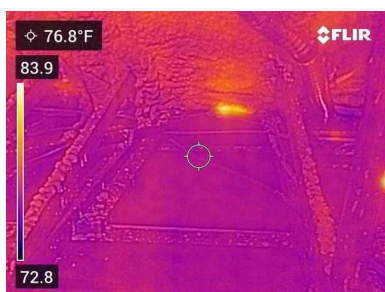
Not sealed at right side wall eaves

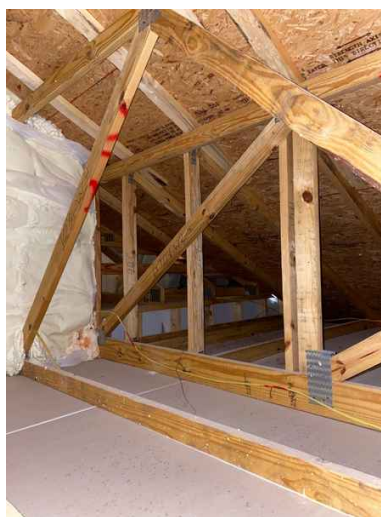
2: Thin/Soft Sheathing

Roof sheathing appears to be unsecured and “bouncy” between the front door and garage where there is a noticeable ridge. Recommend builder investigate and secure sheathing.

Recommendation: Contact a qualified roofing professional.

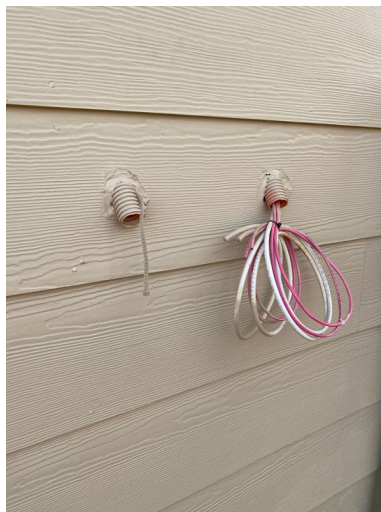
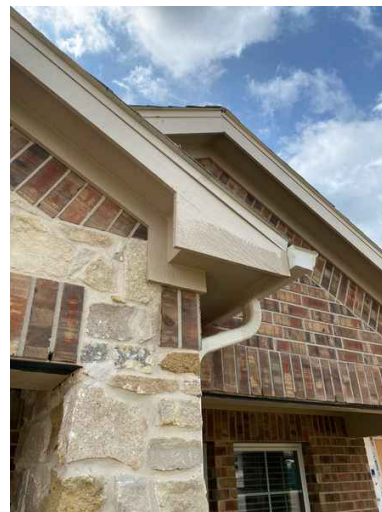
The exterior and interior walls had several areas in need of repainting, sealant, or repairs.

Repaint needed

Recommendation: Contact your builder.

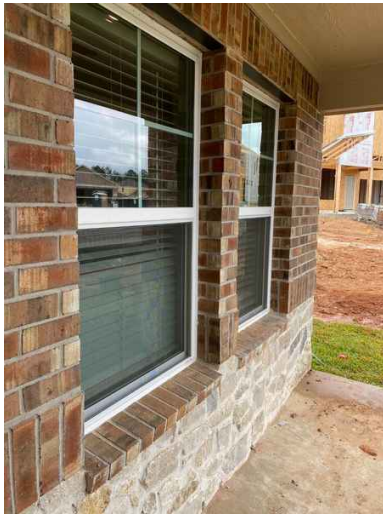
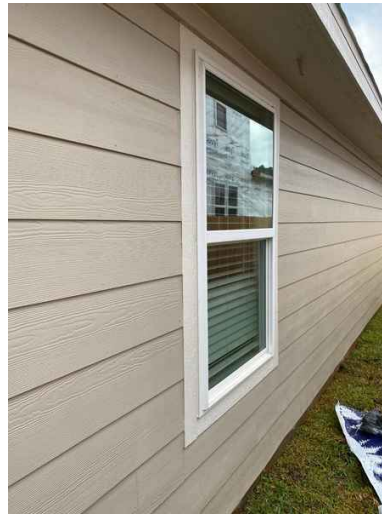
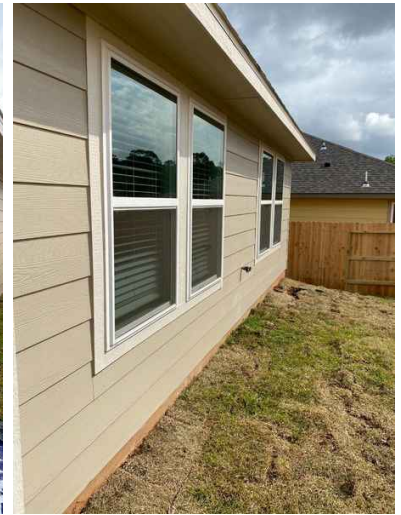
Right wall window needed cleaning, as it had spray foam insulation debris stuck to it. Same wall had a missing screen.

The rear facing windows appeared to be unfinished and lacking sealant at the top surface, which could allow moisture intrusion.

Recommendation: Contact your builder.

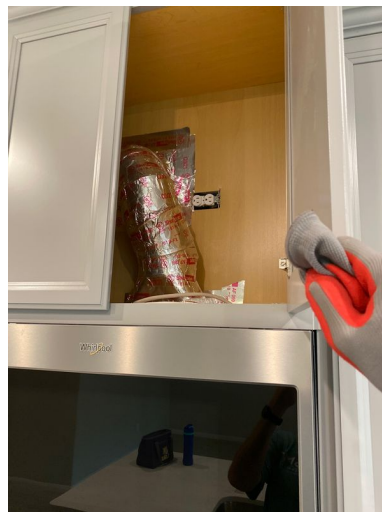
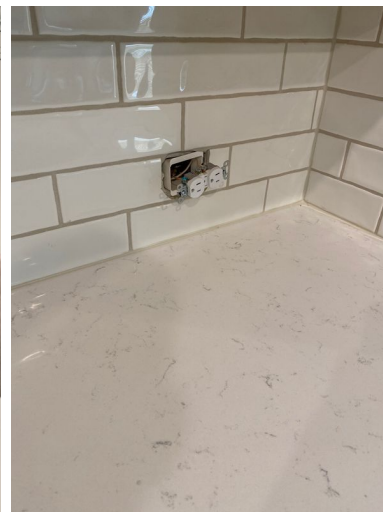
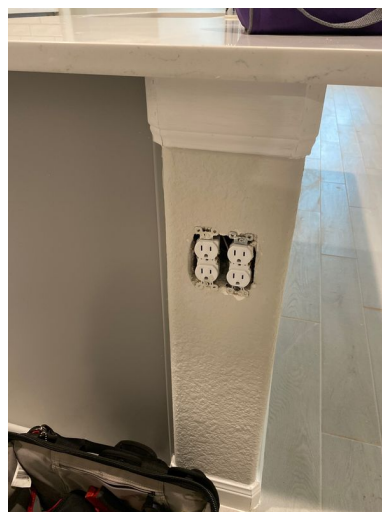
Several cover plates were missing and outlets were unsecured. But only the front door exterior did not appear to have power on the day of the inspection.

No power

Recommendation: Contact your builder.

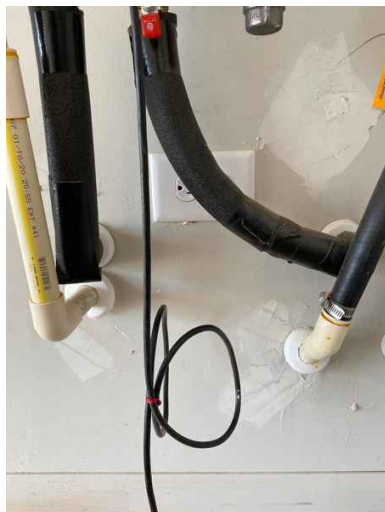
2: Blocked Receptacle

Recommend adjusting either this hot water heater pipe or the location of this outlet.

Recommendation: Contact a qualified professional.

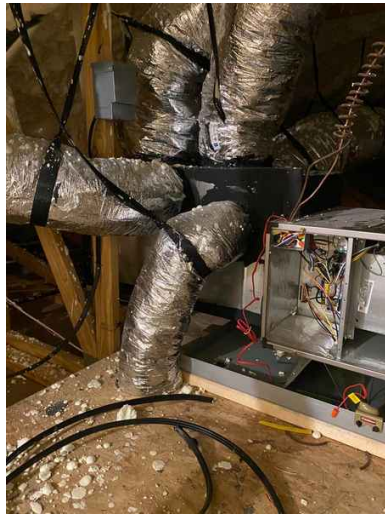
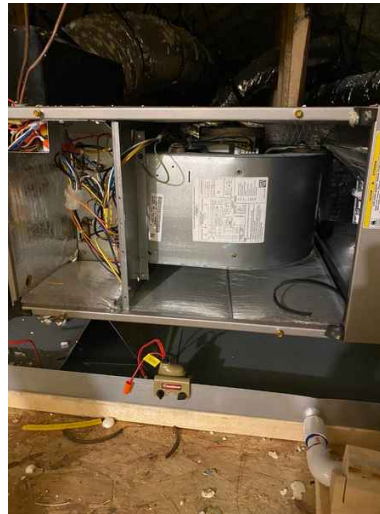
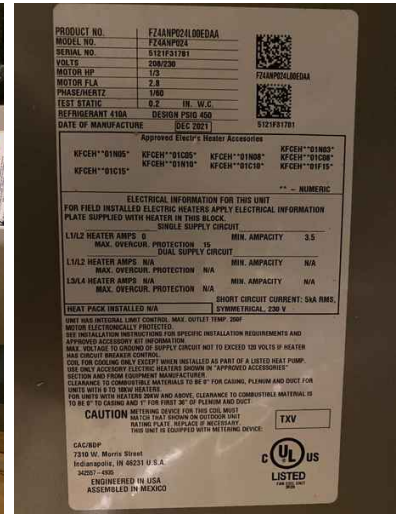
Carrier multi-speed heat pump is a great, energy efficient system! No reportable deficiencies noted with the attic installation or ducting, but the system was not yet wired so it could not be tested.

HVAC not Electrically Connected:

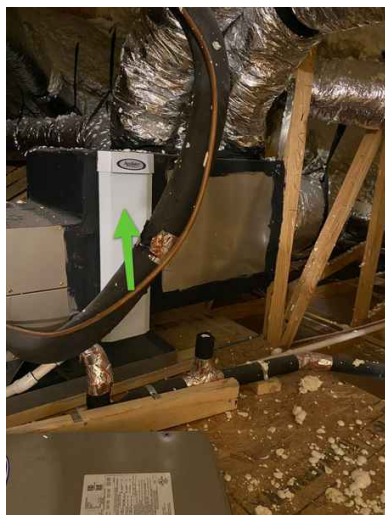
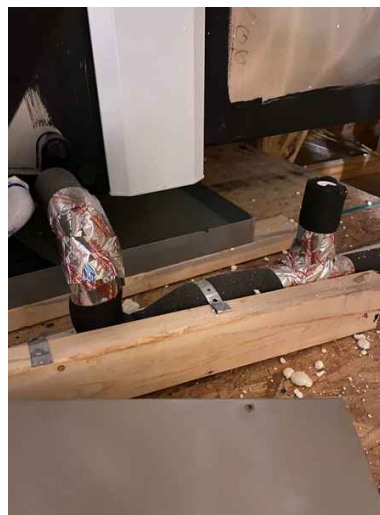
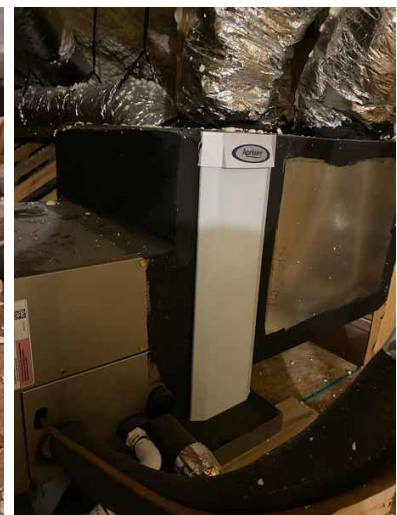
Your whole home air filter is located in the attic. Do not put filters in the return air grilles, as double filters would limit air flow. Be sure to attain the filter size from the builder.

This is your air filter housing.

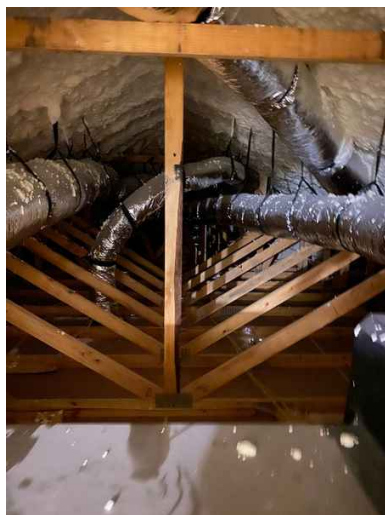
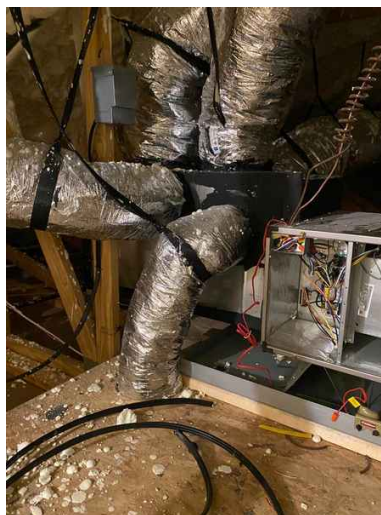
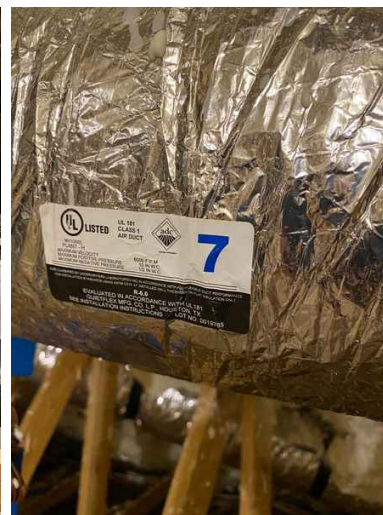
No deficiencies noted with the air ducts.

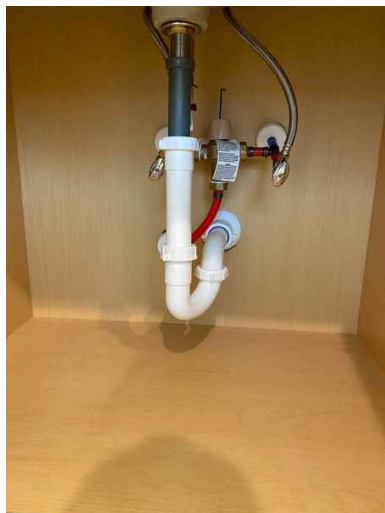
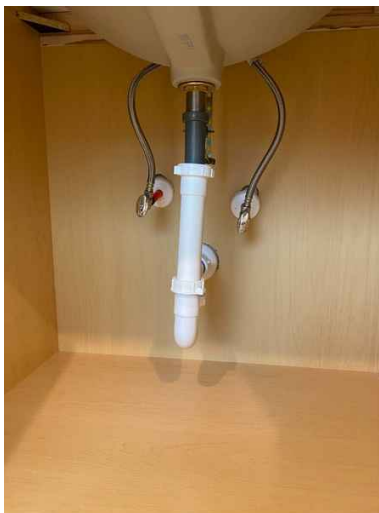
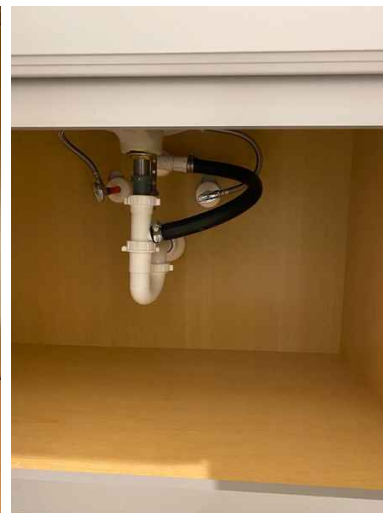
The drainage could not be tested since the whole home water was shut off, but all undersink installations appeared proper.

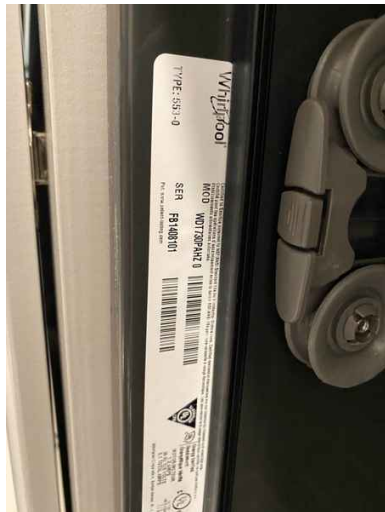
Installation appeared proper, but the unit was plugged in and did not have water supply.

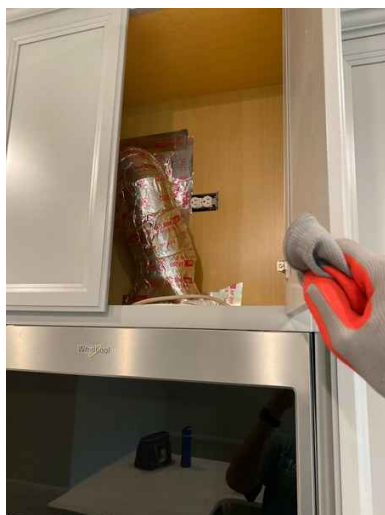
Properly installed but not on yet.

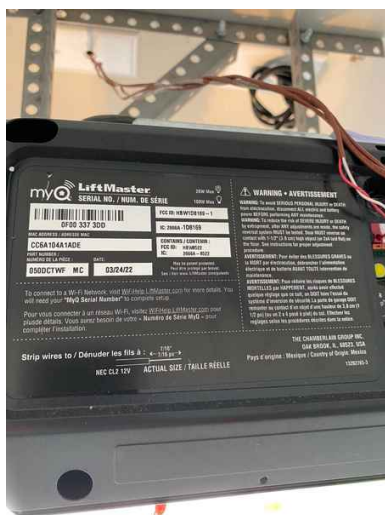
The garage door functioned properly when tested.

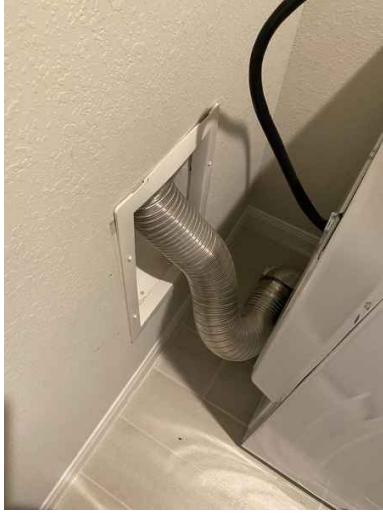
Dryer vent properly exhausted to exterior with no screen (screens on dryer vents are fire hazards due to lint build up).

*The dryer vents through the roof, which is unusual but not a deficiency. I recommend a semi-annual or more frequent check of the roof dryer exhaust to ensure lint is not building up. This would limit air flow and increase a potential fire hazard.
