HEDDERMAN SERVICES

MECHANICAL INSPECTION

4920 Laurel Street
Bellaire Tx 77401

PROPERTY INSPECTION REPORT

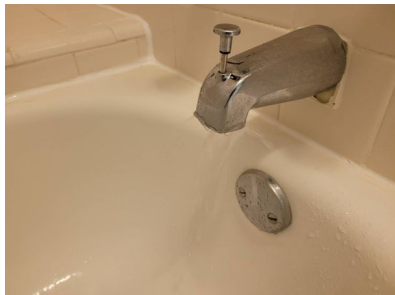
The diverter valve was leaking water past the valve when the valve was turned to the shower.

Obtain Cost Estimate

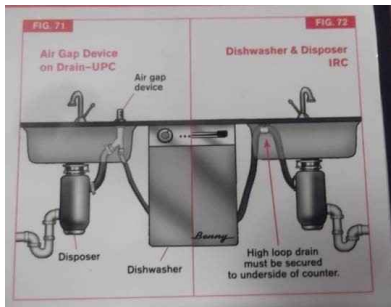
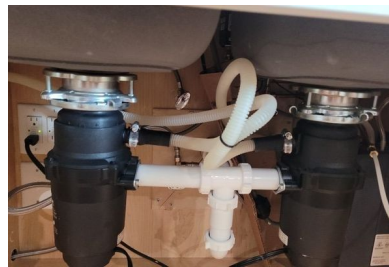
1: Nonfunctional

The right dishwasher was nonfunctional at the time of the inspection. The reason for the condition was not apparent. The unit should needs to be checked by a service company who should provide a cost estimate to repair or replace the equipment.

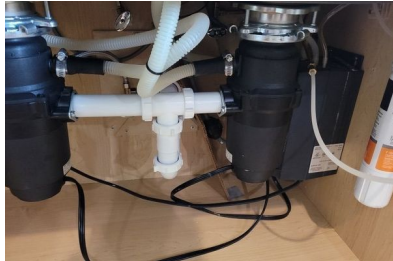
The disposal was nonfunctional at the time of the inspection. The reason was not apparent, and the unit needs to be checked out by a service company who should provide a written statement of the condition of the equipment.

Obtain cost estimate

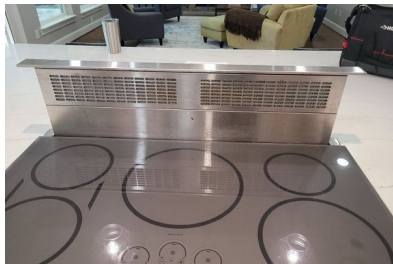
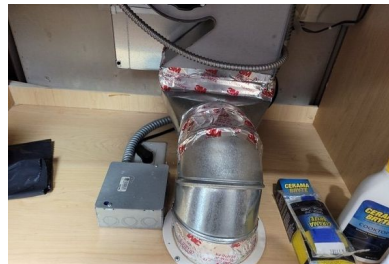
1: Vent Pipe - leaking air

The vent pipe was leaking air into the kitchen cabinet and needs to be sealed.

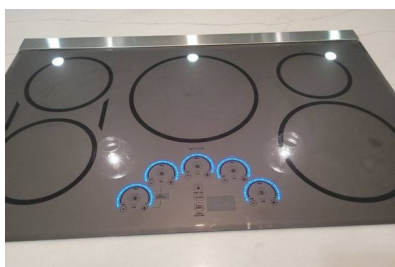
The electric cooktop was an induction type cooktop and the burners will not heat unless steel cookware is in contact with the burner. It is pointed out that the required cookware was not present at the time of the inspection and the cooktop was not operated.

Further investigation is recommended

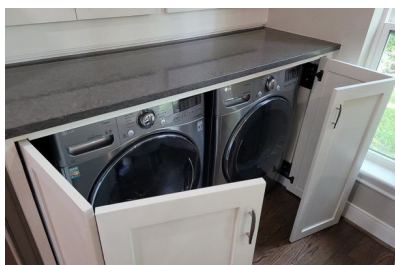
The vent was connected to the dryer but was not tested. It is recommended that the vent be checked for an excess of lint and that it be cleaned if necessary. (Information)

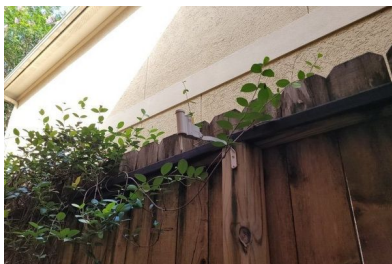
1: Spraying - House

Zones 3,6

A sprinkler head that was not spraying properly and appeared to be clogged was observed.

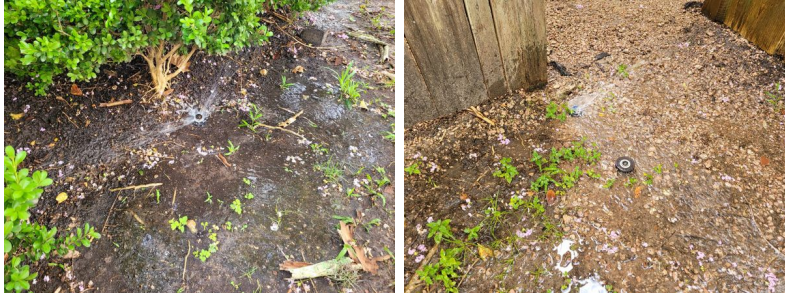
3: Spraying Fence

Zones 3,4

The sprinkler system was spraying the fence and needs to be adjusted to prevent premature deterioration of the fence.
