STRUCTURAL INSPECTION

4920 Laurel Street
Bellaire Tx 77401

JULY 13, 2021

REF: CONDITION OF PROPERTY SURVEY

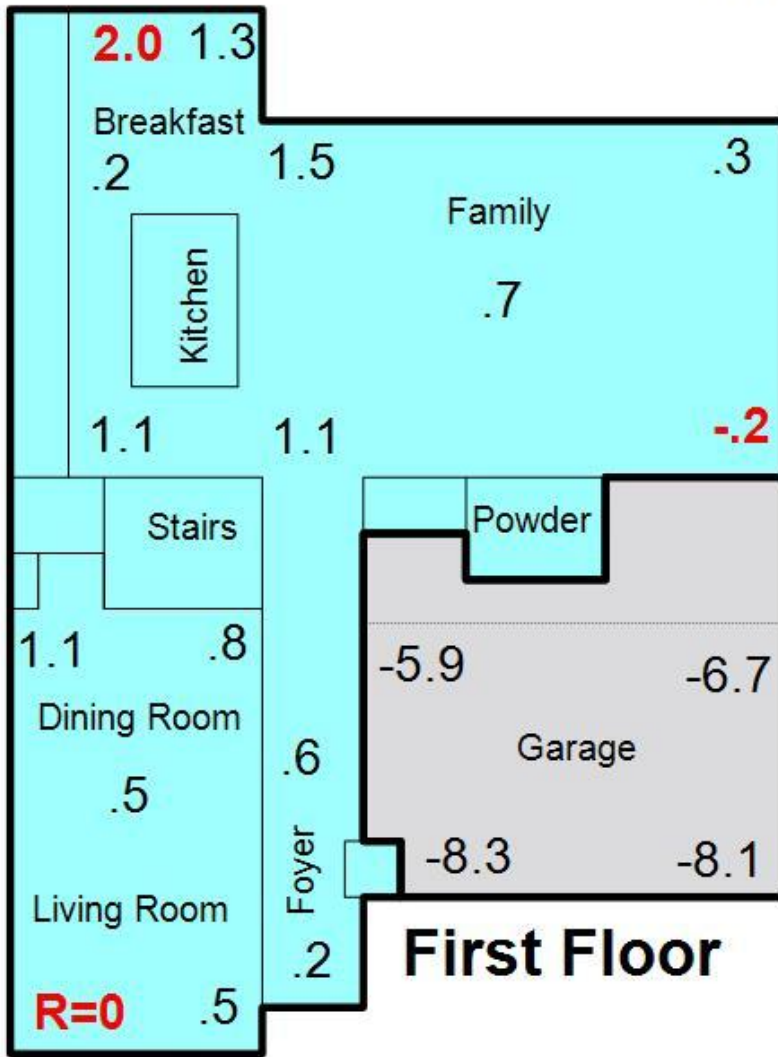
First Floor

The floors were checked with an electronic level, and were observed to be sloping towards the east side of the house. The difference in elevation between the high point and low point was 2.2 inches on the first floor; and 2.3 inch on the second floor. The first floor high point was located at the breakfast area, and the low point was located at the family room. The unlevelness takes place over a horizontal distance of approximately 30-40 feet.

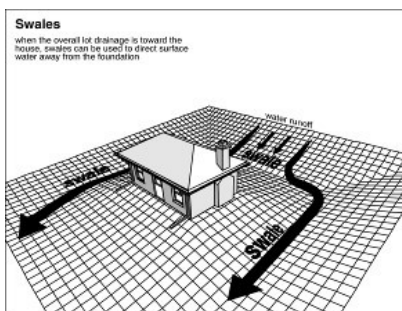
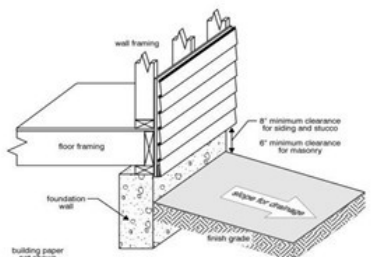
Perimeter Grading/Drainage: Appeared Adequate

The perimeter drainage around the property appeared to generally be adequate. It could not be determined with certainty if water would pool at any localized low areas around the property. Further investigation with the homeowner is recommended to determine if there are any drainage problems or water that ponds on the property after a rain.

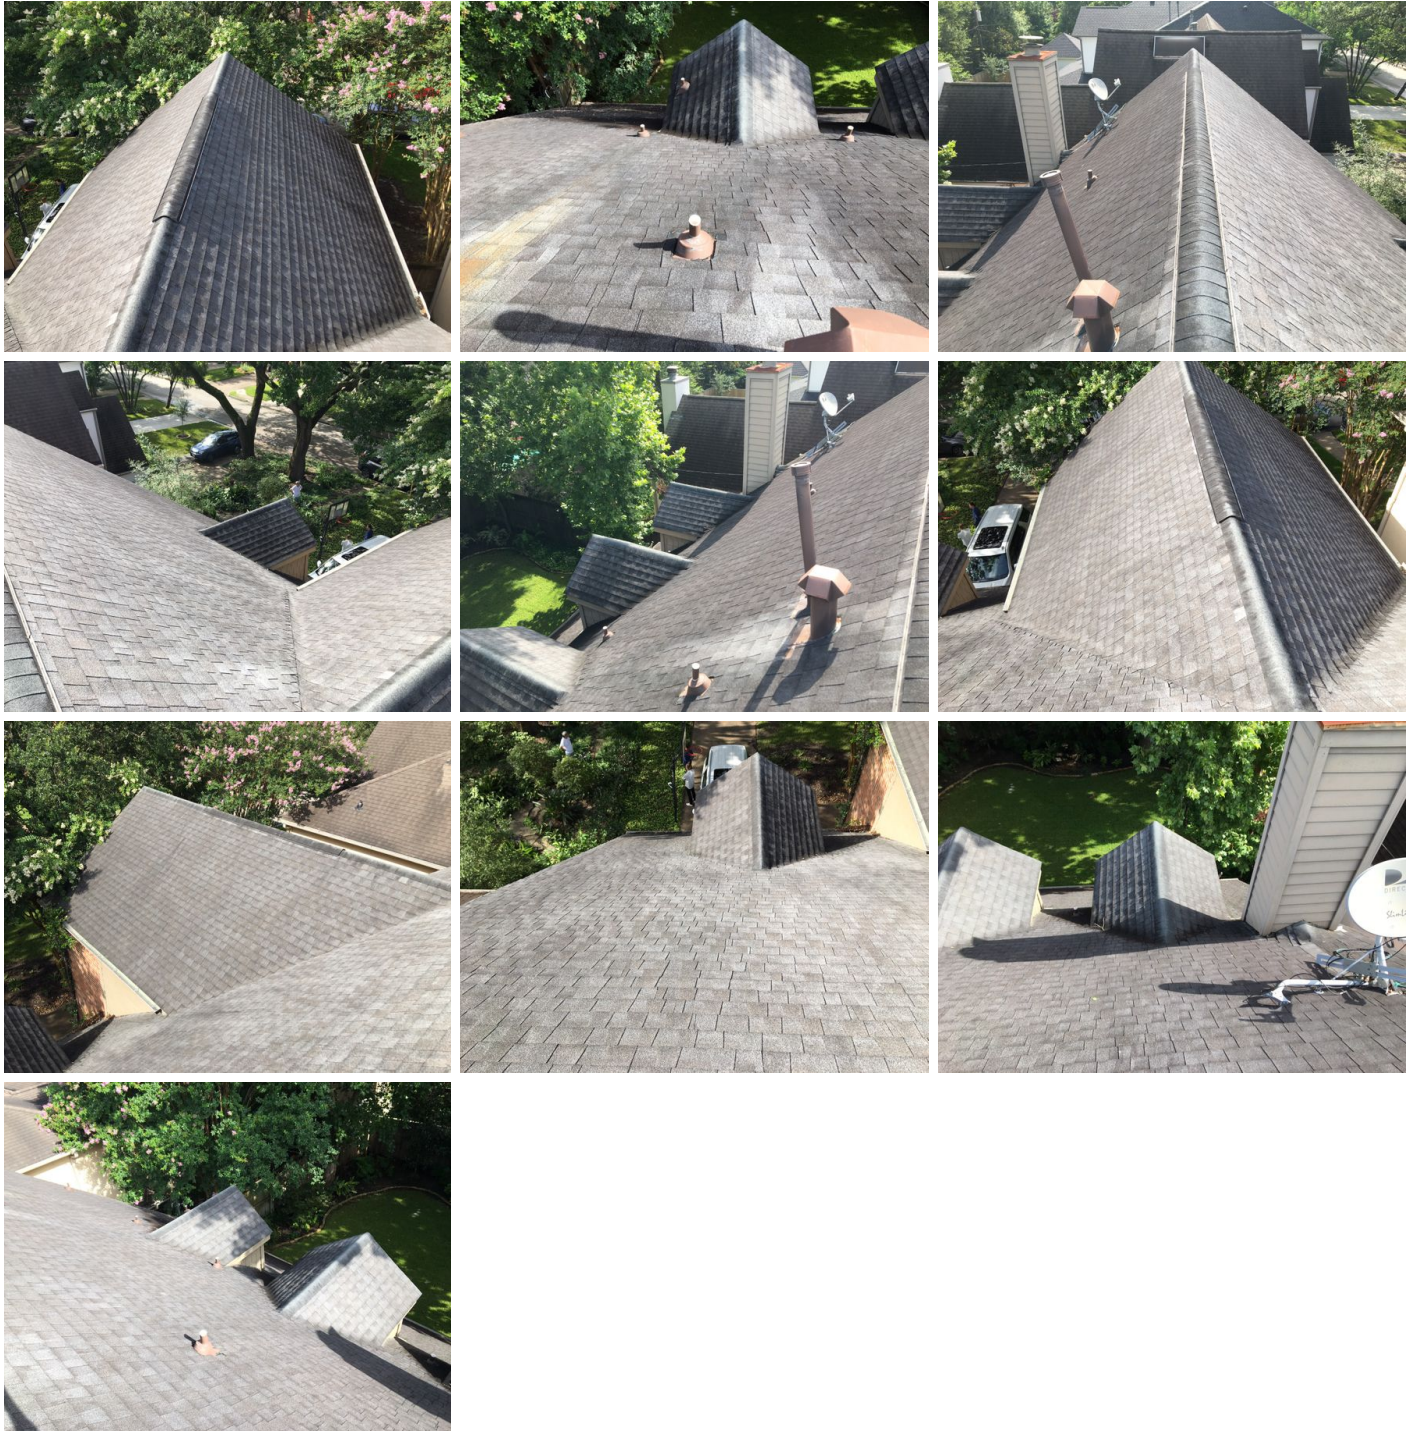
Roof Descriptions: Composition Shingles

The pitched roof surface was constructed of composition shingles. The life expectancy of a composition shingle roof has been observed to vary from 15 to 20 years, with most requiring replacement at about 17-20 years.

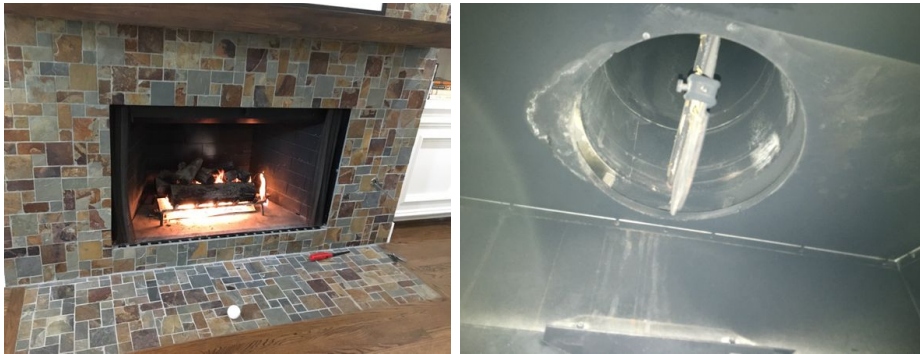
Metal Fireplace: Chimney flue not visible for entire flue

It should be noted that the inside of the chimney flue is not visible due to the construction of the chimney, and was not inspected. The chimney flue extends from just above the fireplace opening inside the house to the top of the chimney. If this a concern to you, we recommend that a fireplace service company be contacted.

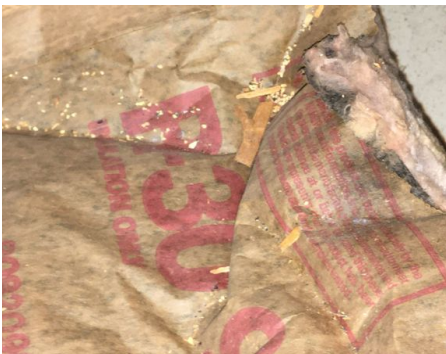
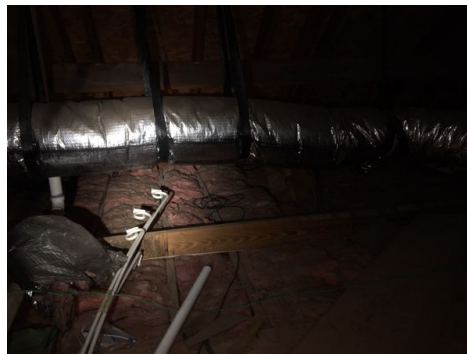
Insulation: R30 Batt

The insulation in the attic was average by today's standards. The normal amount of insulation for attics in this area is an R38 energy rating. This attic had approximately 9-10 inches of fiberglass batt insulation in the ceiling, which was marked as being an R30. It is pointed out that the insulation requirements according to the latest standard for new houses in this area is an R38 energy rating.

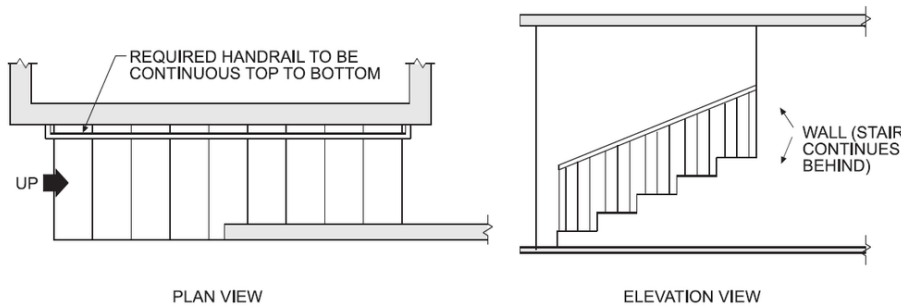
Figure R311.7.8.2
HANDRAILS

The handrails for the stairway were not constructed according to the current building code standards, which is expected given the age of the house. Therefore, the ends of the handrails do not terminate into the wall, which could allow loose clothing or a purse or bag to catch on the open end, causing tripping and/or falling down the stairs.
