Inspection Report

Property Address:
1450 N 23rd St
Beaumont TX 77706

PROPERTY INSPECTION REPORT FORM

Edwardo & Leticia Gutierrez	2/21/2022
<i>Name of Client</i>	<i>Date of Inspection</i>
1450 N 23rd St, Beaumont, TX 77706	
<i>Address of Inspected Property</i>	
Joe Askew	TREC# 0010495
<i>Name of Inspector</i>	<i>TREC License #</i>
<i>Name of Sponsor (if applicable)</i>	<i>TREC License #</i>

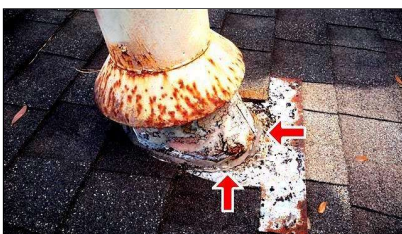
C. (Picture 3)

(3) The sealant at the vent cover above the kitchen was weathered.

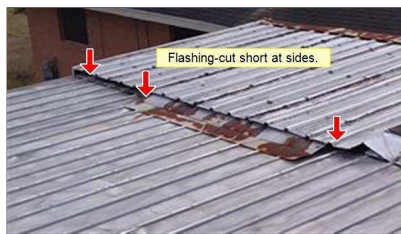
C. (Picture 9)

(6) The roof over the rear addition/sun room was in fair condition. Corrosion was noted. One of the transition flashings was cut short on two sides. Debris/leaves were also noted at the gutters in areas. Evidence of previous sealing/repair was observed.

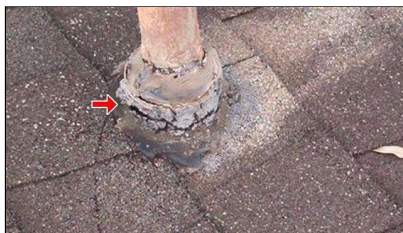
C. (Picture 10)

(7) The sealant at the service mast penetration was weathered/splitting. Maintenance/re-sealing may be needed soon.

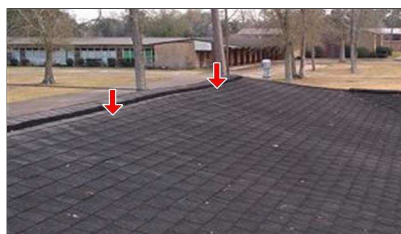
D. (Picture 2)

(2) Visual deflection was noted at the roof decking in areas. Portions of the framing over the garage were reinforced at some point.

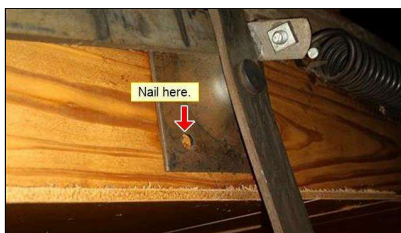
D. (Picture 4)

(3) The pull down attic access ladder in the garage does not have fire-blocking installed, (per current TREC requirements).

(4) Client may wish to install additional nails to secure the attic access ladder (the holes at the reinforcement plates should typically be nailed through).

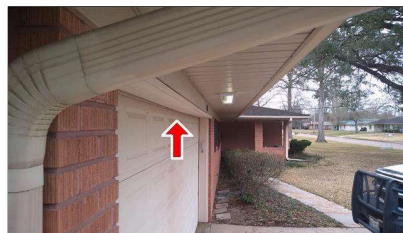
E. (Picture 2)

(1) It appears that a support post or column was removed from the front of the garage. Slight visual sagging was noted at the framing above the overhead door.

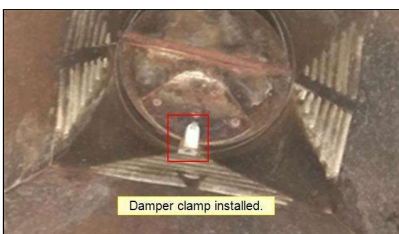
J. (Picture 2)

(2) Note: A damper clamp was installed. This is a safety device that prevents the damper from closing (required for gas fireplaces). This is for your information.

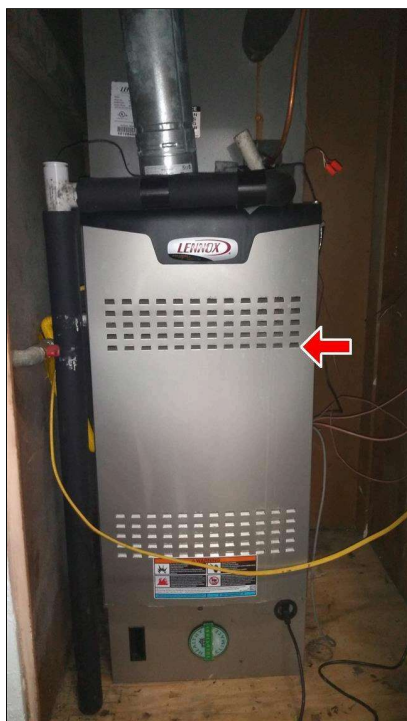
A. (Picture 1)

(2) A Lennox brand furnace/air handler was noted at the hallway HVAC closet. According to accessible serial numbers this equipment was manufactured in 2018.

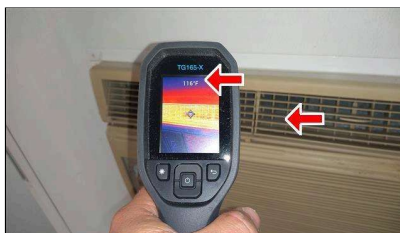
A. (Picture 3)

(3) A window unit was noted at the rear sun room. This unit provided heated air when set to the heat function.

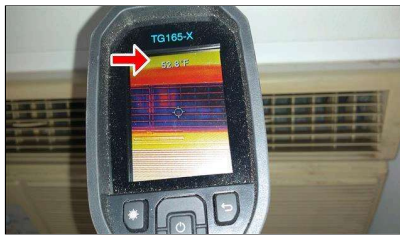
B. (Picture 1)

(2) A window unit was noted at the rear sun room. This unit provided significantly cooled air when set to the cool setting.

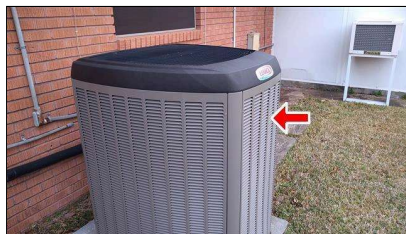
B. (Picture 3)

(4) A Lennox brand condenser unit was noted at the rear of the home. According to the serial number, it was manufactured in 2018.

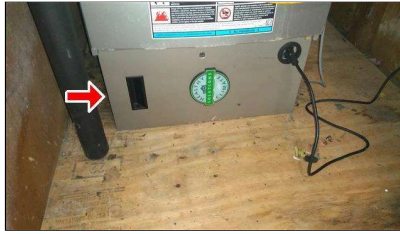
C. (Picture 1)

Note: The filter for the HVAC system is at the bottom of the air handler. This is for your information.

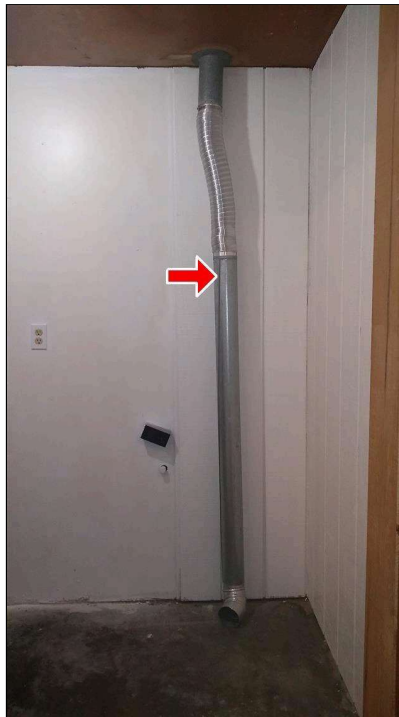
H. (Picture 1)

(1) Note: The dryer vent exits through the roof. With this type of dryer vent, it is important to periodically check to keep clean to avoid blockage.
