Stucco Check Inspections, LLC

Invasive Stucco Inspection

1208 E 29th St
Houston, TX 77009

June 15, 2022

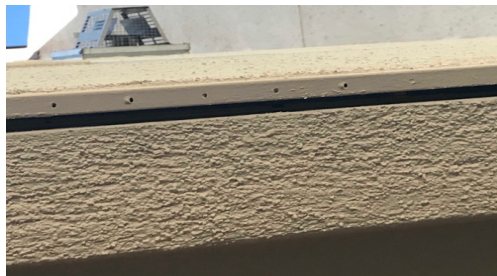
- Suggested to seal all hairline cracks throughout home. Paint is suggested at the 8-10-year mark as well, to alleviate all staining and cracks.
- Front stucco overhang terminates with no drainage accessory and are closed in with stucco. To repair and prevent further damages, it would be suggested to remove necessary stucco at these overhangs to properly install an industry approved drainage accessory/provision. Upon testing, the front overhang noted to no underlying damages at time of inspection. Suggested to further investigate and repair accordingly. Below is an example of a proper overhang drainage accessory detail:
