Property Inspection Report

16283 Wrangler Ave
Conroe, TX 77302

By: Jerry W Lowry, Lic #23830 12/20/2021
(Name and License Number of Inspector) (Date)

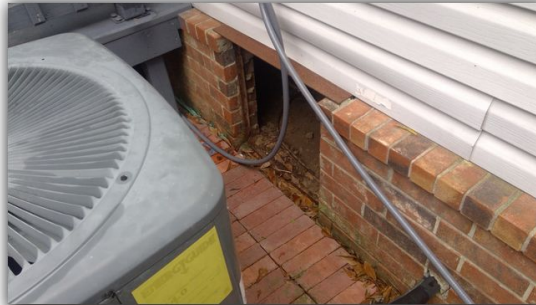
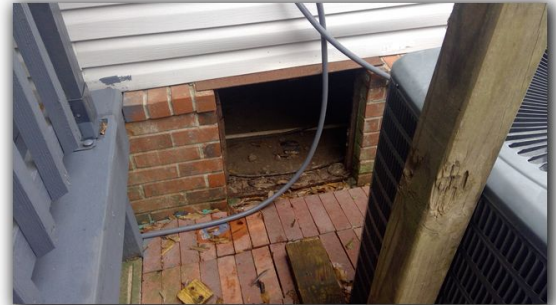
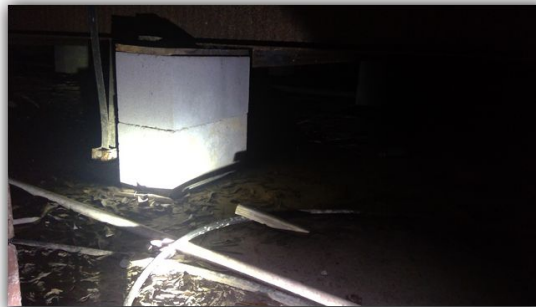
It is the opinion of this inspector that the foundation appears to be performing the function intended on the day of the inspection with the exception of any observed / noted / checked items below

Cracks observed in exterior brick walls showing some evidence that the foundation has moved / settled, see exterior wall section for photos.

Noticeable floor elevation changes observed at multiple locations. Higher spots and lower

spots observed when walking across the floor. No specialized equipment was used in the foundation inspection, see floor section for photos.

Would recommend that a licensed and / or qualified contractor be consulted to make any further recommendations and / or repairs

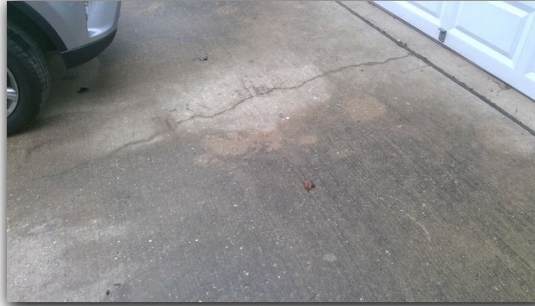
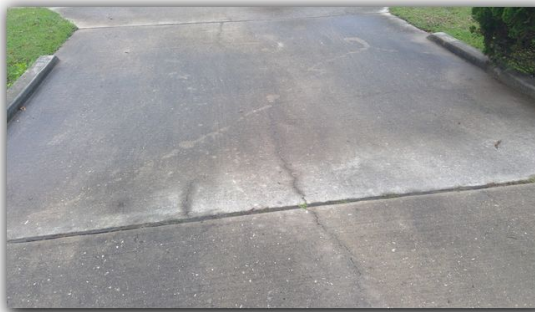
Cracks observed in flatwork (Driveways, sidewalks, etc. Not related to foundation of structure but noted on report for potential buyer to be fully informed.

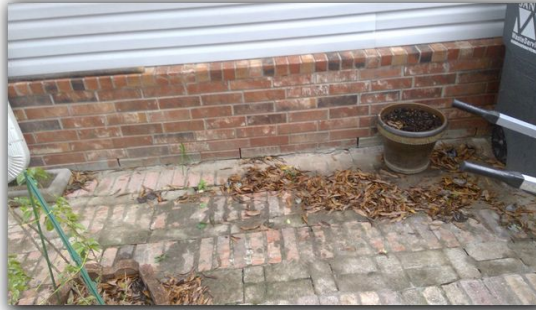
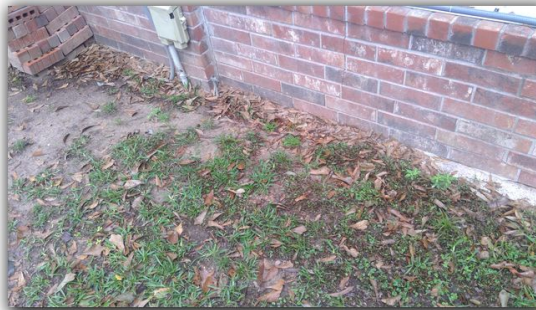
- Soil too high or footing level too low around the perimeter of the slab: Grade does not conform to current code requiring a 4" slab exposure between the finished grade and exterior brick.

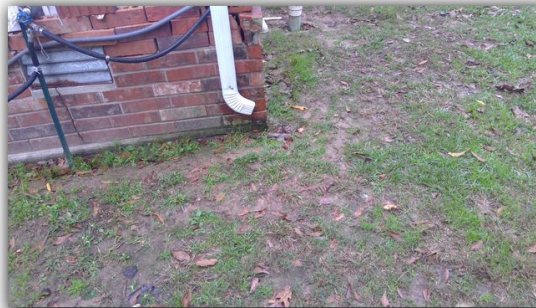
- Splashblocks missing in some locations.

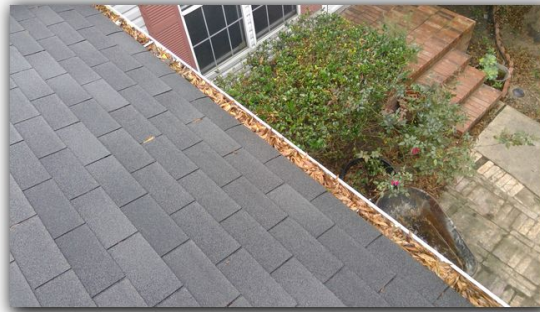
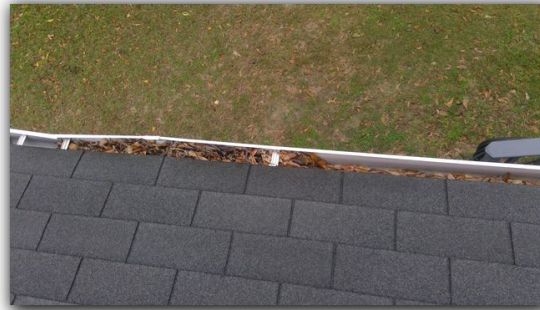
- Gutters need to be cleaned at one or more locations.

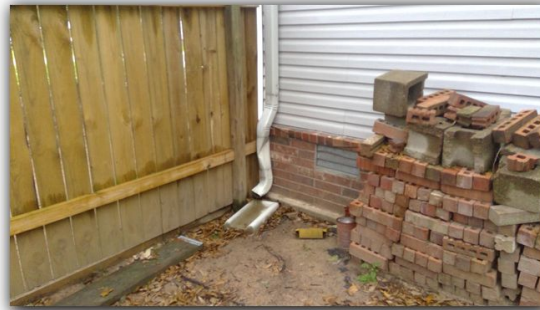
Gutters / downspouts observed to be damaged / dented at one or more locations.

Would recommend that a licensed and / or qualified contractor be consulted to make any further recommendations and / or repairs

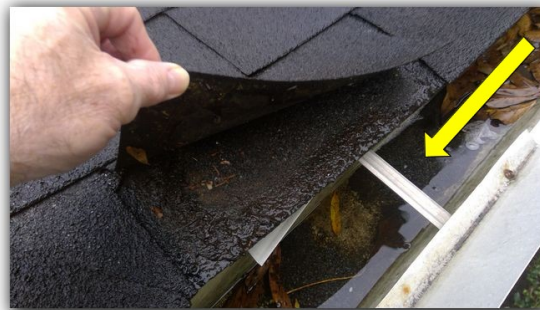
Low areas observed in gutters that appear to be pooling water and not draining properly.

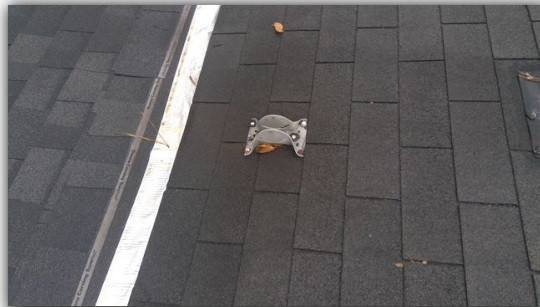
Satellite dish bases and an antenna screwed into the roof covering.

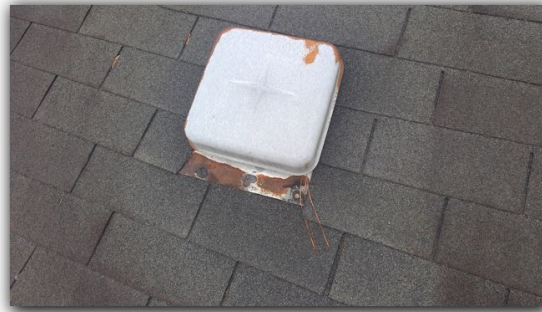
Exposed nails at multiple locations need to be properly caulked / sealed.

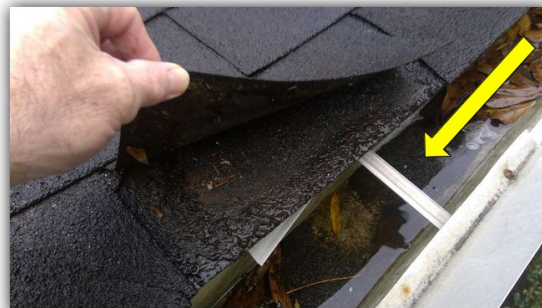
First row of shingles has not been properly sealed to the starter course of shingles below in one or more locations.

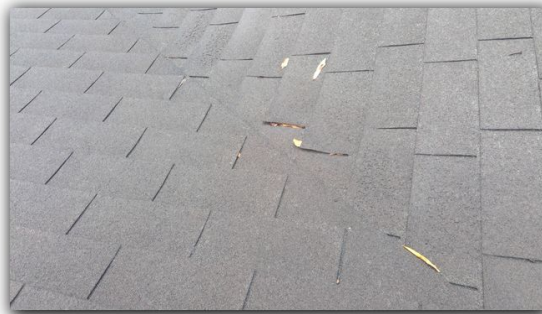
Shingles lifted up and not properly laying down / sealed in some areas.

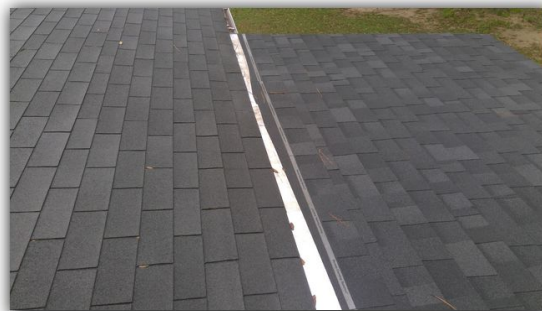
Inappropriate roof covering for slope of the roof. Dimensional / tab shingles should not be used in low slope roof applications. Consult manufacturer's specifications for details, see rear porch addition.

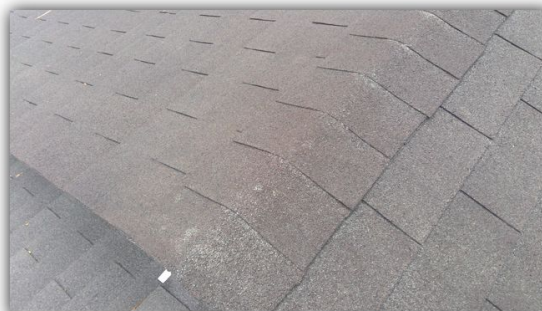
Significant signs of roof deterioration were observed. Gravel coming loose, pitted surfaces, fiberglass threading showing at edge of shingles, shingle corners are turning up. Would recommend contacting a roof professional to make any further recommendations and / or repairs.

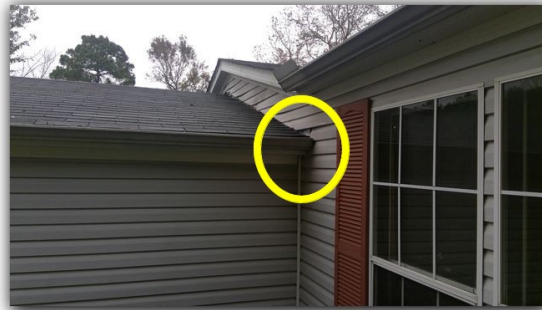
Flashing is incorrectly installed. Diverter flashing needed at all roof / wall intersections.

Would recommend that a licensed and / or qualified contractor be consulted to make any further recommendations and / or repairs

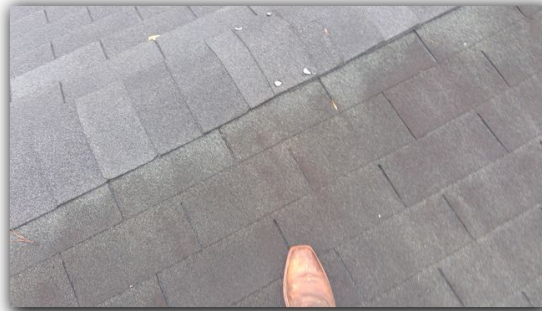
Deflection/Sponginess in roof surface observed in multiple locations. The photo below is representative.

Would recommend that a licensed and / or qualified contractor be consulted to make any further recommendations and / or repairs

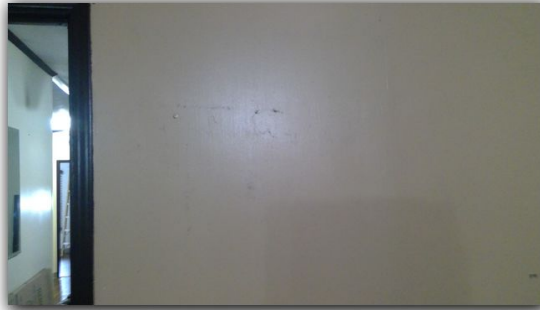
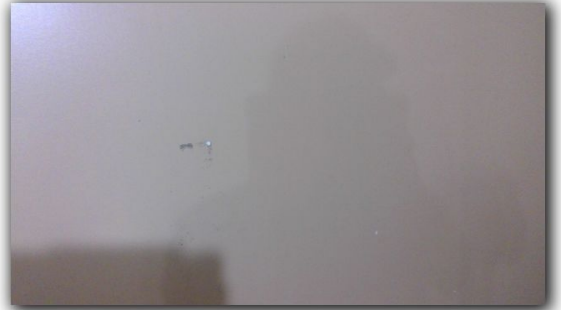
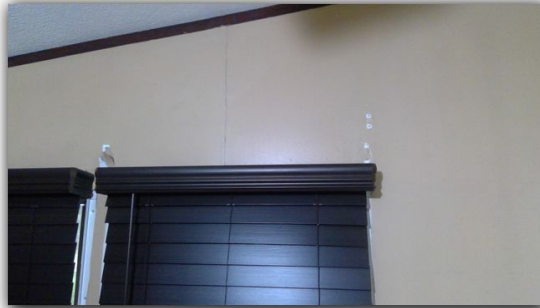
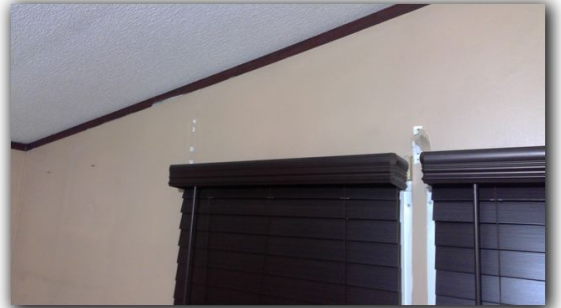
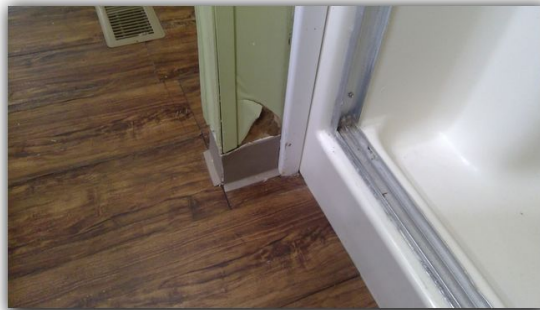
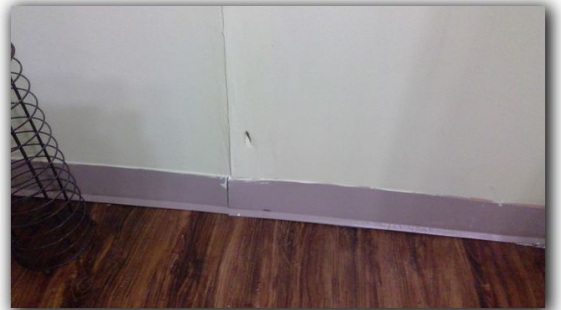
Sheetrock damaged (scarring / nicks / small holes) observed in sheetrock walls at one or more locations.

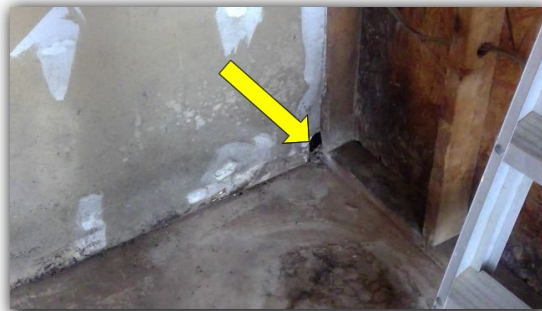
Sheetrock damage observed at one or more locations where it appears the sheetrock has been damaged by animals.

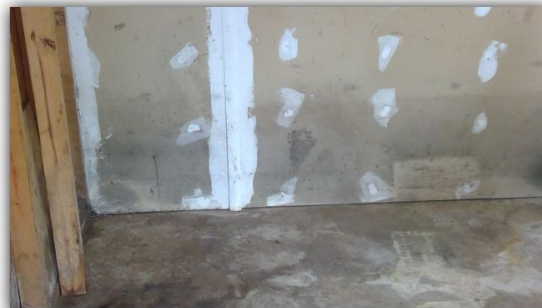
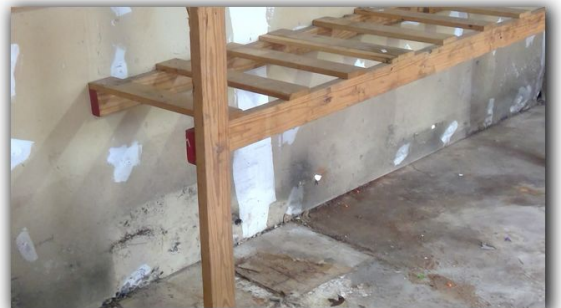
Water stains on walls at one or more locations, see garage.

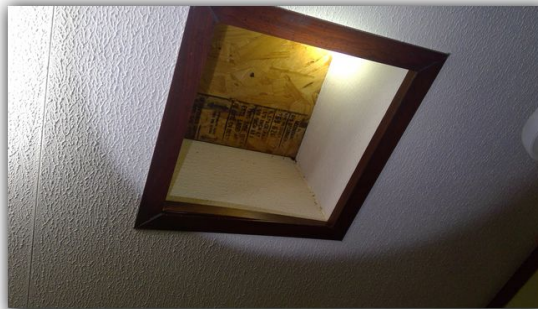
Evidence of previous repair observed in primary and hall bathrooms where skylights were removed and decked over. Work was not performed per usual and customary building practices.

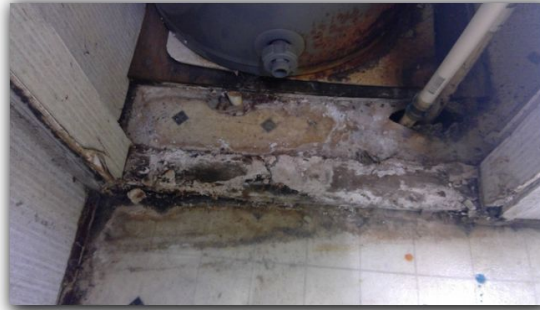
Floor appears to be rot damaged around the water heater and into the floor of the primary bedroom closet.

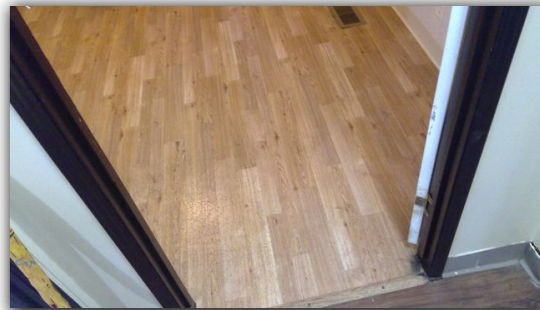
Sub-Floor squeaks in one or more areas

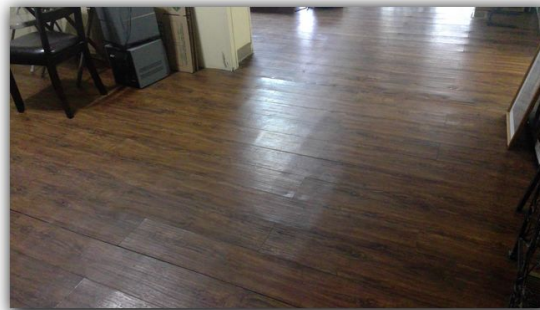
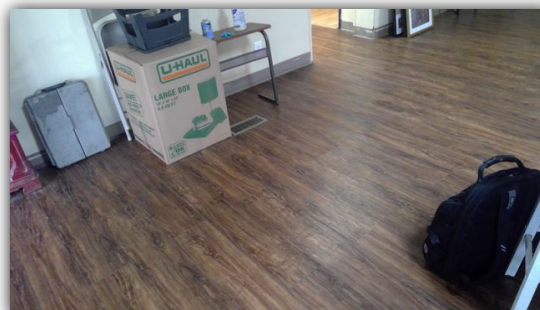
Higher and lower areas observed in floor surface noticeable when walking across the floor.

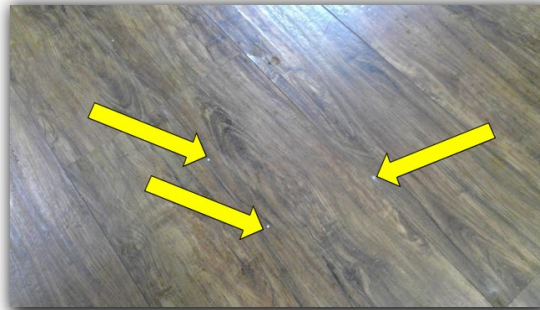
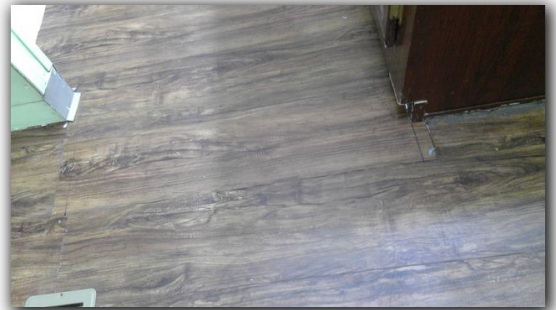
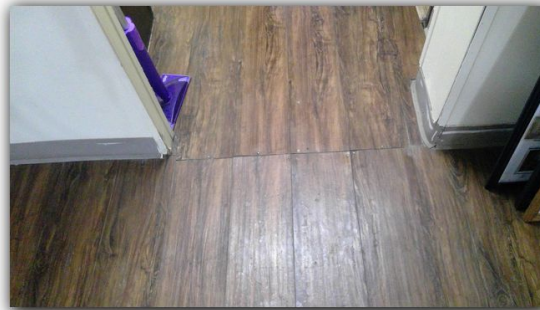
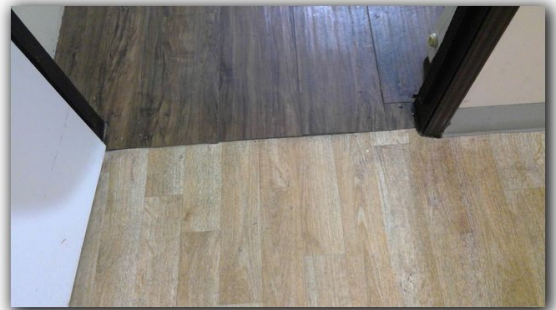
Floor covering is not installed in an usual and customary building practice manner.

Would recommend that a licensed and / or qualified contractor be consulted to make any further recommendations and / or repairs

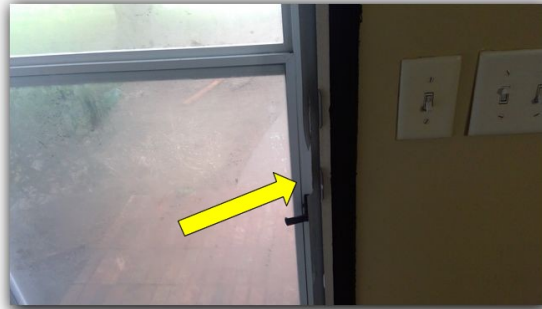
- Damaged weather stripping observed at one or more exterior door locations

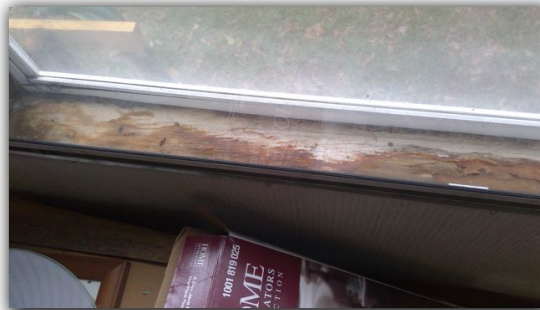
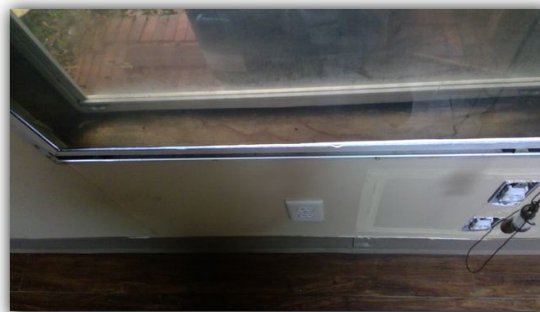
Moisture penetration observed on the window sill areas of one or more window locations. This moisture damage is typically caused by condensation on the interior side of the window soaking into the window sill area.

Would recommend that a licensed and / or qualified contractor be consulted to make any further recommendations and / or repairs

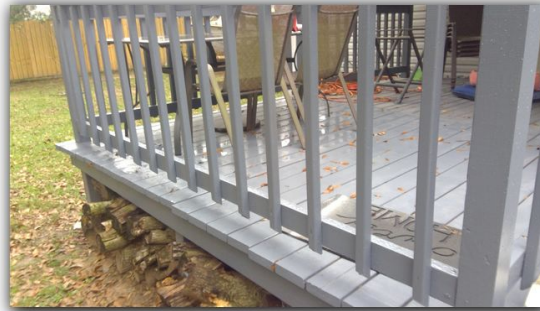
Vertical railing spacing is greater than 4" at exterior stair balcony areas per current code.

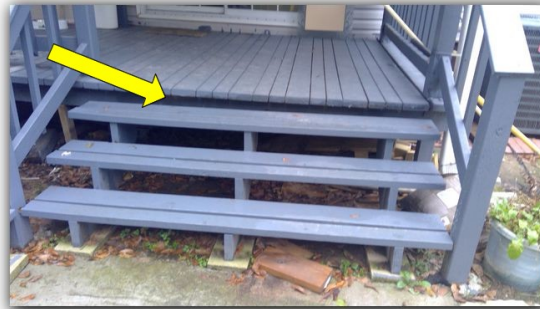
Improper dimensions of exterior stair risers: riser height cannot vary more than 3/8" from the lowest riser to the top riser per current code.

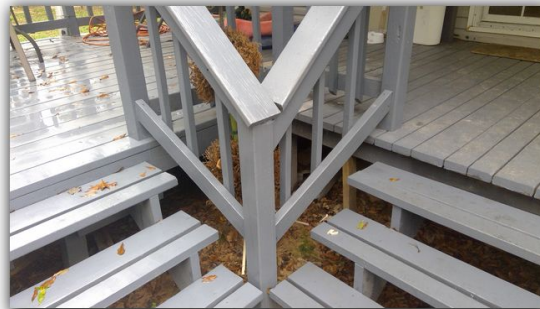
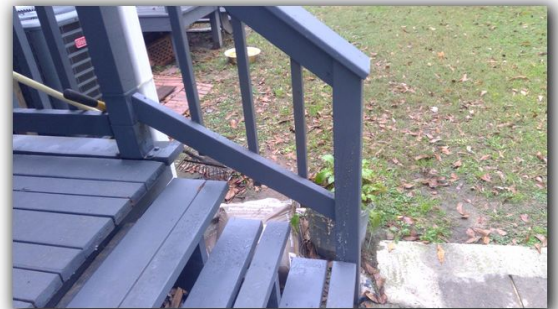
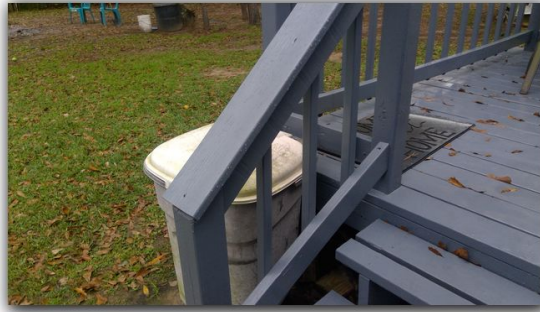
Hand railing at exterior stairs not at proper height: Current code requires handrail to be installed 34" to 38" measured vertically from the bullnose of the stairs

Would recommend that a licensed and / or qualified contractor be consulted to make any further recommendations and / or repair

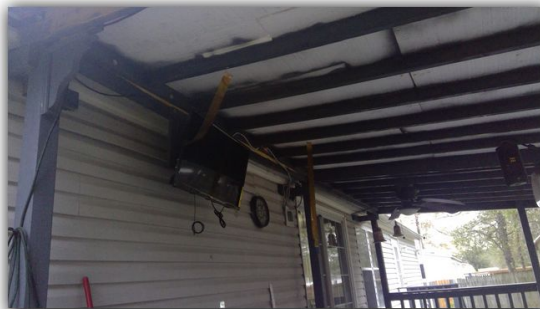
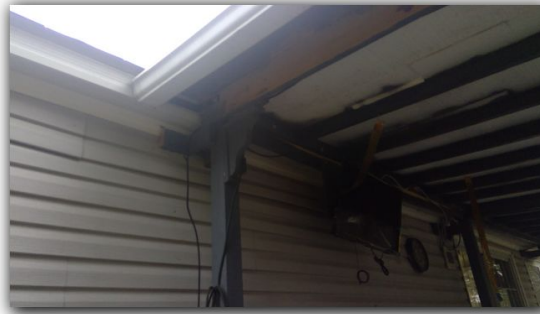
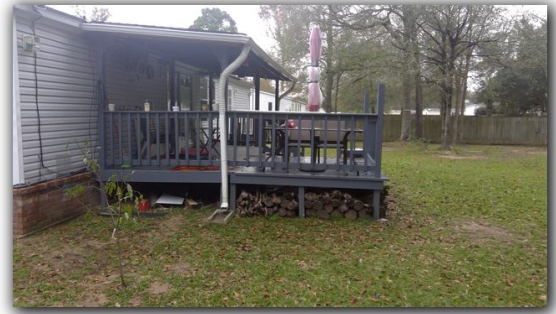
Structural deficiencies: rear porch covering structure was not constructed per usual and customary building practices.

Would recommend that a licensed and / or qualified contractor be consulted to make any further recommendations and / or repair

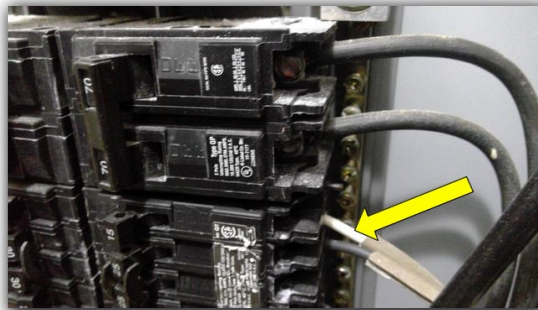
Wiring entering the panel box without appropriate clamps / bushings at knock out holes

Would recommend that a licensed and / or qualified contractor (Electrician) be consulted to make any further recommendations and / or repair

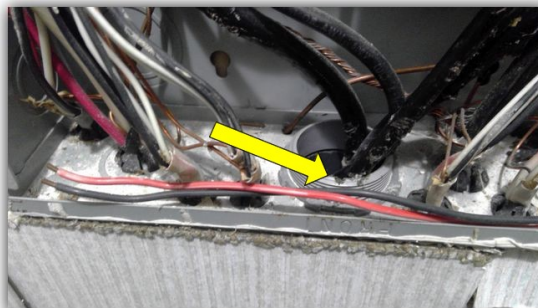
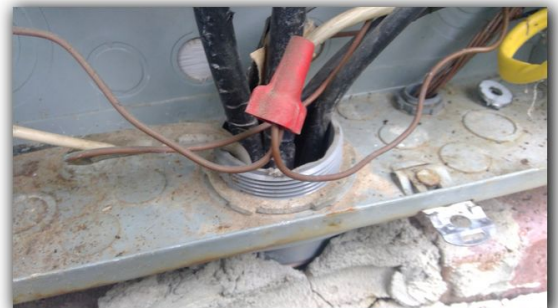
Exposed wiring present in electrical panel box.

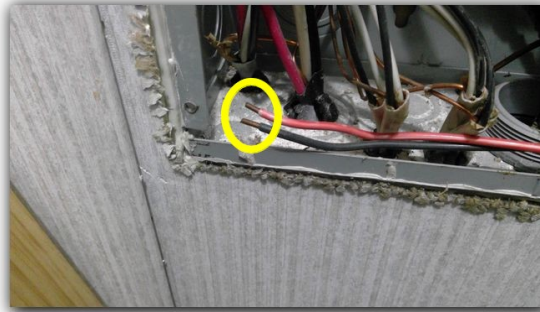
- Wiring in panel box did not appear to be installed in a usual and customary building practice manner, see panel box located in the primary bedroom closet. Did not appear to be professionally installed.
- Electrical panel boxes should not be located in clothes closets, in bathrooms, or over the steps of a stairway per current code.
- Electrical panel box is not properly labeled

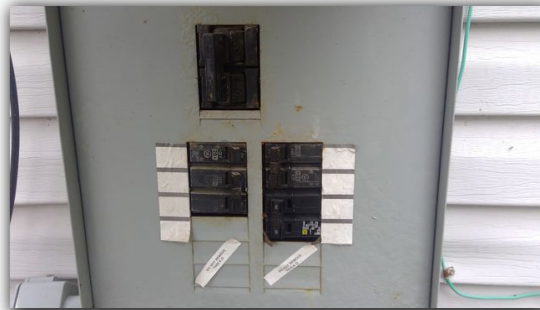
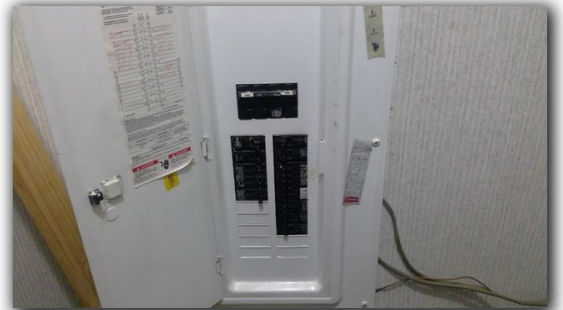
- Panel box does not conform to current code regarding the proper presence of arc fault protection. Arc fault protection did not enter the NEC code until 2002.
- Ground Fault Circuit Inoperable, see exterior outlet on rear of house.

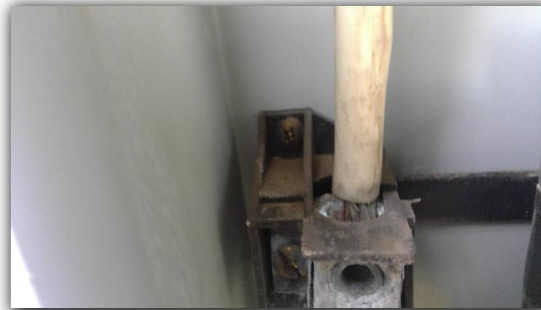
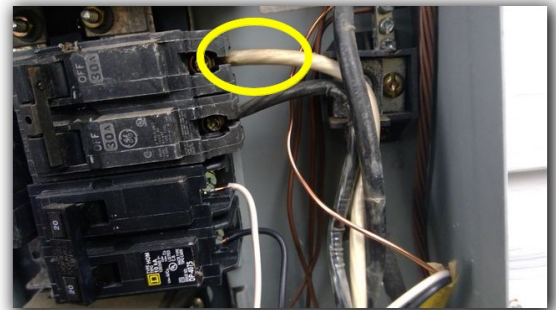
Whole house surge protection did not appear to be present at the time of the inspection. This requirement came into the code in November 2020 in the NEC 2020 (242.1) code.

Exterior disconnect does not conform to current code requiring exterior disconnect to be properly marked: EMERGENCY DISCONNECT / SERVICE DISCONNECT. This requirement came into the code in November 2020 in the NEC 2020 (230.85) code.

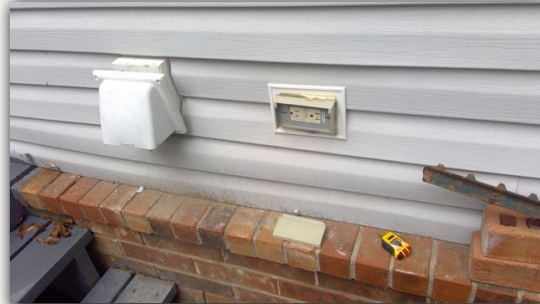
- Test indicate reverse polarity (hot / neutral reversed) at one or more locations, see garage.

- Would recommend that a licensed and / or qualified contractor (Electrician) be consulted to make any further recommendations and / or repair

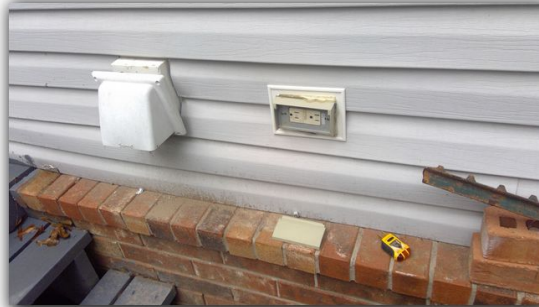
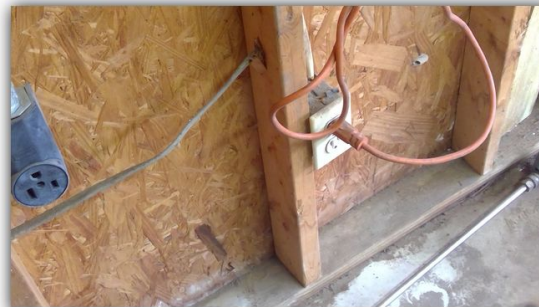
- No GFCI protection at one or more location. This is considered a recognized safety hazard: All kitchen, bathroom, **garage, exterior**, crawl space, **washing machine, dryer 220 receptacle, dishwasher**, disposer, Outdoor Equipment, Hydro-massage therapy equipment and wet bar locations are required by current code to be GFCI protected.

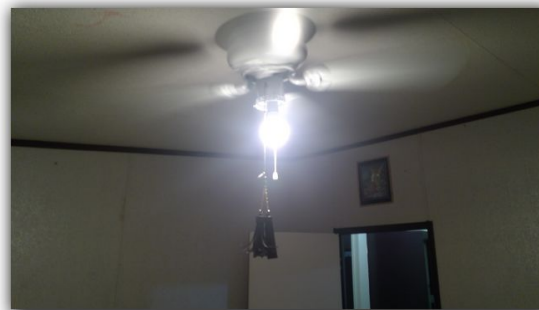
- Electrical fixture missing parts / parts not installed properly

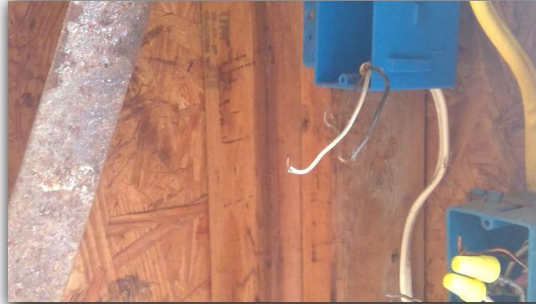
- Electrical wiring observed that was not properly terminated in a junction box, see garage..

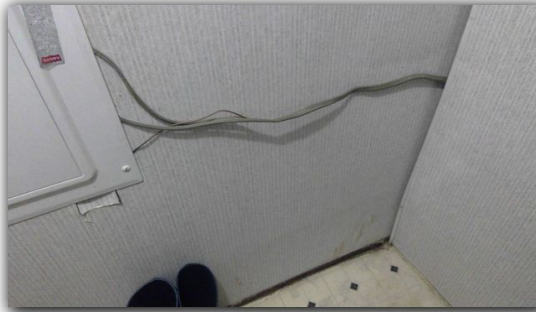
- Electrical wiring that has not been installed in a Usual and Customary Building Practice standard manner. Installed outside of the wall cavity. Installed on top of sheetrock.

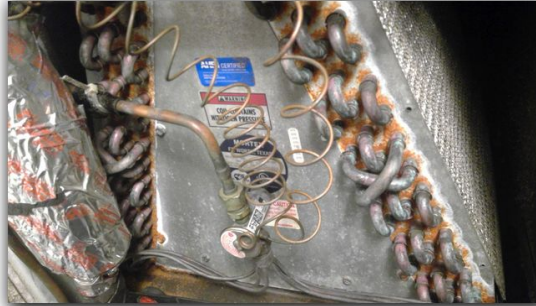
- Refrigerant lines not properly insulated at evaporative coil (wrong thickness per current code)

Would recommend that a licensed and / or qualified contractor be consulted to make any further recommendations and / or repair

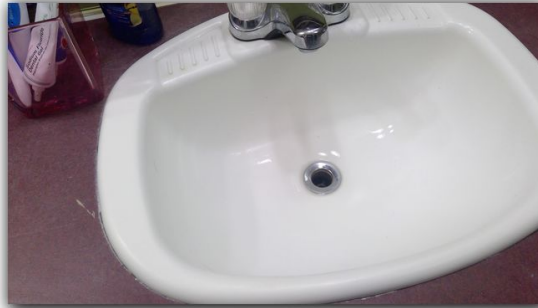
- Sink stopper missing or damaged in primary bath sink right side

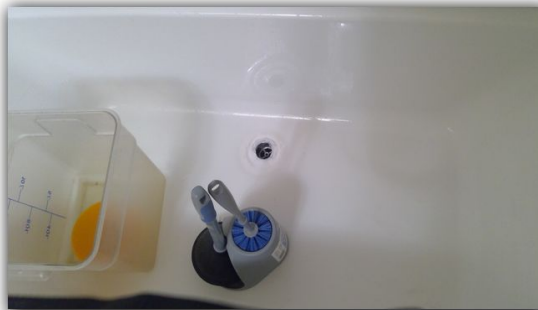
- Drain stop inoperable in hall bathroom tub.

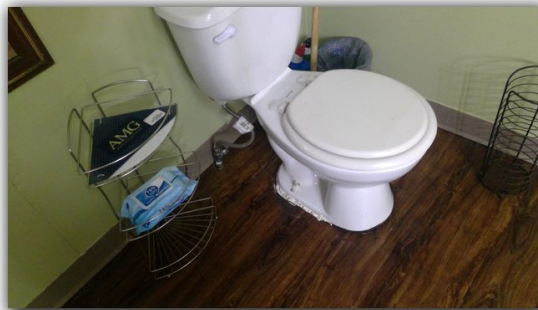
- Loose toilet at floor mounting in primary bathroom.

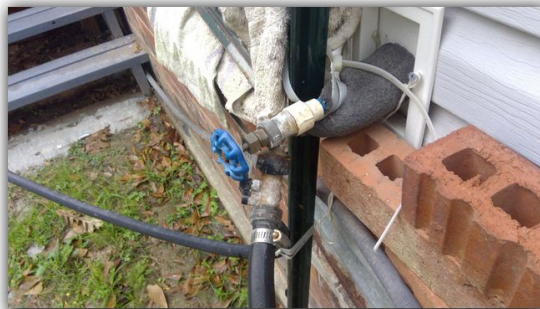
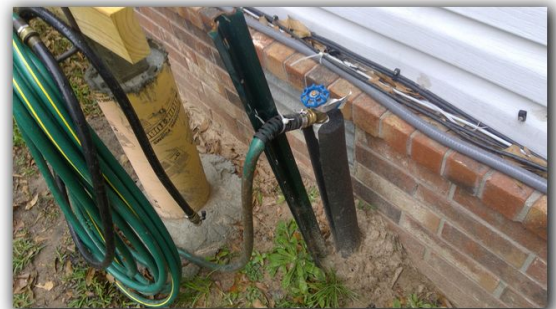
- Exterior hose bibs do not have back-flow prevention at one or more exterior hose bib locations.

Would recommend that a licensed and / or qualified contractor be consulted to make any further recommendations and / or repair

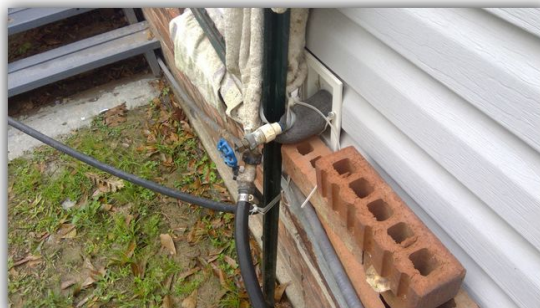
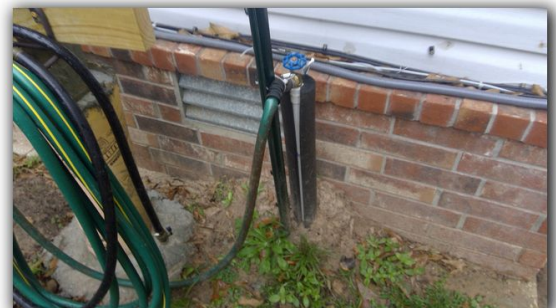
- Proper insulation needed on exterior exposed water lines / plumbing

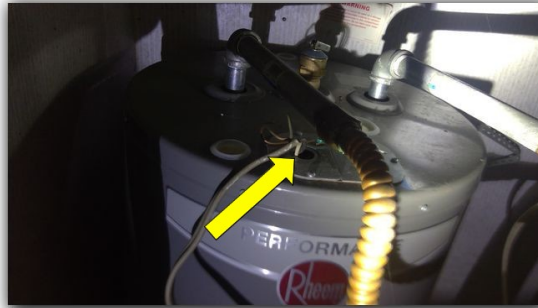
- Lack of pan and drain system/improper termination of water heating equipment.
- Wiring clamp / bushing needed at wiring entrance at the water heating equipment.

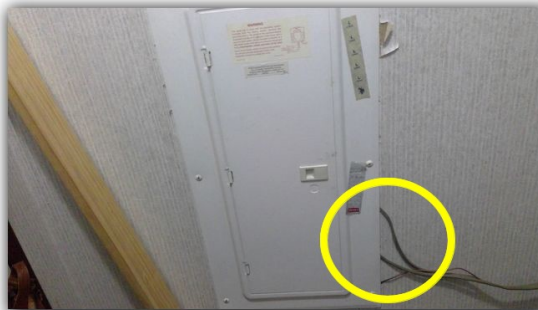
- Water heater electrical connection is not professionally installed per usual and customary building practices and is unsafe in current condition.

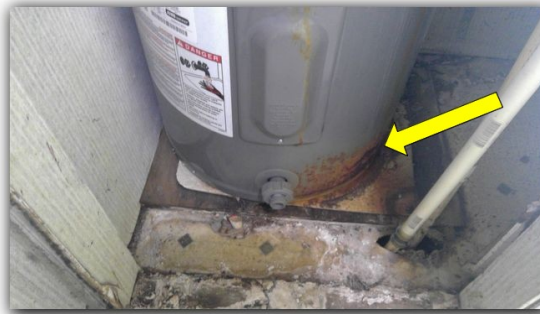
- Water heating unit appeared to be leaning and did not appear to be supported properly.
- Water leaking evidence observed around the water heating unit.

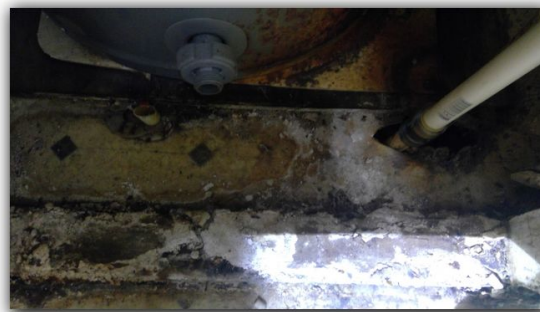
Leakage / Floor rot observed around water heater and water heater appears to be in danger of collapsing through the floor.

Inspection of water heating equipment was limited due to inadequate access and wood rot damaged flooring.

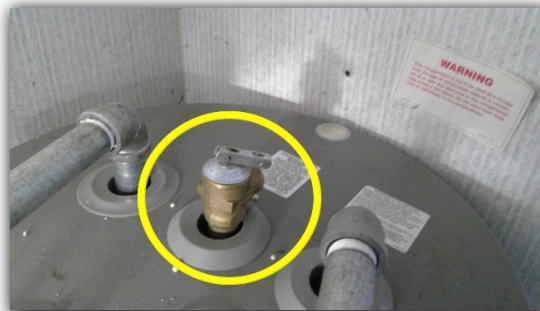
Water heater T & P valve piping does not have proper termination per current code.

Would recommend that a licensed and / or qualified contractor be consulted to make any further recommendations and / or repair

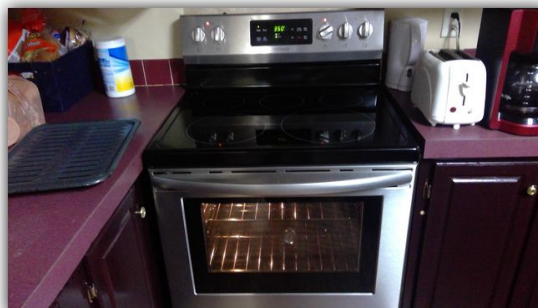
Absence of anti-tilt device observed at range per current standards.

Would recommend that a licensed and / or qualified contractor be consulted to make any further recommendations and / or repair

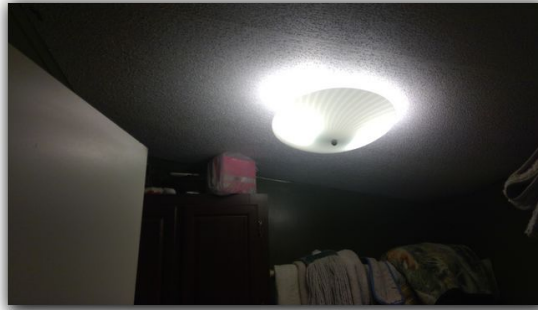
- Lack of exhaust ventilator where required by current code. See utility room (no ventilator present and no openable window present).

Would recommend that a licensed and / or qualified contractor be consulted to make any further recommendations and / or repair

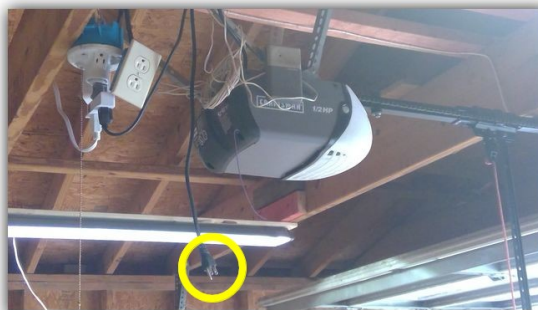
Garage door operator was not plugged in / hooked up / connected and could not be inspected

Would recommend that a licensed and / or qualified contractor be consulted to make any further recommendations and / or repair

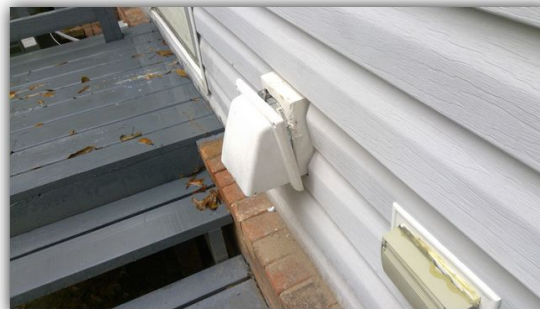
Dryer vent cover is not properly mounted to the exterior wall

Would recommend that a licensed and / or qualified contractor be consulted to make any further recommendations and / or repair
