REDFISH INSPECTIONS LLC

TREC REI 7-6 - REDFISH

5302 Blue Cypress Ln  
League City, TX 77573

# PROPERTY INSPECTION REPORT FORM

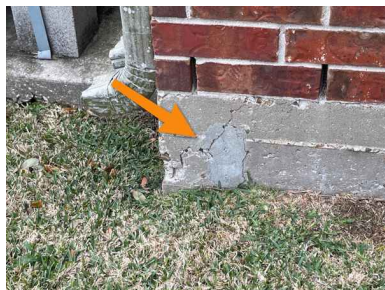
Example Right

Corner cracks were noted on one or more corners of the foundation. Corner cracks are generally caused by the early removal of form boards and/or improper flashing installation between the slab and the brick veneer/stone veneer. **No structural defect was noted with this condition**. We recommend having these cracks patched/sealed to minimize the opportunity of insect infestation.

No Issue. No action taken.

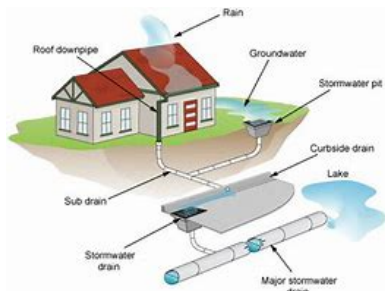
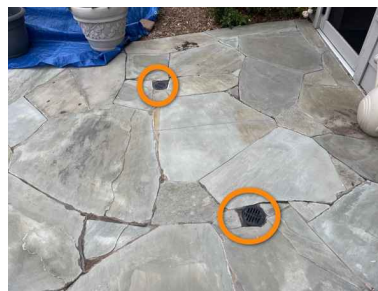
Rear

There is a sub surface draining system around this home. It is unknown whether the drainage system works properly and will be only really be evident when there is a good rain. If the drains are having problems when it rains we recommend that you have a plumber come out and clean out the drain lines.

Deck drains work properly. No Issue. No action taken.

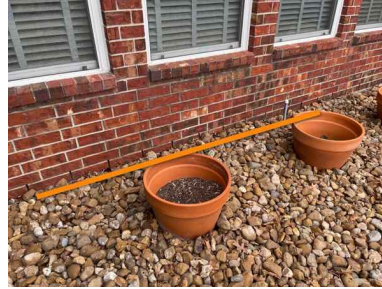
Example Rear

High elevation of grading/soil was noted. The grading should be improved by the removal of top soil. The ground should slope away from the house at a rate of one inch per foot for at least the first ten feet. Ideally, at least eight (8) inches of clearance should be maintained between soil level and the top of the foundation walls.

6" river rock provides unobstructed drainage away from foundation wall. No Issue. No action taken.

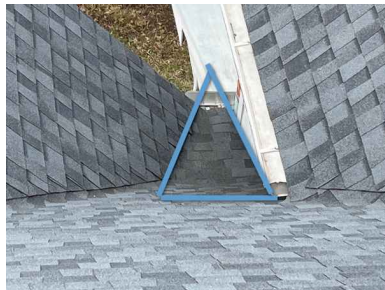
Example Front

The design of the roofing system was such that one or more vulnerable areas existed. There is a higher potential for unanticipated repairs. Annual inspections and ongoing maintenance will be critical to the performance of the roofing system.

Roof was replaced and inspected 3.5 years ago. No issues were noted in this region with the original roof installation, and none is expected with the recent re-roof. No Issue. No action taken.

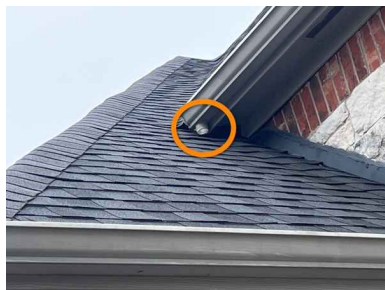
Example Front

One or more downspouts terminated above roof surfaces rather than being routed to gutters below or to the ground level. This is very common, but it can reduce the life of roof surface materials below due to large amounts of water frequently flowing over the roof surface. Granules typically are washed off of composition roofing material as a result, and leaks may occur. We recommend considering having a qualified contractor install extensions as necessary so downspouts don't terminate above roof surfaces.

Roof was replaced and inspected 3.5 years ago. No issues were noted in this region with the original roof installation, and none is expected with the recent re-roof. No Issue. No action taken.

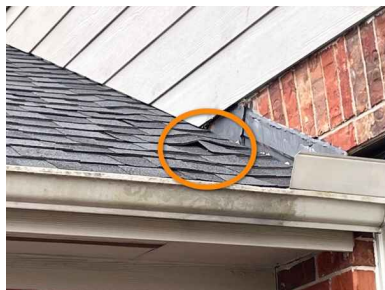
Example Right

Uplifted shingles were observed. We recommend having the fastener (nail) resecured and the shingles sealed down to prevent further uplift and potential damage.

RESOLVED  
Nail added.

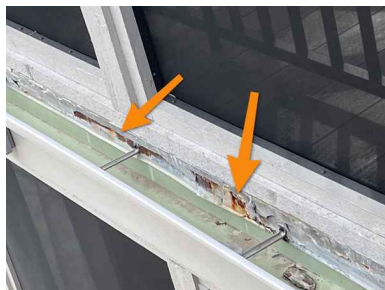
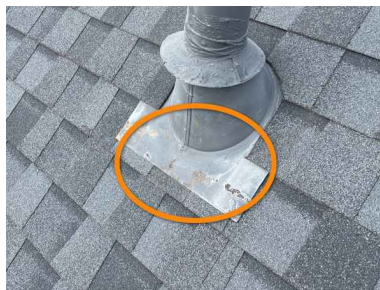
Corrosion was noted on one or more roof flashings. We recommend having these areas cleaned, treated and painted to prevent them from further deteriorating.

RESOLVED.  
Gas vent  
flashing replaced.

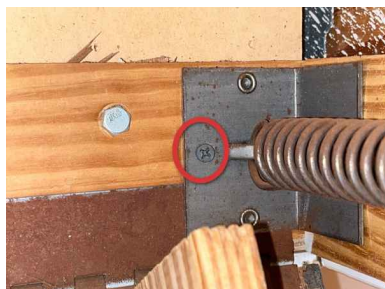
Improper fasteners (nails/screws) were use to secure the attic pull down stairs to the structure. 16d penny nails or 1/4" x 3" lag screws should be used. We recommend repair.

Photo shows required Lag Bolts (to the left of the red circle) securing pull down stairs to structure. No Issue. No action taken.

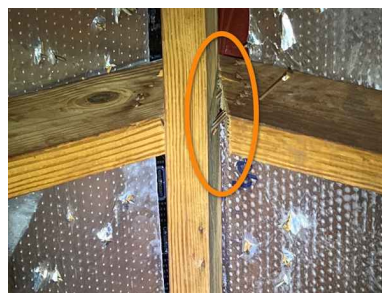
Example

Top of this one rafter is in contact with, and transferring loads to, the ridge board. Angle of this one board was not cut correctly during initial home construction. No Issue. No action taken.

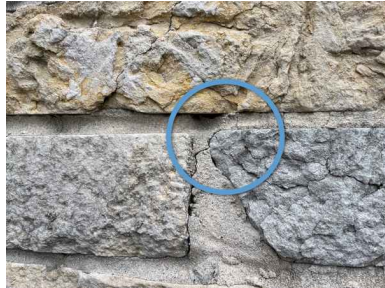
Example Front

A crack was noted in the brick veneer. This appeared to have been the result of thermal expansion. We recommend repointing to prevent further deterioration.

Insignificant crack in mortar. No Issue. No action taken.

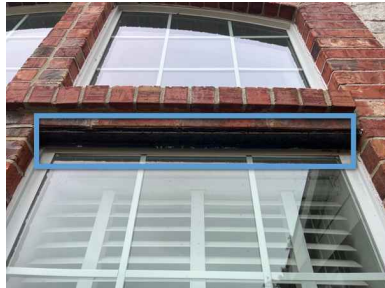
Example Front

The lintels over the openings (windows/doors) were found to be rusted. These elements support the brick veneer above the openings. We recommend having them (re)ainted to prevent deterioration.

RESOLVED

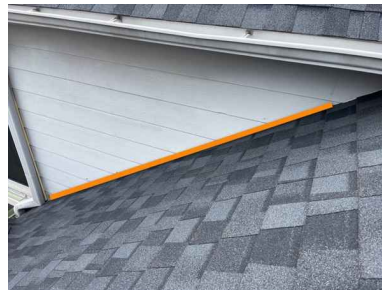
Example Rear

The siding touched the roof line. This can allow the siding to wick up moisture which can lead to moisture damage. The siding needs to be elevated at least 1 inch above the roof line. When corrected, moisture damaged siding and/or sheathing panels may need to be repaired or replaced as well. Flashing in these areas could not be confirmed. This repair is typically performed during roof replacement.

**Metal flashing exists behind siding and roofing at this intersection. Hardie cement siding will not wick moisture. No Issue. No action taken.**

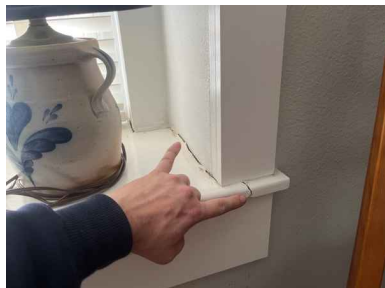
Example Bedroom 1

Separation was observed at the corners and/or baseboards in various areas throughout the structure. This could be indicative of structural/foundation movement or may be the result of regular settlement or improper installation. We recommend having these areas sealed and monitoring for additional signs of movement.

**RESOLVED**  
Cosmetic cracks repaired during interior repainting, March 2024

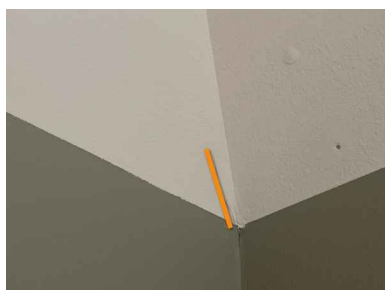
Example Game Room

Hairline cracks, which were by nature mainly cosmetic, were noted on the ceiling. We recommend having these caulked and painted.

**RESOLVED**  
Cosmetic hairline cracks repaired during interior repainting, March 2024

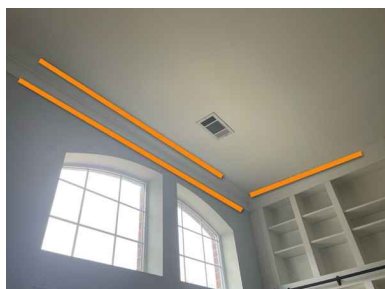
Example Front Room

Separation was observed at the crown molding and/or baseboards in various areas throughout the structure. This could be indicative of structural/foundation movement or may be the result of regular settlement or improper installation. We recommend having these areas sealed and monitoring for additional signs of movement.

**RESOLVED**  
Crown moulding re-caulked repaired during interior repainting, March 2024

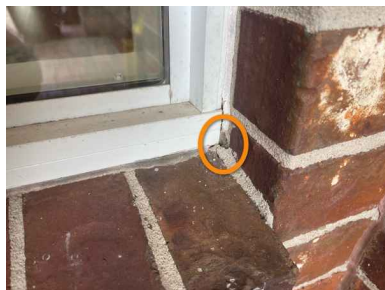
Example Front

Noted minor mortar crack is completely under cover of ground floor porch and not subject to moisture intrusion. No Issue. No action taken.

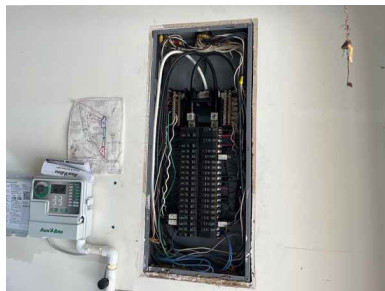
Sub panel - Cover off

**Check NEC. Outside Service Entrance fed directly into a non-main breaker panel does not constitute the breaker panel being a “sub panel” (with all the subsequent requirements for a sub panel).**

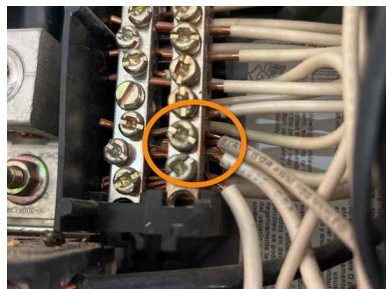
Sub panel

Multiple neutral at the neutral bar were under the same terminals. **Today's standards** require having each neutral conductor to have its own terminal. We recommend having this improved/repared.

This panel was installed per code when constructed and inspected. No action taken.

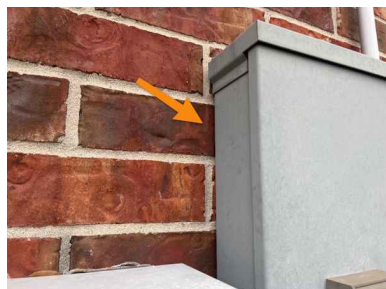
Service panel

We recommend caulking the top and sides of the subpanel to prevent moisture intrusion.

Exterior rated subpanel does not require additional caulking to prevent water intrusion. No Issue. No action taken.

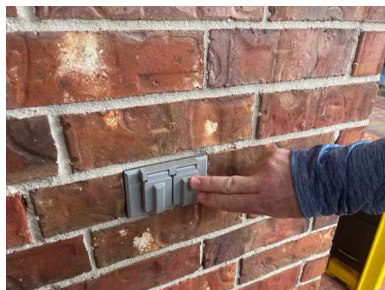
Example Front

**Today's standards** require having a bubble cover on all exterior receptacle outlets exposed to the elements. We recommend making the upgrade.

Outdoor outlet was installed per code when constructed and inspected by City. No action taken.

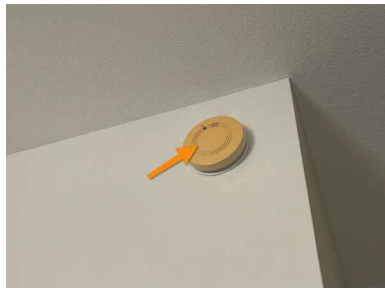
Example

One or more smoke and/or carbon monoxide detectors appear to be outdated. Smoke and carbon monoxide detectors have a reliable lifespan of 10 years. Recommend replacing.

**RESOLVED**  
All smoke detectors replaced by current smoke/carbon dioxide detectors

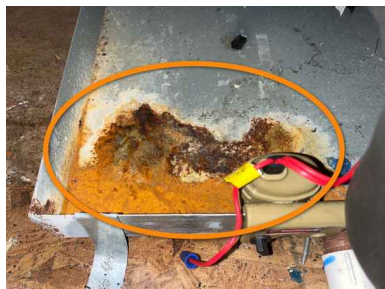
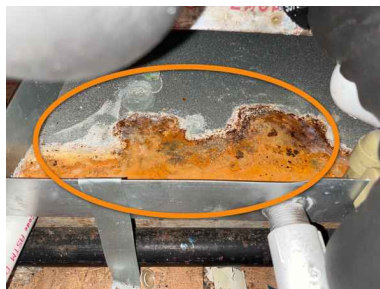
The condensate drain pan was rusted. This indicates that there has been a failure in the primary condensate drainage system at some point in time. This may or may not have been corrected. There is potential for extensive ceiling damage if this pan overflows. You should have a qualified HVAC contractor repair or replace the condensate drainage system.

Condensate drain system replaced in 2018/2020 and tested semiannually. No Issue. No action taken.

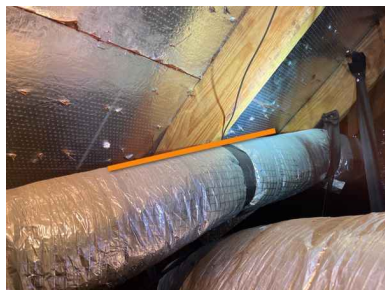
Example

Air ducts were placed on the attic floor or otherwise in contact with the roof structure. **Today's standards** do not allow this practice anymore as thermal bridging could create condensation inside the ductwork. We recommend having these strapped/elevated from the floor or separated from the structure by insulation.

**Ductwork installed per code when constructed and inspected by City. No action taken.**

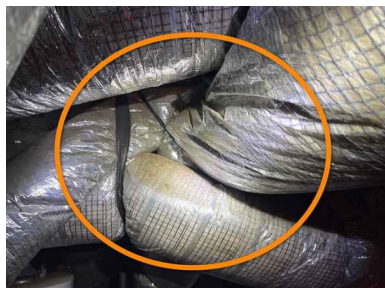
Example

Multiple air ducts were found to be in contact with one another. **Today's standards** do not allow this practice anymore as thermal bridging could create condensation inside or between the ductwork. We recommend having the ducts strapped and separated.

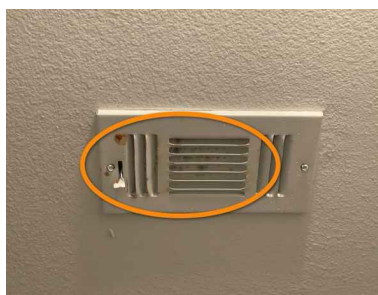
Example Bathroom 3

**RESOLVED**  
Air vents cleaned or replaced

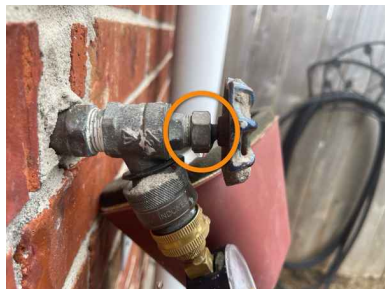
Example Right

A leak was noted at a hose bibb valve when turned on. We recommend having this repaired.

**RESOLVED**

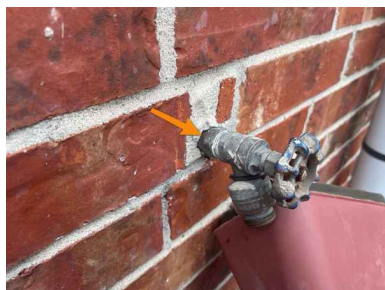
Example Right

Today's standards require plumbing distribution lines to be protected at all wall protrusions by a sheathing/insulation to prevent pipes from bonding to the mortar. No indication of moisture damage was noted on the inside of the structure in these areas. It may not be cost effective to add this level of protection at this point in time. We recommend monitoring these areas on the interior.

Hose bibbs have performed well for 20+ years. Plumbing installed per code when constructed and inspected by City. No action taken.

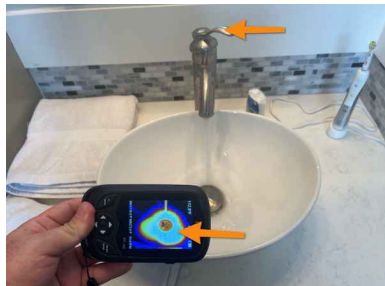
Example Bathroom 1

The hot/cold plumbing was reversed. This can be a scalding hazard. We recommend having this repaired/improved.

No Issue. No action taken.

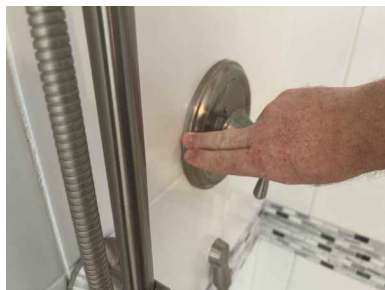
Example Bathroom 1

All shower and bathtub handles, faucets, spouts and shower heads should be caulked at the wall. Be sure to caulk any gaps that may appear between the hardware & tile of the fixtures or shower enclosures. Most tile surfaces will have gaps in the grout that can also allow for water penetration past the tile work. A leak in any one of these areas can cause concealed structural damage that would not be obvious in a visual inspection.

High end shower fixtures feature integral seals to negate unsightly caulking. No Issue. No action taken

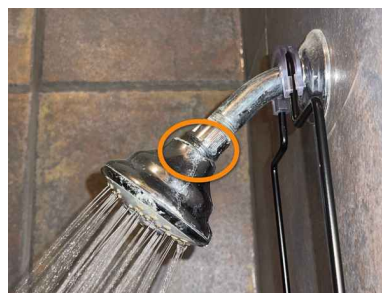
Example Bathroom 3

RESOLVED  
Shower head tightened

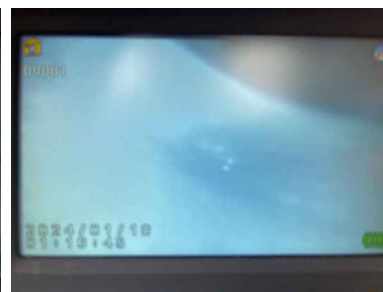
General view obstructed by water

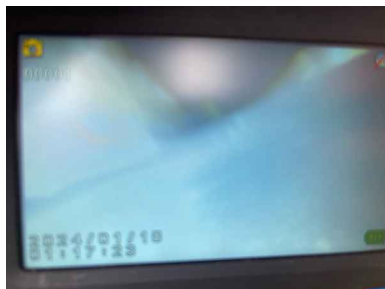
General view obstructed by water

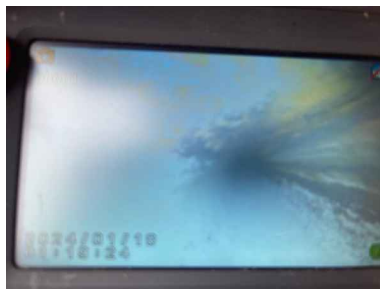
End of scope due to bends in line

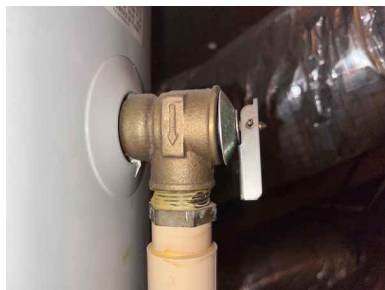
**1: Corroded fittings**

Pipe fittings at the water heater were corroded. We recommend having these repaired.

**RESOLVED**  
Gas water heaters, relief valves and pipe fittings replaced February 2024.

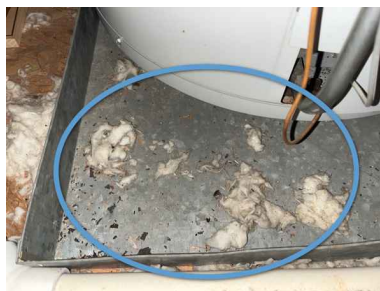
Unit 2

It is not uncommon for insulation or other debris to enter into the drain pan. We recommend to clean drain pan upon move in and then reinspect annually.

**RESOLVED**  
All drain pan debris removed when gas water heaters were replaced February 2024.

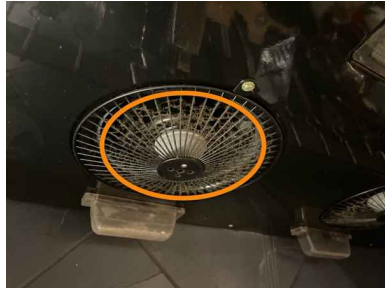
The exhaust fan filters needed cleaning at the time of the inspection.

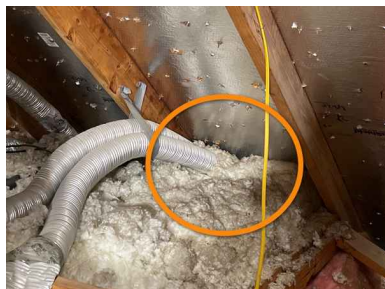
Example

The bathroom exhaust vent terminated in the soffit at the roof eaves. This condition is improper and could introduce excessive amounts of moisture to the attic space. Excessive moisture deposited into the attic may result in damage to home materials from decay or encourage the growth of microbes such as mold. Exhaust vents should terminate at the home exterior. We recommend correction by a qualified contractor.

**Bath exhaust vents terminate at roof eave soffit. No issues noted for 20+ years. No action taken.**

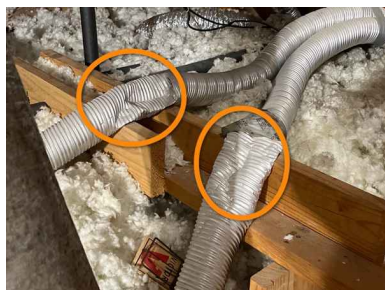
Example Walk-in attic

A bathroom vent duct was found to be crimped. We recommend repair to allow proper ventilation of the warm moist air to the exterior. This was noted in the attic.

**RESOLVED  
Crimps removed from ducts**

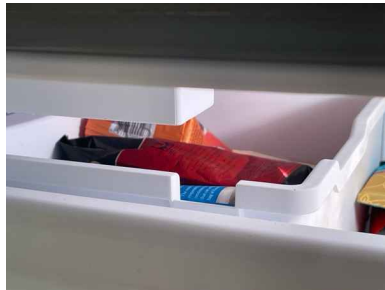
**1: Ice or water dispensor not working**

Water inlet to ice maker frozen. Will require defrosting of freezer to resume operation. No action taken.

Recommended to repair.

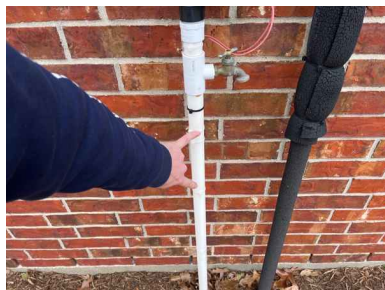
Left

Pipe insulation improvement needed. Repair as needed.

Pipe is insulated on supply side of vacuum breaker to inlet supply valve. During freezing weather the water supply would be shut off here (or at the sprinkler main valve in the front yard) so insulation downstream of the shutoff valve is not needed.

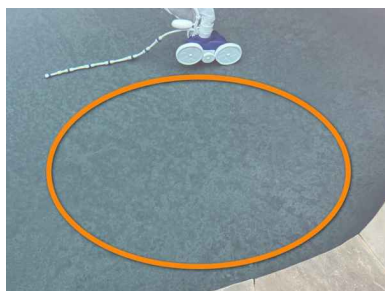
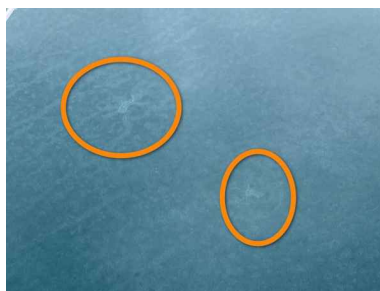
Example

**1: Condition: Poor Surface Condition**

The Pool Wall Surface was somewhat aged/deteriorated at the time of inspection. We recommend consulting with a Qualified Pool Contractor to discuss options for repairs or re-surfacing before the end of your inspection deadline.

Pool plaster is a premium Diamond Brite product that produces a mottled, natural looking pool surface. No action taken

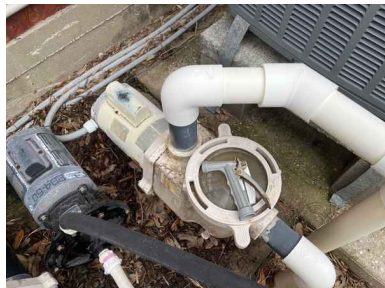
The seller informed us that the water feature pump was not properly operating. Water features were not tested. We recommend repair.

**RESOLVED**

Water feature pump replaced March 2024 and water feature fully functional.

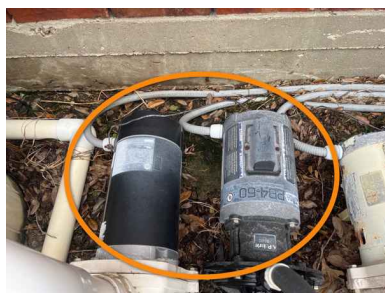
The Pool Filter and cleaner Pumps had visible rust/corrosion at the time of inspection. Although they were operational at the time of inspection, these are visual signs that the pool pumps will need to be replaced.

Pool pump motors have been replaced every 3-5 years due to normal wear. No Issue. No action taken.

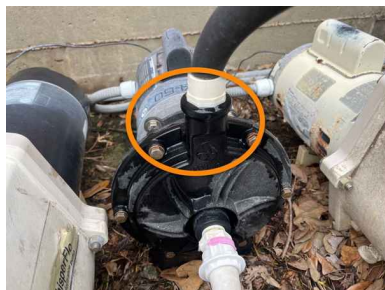
A connection at the Pool Cleaner Pump Leaked at the time of inspection. We recommend to inspect and repair as needed.

A few drops of water from the pool equipment is expected in normal operation. No Issue. No action taken .

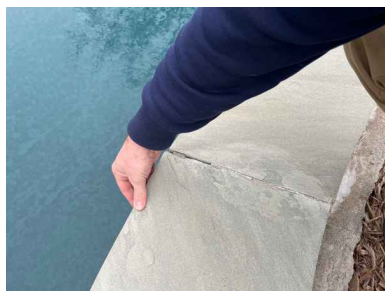
8: Coping Loose

Loose pieces of coping were found. Recommended that it be repaired.

RESOLVED  
Loose coping re-attached
