MECHANICAL INSPECTION

PROPERTY INSPECTION REPORT

Concerning: 10818 Moonlight Dr, Houston TX 77096
(Address or Other Identification of Inspected Property)

By: Daniel Koteles - TREC #21157 08/31/2021 9:00 am
(Name and License Number of Inspector) (Date)

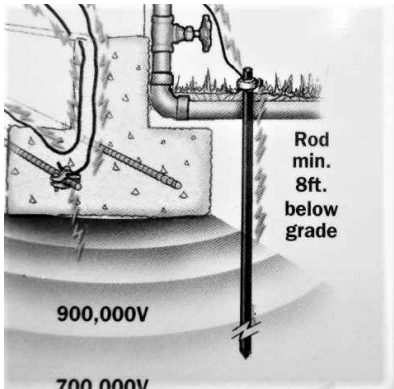
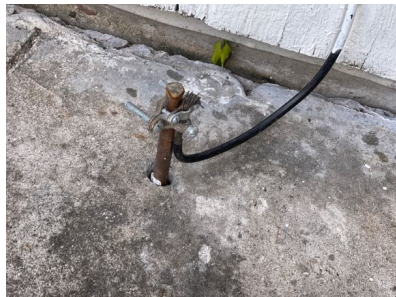
The ground rod was sticking out of the ground a few inches, and, since ground rods are typically 8 feet long and all 8 feet of the rod are required to be in the ground, it is recommended that the ground rod be pounded down flush with the top of the ground. The clamp on the rod should be an acorn clamp is approved for direct burial in the ground.

Obtain Cost Estimate

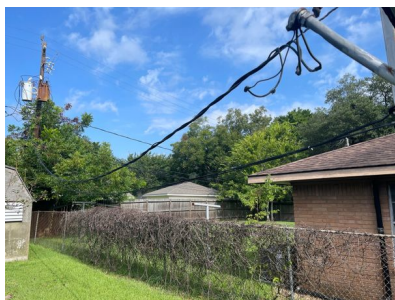
The service entrance conductors were observed to be too low and need to be raised. When this house was built, the lowest point of the incoming service was required to be a minimum of 8 feet above grade. The lowest point of the service was observed to be approximately 7 feet. Therefore, the service will need to be raised, and since the current electrical code requires the lowest point to be a minimum of 10 feet above grade, then it is recommended that the service be raised to meet the current minimum standard.

Obtain Cost Estimate

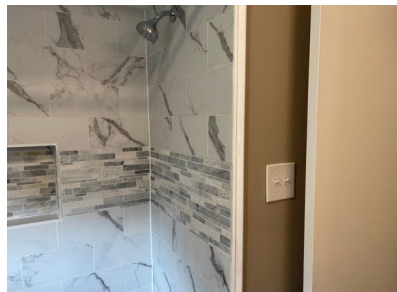
A light switch was located within three feet of the tub/shower. The light switch can be operated while standing in the tub/shower, which can be a hazardous condition. While it is not required by the National Electrical Code, we recommend for general safety purposes that the light switch either be moved further away from the tub/shower, or protected by a Ground Fault Circuit Interrupt device.

Obtain Cost Estimate

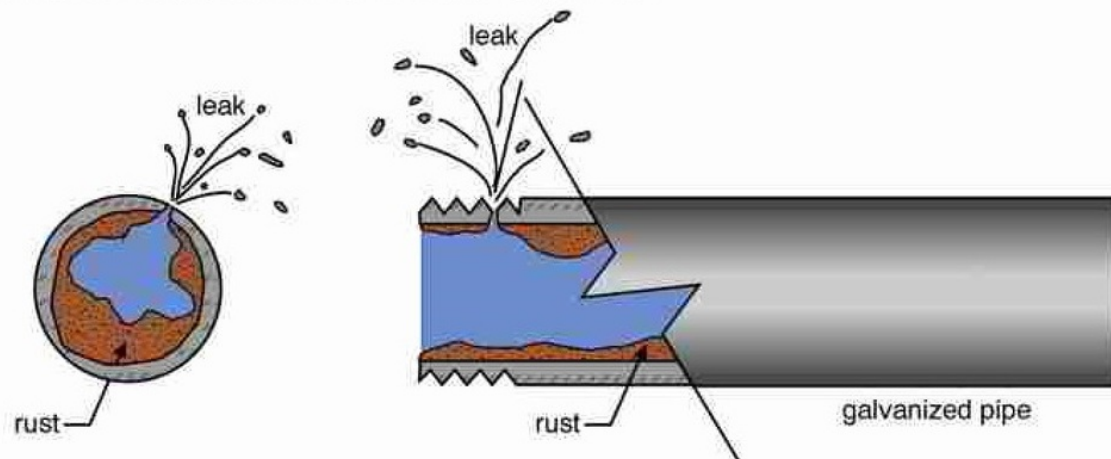
Water Supply Piping - Galvanized Steel:

All or portions of the water piping for the property was observed to be the original galvanized piping. It is pointed out that the galvanized piping will deteriorate with time, and will corrode on the inside of the piping, thereby reducing the inside diameter of the pipe, and restricting the flow of the water through the pipe. In addition, the piping will corrode through to the outside of the pipe and will eventually deteriorate to where the pipe will start leaking. It can be anticipated that the galvanized water piping

rusting of galvanized pipe can greatly reduce water pressure and will eventually cause leaks as rust creates holes in the pipe walls

problems are likely to occur soonest on pipes carrying hot water, horizontal pipes and at threaded (thinner) sections

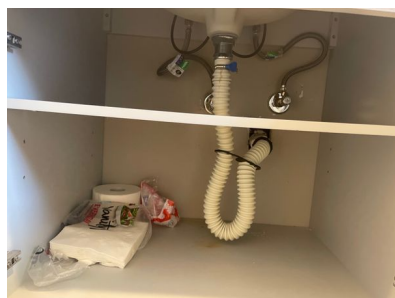
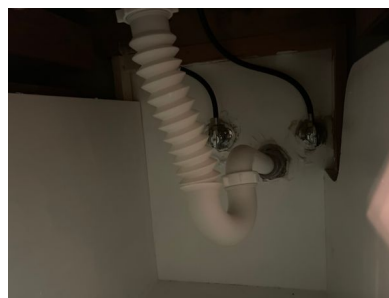
Bellows piping was used on a portion of the drain piping. In the plumbing industry the use of bellows piping is considered amateur workmanship as bellows piping is prone to frequent clogs. Consideration should be given to replacing the Bellows piping.

Obtain Cost Estimate

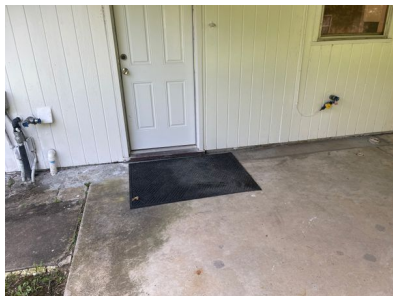
Sewer Piping - Some new PVC:

We observed new PVC drain line and sewer piping at the rear of the house at the kitchen and the utility room area. Apparently, the original cast iron sewer piping has been replaced at these areas. It is recommended that further investigation be done with the homeowner and a plumber to determine if any of the original underground cast iron sewer piping is still active. If portions of the original cast iron piping are still present, it can be anticipated that the cast iron will rust out at some time, and will then need to be replaced with PVC sewer piping. Consideration should be given to having the underground sewer piping checked by a plumber to determine if all of the cast iron has been replaced, to determine the quality any repairs that were made, and to determine if any additional repairs are needed.

Further investigation is recommended with a plumber

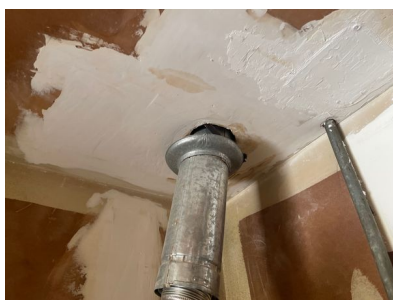
The vent flange was loose at the ceiling and needs to be secured.

Obtain Cost Estimate

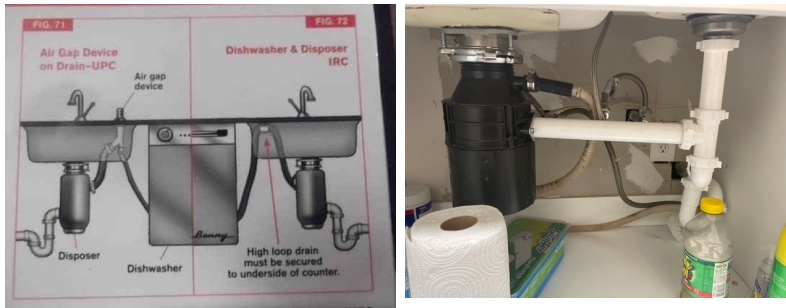
The drain line under the sink was not equipped with an anti-siphon device, nor was it looped up so that the top of the loop is at least six inches above the entrance of the drain line into the disposal. It is recommended at least that the drain line be looped to prevent the water from the garbage disposal from siphoning back into the dishwasher, or an anti-siphon device installed.

Obtain Cost Estimate

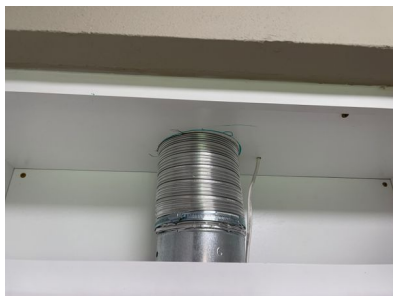
One or more sections of the vent pipe for the equipment was a flexible vent material, rather than rigid sheet metal vent pipe. An approved sheet metal vent pipe is required. Flexible vents can allow a buildup of grease in the joints of the flex duct, which is a known fire hazard.

Obtain Cost Estimate

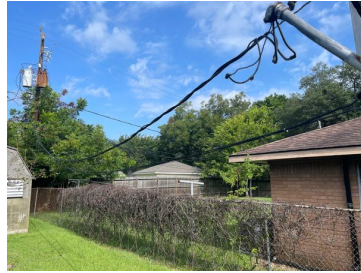
The service entrance conductors were observed to be too low and need to be raised. When this house was built, the lowest point of the incoming service was required to be a minimum of 8 feet above grade. The lowest point of the service was observed to be approximately 7 feet. Therefore, the service will need to be raised, and since the current electrical code requires the lowest point to be a minimum of 10 feet above grade, then it is recommended that the service be raised to meet the current minimum standard.

Obtain Cost Estimate
E3504.2.2

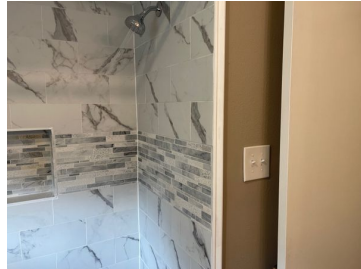
A light switch was located within three feet of the tub/shower. The light switch can be operated while standing in the tub/shower, which can be a hazardous condition. While it is not required by the National Electrical Code, we recommend for general safety purposes that the light switch either be moved further away from the tub/shower, or protected by a Ground Fault Circuit Interrupt device.

Obtain Cost Estimate

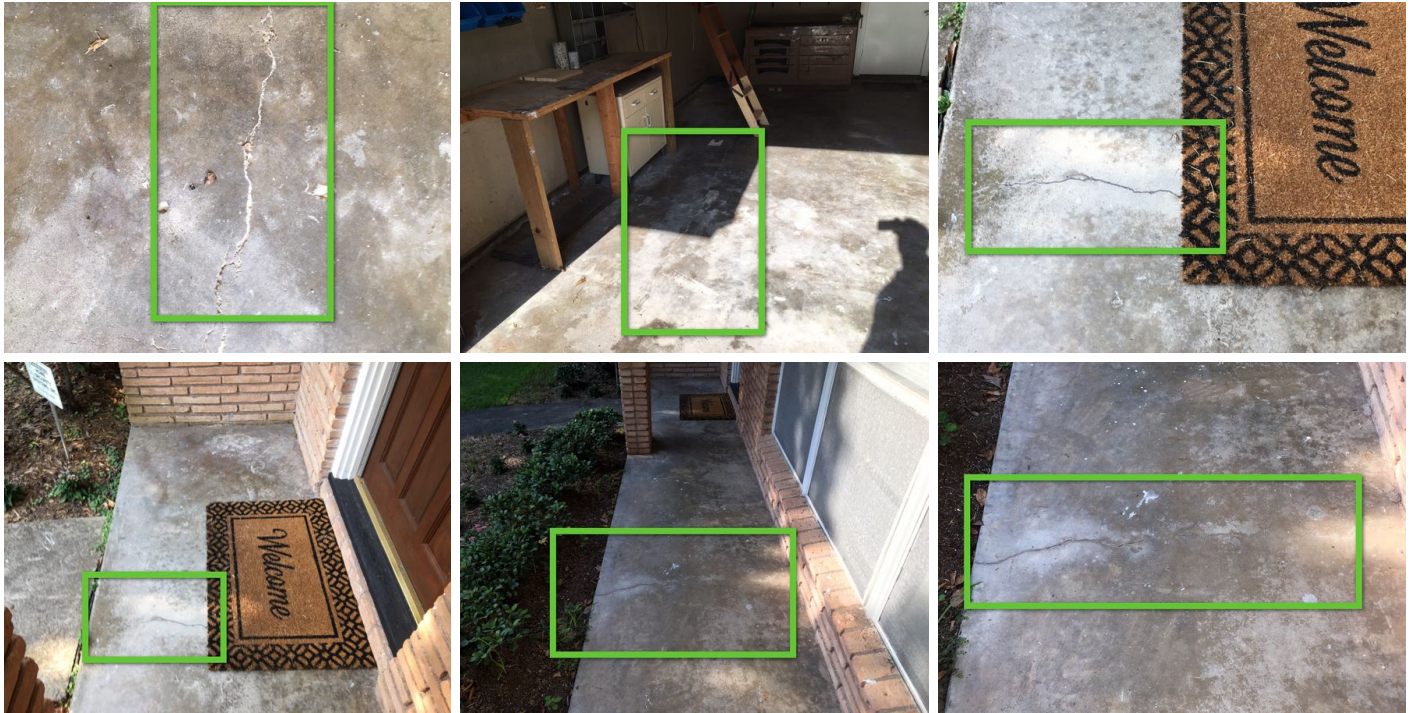
Concrete Cracks - Garage

Cracking of the foundation concrete exists in virtually all foundations. It is pointed out that cracking is a normal property of concrete and other brittle materials, and Hedderman Engineering, Inc. assumes no responsibility should cracks be found that are not mentioned in this report. Some cracking was observed in this concrete foundation, including at the front porch and the garage floor.

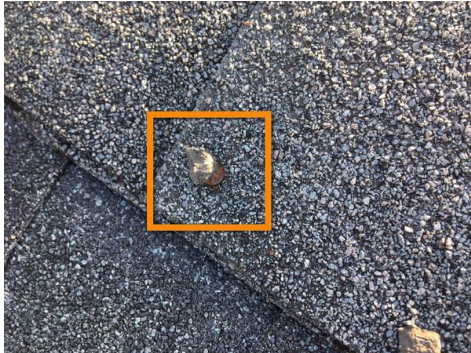
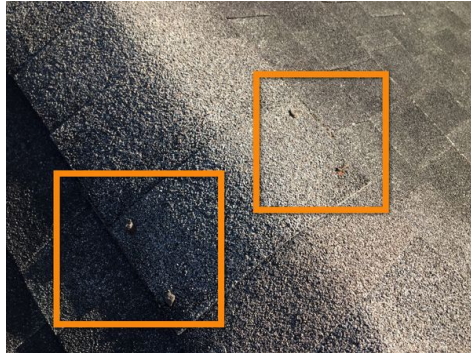
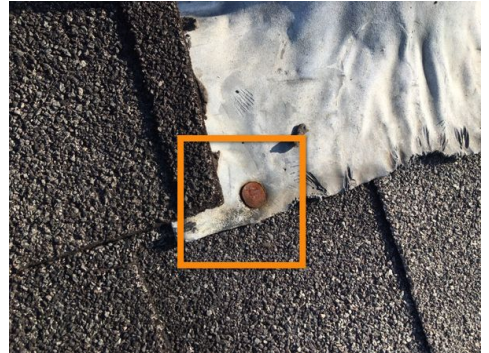
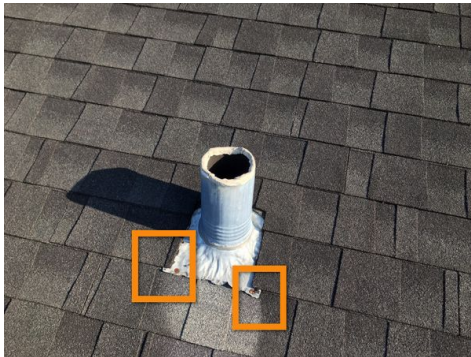
DETERIORATED/MISSING SEALANTS

We observed sealants that were cracked/separated/missing and repair is needed.

Contact a qualified professional.

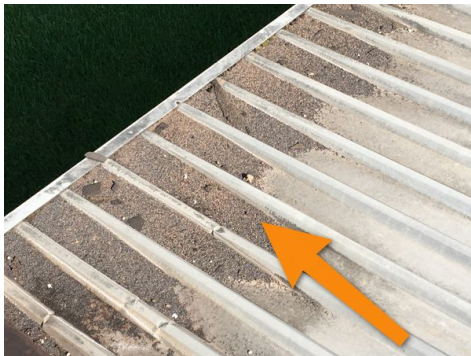
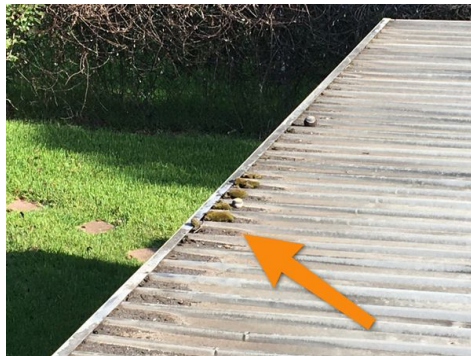
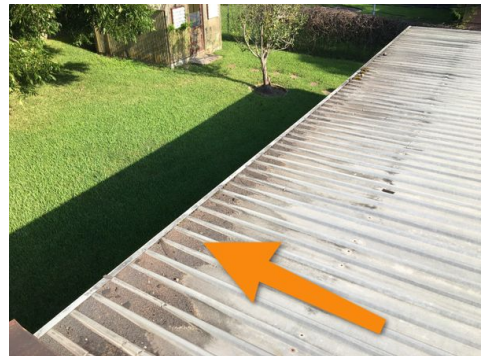
5.5.2 Roof Details

ROOF: MISCELLANEOUS

We observed some miscellaneous items related to the surface of the roof, including the items listed above. Have a roofing contractor provide a cost estimate to make any needed repairs.

Contact a qualified professional.

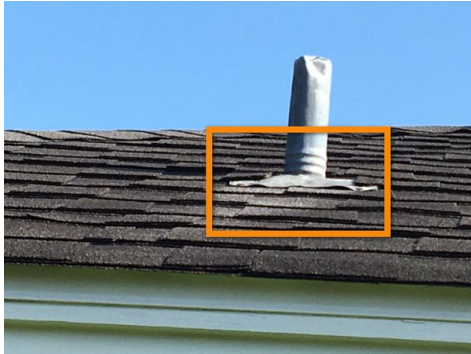
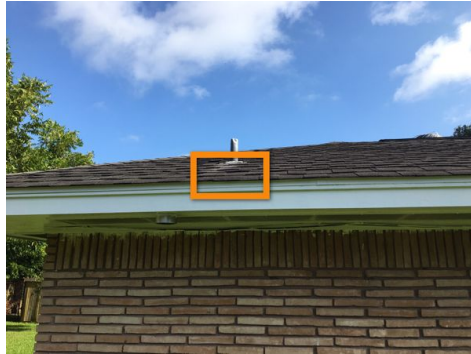
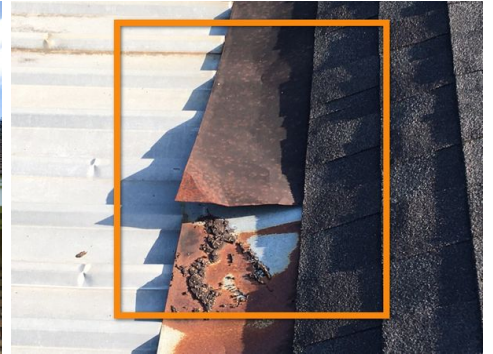
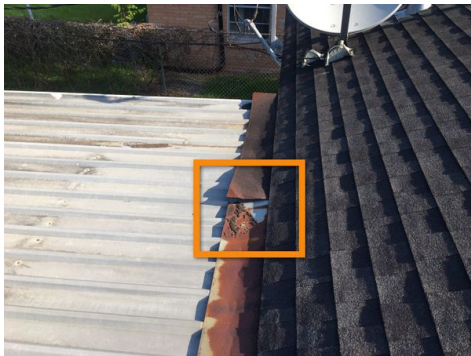
5.5.3 Roof Details

FLASHING/COUNTER FLASHING

We observed one or more conditions with the roof flashing as pointed out above. Have a roofing contractor provide a cost estimate to make all needed repairs

Contact a qualified professional.

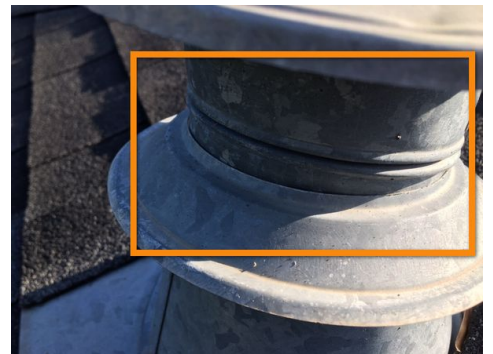
5.5.4 Roof Details

METAL VENT PIPES

Storm Collar Sealant Deteriorated

We observed metal vent pipe(s) that were in need of repair, including the conditions listed above.

Contact a qualified professional.

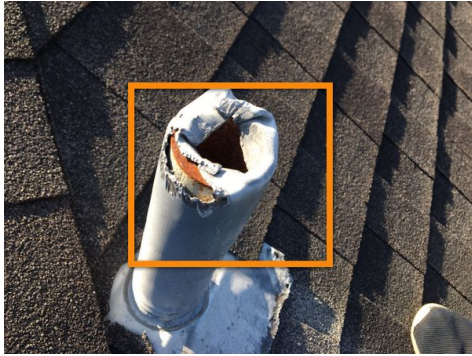
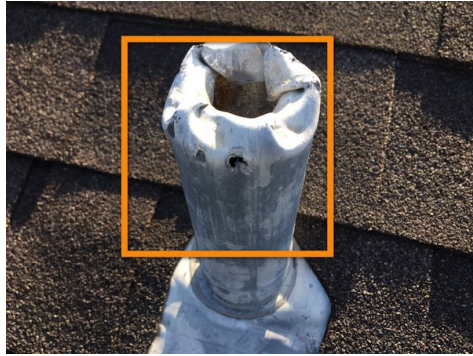
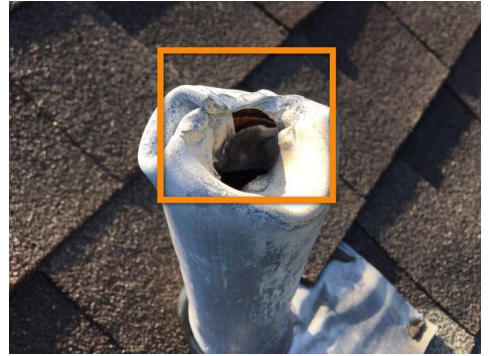
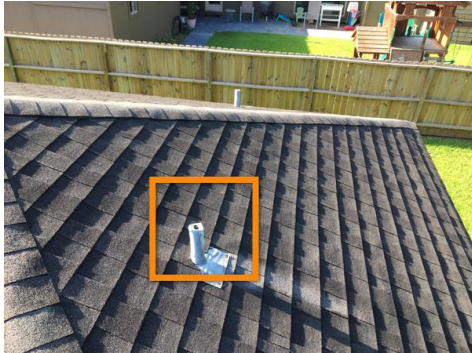
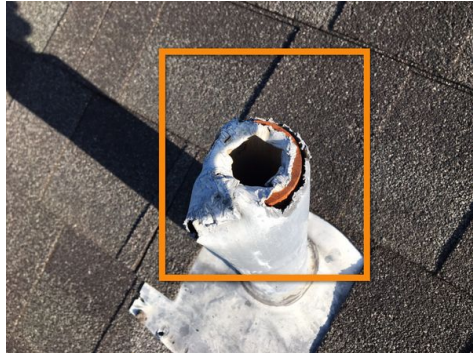
5.5.5 Roof Details

ROOF JACKS

Lead - Squirrel Damage, Lead - Not completely covering vent pipe

The roof jacks at the plumbing vent pipes were observed to have the conditions as described above. Further investigation with a roofing contractor is recommended to make all needed repairs.

Contact a qualified professional.

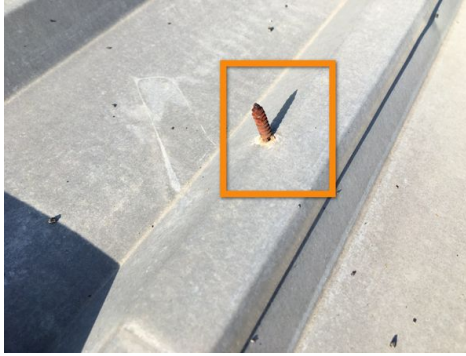
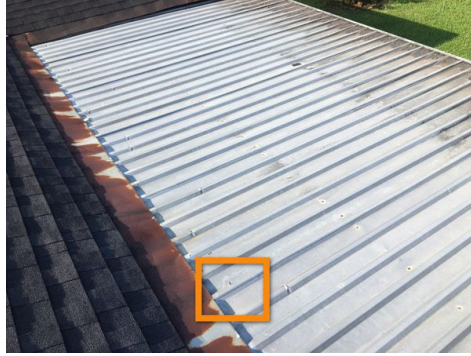
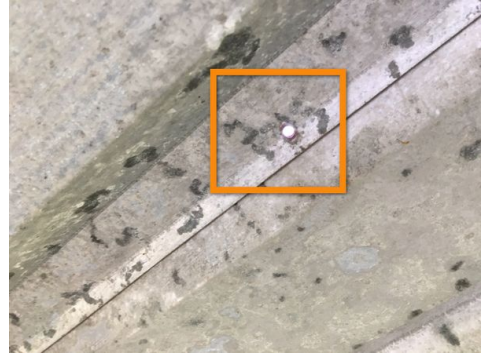
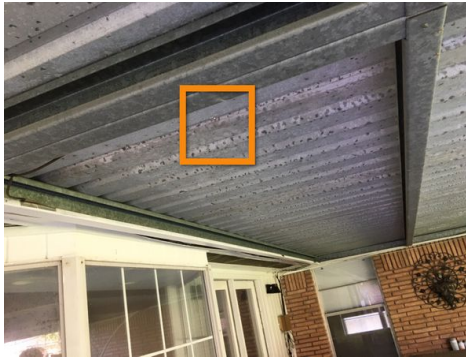
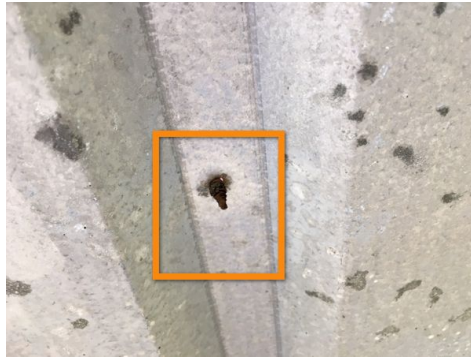
5.5.6 Roof Details

HOLES IN ALUMINUM ROOF

Some holes and non-sealed screws were observed on the aluminum roof. Contact a roofer to seal all the areas in need.

Contact a qualified professional.

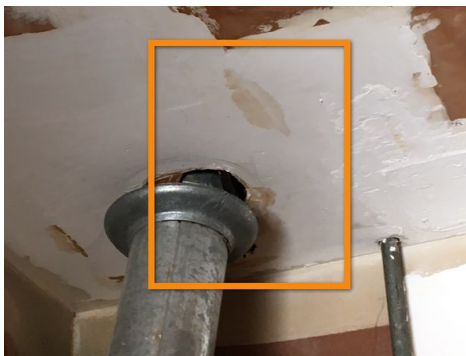
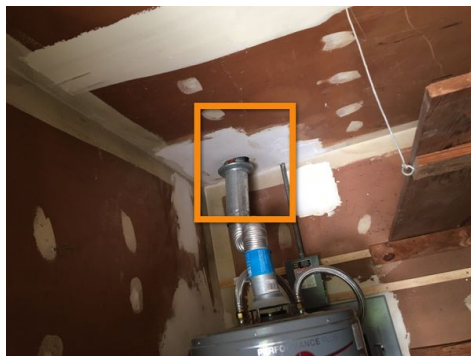
5.6.1 Roof Leaks

OBSERVED ON CEILING

After observing the interior of the structure, evidences of roof leaks were visible, where the ceiling was water stained. It is recommended that a roofing contractor be contacted to find the source of the leaks, and to make any needed repairs.

Contact a qualified professional.

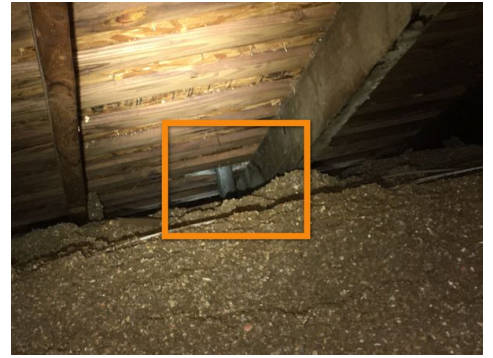
5.6.2 Roof Leaks

ATTIC ROOF DECKING AND/OR FRAMING MEMBERS

After observing the interior of the structure, evidences of roof leaks were visible in the attic, where the roof decking and/or roof framing members were water stained. It is recommended that a roofing contractor be contacted to find the source of the leaks, and to make any needed repairs.

Contact a qualified professional.

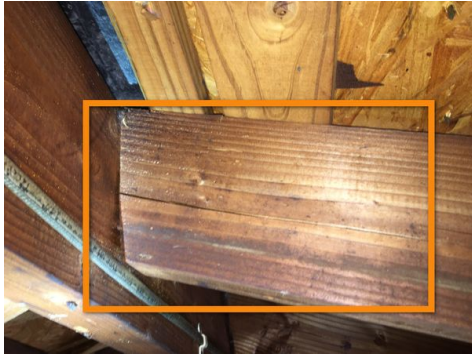
Center of the house

Some of the rafters in the attic were observed to be split, and need to be repaired.

Contact a qualified professional.

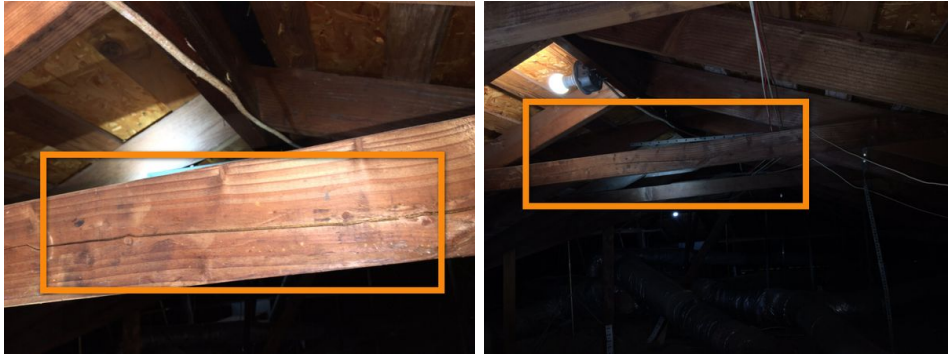
6.5.1 Purlins

REPAIR - PURLIN DAMAGED

One of the roof purlins was damaged and is in need of repair.

Contact a qualified professional.

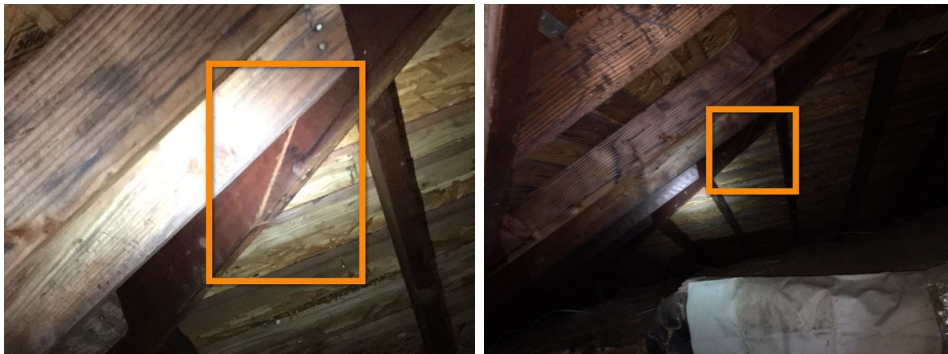
6.8.1 Hip rafter

REPAIRS - SPLICED, SEPARATED

The hip rafter was spliced and the two side of the hip rafter have separated and it is recommended that additional support be provided at the joint.

Contact a qualified professional.

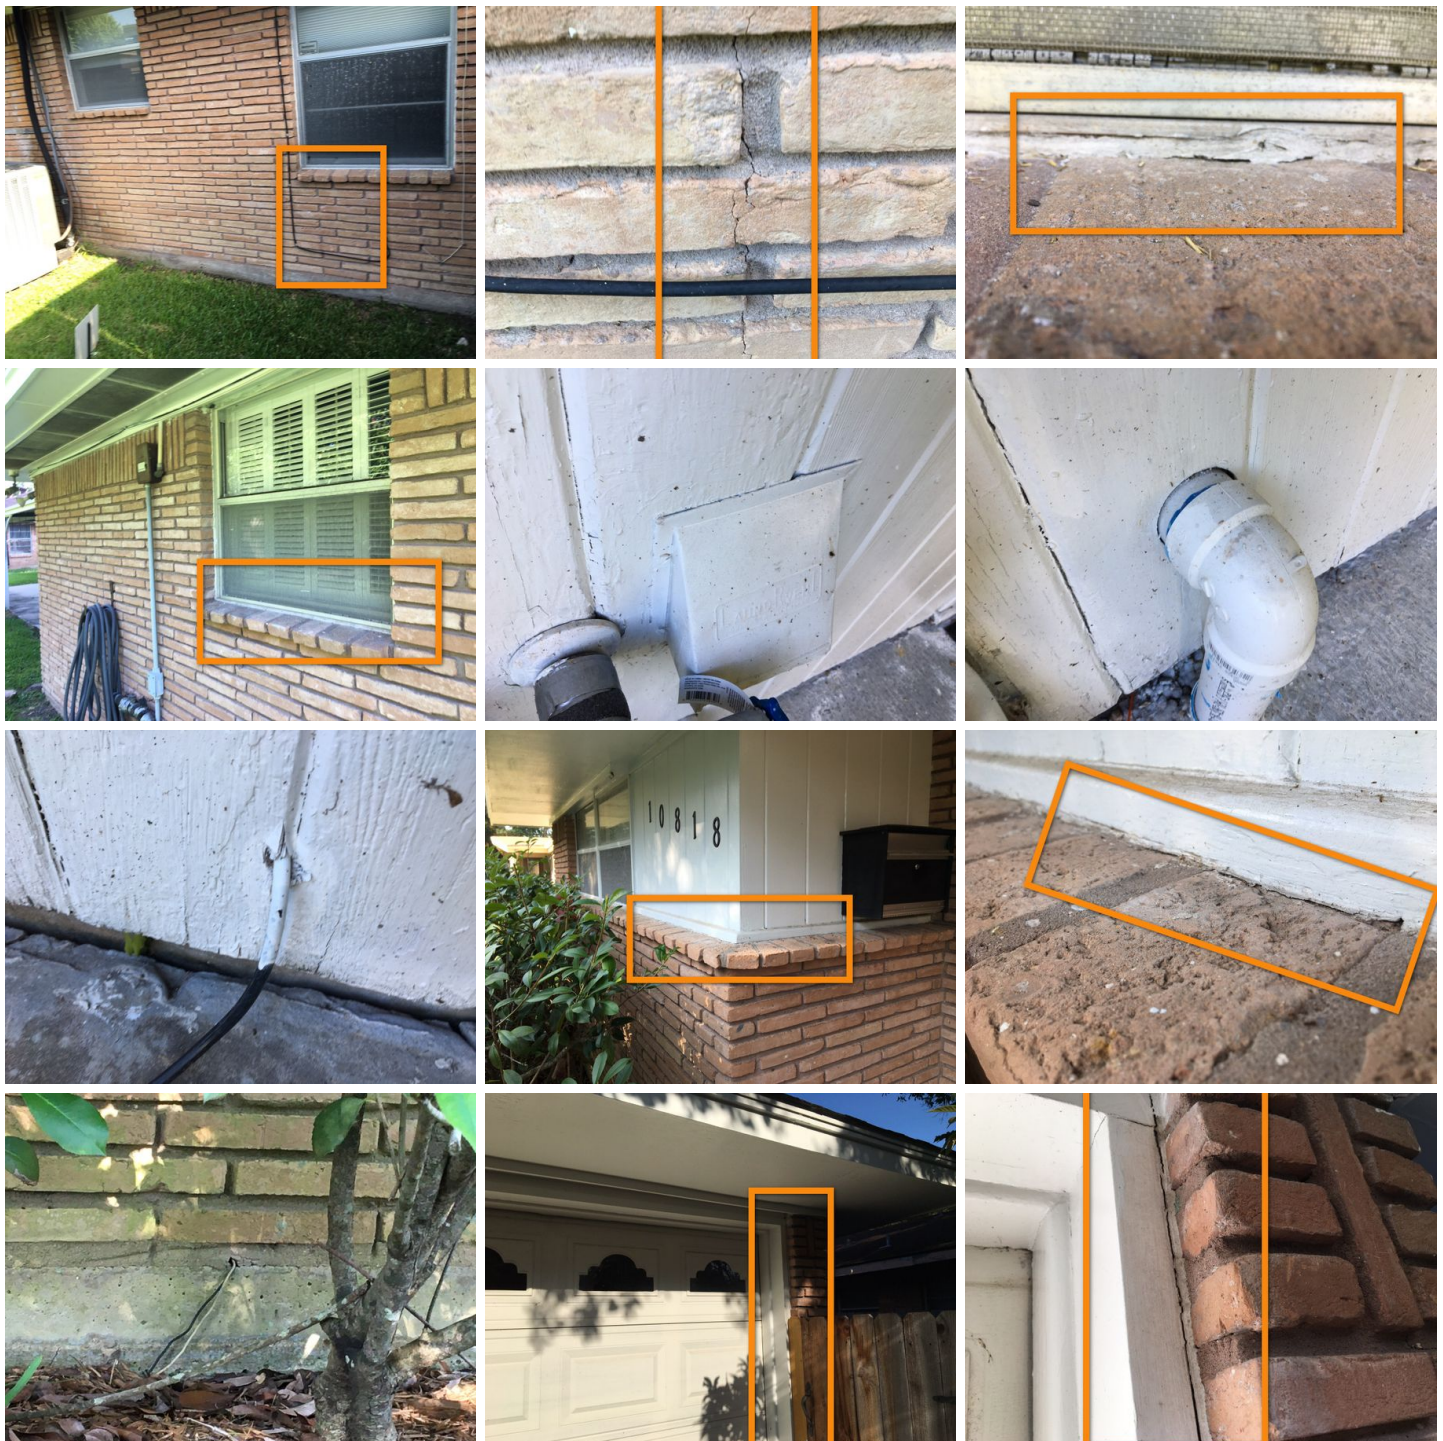
Sealants deteriorated/missing, Window sealants, Light Fixtures, Piping, Brick Veneer, Wires, Vent Caps

Contact a qualified professional.

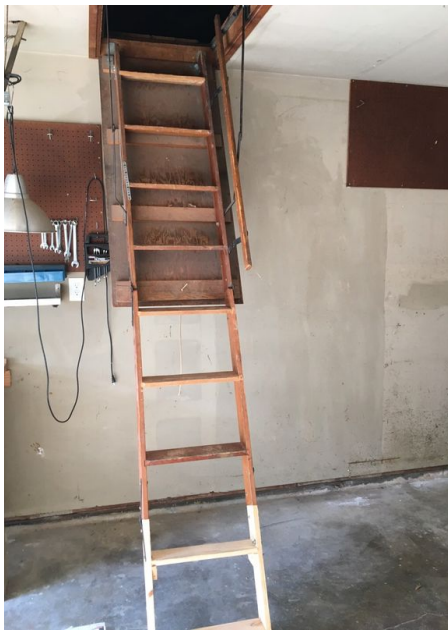
Ladder: Original ladder - Not rated

The access ladder into the attic appeared to be the original installation ladder, and the ladder was not labeled to indicate the rated capacity of the ladder. The ladder does not meet current code requirements for ladders into attics. Consideration should be given to replacing the ladder with a ladder that meets current code requirements.

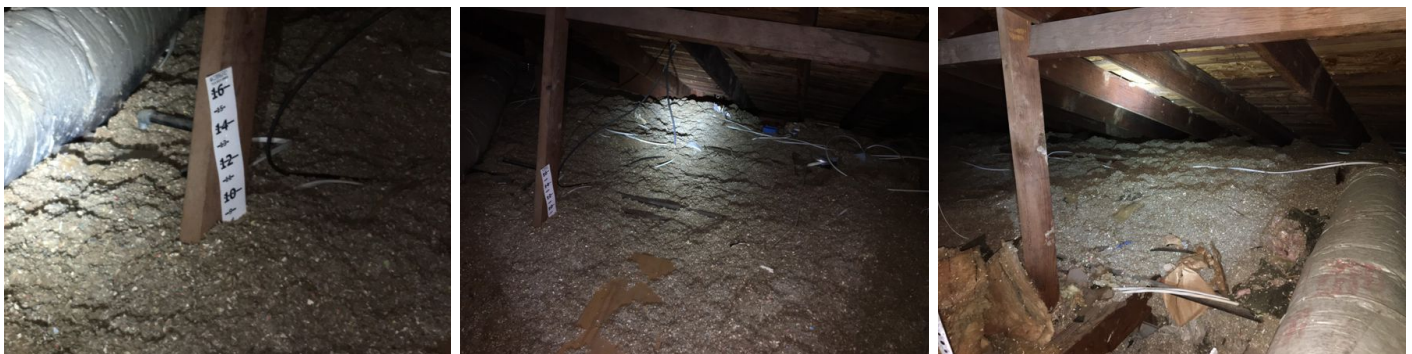
The insulation in the attic varied in thickness from approximately 4-5 inches to approximately 8-9 inches. It is pointed out that the normal amount of insulation for new houses in this area is currently an R38 energy rating, or approximately 14 inches of blown in fiberglass insulation.

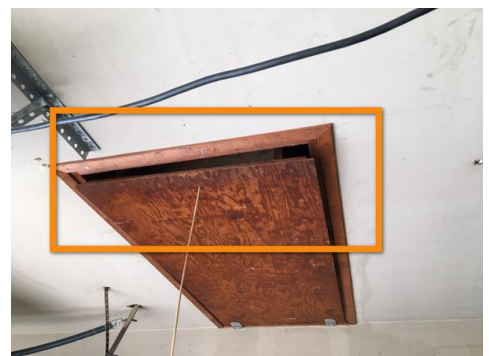
8.1.2 Ladder

LADDER NOT CLOSING PROPERLY

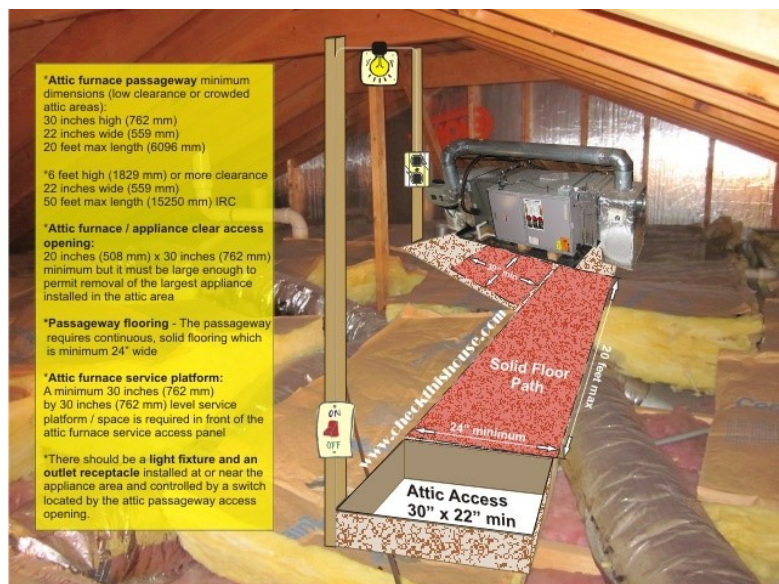
INADEQUATE WALKWAY DECKING

The attic did not have adequate service decking to all the equipment in the attic. The service decking should be a continuous deck that is a minimum of 24 inches wide, that extends from the attic access opening to all equipment in the attic. In addition, the decking should be free from any obstructions, such as gas lines, electrical wiring, ductwork, framing members, etc.

M1305.1.3**Obtain Cost Estimate**

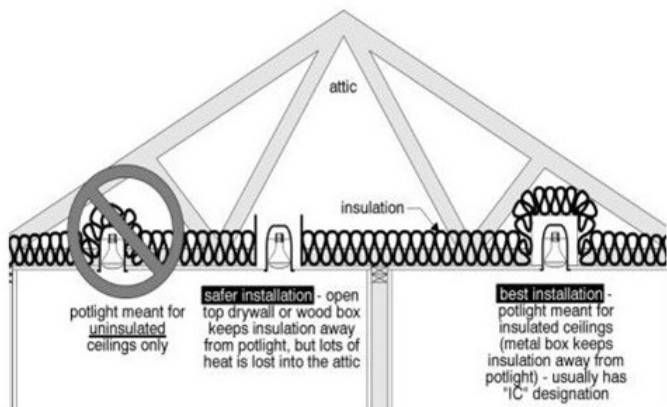
Potlights in insulated ceilings

The insulation was in contact with the recessed lights, which can be a fire hazard and shorten the life of the light bulbs. It is recommended that the insulation be pulled back to provide a three inch air space.

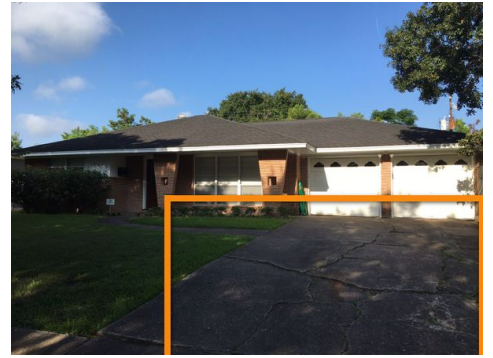
9.1.1 Flatwork Concrete/Patios/Walkways

DRIVEWAY REPAIR

The driveway concrete was badly cracked, and the damaged portion presents a tripping hazard. It is recommended that a contractor be contacted to provide a cost estimate to make the needed repairs.

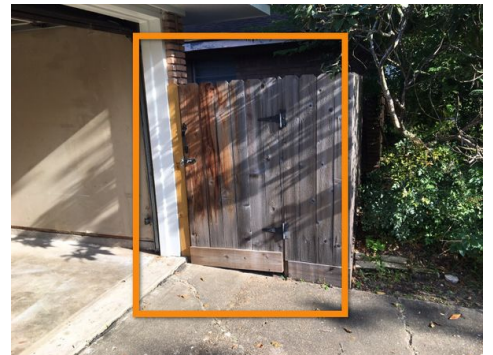
The wood gate was in need of some repairs.

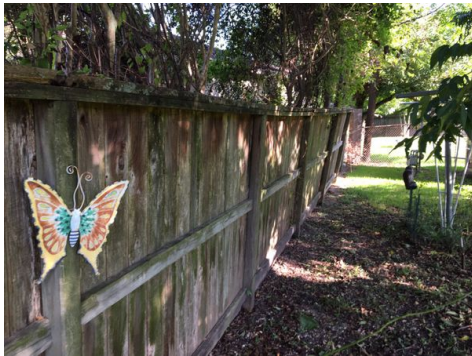
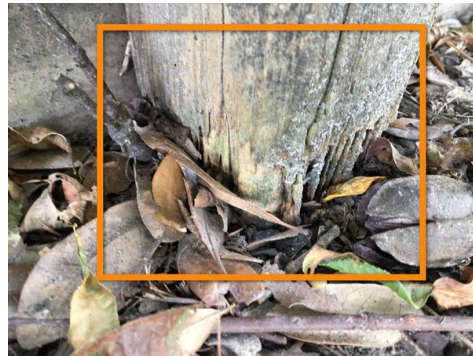
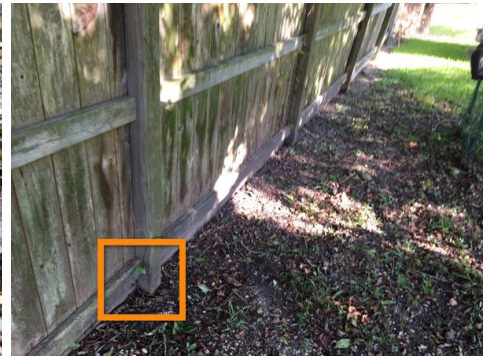
9.3.2 Gates and Fences

WOOD FENCE

Leaning, Starting to rot

The wood fence was in need of some repairs.

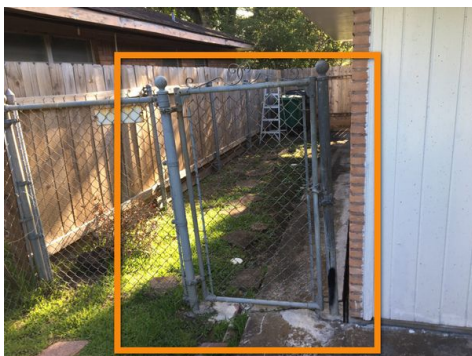
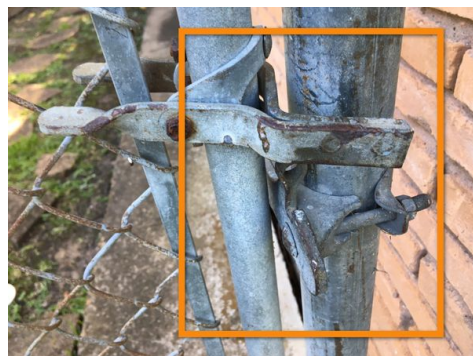
9.3.3 Gates and Fences

CHAIN LINK GATE

The chain link gate was in need of repairs.

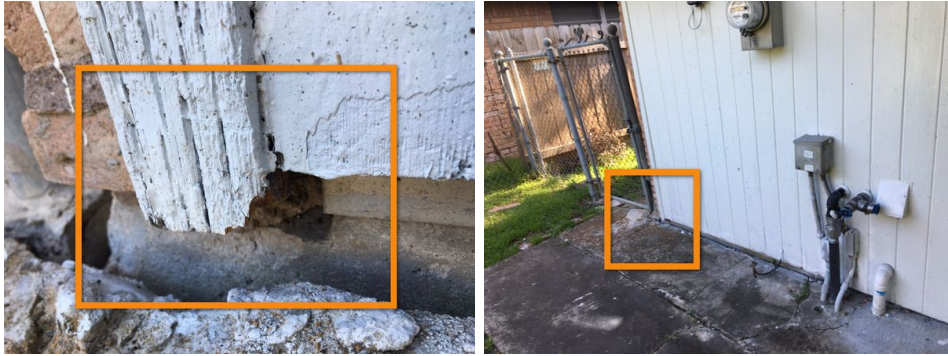
9.4.1 Wood Rot

WOOD ROT

Wood rot was observed and needs to be replaced. Have a contractor provide a cost estimate to determine the entire scope of the wood rot, and provide a cost estimate to replace all rotted wood in the house.

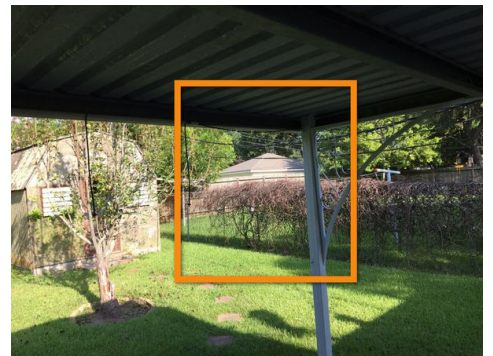
9.9.1 Miscellaneous Exteriors

MISSING LATERAL SUPPORT

One of the lateral supports the back porch roof framing was missing and needs to be installed.

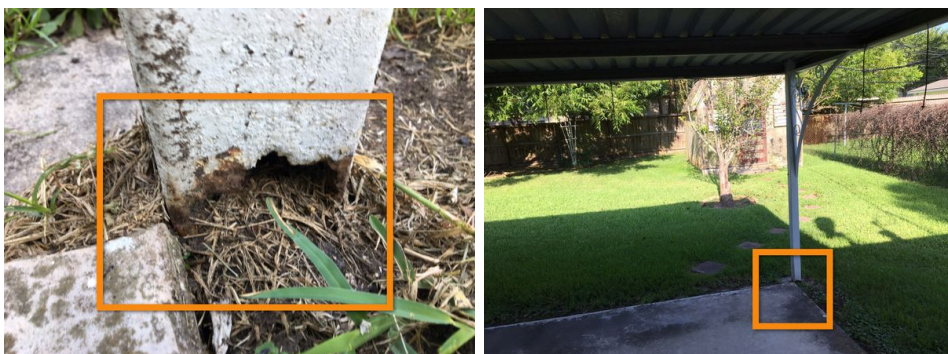
9.9.2 Miscellaneous Exteriors

RUSTED COLUMNS

Several of the back porch columns from the roof framing were severely rusted and need to be repaired/replaced.

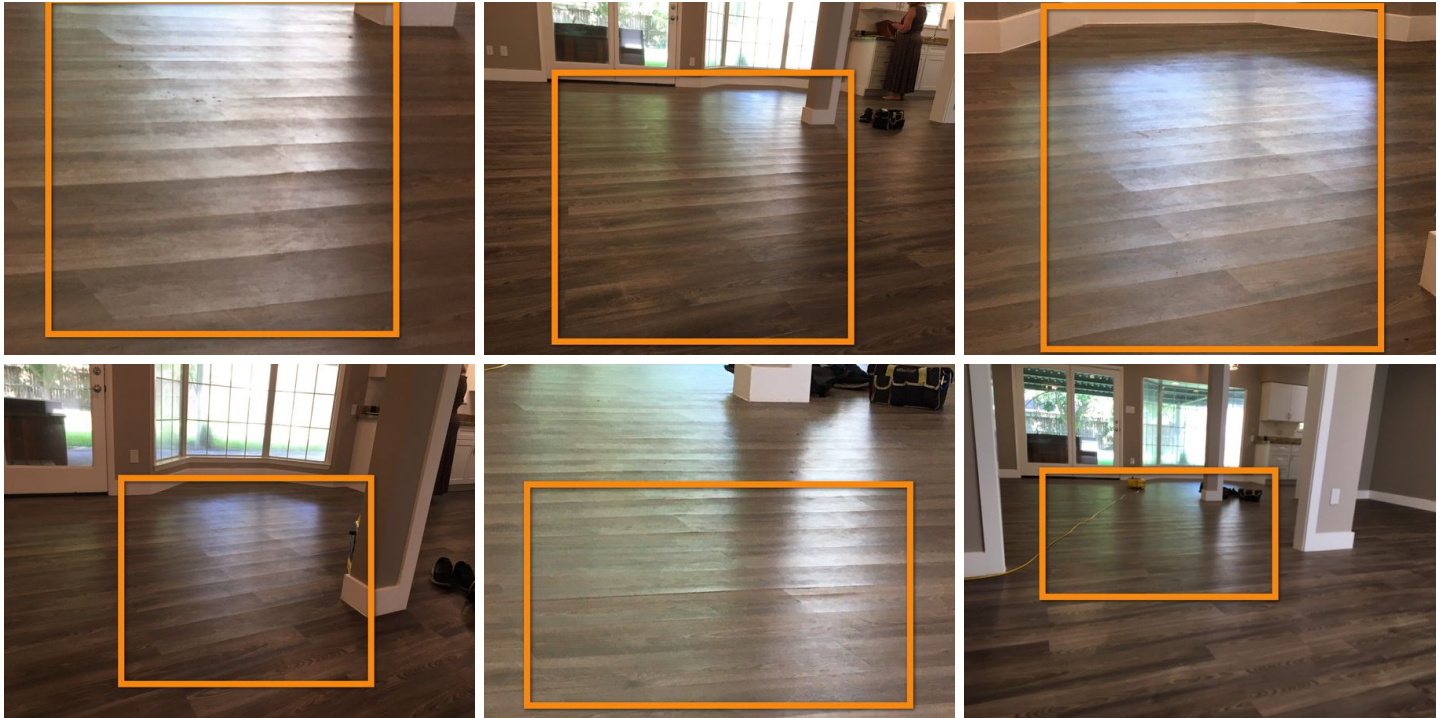
The wood floor was observed to be buckled, with the edges of the boards curling upwards into a "washboard" effect. Further investigation with a wood floor specialist and/or a service company is recommended to make any needed repairs.

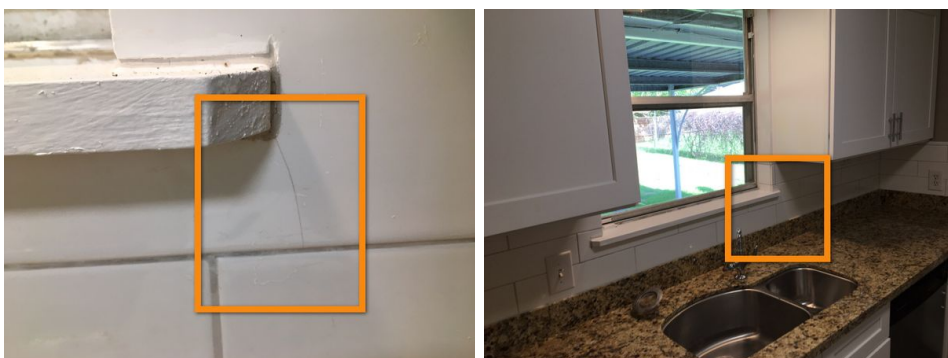
10.9.1 Miscellaneous interiors

WALL TILES CRACKED

Wall tiles were cracked and it is recommended they be replaced.

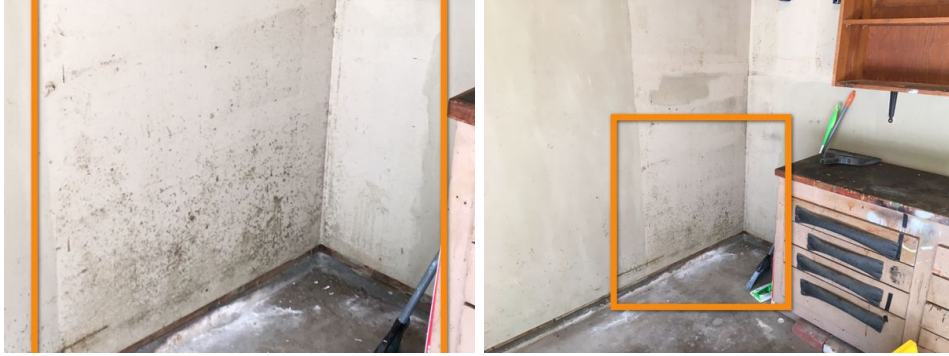
10.9.2 Miscellaneous interiors

MICROBIAL GROWTH

A microbial growth was observed, and further investigation is recommended with a service company to determine the cause of the growth, and to provide a cost estimate for any needed repairs.
