HEDDERMAN SERVICES

STRUCTURAL INSPECTION

10726 Tupper Lake Dr
Houston TX 77042

JULY 2, 2021

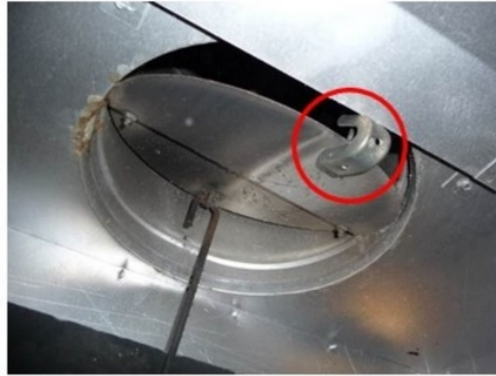
HEI file photo showing c-clamp in metal fireplace
