## MECHANICAL INSPECTION

10726 Tupper Lake Dr  
Houston TX 77042

# PROPERTY INSPECTION REPORT

**Concerning:** 10726 Tupper Lake Dr, Houston TX 77042  
(Address or Other Identification of Inspected Property)

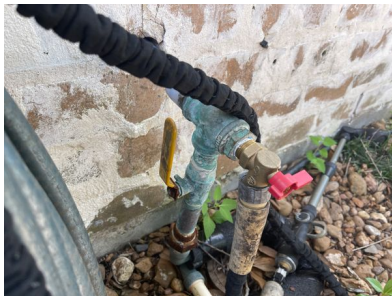
The static water pressure to the house at the time of the inspection was measured with a pressure gauge at the hose bibb nearest the shut off valve, and the static pressure was observed to be 59 psi.

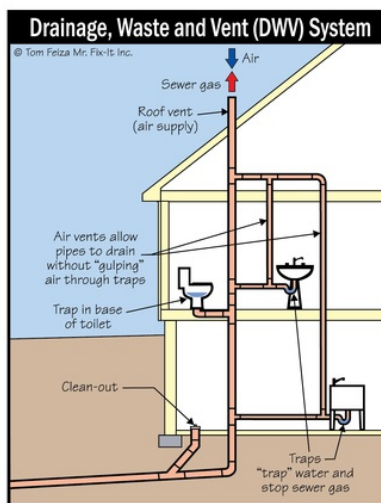
*Sewer Piping - Some new PVC:*

We observed new PVC drain line and sewer piping at the west side of the house at the kitchen and the utility room area. Apparently, the original cast iron sewer piping has been replaced at these areas. It is recommended that further investigation be done with the homeowner and a plumber to determine if any of the original underground cast iron sewer piping is still active. If portions of the original cast iron piping are still present, it can be anticipated that the cast iron will rust out at some time, and will then need to be replaced with PVC sewer piping. Consideration should be given to having the underground sewer piping checked by a plumber to determine if all of the cast iron has been replaced, to determine the quality any repairs that were made, and to determine if any additional repairs are needed.

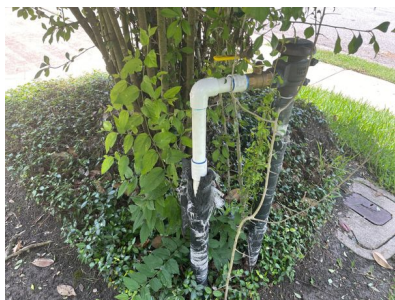
**1: Spraying - House**

Zone 2, 3, 4, 8, 9
