STRUCTURAL REPORT

1234 Lehman St
Houston, TX 77018

APRIL 26, 2024

REF: CONDITION OF PROPERTY SURVEY

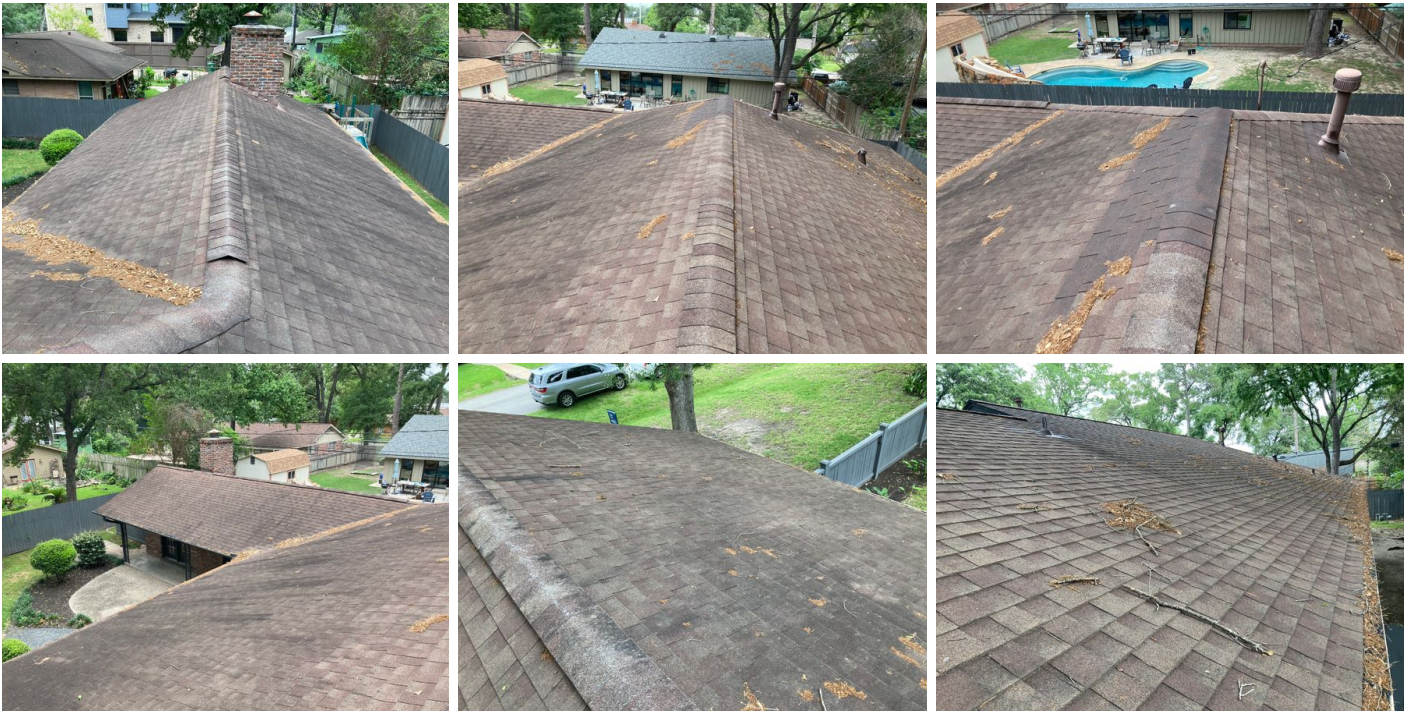
Roof Description: Composition Shingles

The pitched roof surface was constructed of composition shingles. The life expectancy of a composition shingle roof has been observed to vary from 15 to 20 years, with most requiring replacement at about 17-20 years.

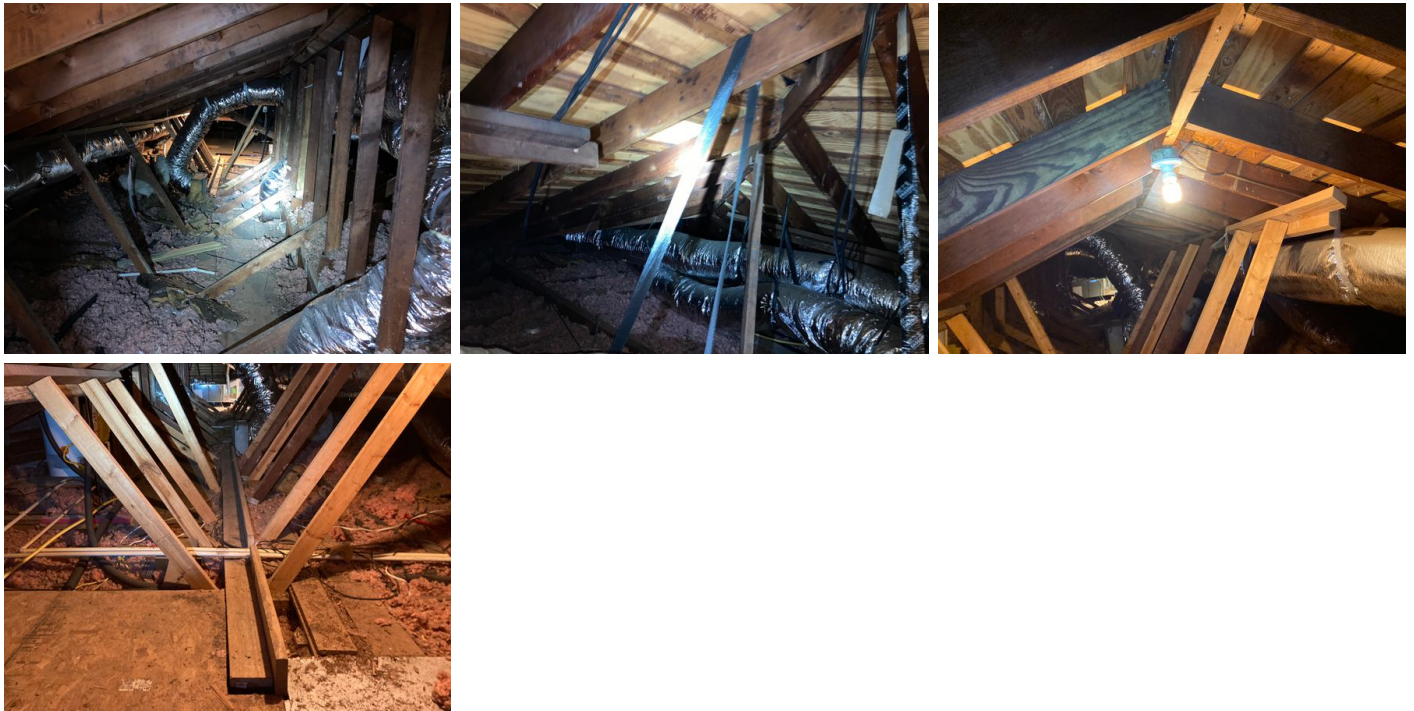
Framing Description: One story house wood frame

The house was observed to be a one story wood frame structure that includes the standard major framing components, including wall framing and ceiling joists, and roof framing.

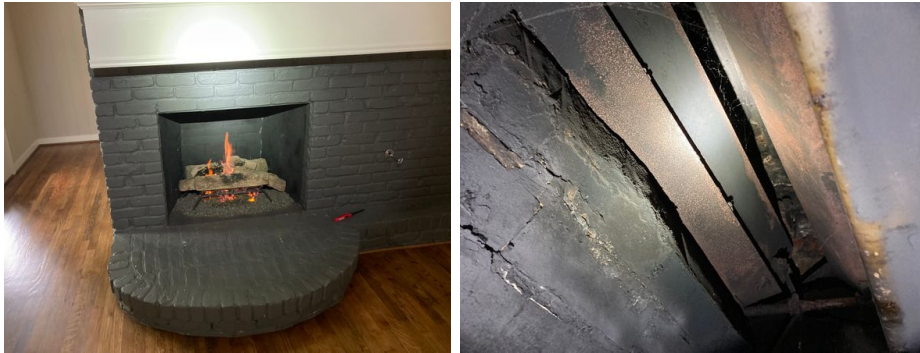
Ceramic Gas Log, Manual Gas Shut-off Valve

The fireplace was a masonry fireplace as described above and shown in photos below.

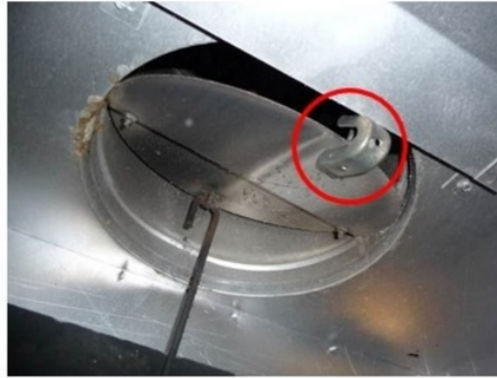
HEI file photo showing c-clamp in metal fireplace

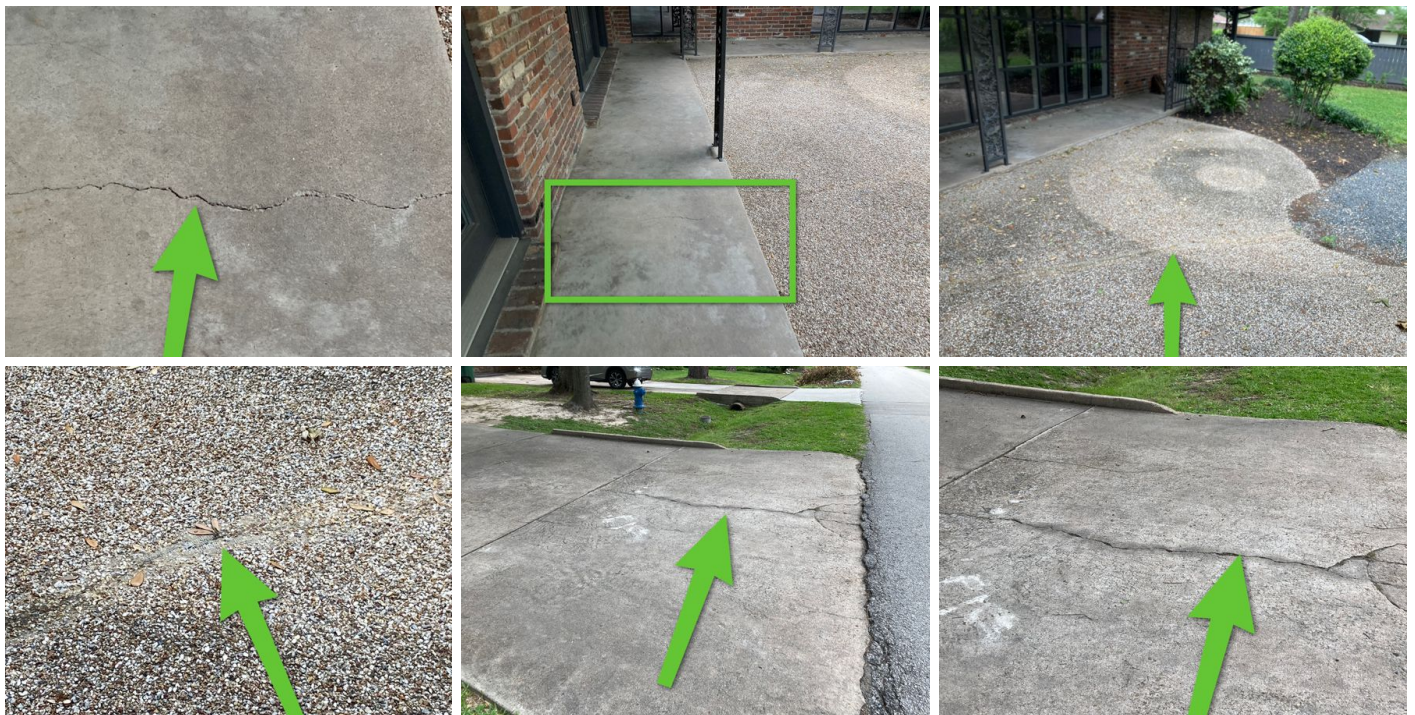
Driveway, Sidewalk, Porch

The flatwork concrete listed above was in generally good condition at the time of the inspection with no significant repairs needed. Note that there may be some small cracks in the concrete, but in the opinion of the inspector, the concrete is still functional.

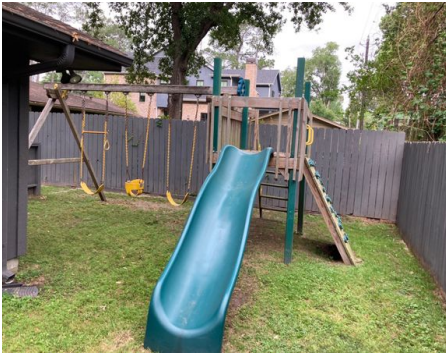
Playground Equipment: Playground Equip.

The playground equipment is omitted from the scope of the inspection, and was not inspected.
