HEDDERMAN ENGINEERING, INC.

MECHANICAL REPORT

1234 Lehman St
Houston, TX 77018

Frank Knott & Bonnie Reay <i>Name of Client</i>	04/26/2024 9:00 am <i>Date of Inspection</i>
1234 Lehman St, Houston, TX 77018 <i>Address of Inspected Property</i>	
Luis Mireles <i>Name of Inspector</i>	TREC#22797 <i>TREC License #</i>
<i>Name of Sponsor (if applicable)</i>	<i>TREC License #</i>

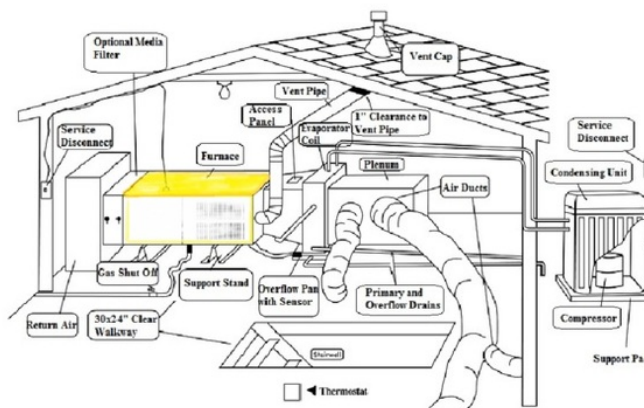
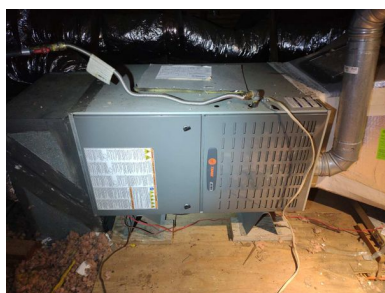
The heating for the property was provided the following natural gas-fired equipment:

<u>ZONE</u>	<u>BRAND</u>	<u>BTU</u>	<u>DATE</u>	<u>LOCATION</u>
House	Trane	100k	2012	attic

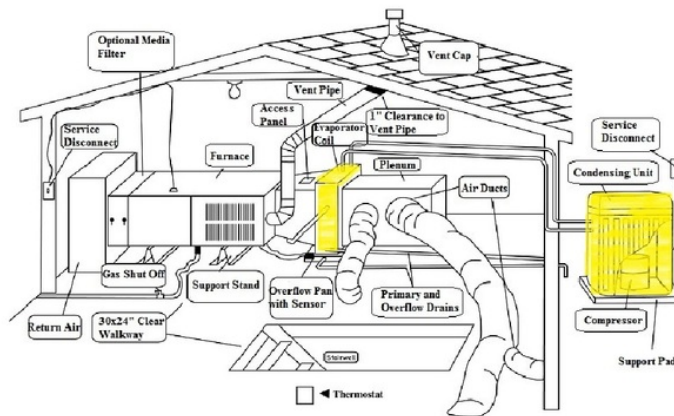
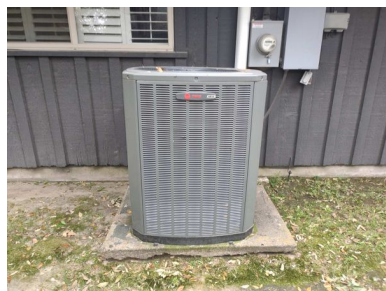
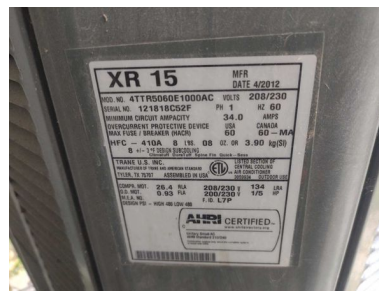
The type of air conditioning for the property is a forced air split system. The cooling equipment for the property was as follows:

ZONE	CONDENSING UNIT			EVAPORATOR COIL		TEMP DELTA
	BRAND	TONS	DATE	TONS	DATE	
House	Trane	5	2012	5	2012	17

Condensing Unit Equipment - Functional:

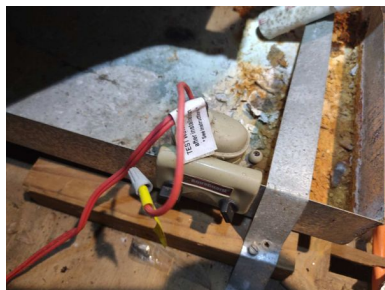
Overflow Pan - Water sensor present:

The overflow pan under the evaporator coil was equipped with a water sensor that is intended to shut off the air conditioning equipment if the pan fills with water.

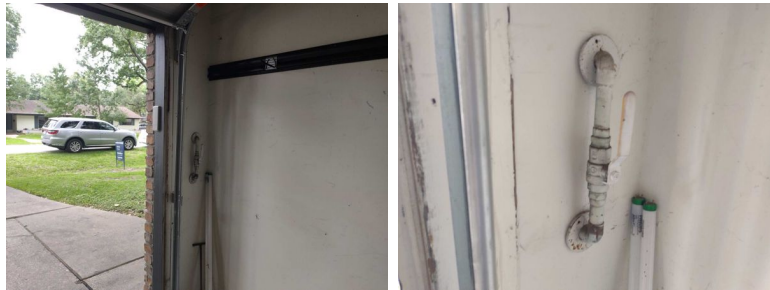
Main Water Shut Off Valve Location: Inside garage -

The main shut-off valve for the water line service piping is intended to provide a means to disconnect the water service to the structure/property.

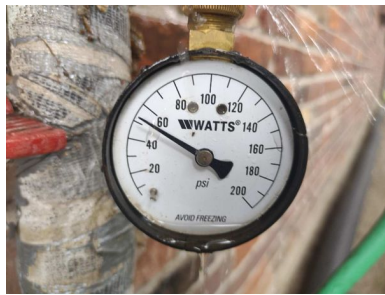
Static Water Pressure: 50-55 PSI -

The static water pressure at the property was measured with a water pressure gauge at the hose bibb nearest to the shut off valve at the time of the inspection.

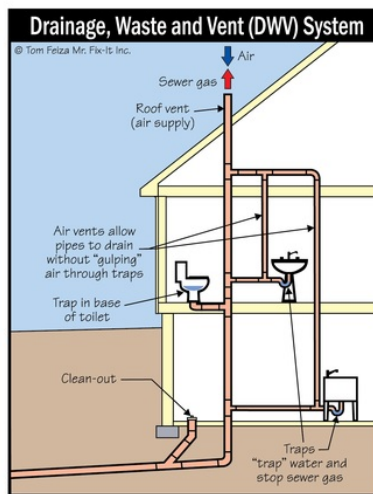
Sewer Piping - Evidence of repairs observed: PVC clean out present -

Evidences of sewer line repairs and/or replacement were observed. It is noted that we could not determine the extent of the repairs to the sewer system or if any of the original cast iron piping is still active. Further

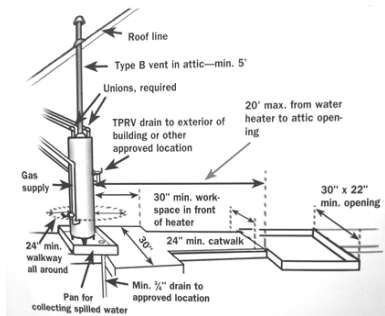
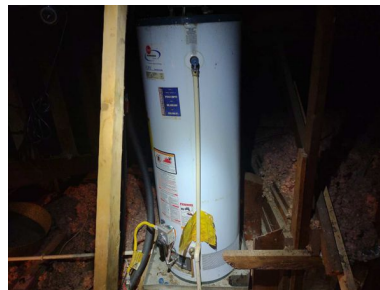
The hot water for the property was provided by the following natural gas fired gas water heater(s):

<u>Location</u>	<u>Brand</u>	<u>Capacity</u>	<u>Age</u>	<u>Energy Type</u>
Attic	Rheem	50-gallons	2011	Gas

Water Heater Equipment - Functional:

The water heater equipment was functional at the time of the inspection and providing hot water to the applicable plumbing fixtures.

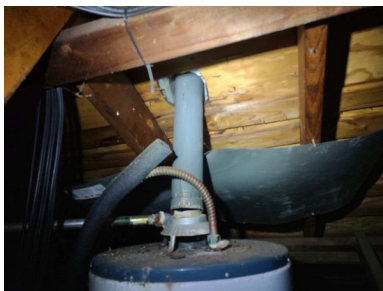
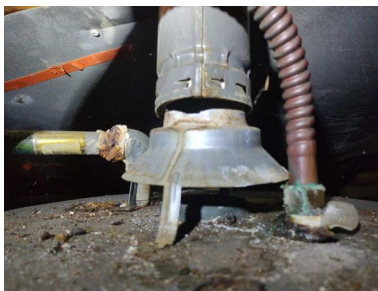
2: Fittings - Corroded

The piping at the top of the water heater was severely corroded at the fittings and is in need of repair.

Obtain cost estimate

Recommendation: Contact a qualified professional.

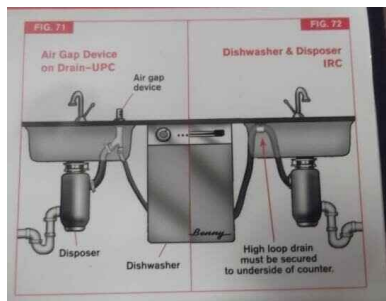
Drain Line Loop Present:

The drain line under the sink was looped up so that the top of the loop was higher than the point where the drain line connected to the disposal. This will help to prevent garbage from running down the drain line into the dishwasher.
