AM SOLUTIONS, LLC

PROPERTY INSPECTION REPORT FORM

Jose Flores <i>Name of Client</i>	09/29/2023 <i>Date of Inspection</i>
6610 Deckard St, Houston, TX 77061 <i>Address of Inspected Property</i>	
Arturo Marquez <i>Name of Inspector</i>	TREC 2685 <i>TREC License #</i>
 <i>Name of Sponsor (if applicable)</i>	 <i>TREC License #</i>

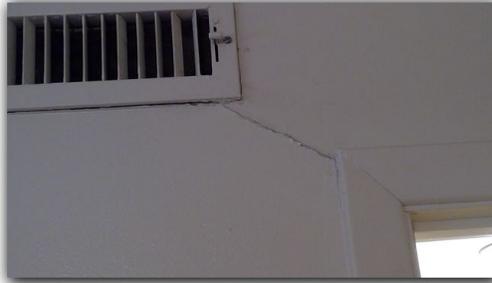
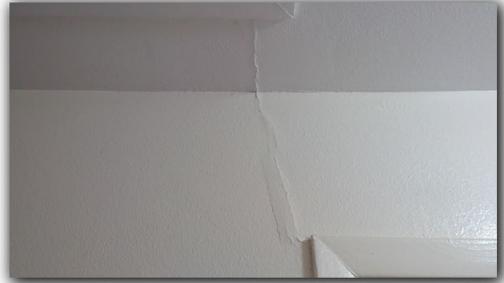
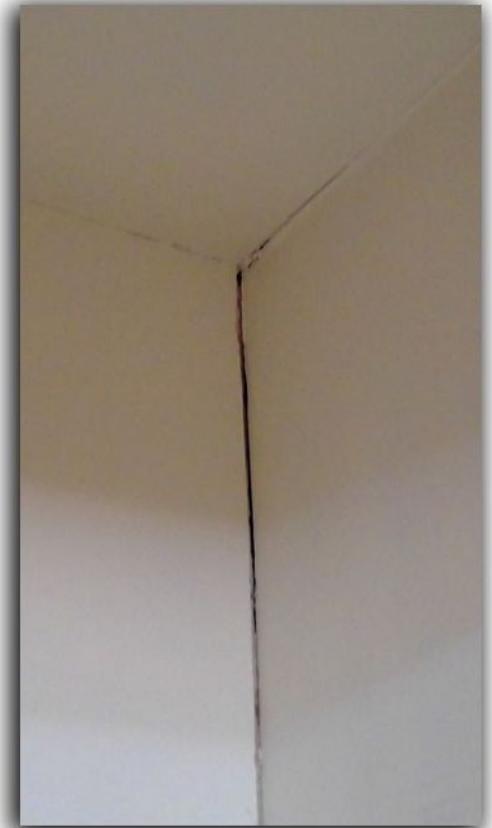
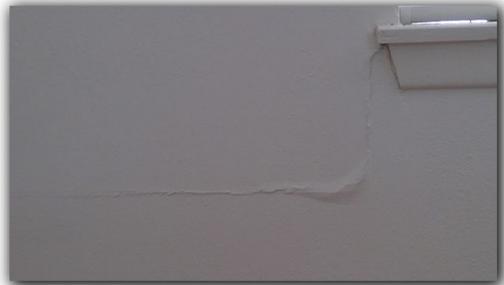
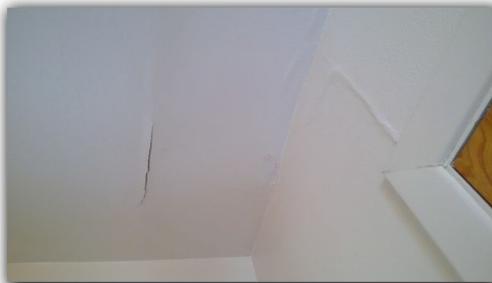
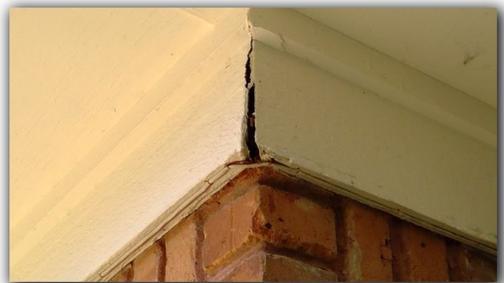
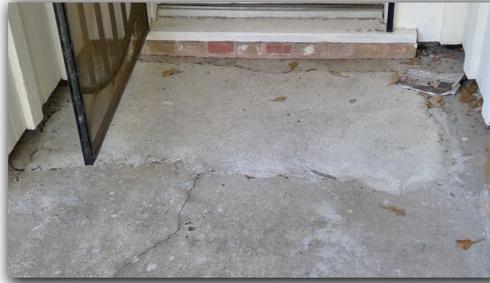
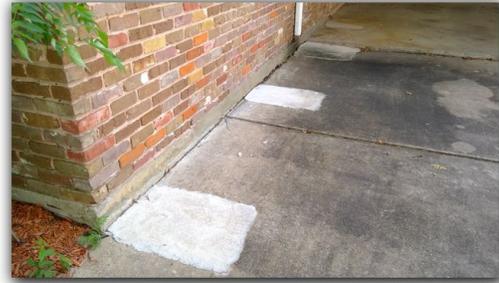
A. Foundations

Comments: Numerous cracks and/or crack repairs were observed including but not limited to: the front, right, and rear brick veneers, the front porch slab, the carport slab, the garage slab, and on multiple interior wall or ceilings spots, see sample pictures. The rear left corner brick frieze boards were observed pushed outwards, see sample picture. The concrete patches on exterior flatwork, see sample pictures, indicates previous foundation repairs may have already been performed on this home.

However, differential movement in excess of marginal was detected using a four ft. digital level; marginal being described as within the generally accepted criteria for foundation performance and repair of L/360 (1 inch bend/differential movement, in 30 feet). Several door frames were observed out-of-square. The laundry/kitchen door, and the hallway front closet door stick on jambs and would not close

It is this inspector's opinion additional piers and/or adjustment on existing piers may be required. Need to contact homeowner regarding extent of any previous foundation repairs and warranty. Need to also contact contractor that performed any previous work and/or a qualified engineer for further evaluation regarding any necessary corrections.

It is also recommended that a monitoring and maintenance program be initiated in an effort to minimize possible future differential movement.

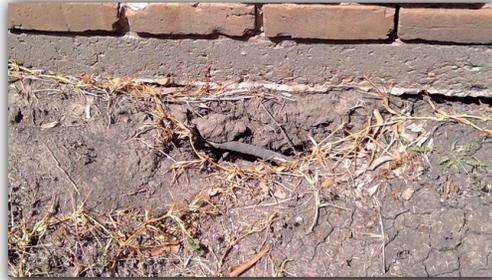
B. Grading and Drainage

Comments: Need additional soil to make up for soil erosion observed along the perimeter grade beams, see sample picture.

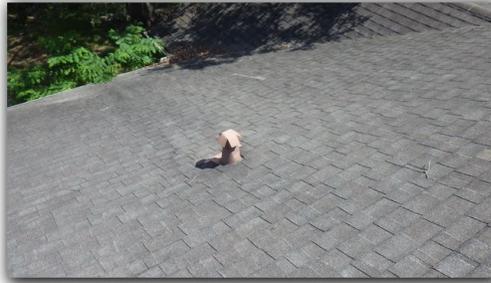
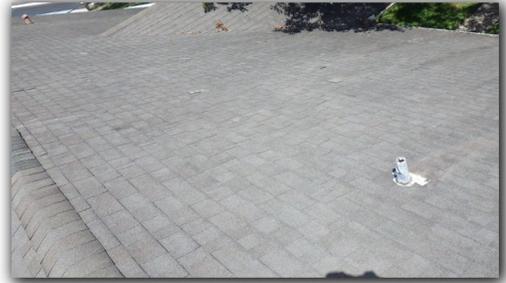
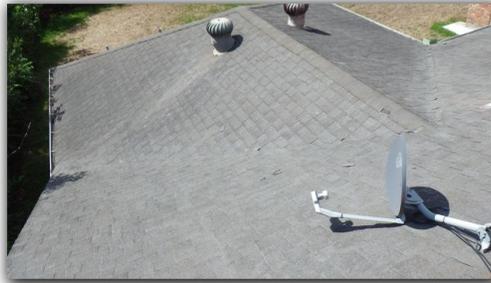
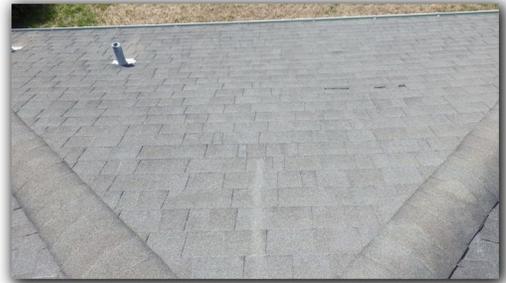
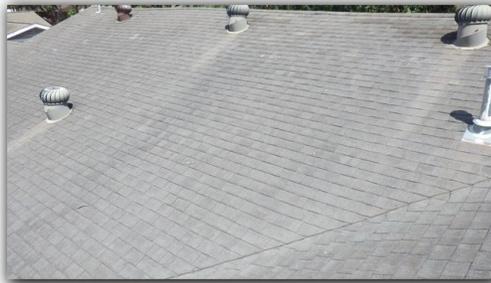
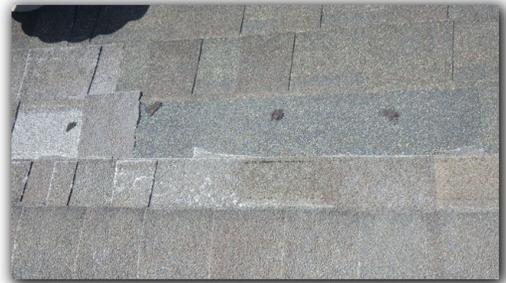
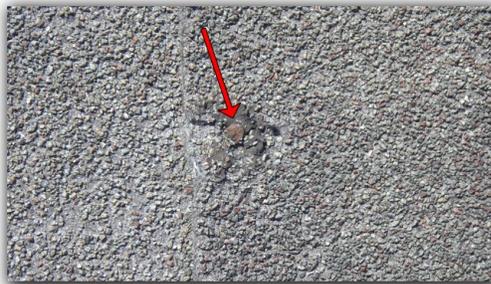
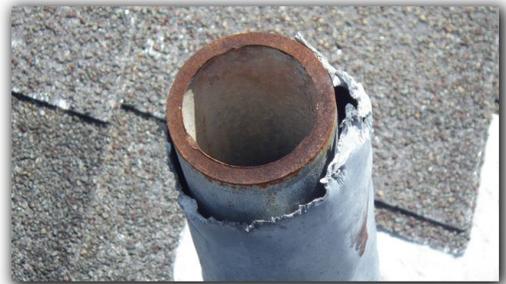
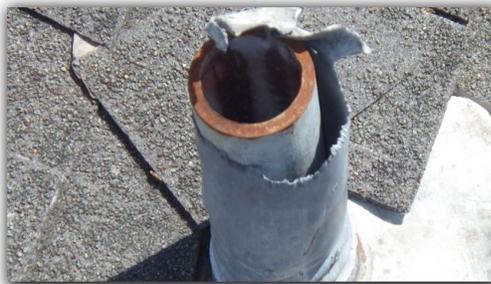
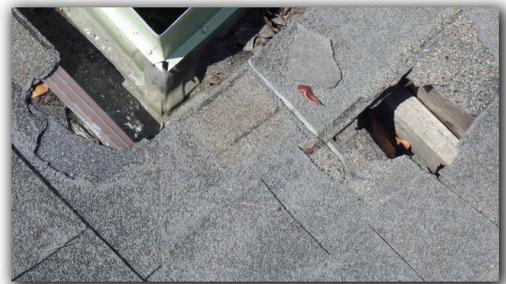
C. Roof Covering Materials

Comments: **However**, multiple damaged shingles were observed, see sample picture.

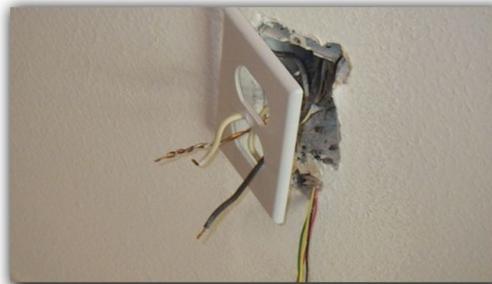
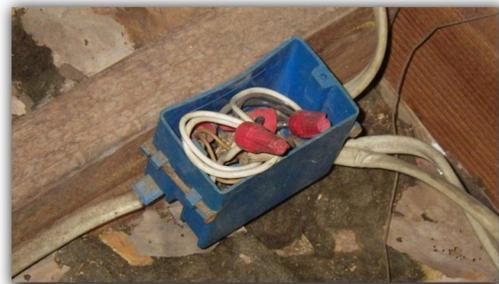
Missing receptacle and exposed wires were observed in foyer, see sample picture.

Missing cover plate was observed on a junction box in the attic, see sample picture.

These items present potential safety hazards.

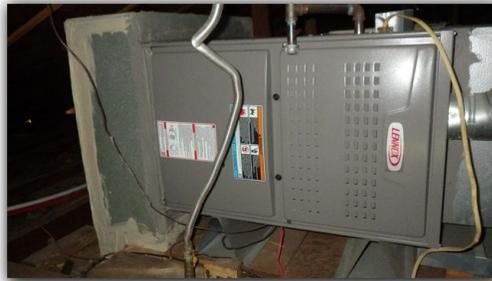
Comments: No inspection was performed to check for possible heat exchanger cracks as this would involve dismantling of unit, which is beyond the scope of this inspection. Unit was turned on and observed currently operable and performing it's intended function relative to accepted industry standard practices, see sample picture.

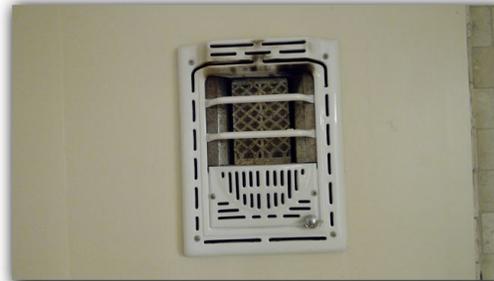
Comments: **NOTE:** The inability to verify combustion clearances for gas wall space heaters presents a potential safety concern; these space heaters should be removed/discontinued and disconnected.

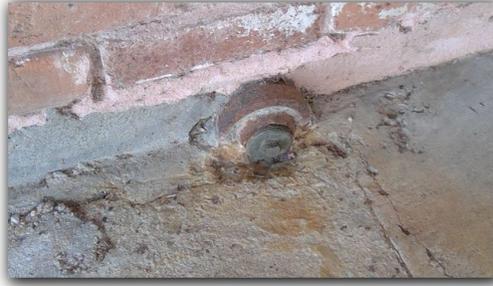
Type of drain piping material: Partially visible PVC and Cast Iron, see sample picture

However, no in-ground drain clean-out observed; one should be installed.

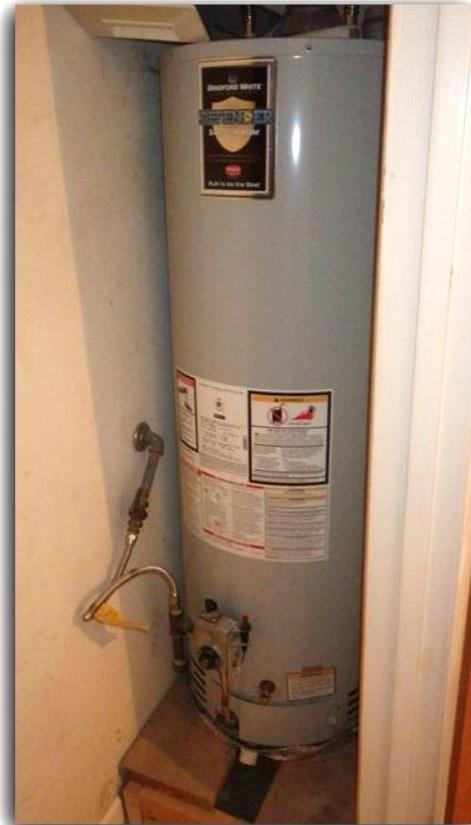
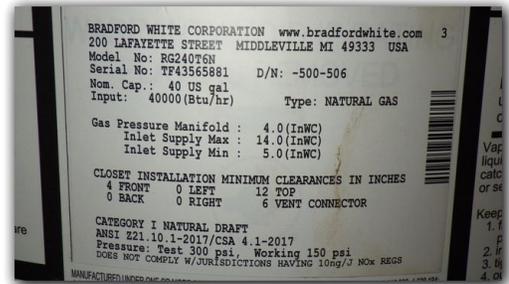
However, the wall currently obstructs operation of the water heater T&P relief valve test lever; and, valve lacks a discharge line to the exterior or into a drain pan, see sample picture.

Water heater drain pan is too small and lacks a discharge line to the exterior, as required by the **IRC**.

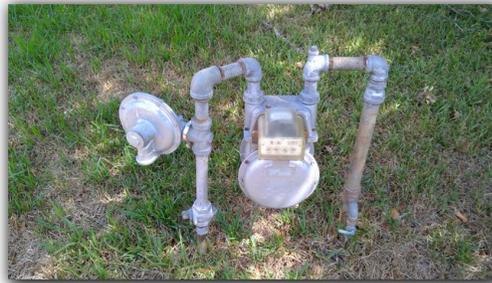
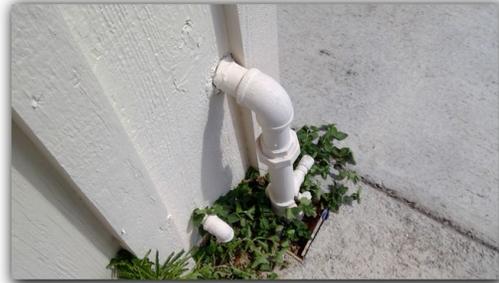
Comments: Visible components were observed currently operable, see sample pictures.

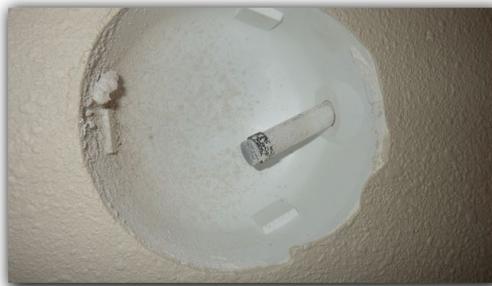
Comments: Refrigerator water supply line lacks a shut-off valve, see sample picture.
