RESIDENTIAL INSPECTION REPORT

4326 Hazelton St
Houston, TX 77035

PROPERTY INSPECTION REPORT FORM

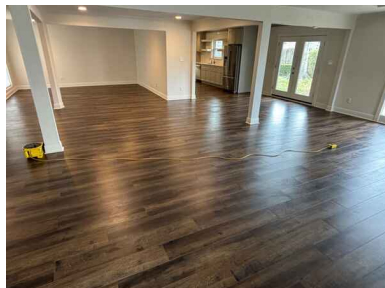
1: Evidence of Foundation Settlement Present

Noticeable floor slope, Drywall cracks, Brick Cracks, Slab Cracks -

Living room (floor slope)

Due to evidence of foundation settlement, further evaluation by a licensed structural engineer and/or qualified foundation contractor is recommended.

Recommendation: Contact a qualified structural engineer.

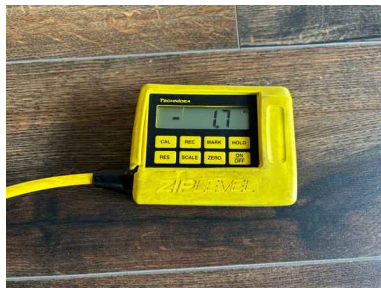
Living room (slope measurement)
