Lone Star Stucco, LLC

Moisture Assessment Report

2638 Westgate Street

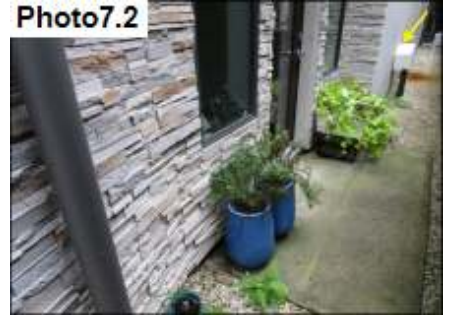
Photo7.2

- The penetration sealants are aged in this location. The inspector suggests to have a qualified waterproofing contractor seal this area with a low modulus sealant in an effort to prevent moisture intrusion. These types of sealants are of high quality and compatible with stucco and other termination points. Please refer to photos #7.2, #7.3, #7.4, #7.5 and #7.6 for more detail.

Penetration Sealants / Seal

Grid Location	Item Description	Moisture Readings	Substrate Condition	Observations
Yellow Arrows	Penetrations			The penetration sealants are aged in this location. The inspector suggests to have a qualified waterproofing contractor seal this area with a low modulus sealant in an effort to prevent moisture intrusion. These types of sealants are of high quality and compatible with stucco and other termination points. Please refer to photos #7.2, #7.3, #7.4, #7.5 and #7.6 for more detail.

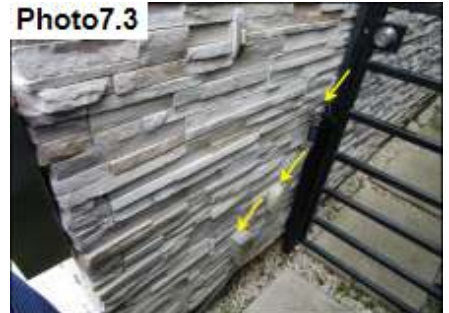
Photo7.3

Penetration Sealants / Seal

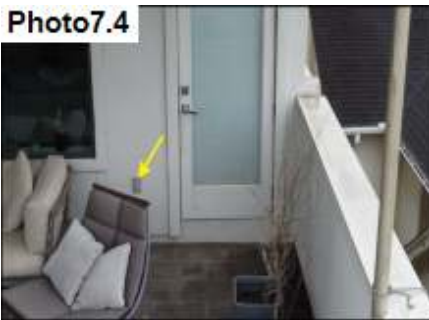
Photo7.4

Penetration Sealants / Seal

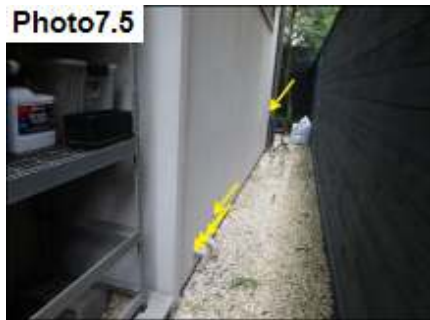
Photo7.5

Penetration Sealants / Seal

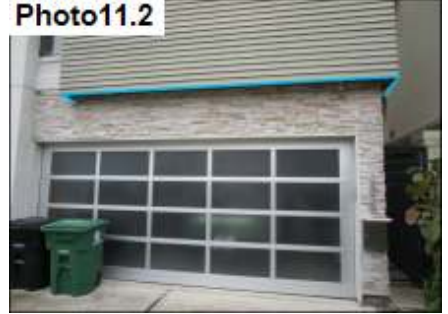
Photo11.2

- Although a relief is present at this location, excess sealant was applied to the drainage plane obstructing proper moisture evacuation of the system. The inspector recommends having a qualified waterproofing contractor further assess, clean out excess material and verify the house back wrap has been cut. This will provide the proper functioning of the system at this location. Please refer to photos #11.2, #11.3 and #11.4 for more detail.

Obstructed Relief / Clean Out

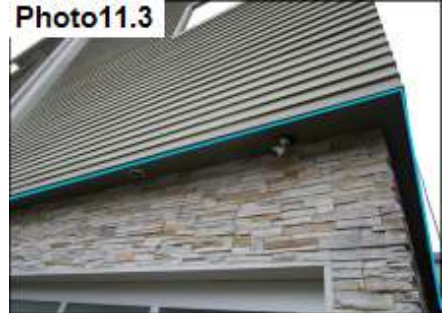
Photo11.3

Obstructed Relief / Clean Out

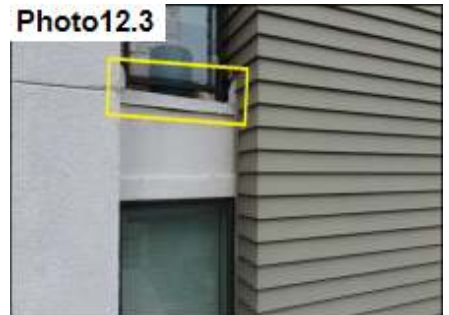
Balcony Flashing / Seal

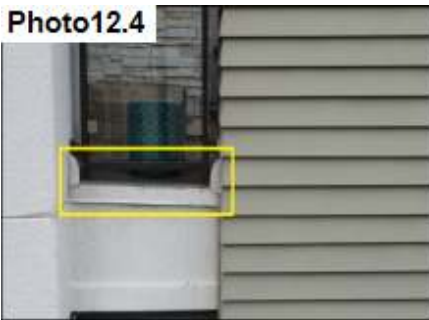
Balcony Flashing / Seal

Balcony Flashing has been sealed.

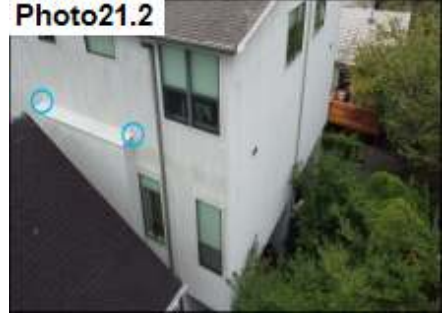
Photo21.2

Roof Diverter Flashing and Metal Cap / Seal

Grid Location	Item Description	Moisture Readings	Substrate Condition	Observations
Blue Circle	Flashing			The roof diverter flashing/metal cap sealants are aged at this location. The inspector suggests to have a qualified waterproofing contractor further assess and seal this area in an effort to prevent moisture intrusion. Please refer to photos #21.2, #21.3, #21.4, #21.5 and #21.6 for more detail.

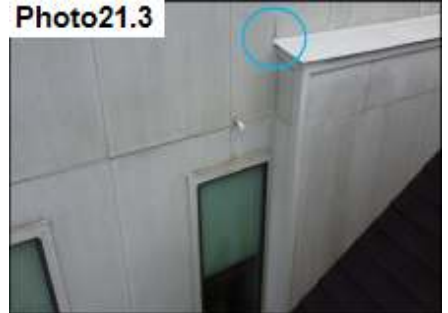
Photo21.3

Roof Diverter Flashing and Metal Cap / Seal

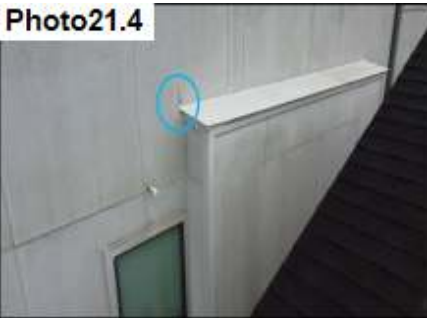
Photo21.4

Roof Diverter Flashing and Metal Cap / Seal

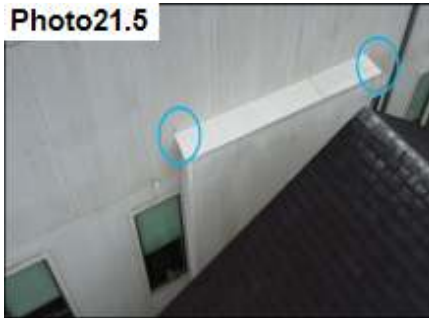
Photo21.5

Roof Diverter Flashing and Metal Cap / Seal

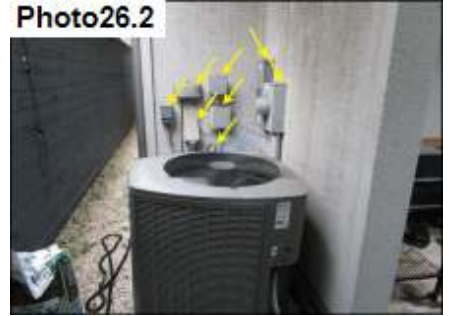
Photo26.2

Penetration Sealants / Seal

Grid Location	Item Description	Moisture Readings	Substrate Condition	Observations
Yellow Arrows	Penetrations			The penetration sealants are aged in this location. The inspector suggests to have a qualified waterproofing contractor seal this area in an effort to prevent moisture intrusion. Please refer to photos #26.2, #26.3, #26.4 and #26.5 for more detail.

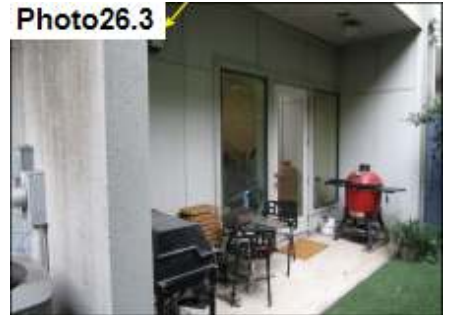
Photo26.3

Penetration Sealants / Seal

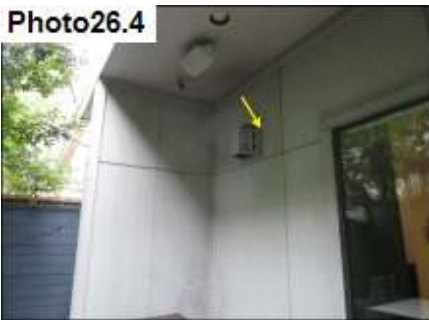
Photo26.4

Penetration Sealants / Seal
