PROPERTY INSPECTION REPORT FORM

Corbin Beall <i>Name of Client</i>	04/24/2024 <i>Date of Inspection</i>
19002 Village Creek Park Drive , Cypress, TX 77433 <i>Address of Inspected Property</i>	
Jason Micallef <i>Name of Inspector</i>	TREC # 25743 <i>TREC License #</i>
<i>Name of Sponsor (if applicable)</i>	<i>TREC License #</i>

Home Inspection Report

Inspection No. 521560-390

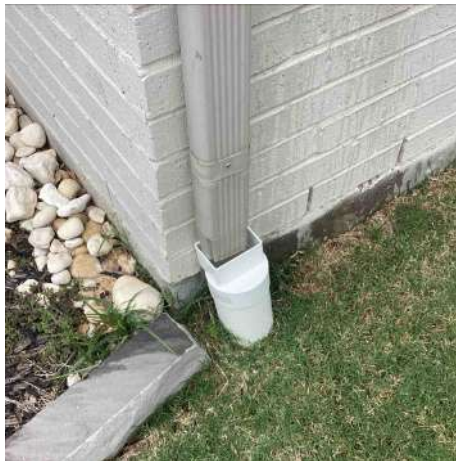
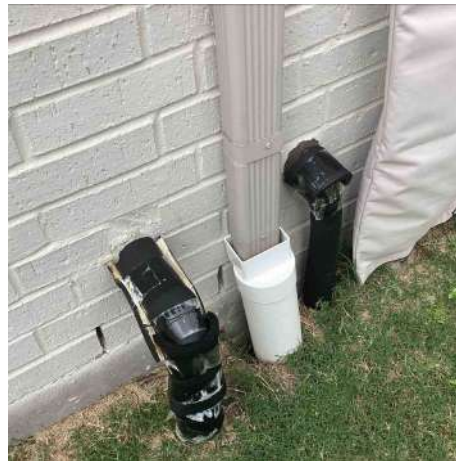
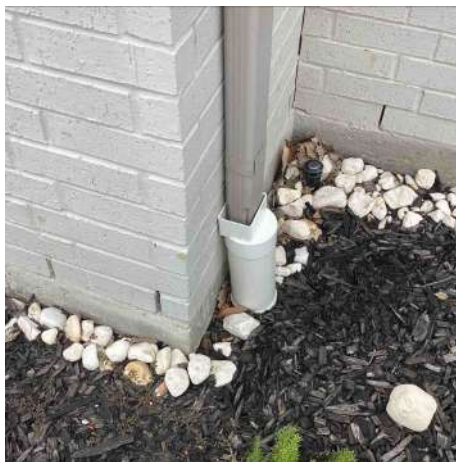
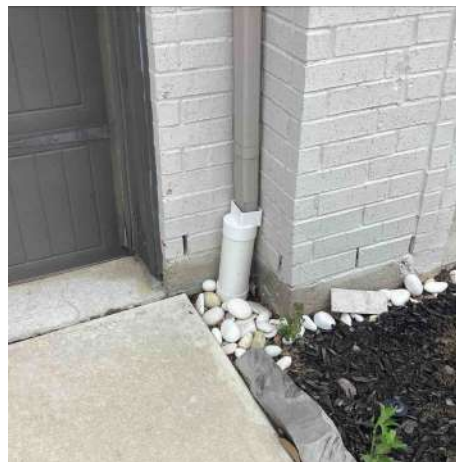
- Under ground drainage often requires routine cleaning to help prevent clog. Recommend cleaning annually to help ensure proper function.
 - Exterior Back
 - Exterior Front
 - Exterior Left
 - Exterior Right

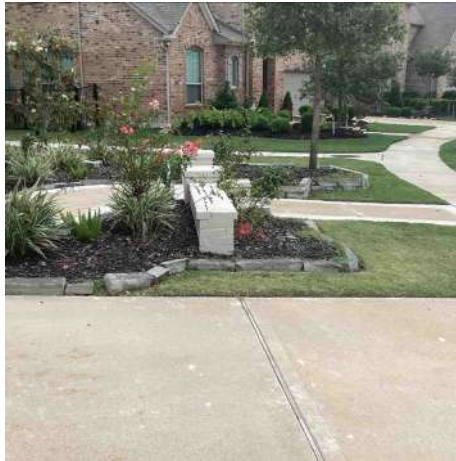
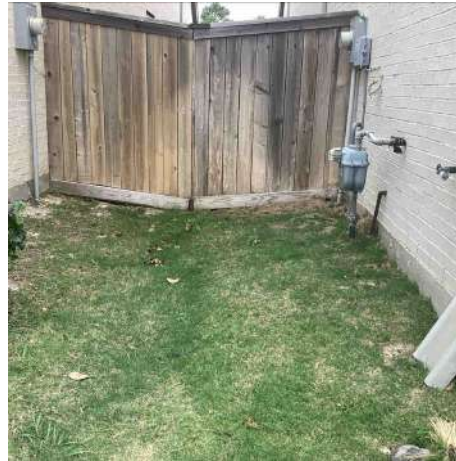
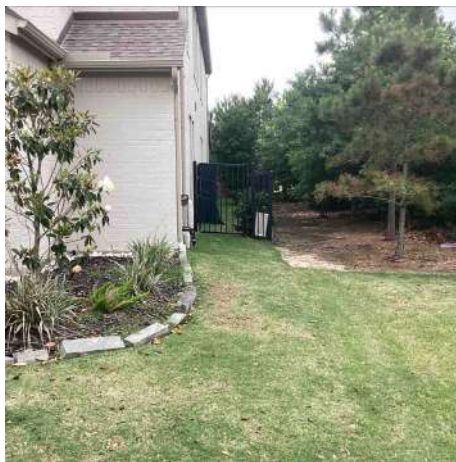
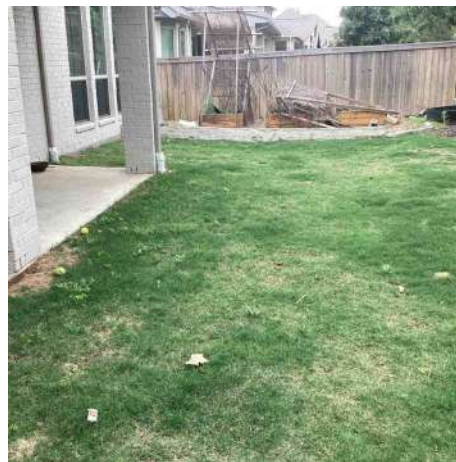
- Exterior Back
- Exterior Front
- Exterior Left
- Exterior Right

• Drainage is functioning as intended to. Proper drainage is defined by the final grade sloping away from the structure at a slope of 6 inches down over 10 feet out where possible. Ensure this proper drainage continues, to help prevent damage to the structure.

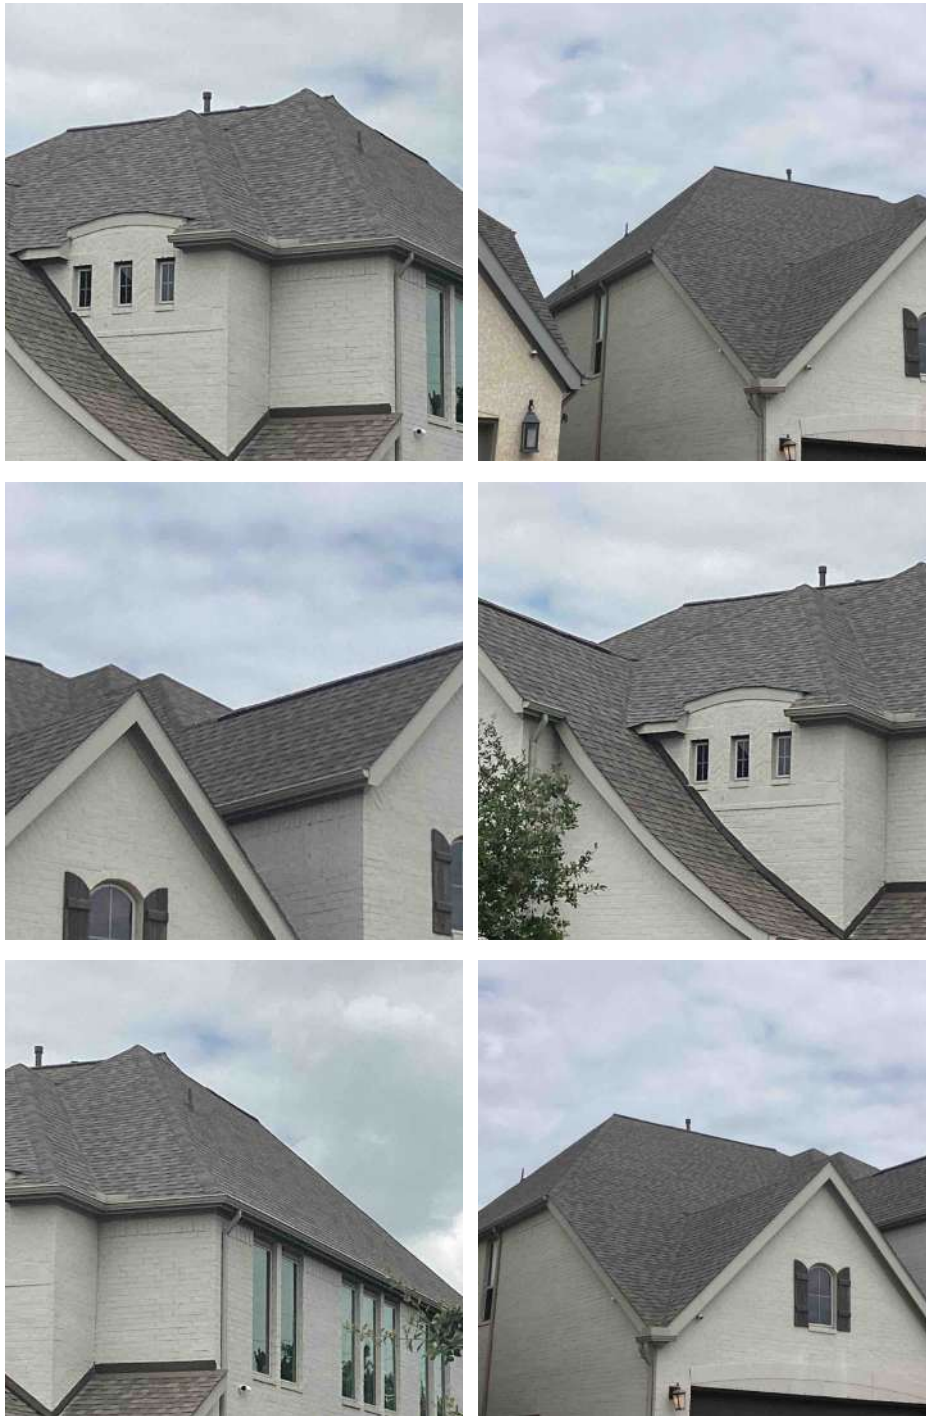
- The roof covering is comprised of architectural asphalt shingles. The roof covering appears to be ok and no obvious deficiencies were observed during the time of inspection.

Due to the height and pitch of the roof, the roof was observed from the ground with binoculars.

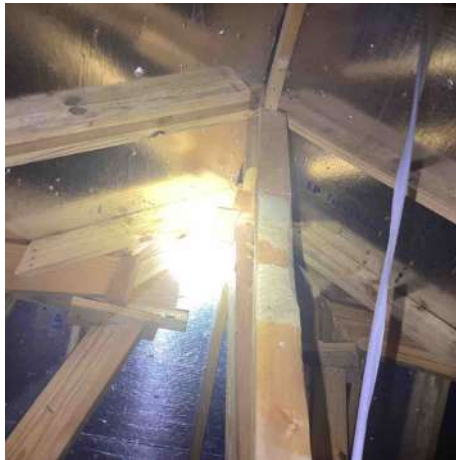
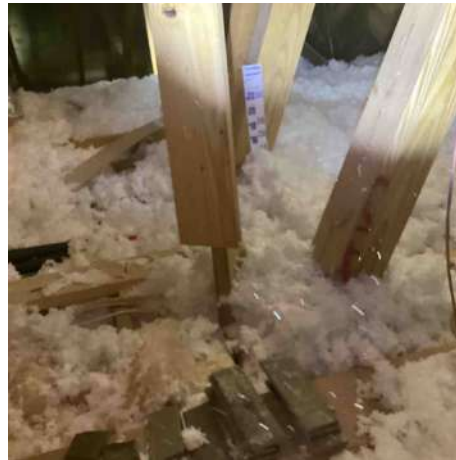
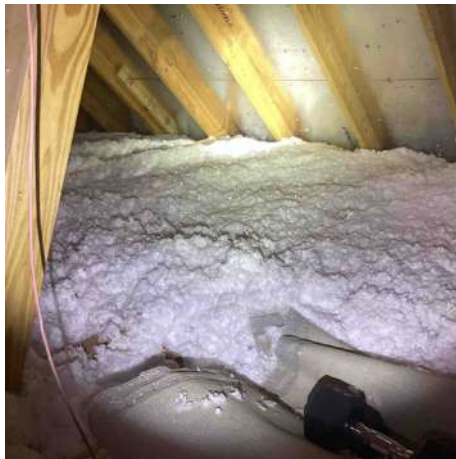
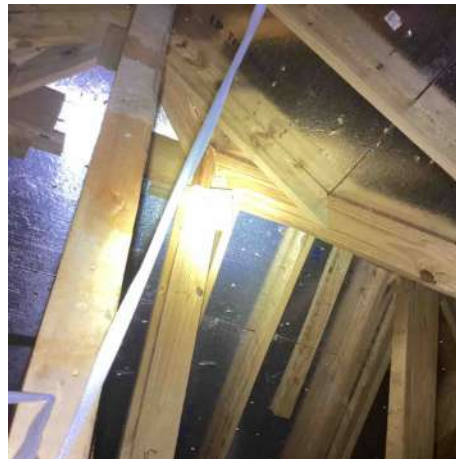
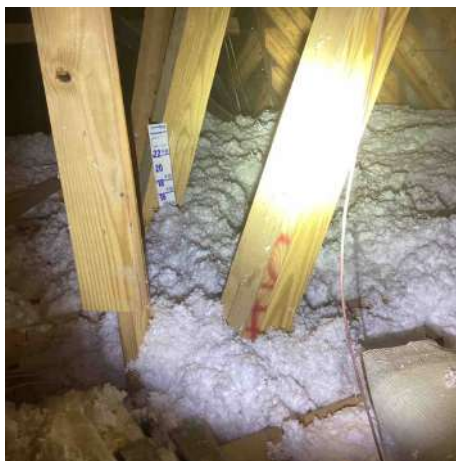
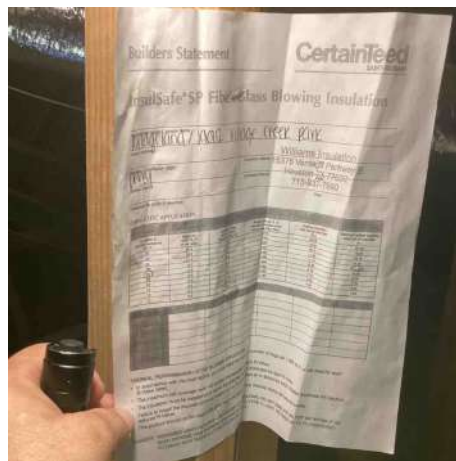
- The roof structure is constructed from wood rafters and Tech Shield roof decking. No deficiencies were observed during the time of inspection.

The insulation is blown in fiberglass, with an approximate depth of 11-12". No deficiencies were observed during the time of inspection. **(Attic)**

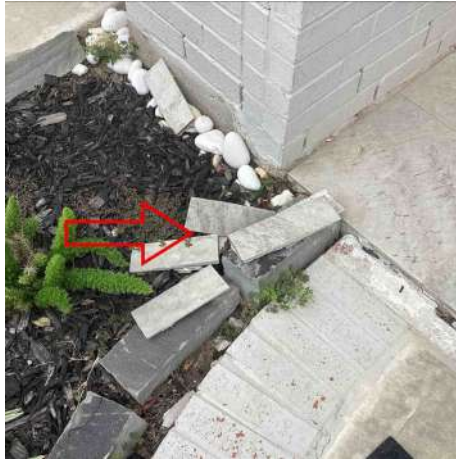
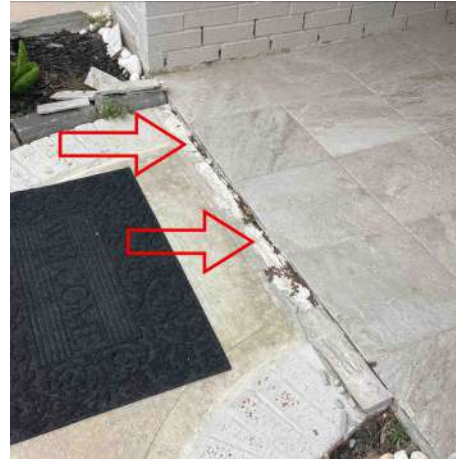
- Tile transition strip has been removed or has detached from the ground. It is recommended to reinstall the tile to reduce the tripping hazard and restore intended aesthetics. **(Exterior Front)**

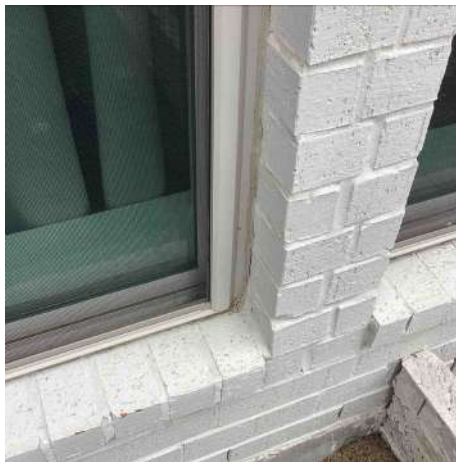
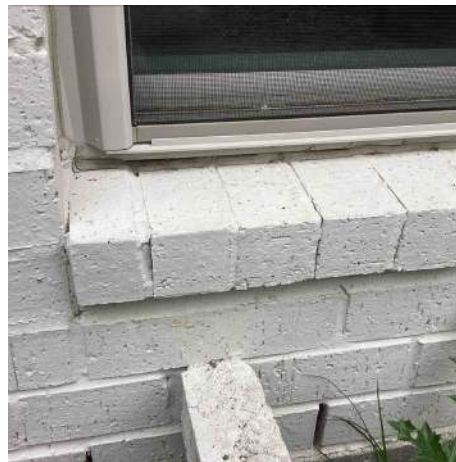
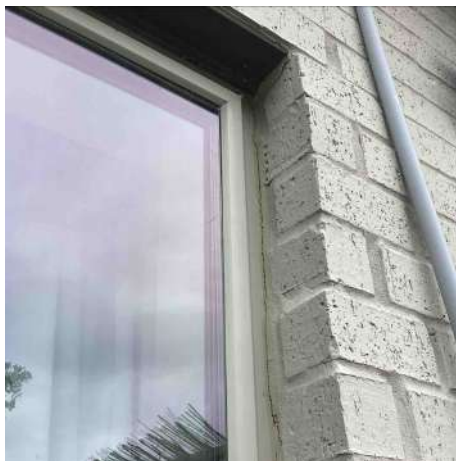
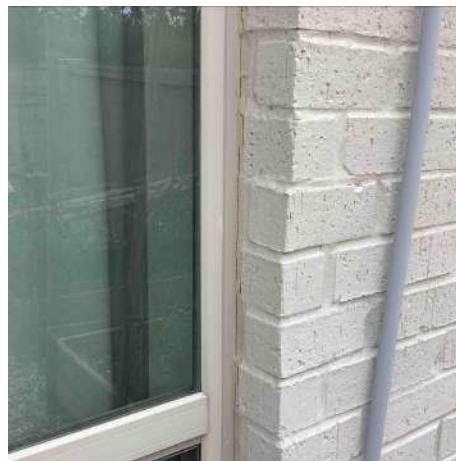
- The window caulking is cracked. It is recommended to remove old caulking and re-apply to prevent moisture or pest intrusion.

- Exterior Back
- Exterior Front
- Exterior Left
- Exterior Right

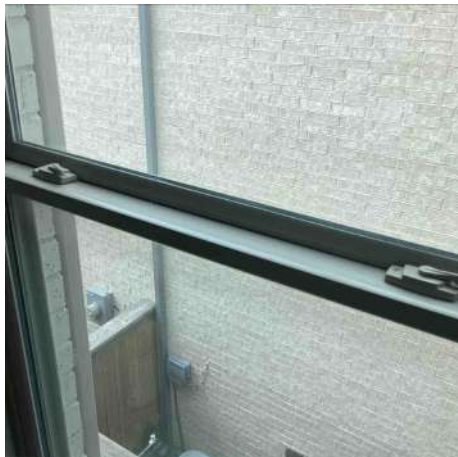
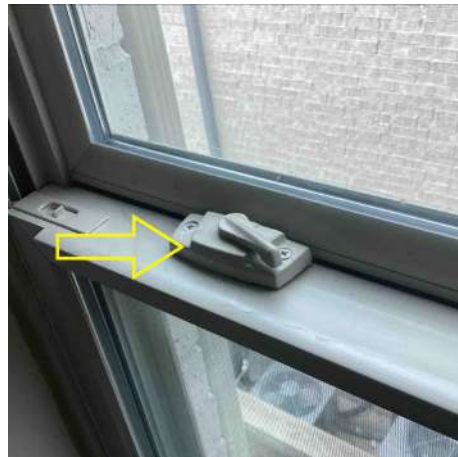
• Window does not close enough to latch, and the one window latch is loose. It is recommended to consult with a qualified contractor to evaluate and make any necessary repairs to restore proper function. (Upper Front Bedroom)

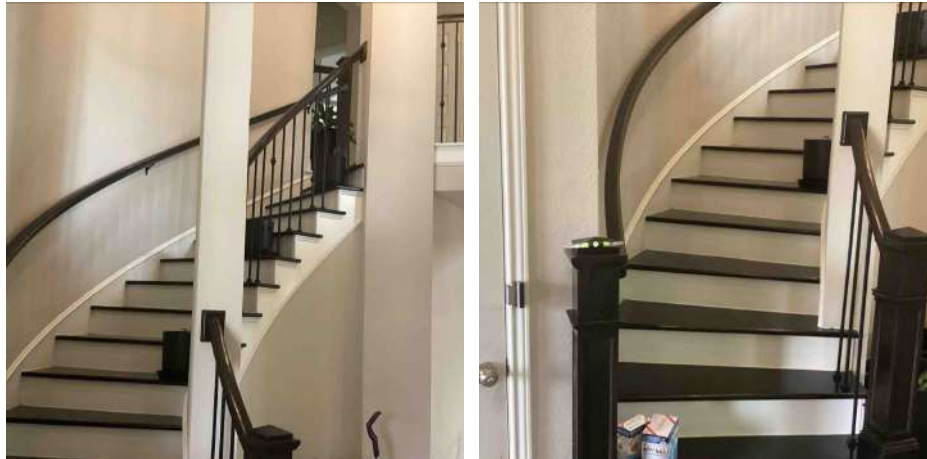
- No deficiencies were observed with the stairway during the time of inspection. **(Throughout)**

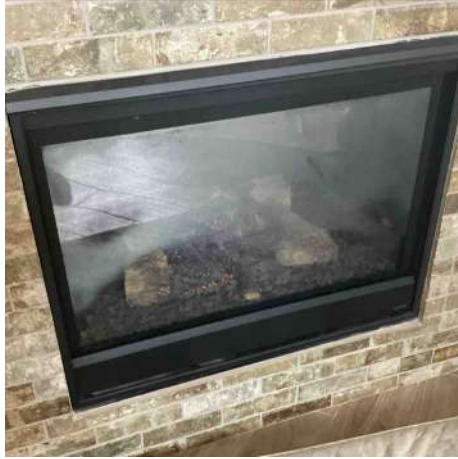
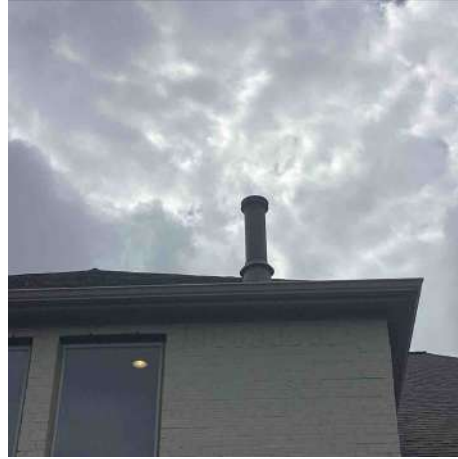
- Fireplace was tested and functioned during the time of inspection. Chimney is concealed within the wall and its own chase. The unit is a insert self-contained unit. **(Family Room)**

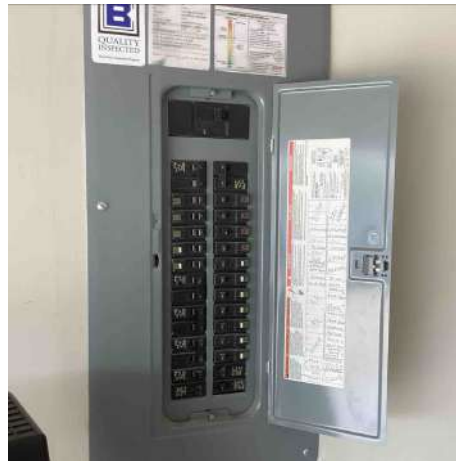
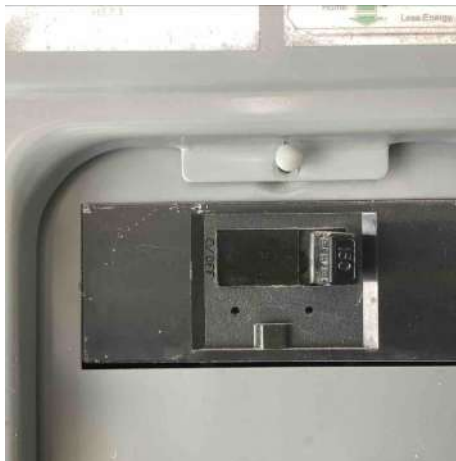
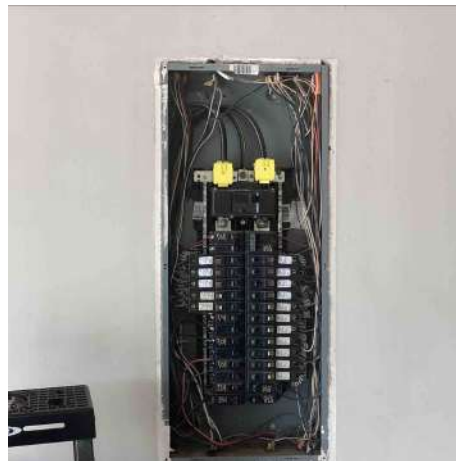
Dead front cover cover screw is missing. It is recommended to install the remaining hardware. **(Garage)**

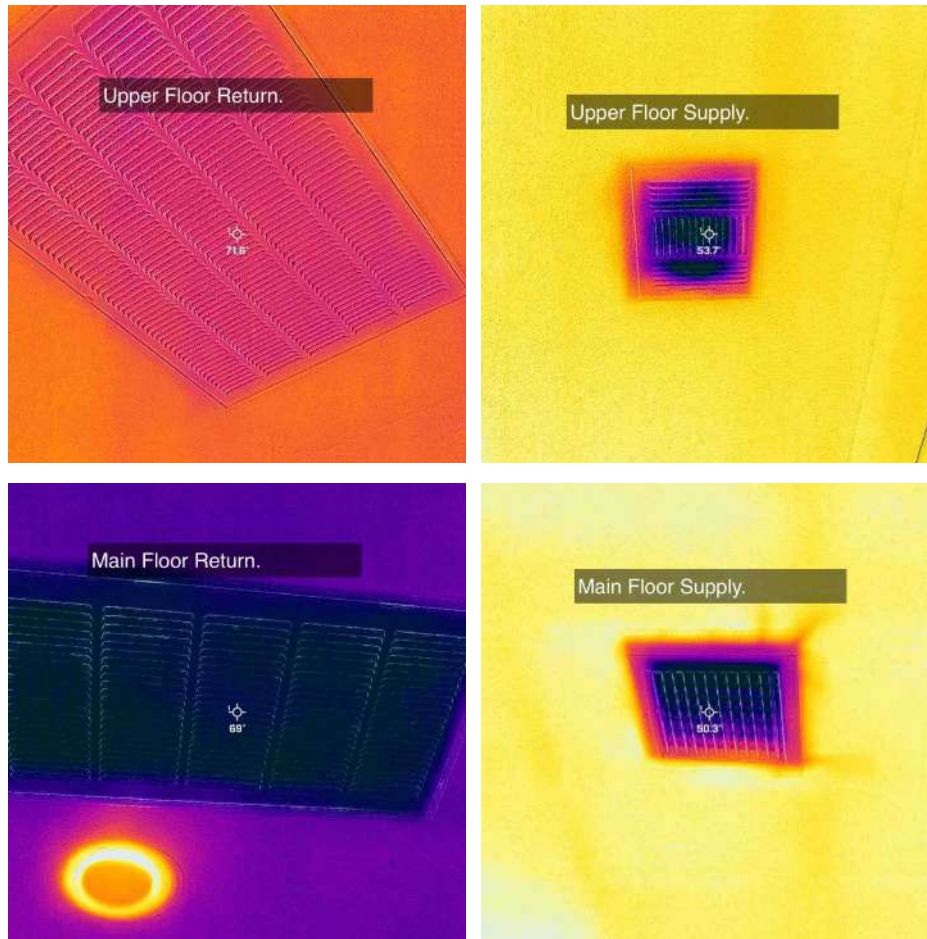
• A/C (Main Floor) return air tested at 69° degrees F. Supply air tested at 50.3° degrees F. A difference of 18.7° degrees F. 15 to 22 degrees F is considered normal differential.

A/C (Upper Floor) return air tested at 71.6° degrees F. Supply air tested at 53.7° degrees F. A difference of 17.9° degrees F. 15 to 22 degrees F is considered normal differential. **(Throughout)**

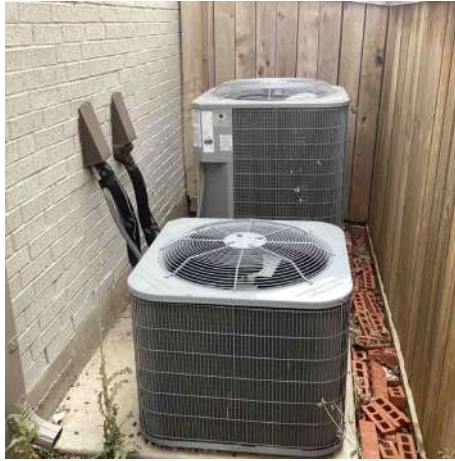
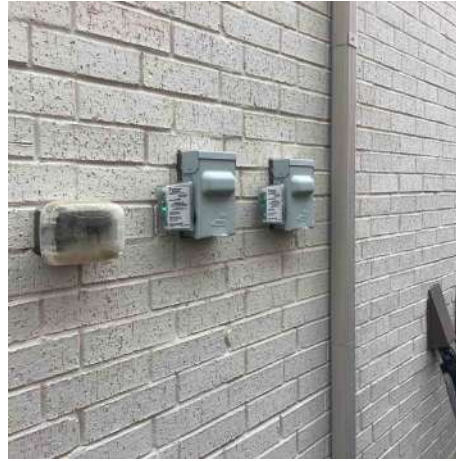
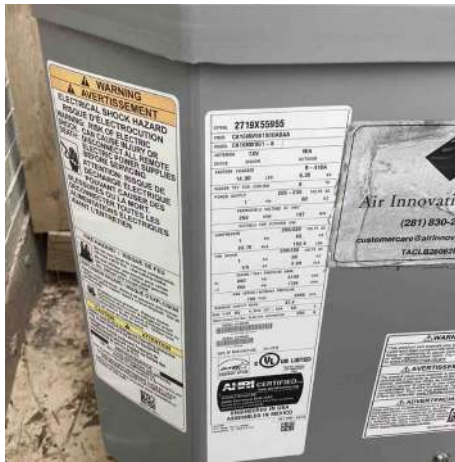
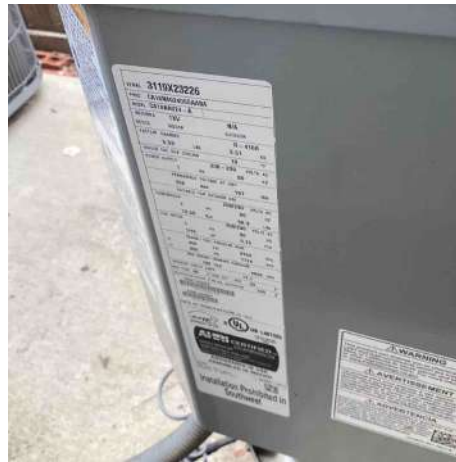
- The home is equipped with 2- air conditioning condensing units, manufactured in 2019. No deficiencies were observed during the time of inspection. **(Exterior Left)**

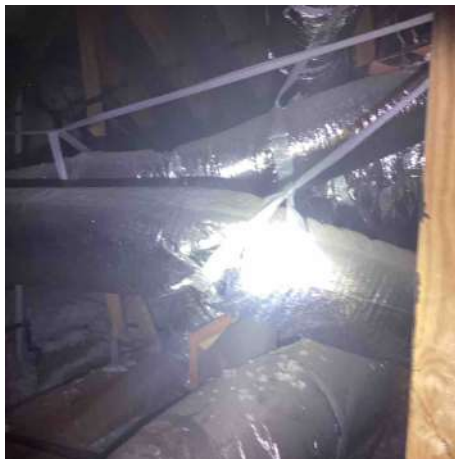
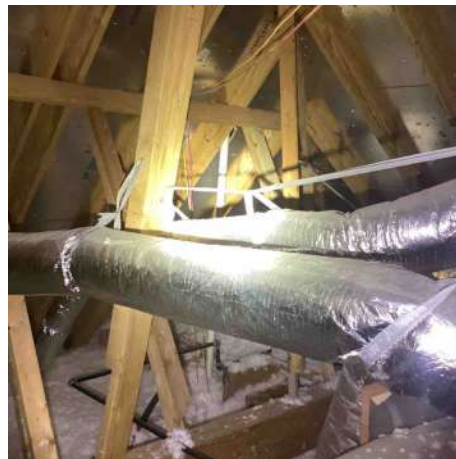
- No deficiencies were observed with the ductwork during the time of inspection. **(Attic)**

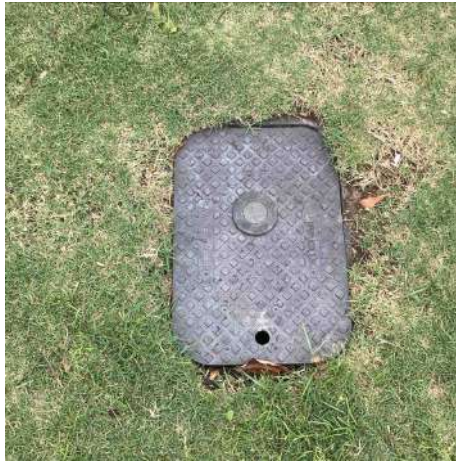
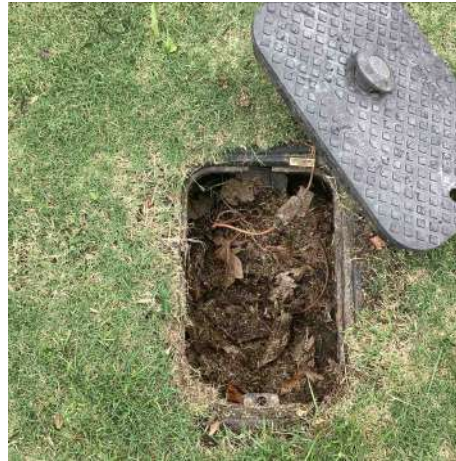
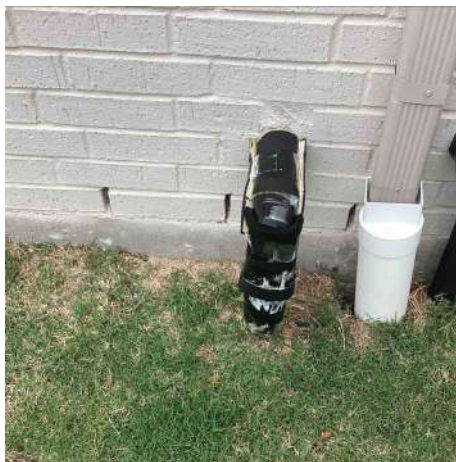
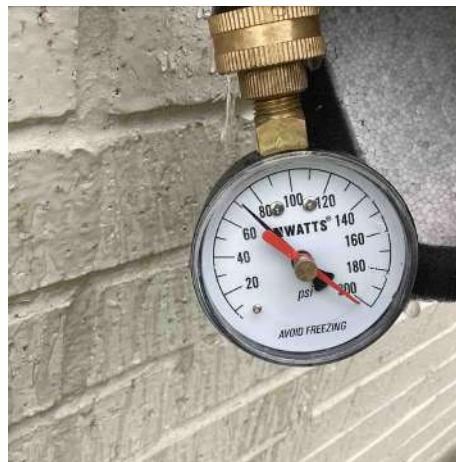
Static water pressure tested at 71 psi during the time of inspection.

- Exterior Front
- Exterior Right
- Throughout

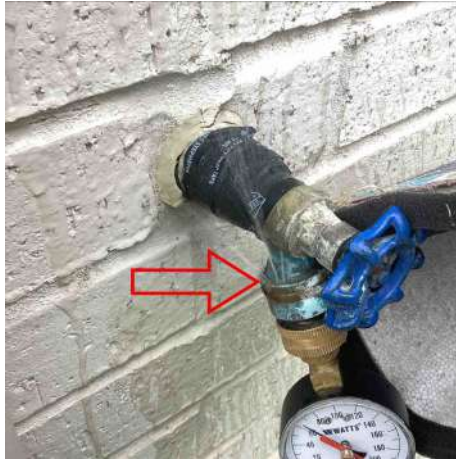
- Vacuum breaker is leaking when the faucet is under pressure. It is recommended to consult with a licensed plumber to replace the vacuum breaker. **(Exterior Right)**

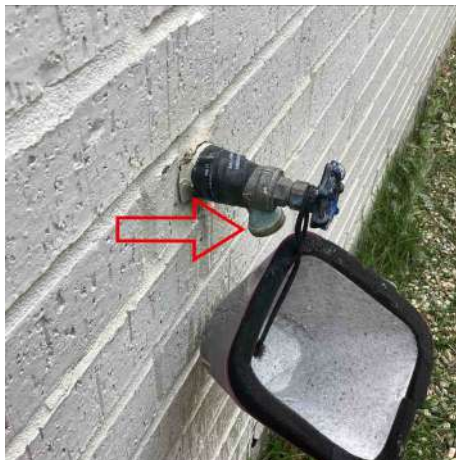
- No anti-siphon protection present on exterior hose bibs/faucets. This is a basic safety attachment to the end of faucets that will protect from a cross connection or back-siphonage into the drinking water system. **(Exterior Left)**

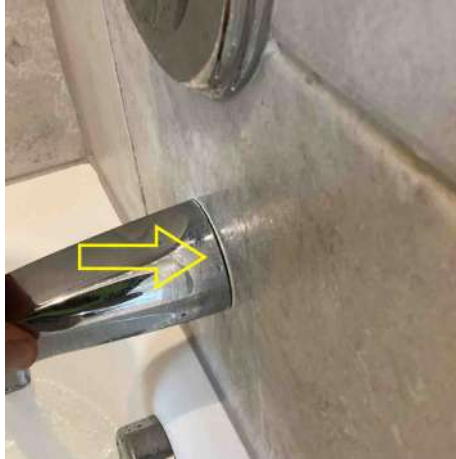
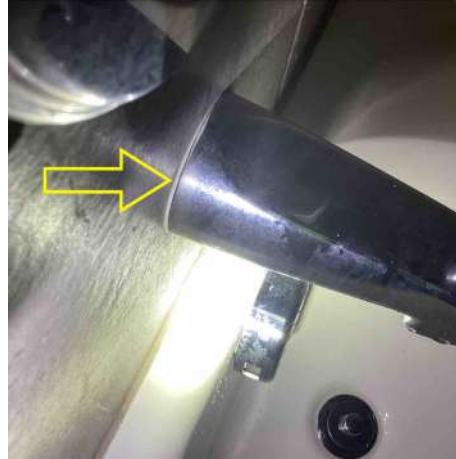
- Caulking around the tub spout is cracked. It is recommended to reapply caulking to prevent water from entering into the wall.
 - Upper Front Bedroom
 - Upper Hallway Bathroom

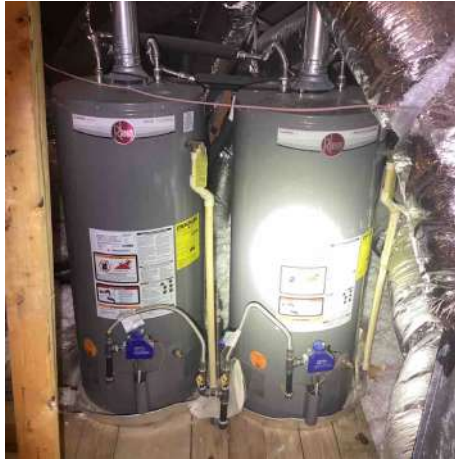
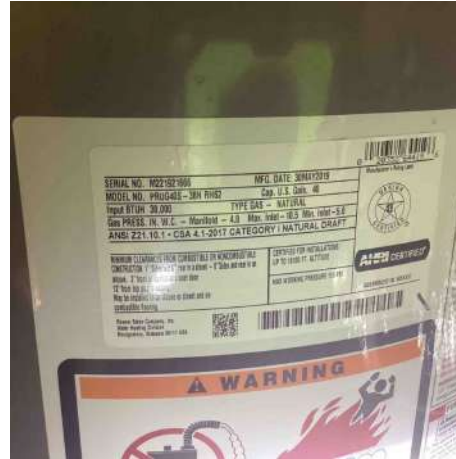
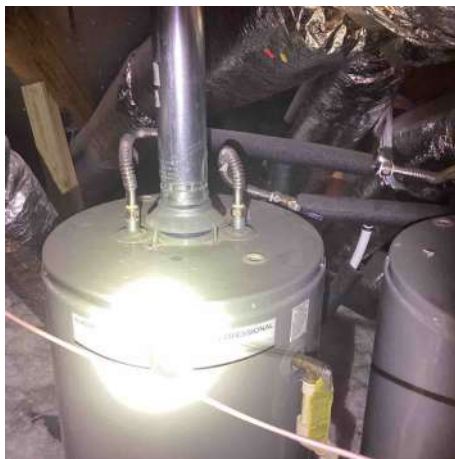
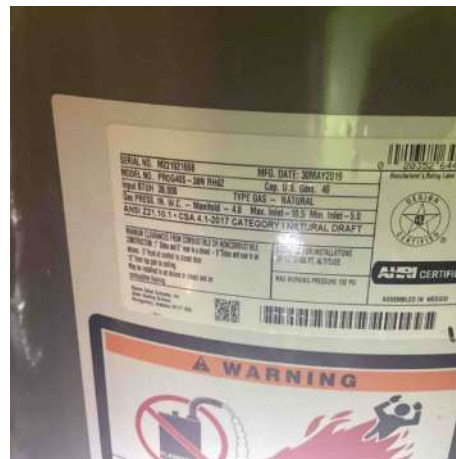
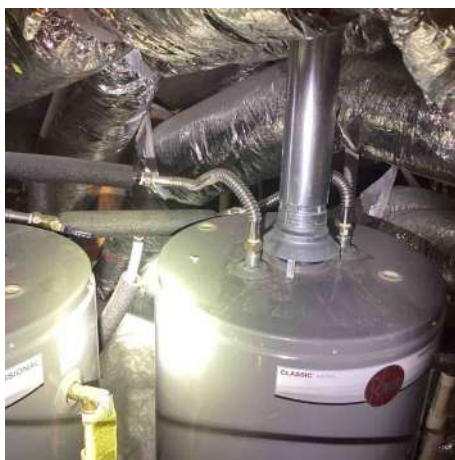
- The home is equipped with 2- 40 gallon gas fired units, manufactured in 2019. No deficiencies were observed with the units during the time of inspection.

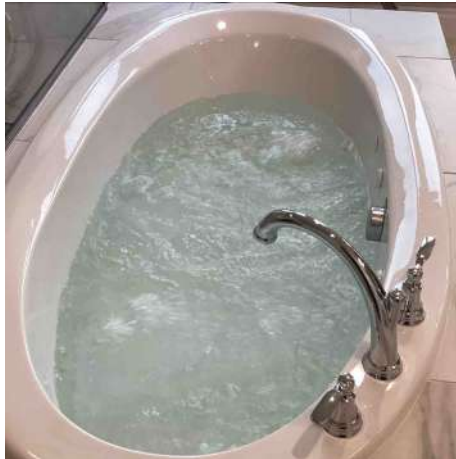
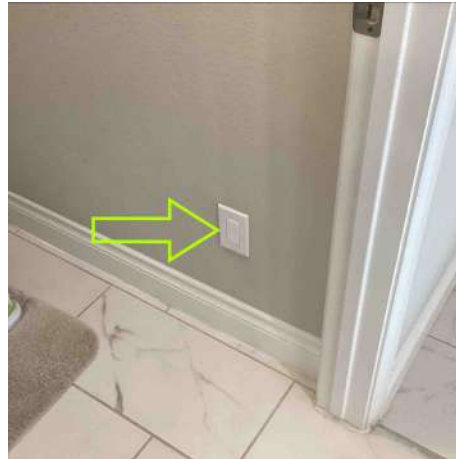
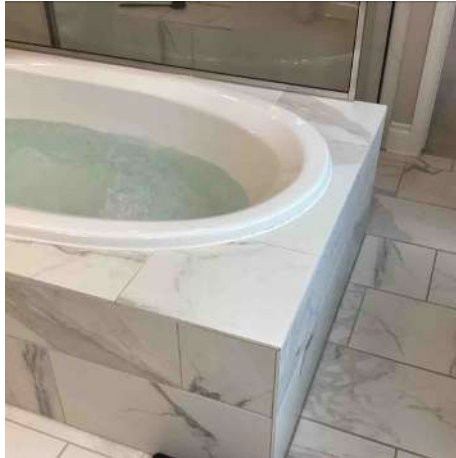
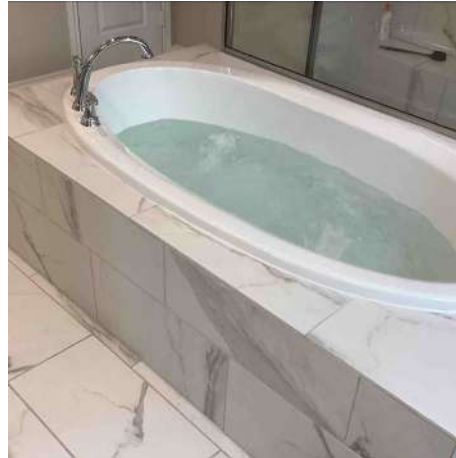
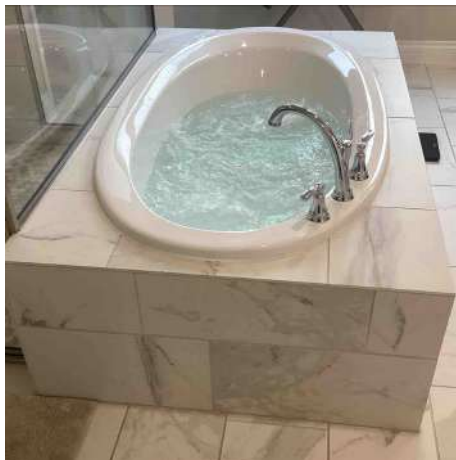
- Hydro massage tub was tested and functioned as intended during the time of inspection.

No access panel to the pump or other components of the jet tub. Please note that if a repairs are required, the tile will need to be removed. It is recommended to install an appropriate access panel for servicing purposes.
(Primary Bathroom)

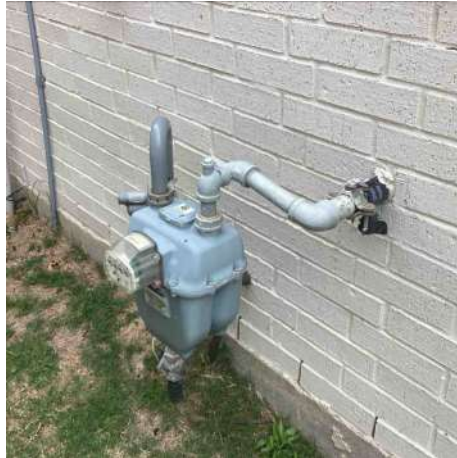
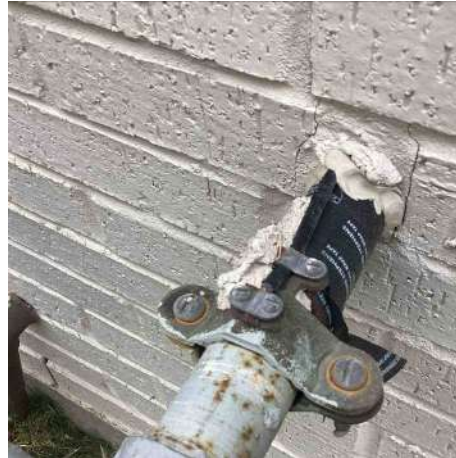
- The gas meter is located on the left side of the home. The gas meter is equipped with a bond wire. No deficiencies were observed during the time of inspection. **(Exterior Left)**

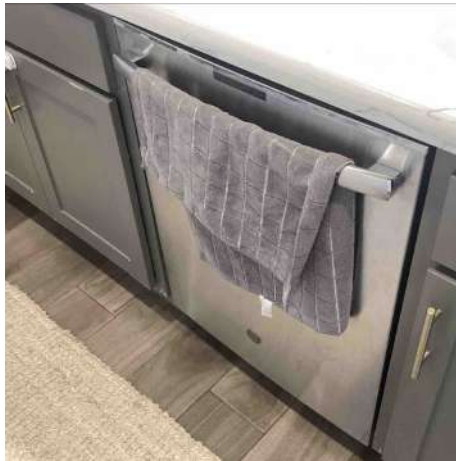
There was no anti siphon loop or mechanical air gap in the drain pipe. An air gap or anti siphon loop is used to prevent back flow of contaminated water or bacteria from the disposer or plumbing drain back into the dishwasher. Many models come with back flow valves, but the anti siphon loop or mechanical air gap is still required. An anti siphon loop is created by forming an upside down "U" in the drain hose. The top of the "U" must be in contact with the bottom of the counter. The hose is then tied in place, usually to the underside of the sink or to the faucets.

It is recommended to consult with a licensed plumber or qualified appliance company to extend the high loop to make contact with the bottom of the countertop. **(Kitchen)**

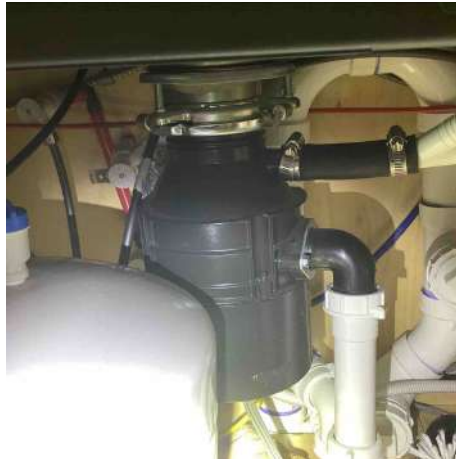
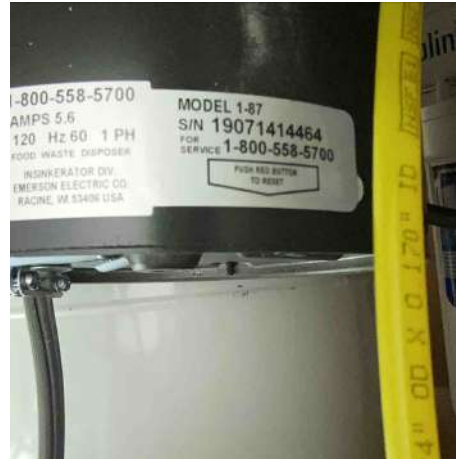
- Food disposal was tested and functioned as intended during the time of inspection. **(Kitchen)**

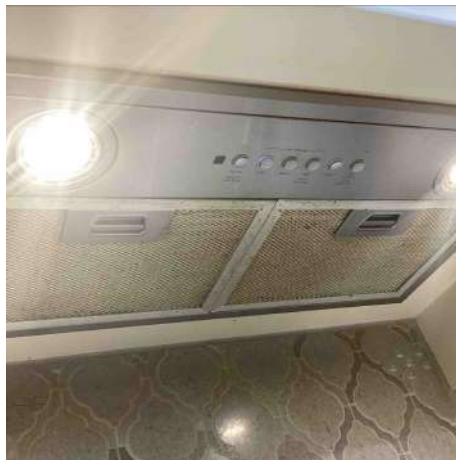
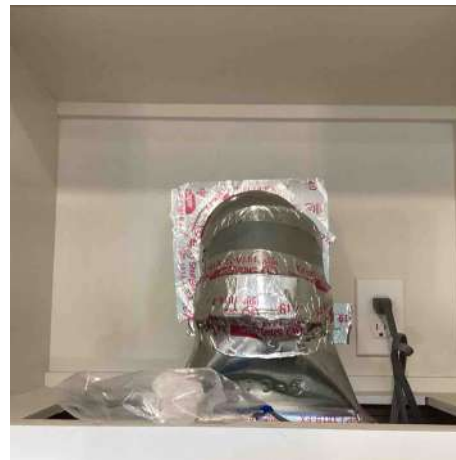
- Range hood was tested and appears to be functioning normally at the time of the inspection. Vented to the outside. **(Kitchen)**

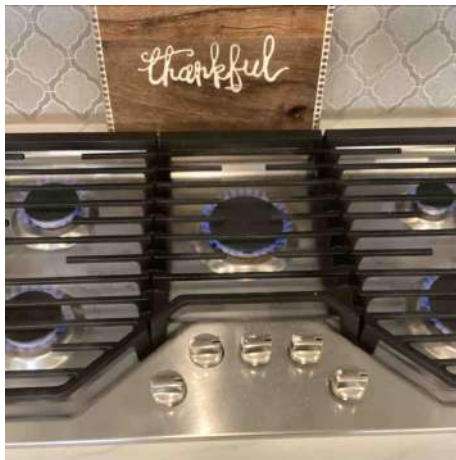
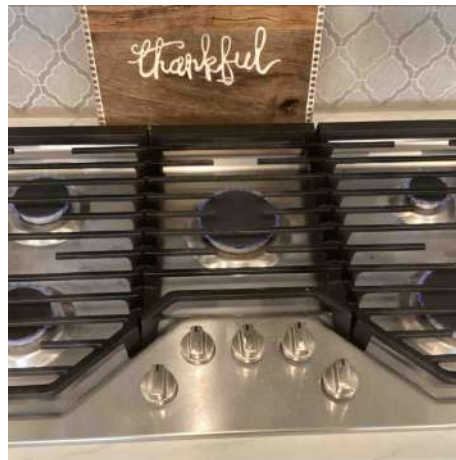
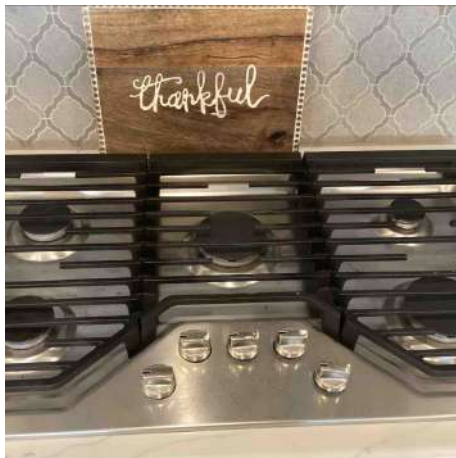
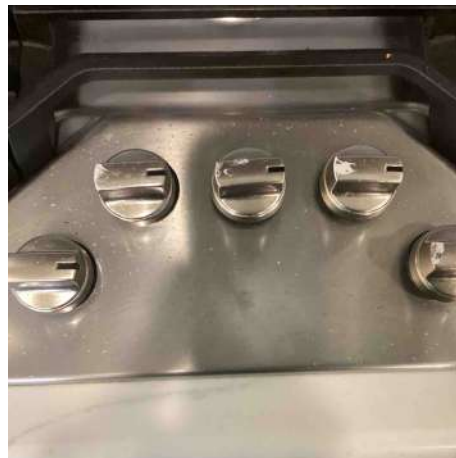
- The cooktop burners were tested on high, medium and low. All burners functioned as intended during the time of inspection.

Labeling for the burner settings has worn off. It is recommended to consult with a qualified contractor to add the appropriate labels for ease of use.

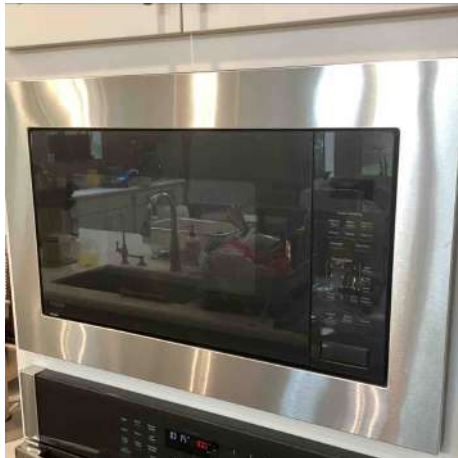
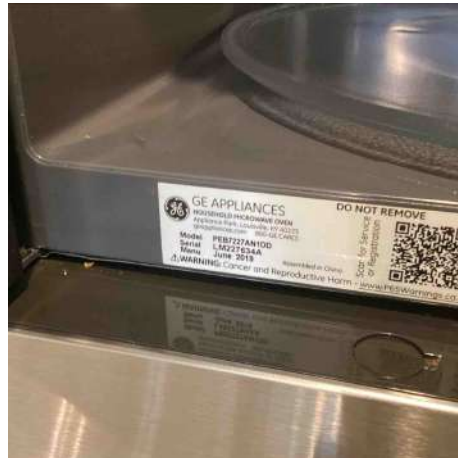
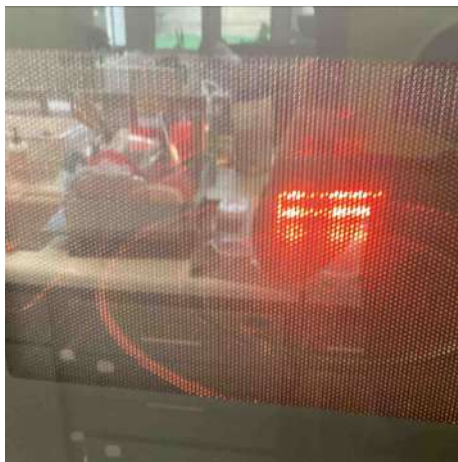
- Microwave was tested and functioned as intended during the time of inspection. **(Kitchen)**

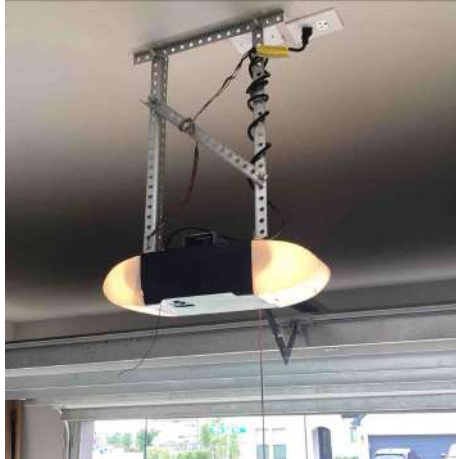
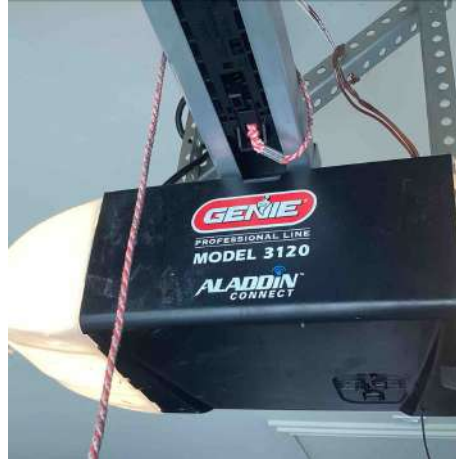
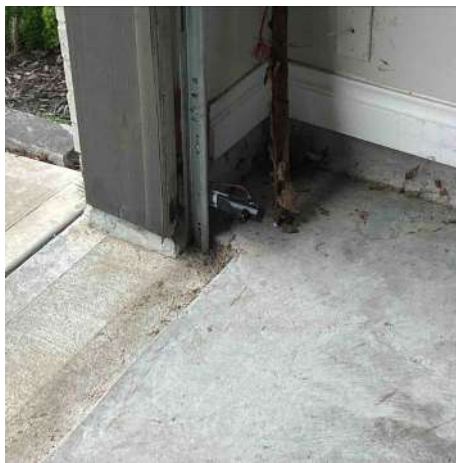
- The garage door was tested and passed the photo sensor and pressure test. No deficiencies were observed during the time of inspection. **(Garage)**
