## **Property Inspection Report**

**18726 Haughland Dr, Cypress, TX, 77433**

*Inspection Date: 5/31/2024*

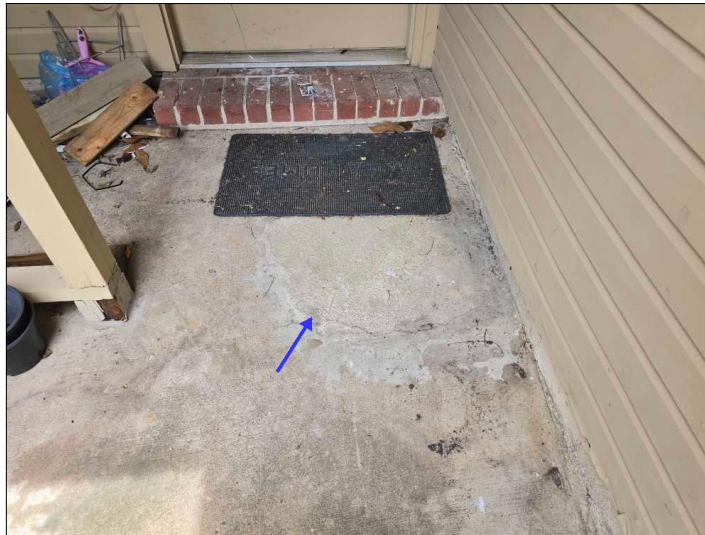
A.1. There are indications of previous foundation repair. However, there are some significant signs of subsequent movement. Recommend a structural engineer and/or foundation specialist be consulted for evaluation and/or possible repairs. There is often a transferable warranty after work has been completed, recommend contacting the homeowner for more information.

There are indications of previous foundation repair. However, there are some significant signs of subsequent movement. Recommend a structural engineer and/or foundation specialist be consulted for evaluation and/or possible repairs. There is often a transferable warranty after work has been completed, recommend contacting the homeowner for more information.

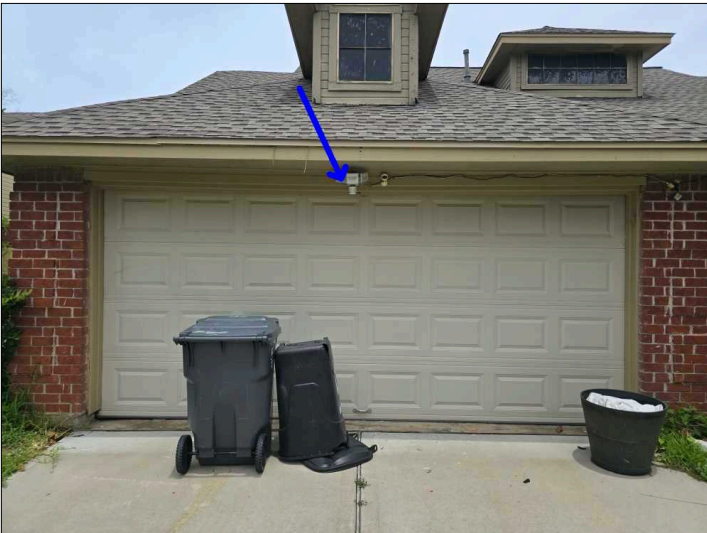
The header is showing signs of sagging over the garage. This is often caused by improper support over the garage door. If this is minor settlement and home is older this may have settled and is likely not to be a major problem in the future, however if there is substantial movement it is recommended that this be looked at by a contractor or structural engineer for further evaluation and repairs as needed.

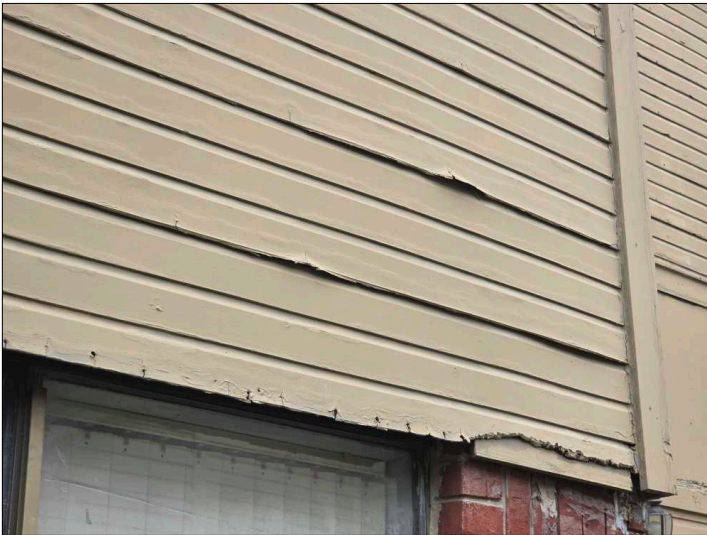
Deterioration was noted at the siding, recommend replacing all deteriorated siding to help prevent further deterioration and water penetration. Unable to determine the condition of the underlying materials. Mainly at - right

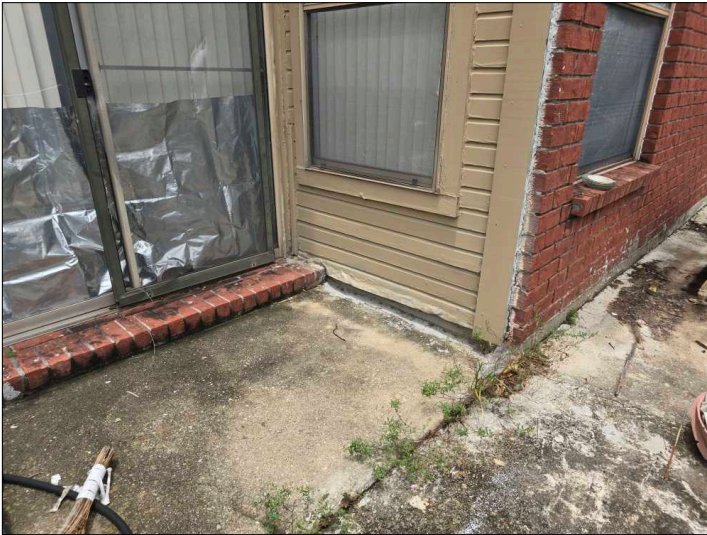
Deterioration was noted at the siding, recommend replacing all deteriorated siding to help prevent further deterioration and water penetration. Unable to determine the condition of the underlying materials. Mainly at - right

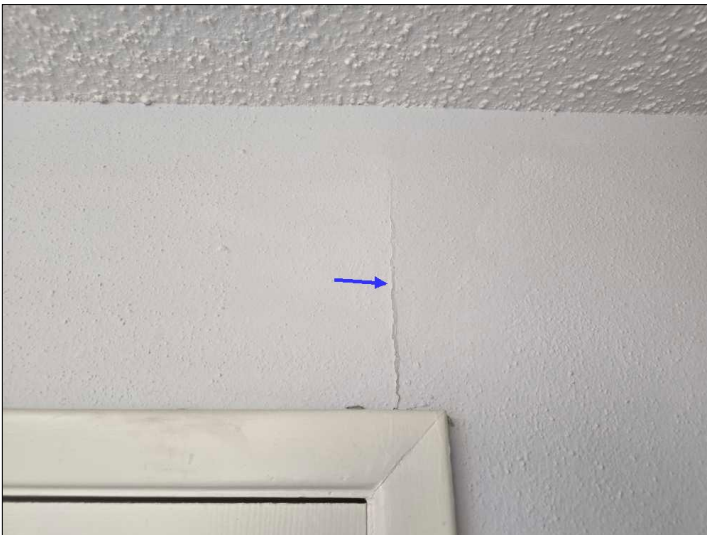
Settlement cracks were noted in the drywall. Mainly at - right rear bedroom

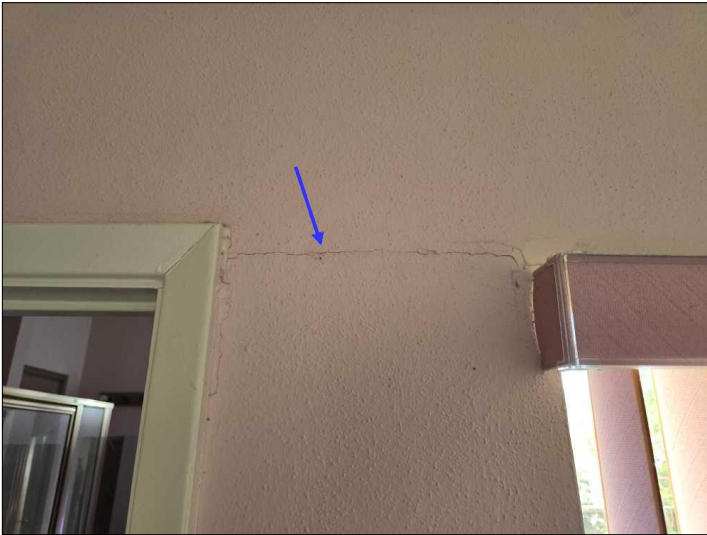
Settlement cracks were noted in the drywall. Mainly at - primary bedroom

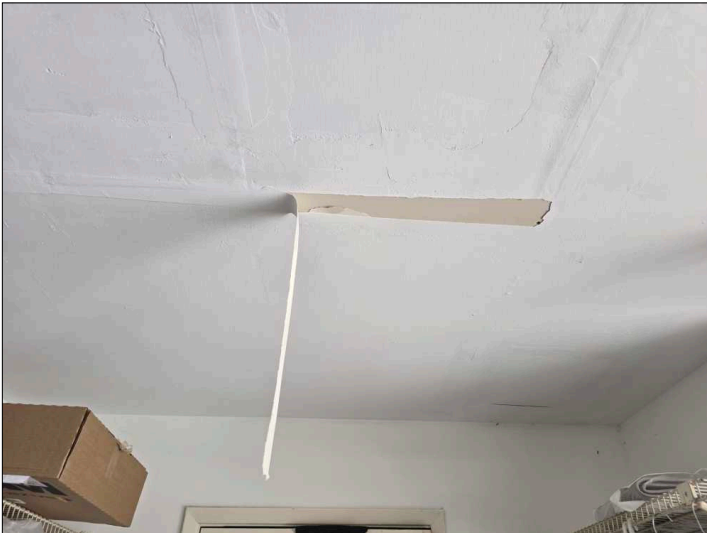
G.2. Settlement cracks were noted at the tape joint in the drywall. Mainly at - garage, kitchen

Settlement cracks were noted at the tape joint in the drywall. Mainly at - garage

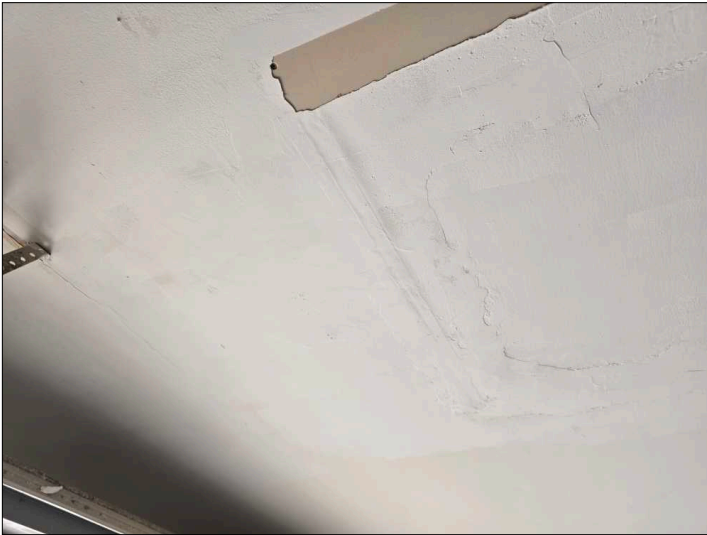
G.3. There is evidence of previous patch work and or painting on the interior finishes. This condition may limit the inspector's visual observations and ability to render accurate opinions as to the performance of the structure. Recommend contacting homeowner for more information. Mainly at - garage, living room

There is evidence of previous patch work and or painting on the interior finishes. This condition may limit the inspector's visual observations and ability to render accurate opinions as to the performance of the structure. Recommend contacting homeowner for more information.  
Mainly at - garage

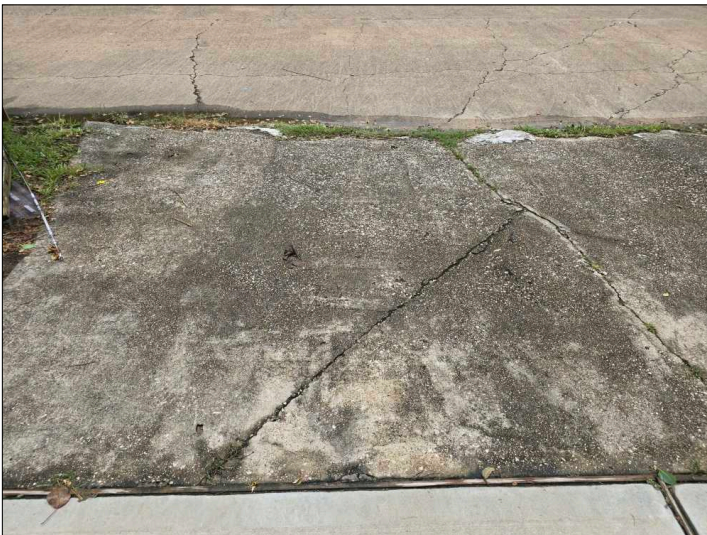
Cracks were noted in the pavement. These are cosmetic in nature at this time. Recommend sealing to help prevent further deterioration. Mainly at - driveway

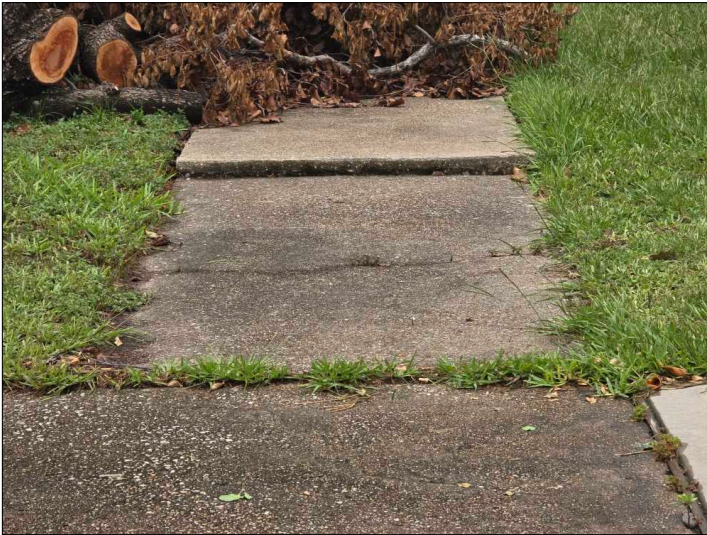
Uneven pavement was noted, recommend repairs to help prevent tripping. Mainly at - sidewalk

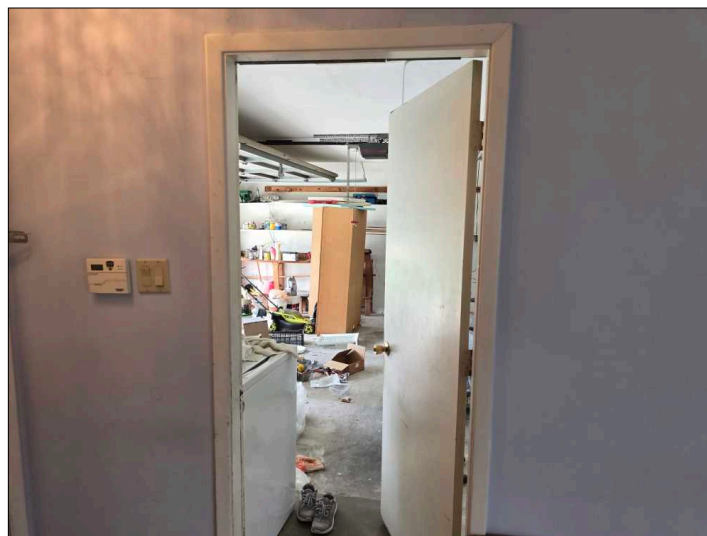
I.1. The garage door self-closing hinges are not installed.

The garage door self-closing hinges are not installed.

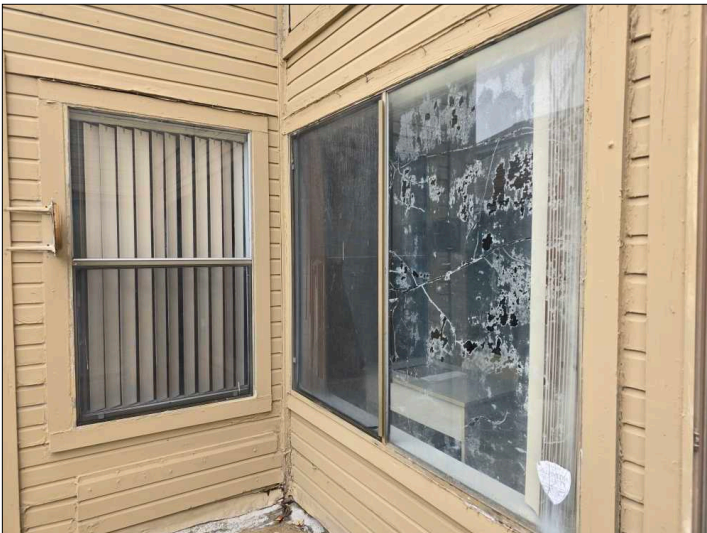
The window frame is damaged. Mainly at - right

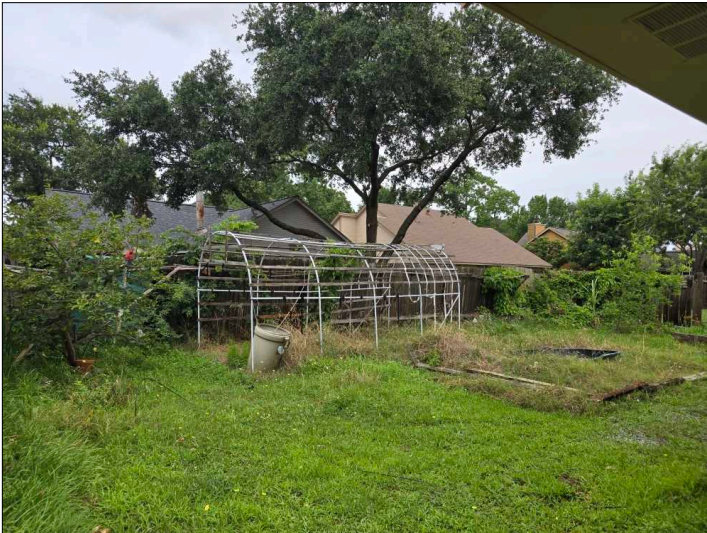
Although fences are not inspected it was noted that the fence is showing some signs of damage or deterioration.

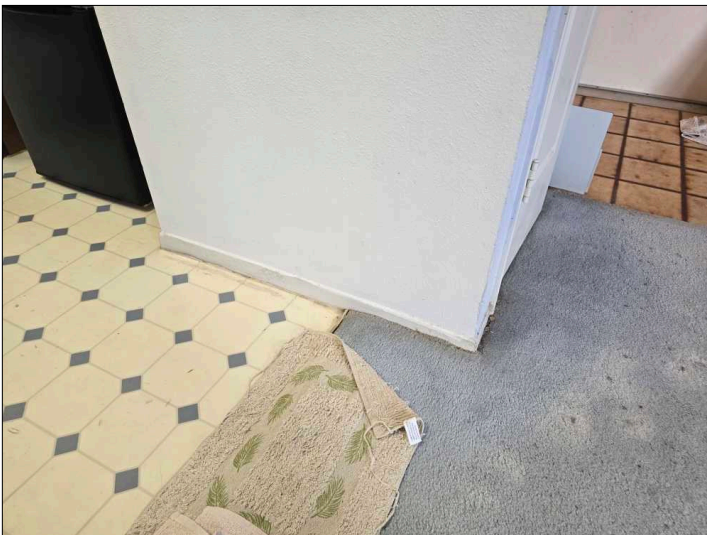
It appears that the baseboards throughout the house have sustained water damage. It is advised to either replace or rectify these issues in order to prevent further deterioration.

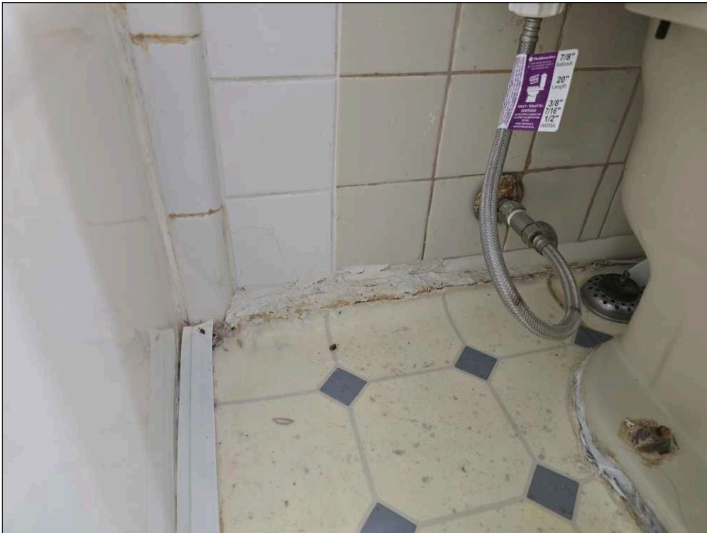
It appears that the baseboards throughout the house have sustained water damage. It is advised to either replace or rectify these issues in order to prevent further deterioration.

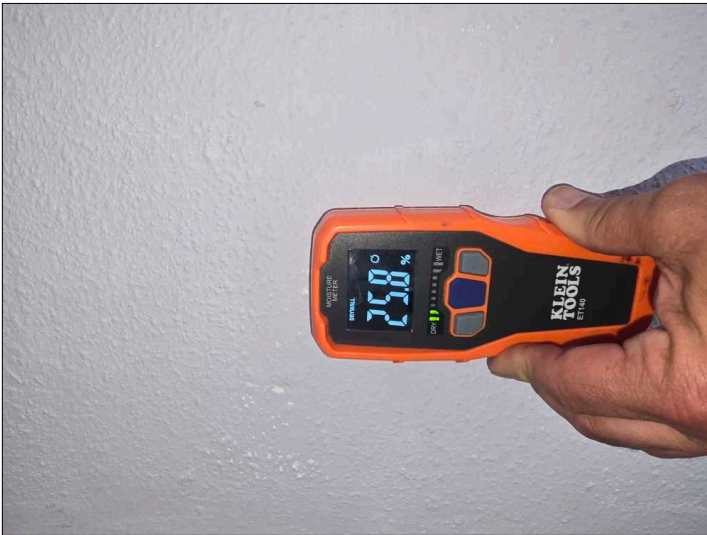
Checked water stain on the walls with a moisture meter and found to be at higher than normal moisture level. Unable to determine condition of the underlying materials. Mainly at - living room

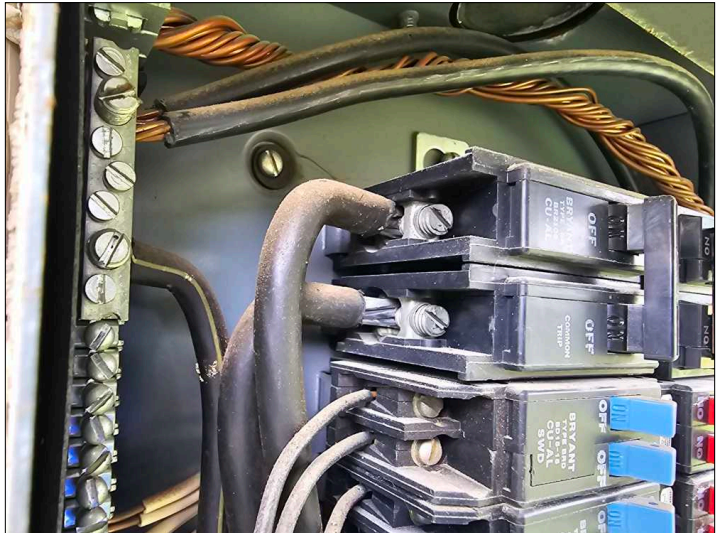
There is no antioxidant on main aluminum feeds to the panel box. This should be used to help prevent overheating.

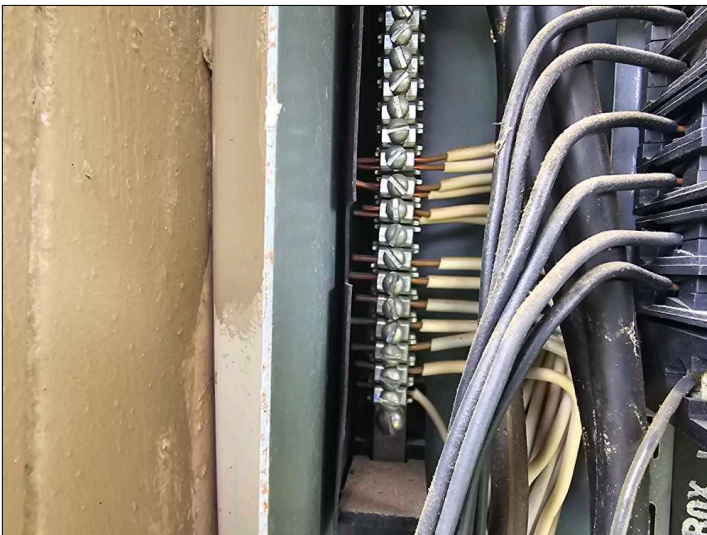
There are more than one neutral wire located under the same screw. Neutral wires should be separated to individual screws.

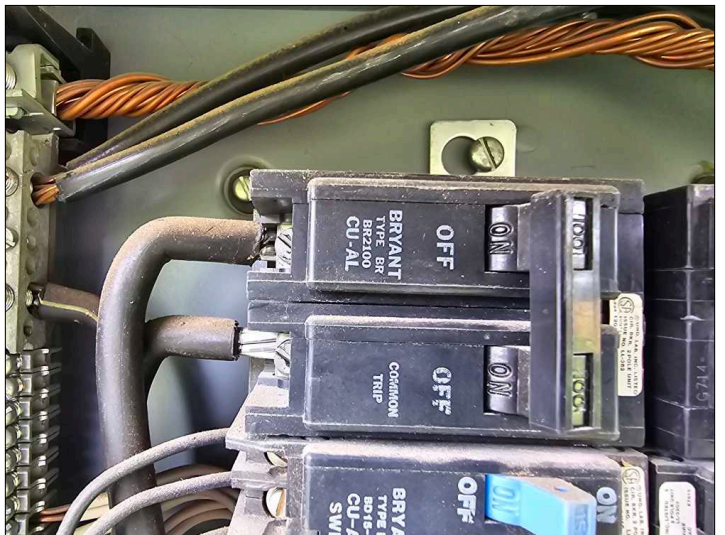
The Back-fed main breaker is not properly secured inside the panel. The back-fed main should be mechanically "fixed" to the panel and the breaker should be clearly labeled as the MAIN BREAKER. One additional requirement for a back-fed main breaker is that the "maximum amps per stab" does not exceed what the manufacturer allows. This maximum is listed in the data plate. If you back-feed a panel with a 100-amp service breaker, and the maximum allowed by the manufacturer is 125 amps per stab, then the max you can install on the other side of the stab is 20 amps.

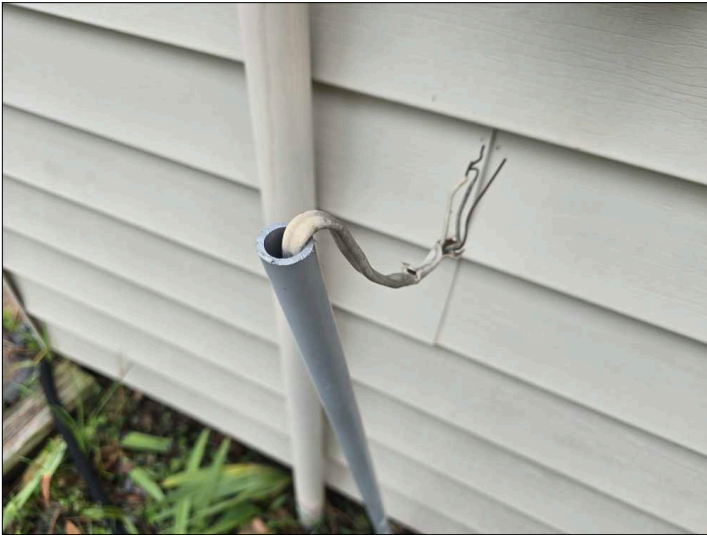
There are visible unprotected wiring splices. Recommend the wiring be properly enclosed. Mainly at - rear

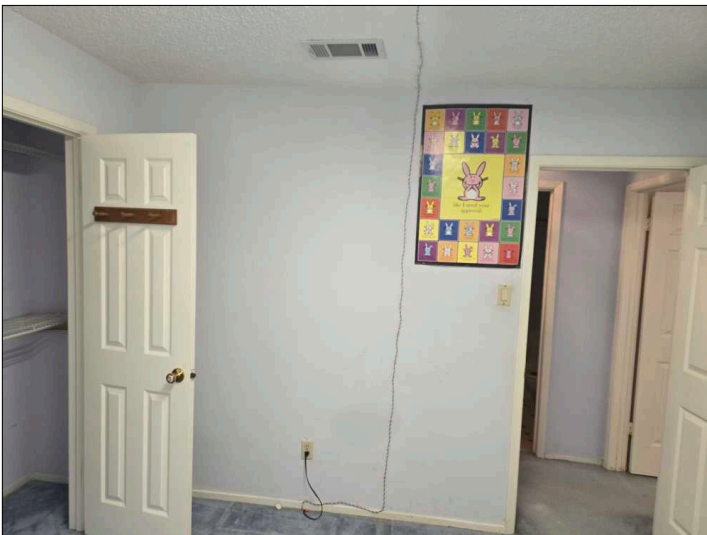
There is some extension cord type electrical wiring present. Recommend wiring be replaced with permanent wiring. Mainly at - bedrooms

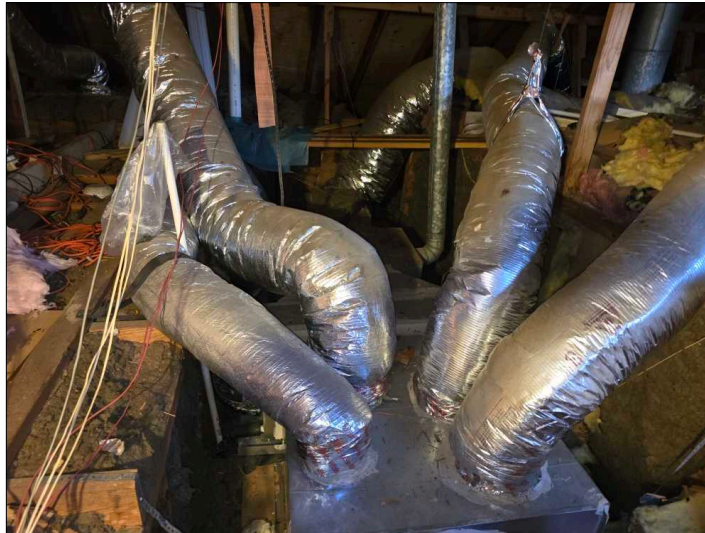
There is not an adequate workspace and/or pathway to the furnace , located in the attic as recommended.

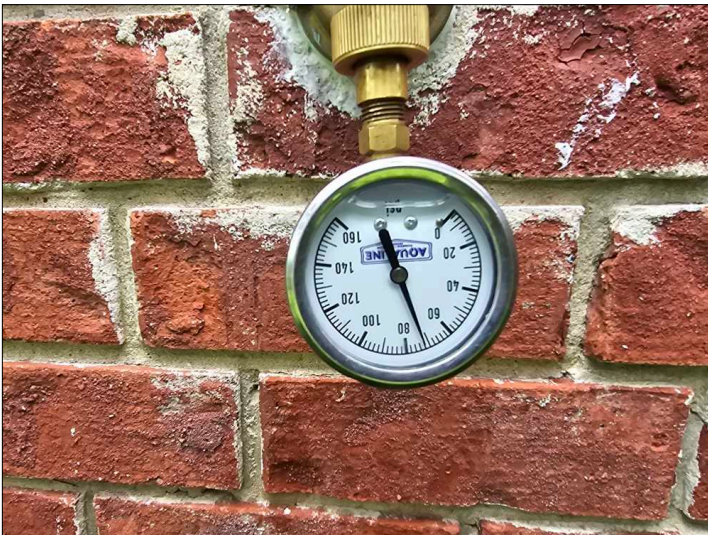
- Water supply lines are made of Copper.
- Unable to locate the main water shutoff, recommend contacting homeowner for location.
- Static Water Pressure Reading: 72 PSI.

Water Pressure for home.

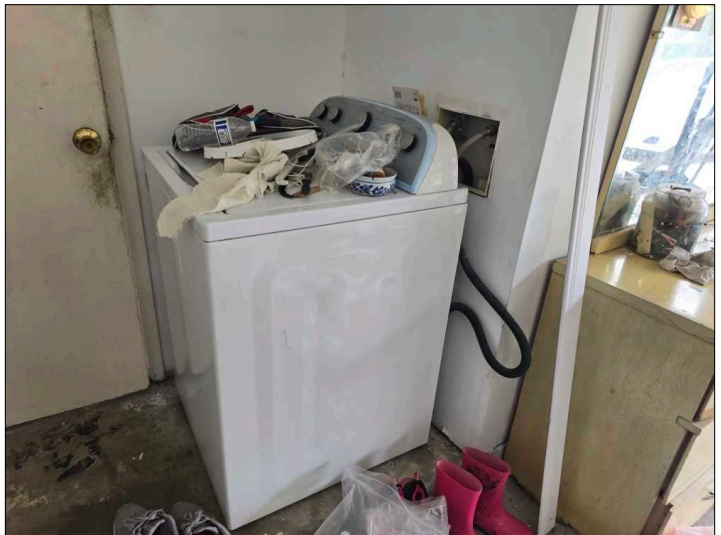
Appliances are connected and therefore the laundry water supply valves and drain line could not be tested. Sometimes when units are installed the inspector may not have been able to see behind the units and fully test electrical and plumbing connections due to limited access.

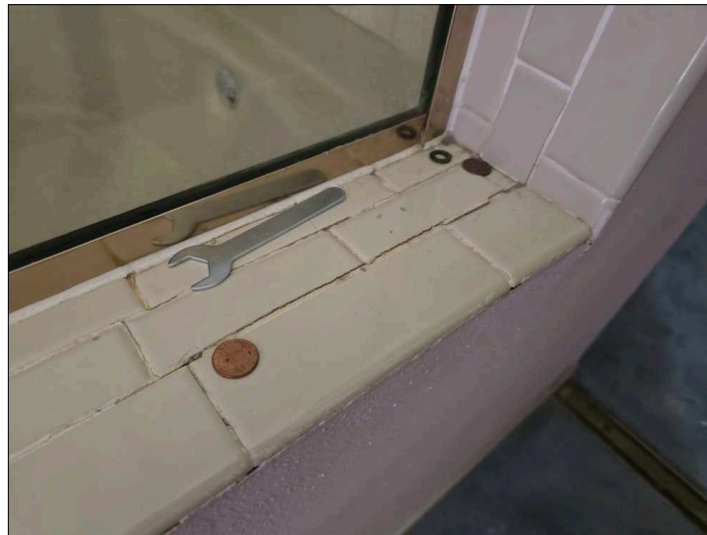
Cracked or missing tiles were noted in the tub/shower surround or shower stall, recommend repairs to help prevent water penetration to underlying materials. Unable to determine the condition of underlying materials. Mainly at - primary bathroom

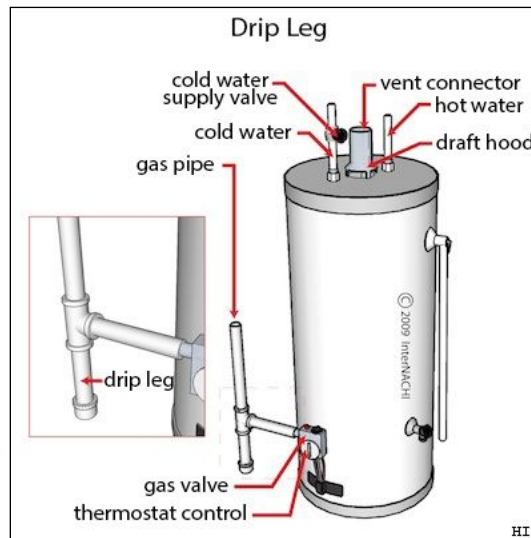
There is no drip pan for the water heater installed in the garage. It is recommended that if the water heater is installed in the home or attic that a pan be installed and drain to the exterior of the home. If the water heater is installed on the upper level of the garage it should drain to the exterior or at least drain to the lower level of the garage to help prevent the water heater from flooding the home in case of a failure.

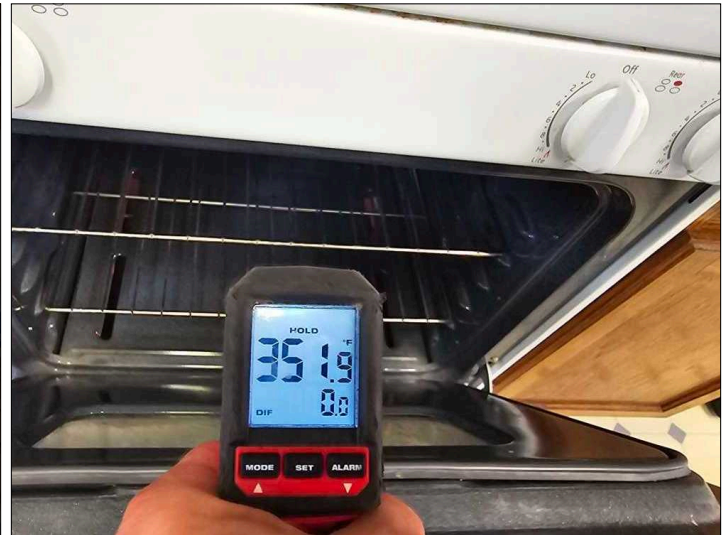
Oven Thermostat to Temperature Reading: 350F / 350-355F
