Property Inspection Report #5/16/2022 2832 Lockett Street
8616 Daffodil St. Houston, TX 77063

PROPERTY INSPECTION REPORT FORM

<u>Juan Echeverry</u>	<u>5/16/2022</u>
<i>Name of Client</i>	<i>Date of Inspection</i>
<u>2832 Lockett Street , Houston, TX 77021</u>	
<i>Address of Inspected Property</i>	
<u>Josh Burk</u>	<u>22850</u>
<i>Name of Inspector</i>	<i>TREC License #</i>
<u> </u>	<u> </u>
<i>Name of Sponsor (if applicable)</i>	<i>TREC License #</i>

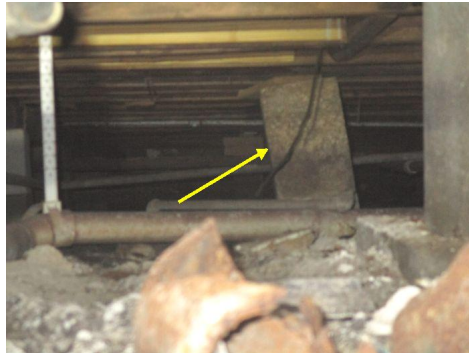
Piers leaning under center of home

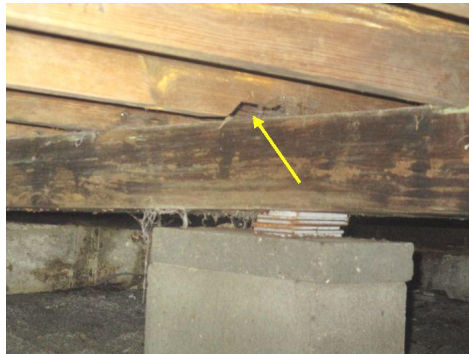
Pier leaning Northwest

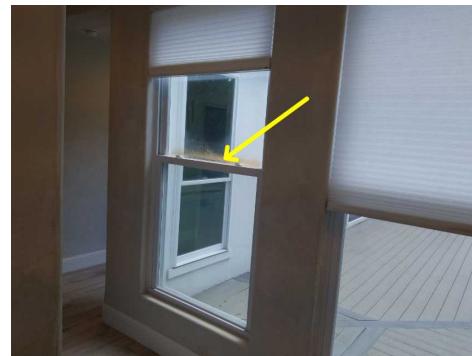
Sliding door system lost its seal

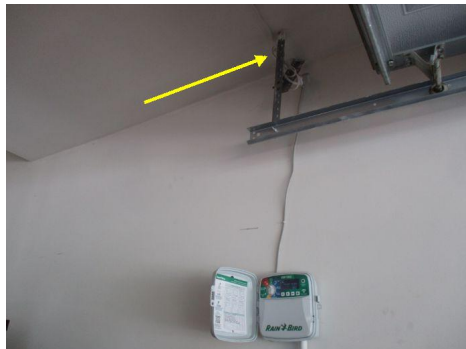
Extension cord wiring for irrigation controller
