Confidential Inspection Report

LOCATED AT:
4919 Southpoint Wy
Fulshear, TX 77441

INSPECTED ON:
Tuesday, October 31, 2023

Inspector, Chris Beasley, Paul Ferguson
A Plus Inspections of Texas

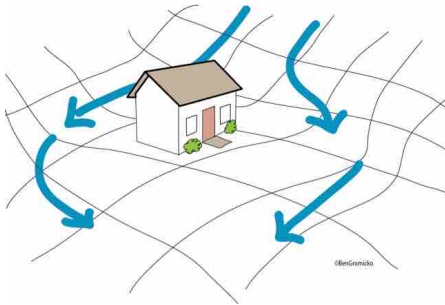
REP 1: There were low and muddy areas where water will stand on the lot and next to the home and some areas may affect the foundation. Grading and drainage adjustments and repairs should be performed. See IRC R401.3

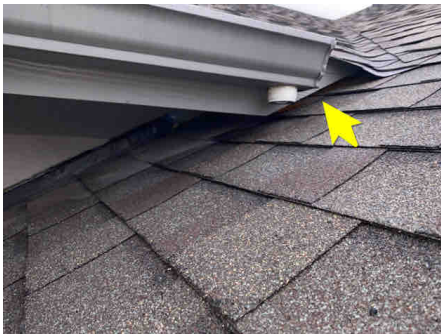
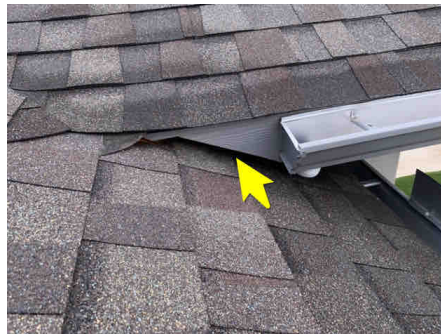
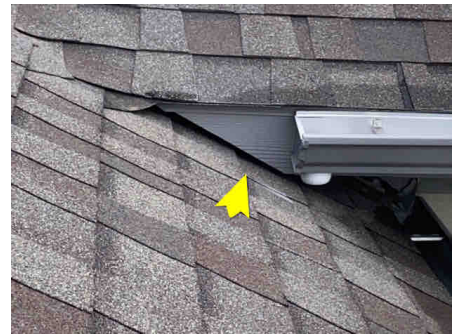
Upper front left

REP 4: There were gaps at the soffit and roofing areas that need to be covered with flashing, to reduce chances wind driven rain entry, and to keep out small animals such as rodents, bats or birds. See IRC 1503.2.1

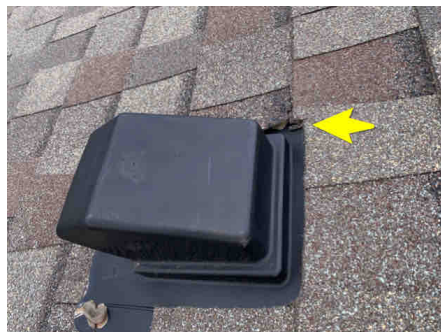
Upper front right

REP 5: The shingles had limited damages, gaps and loose parts that need to be repaired by a qualified roofing contractor.

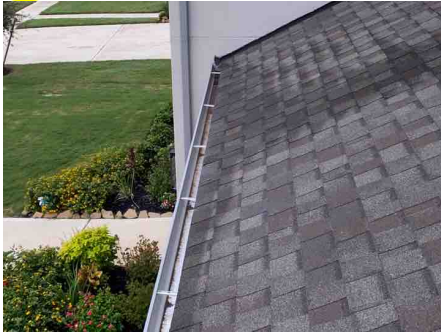
Lower roof front left

REP 6: Water was standing in some of the rain gutters. Adjustments are needed.

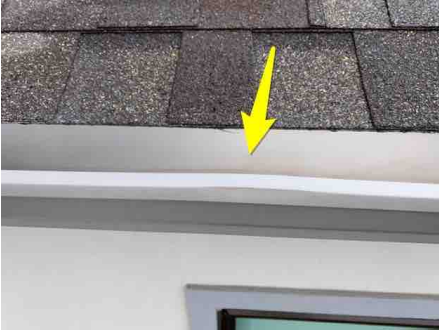
Lower back left

REP 8: The rain gutters had minor damage that could be repaired.

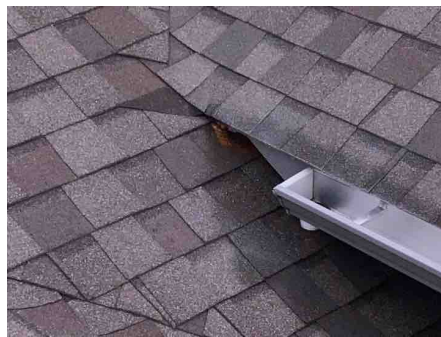
Upper front right middle

REP 9: Some of the rain gutters and gutter downspouts terminated at the roof surfaces as is found at many homes of this type. It is recommended that they be extended to the roof edges/lower rain gutters/soil areas, to reduce chances of damage and wear, and leaks at the shingles and flashings. See GAF Technical Bulletin No. TAB-R-2011-150

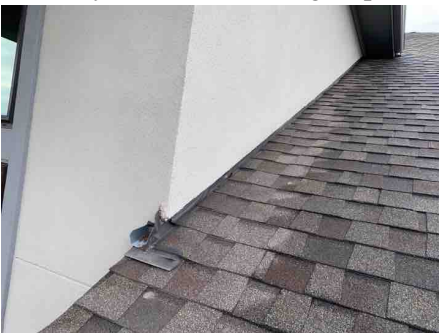
IMPR 10: J flashing was used where the walls meet the roofs as is found at most newer homes. Shingle manufacturers normally recommend using step flashing here. No damage was visible as a result of this.

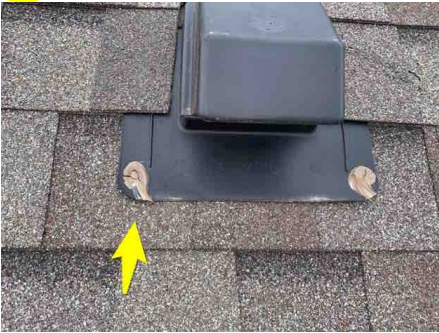
Upper front right

REP 12: Some of the vent flashing parts were found to be damaged. They need to be repaired or replaced.

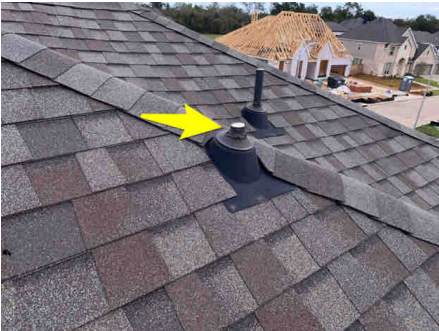
Upper front left

REP 13: One of the plumbing vents was shorter than 6" inches above the roof surface as is required by present standards. Repairs are recommended.

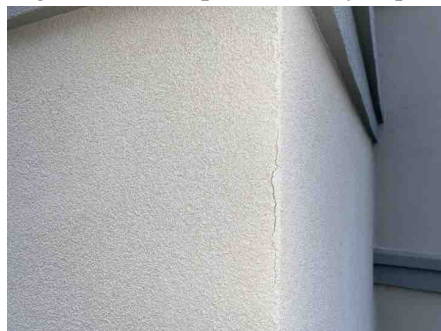
Front left

REP 17: The stucco walls had signs of settling and movement, and had gaps and damages. There may also be concealed conditions requiring repairs present. Further evaluation by a qualified stucco testing specialist is recommended. Repairs at areas with damages should be performed by a qualified stucco repair contractor.

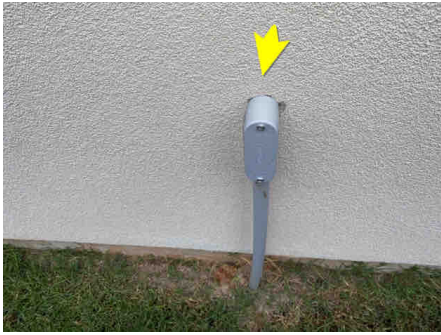
Left wall

REP 18: There were gaps at the exterior wall surfaces at multiple locations. Gaps and damages should be repaired, to reduce chances of moisture entry. See R703.8

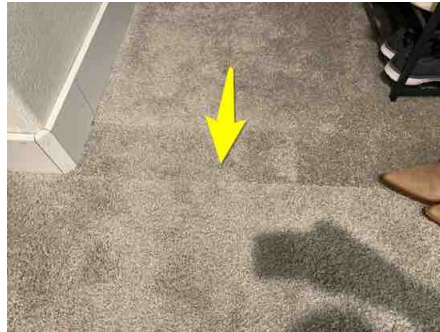
Primary closet

MONI 23: Some of the floor and floor trim parts had marks, damage, and irregularities as are found at many homes and could be repaired.

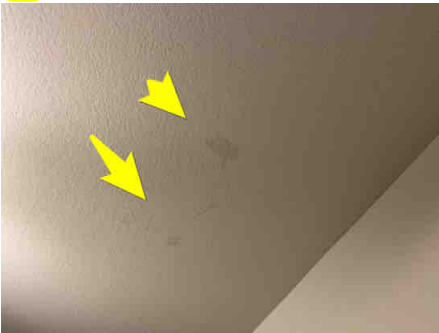
Media room

REP 26: There were limited gaps and marks at the ceilings that need to be evaluated and repaired.

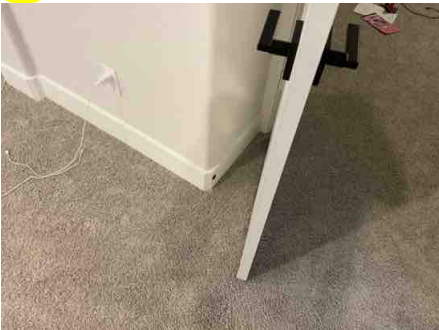
REP 28: Some of the doorstops were missing and some were broken. They need to be replaced.

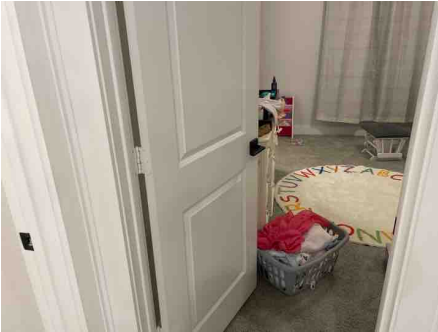
Back left guest bedroom

REP 29: Some of the doors swung shut or open after they were used. This may be related to limited settling and movement of the building, and often occurs when the foundation is a bit out of level or the framing or doors are not perfectly plumb.

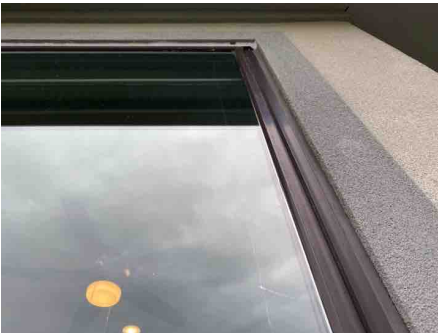
Breakfast area back window

REP 30: Some of the windows had surface discoloration. It appeared that the low-e or low emissivity coating that is a surface tint or coating to block some of the light entry and resulting heat accumulation had begun to age and deteriorate and was discolored. The damaged window panes could be replaced.

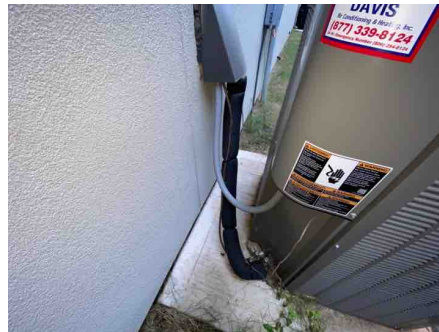
REP 40: The air-conditioner condenser unit refrigerant line insulation did not have a weatherproof protective sleeve, which should be installed. See IECC, C402.2.10.1

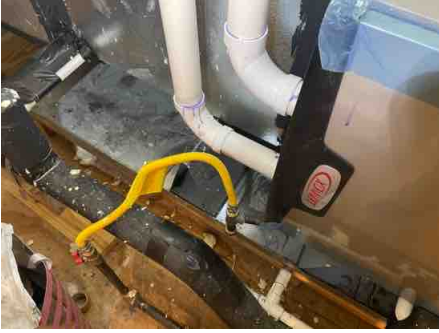
REP 43: The air-conditioner secondary condensation drain pan did not have a float cutoff switch, which could be installed to reduce chances of water damage in the building.

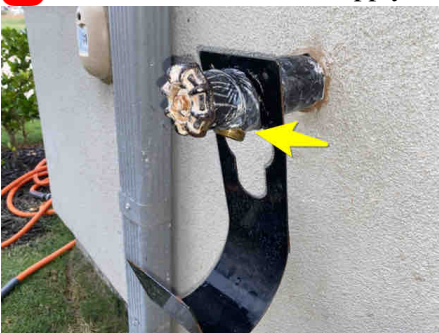
SAFT 47: The exterior water supply faucets did not have backflow prevention devices, which should be installed.

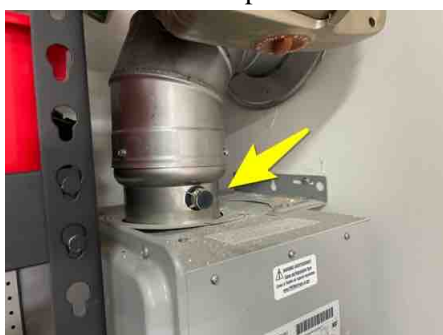
REP 51: The water heater condensation management hose and drain had not yet been installed. The drain hose and drain line should be present and should extend to the exterior of the home.

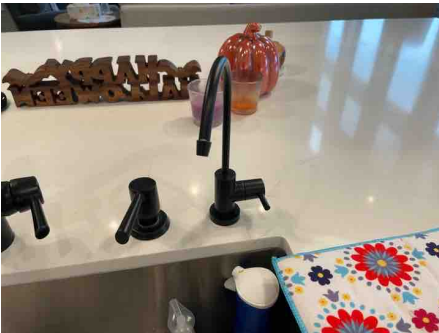
MONI 54: Part of a water filter system was present that will need to be set up for use, maintained and serviced on a periodic basis.

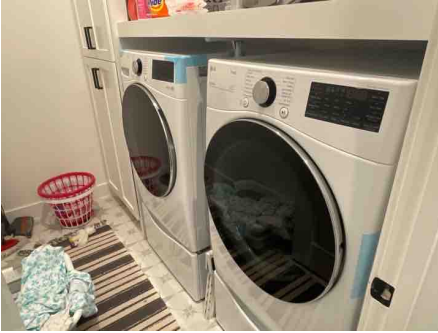
MONI 58: A washing machine and dryer were present, that were not inspected since there were clothes and items in them.

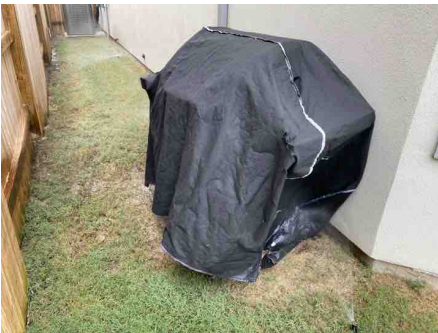
MONI 59: There was a portable outdoor cooking grill that was not inspected. As a safety precaution, the grill should be kept clean since a grease fire might cause damages. As a precaution, we recommend not using the outdoor cooking grill within 15 feet of the building.

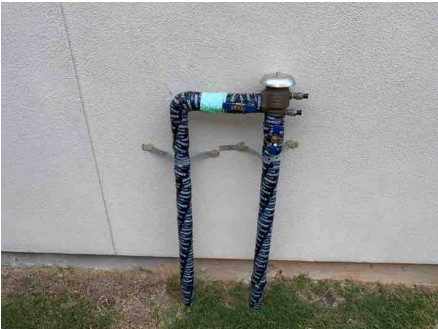
REP 60: The PVB backflow prevention device for the sprinkler system was exposed along with some of the plumbing and fittings. These should be insulated to reduce chances of freeze damage and water leaks during cold weather, or replaced with a dual check assembly, buried in a box in the soil.

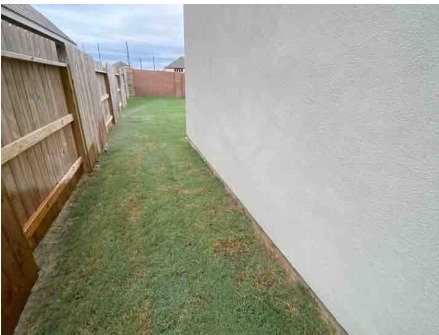
REP 61: The sprinkler system over-sprayed onto the fences, flatwork, building, etc. Adjustments are needed to reduce chances of moisture damage, slip hazards, and to prevent wasted water.

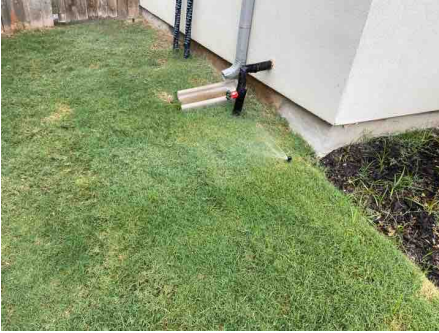
REP 63: Some of the sprinkler heads were leaning over. They need to be adjusted and repaired.
