**2328 Jackson St.
Houston 77004**

PROPERTY INSPECTION REPORT FORM

Paul Homeyer <i>Name of Client</i>	03/11/2024 <i>Date of Inspection</i>
2328 Jackson St., Houston 77004 <i>Address of Inspected Property</i>	
Ruben Santillan <i>Name of Inspector</i>	5570 <i>TREC License #</i>
<i>Name of Sponsor (if applicable)</i>	<i>TREC License #</i>

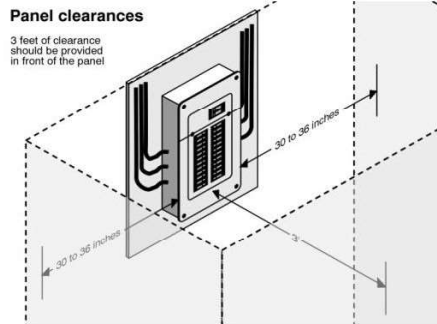
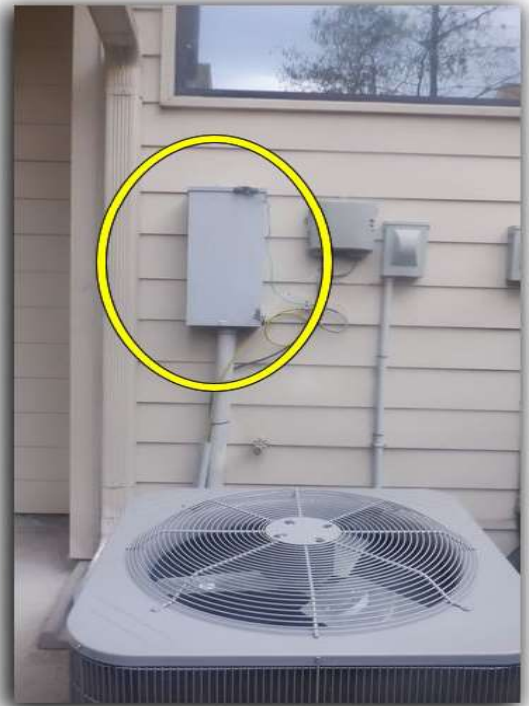
150 AMP ELECTRICAL SERVICE PANEL LOCATED AT NORTH EXTERIOR

Code requires minimum clearance to electrical service panels to be 36" in front of and 30" from side to side.

PLACEMENT OF THE HOMES ELECTRICAL SERVICE PANEL WAS INSTALLED ACCORDING TO THE CITY OF HOUSTON BUILDING CODE YEAR 2006

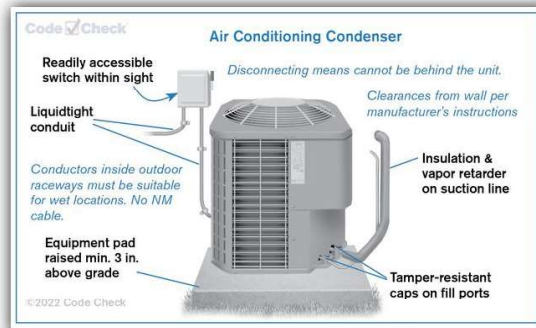
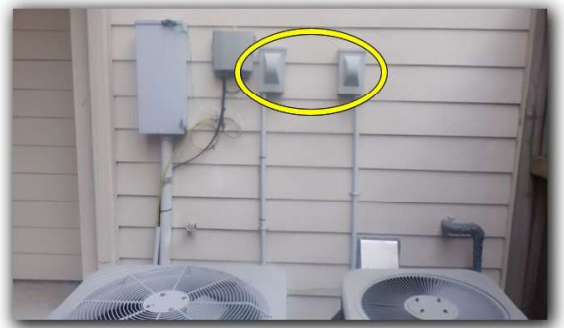
EQUIPMENT DISCONNECTS:

Code requires minimum clearance to electrical service panels (including A/C disconnects) to be 36” in front of and 30” from side to side.

ELECTRICAL SERVICE PANELS INSTALLED PER CITY OF HOUSTON BUILDING CODE YEAR 2006

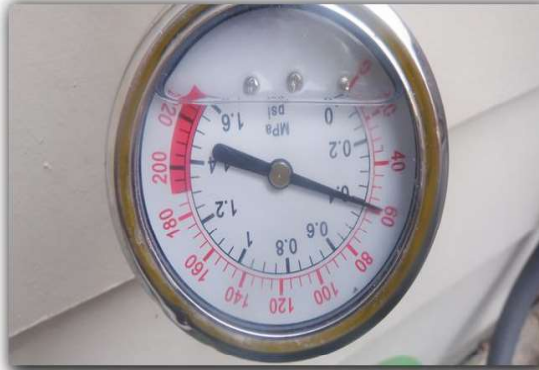
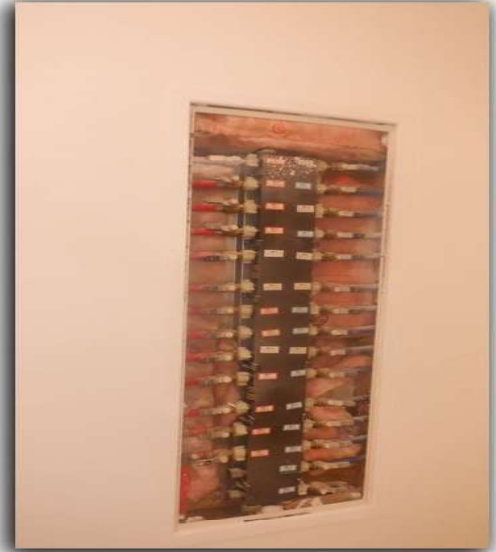
Type of supply piping material: Water supply piping observed to be predominantly PEX (cross-linked polyethylene) plastic.

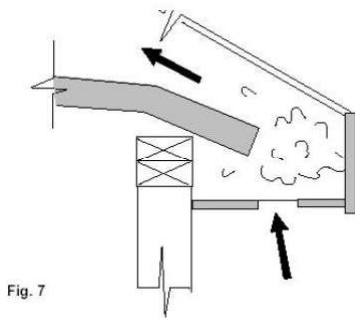
Fig. 7

Improperly vents to soffit. Should vent to exterior.

Terminating exhaust fans to soffits/eaves builds up condensation moisture within the soffit that can deteriorate the fascia board, soffit and/or plywood roof decking and cause paint peeling. A soffit/eave is part of attic air space where exterior air is drafted in to the attic space with the exhaust duct fumes and moisture.
