**MLC Real Estate
Inspections
& Building Consulting**
713.298.9310

Inspection report of: 14318 Splendid Oak, Cypress Texas

Performed for: Anna Weatherstone

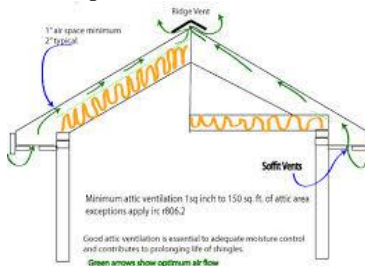
Most codes use the 1/300 rule for minimum residential attic ventilation recommendations. This means that for every 300 square feet of enclosed attic space, 1 square foot of ventilation is required – with half at the upper portion (exhaust vents) and half in the lower portion (intake vents). Attic venting is very important for heat and moisture removal. The present of the passive and motorized vents prevents the natural flow of air from the lower soffit vents allowing the area under the level of the passive and motorized vents to become stagnant and without air flow. IBC 1203.2 requires 1/150th of the attic area to be ventilated but there is an exception that is commonly used instead. Attic venting is very important for heat and moisture removal year ‘round. The present of the passive and ridge vents prevents the natural flow of air from the lower soffit vents allowing the area under the level of the passive/turbine and ridge vents to become stagnant and without air flow. The ideal is pictured below.

Reader be aware that the seller may be upset at the builder about this issue as it prevents moisture and heater removal from the attic.

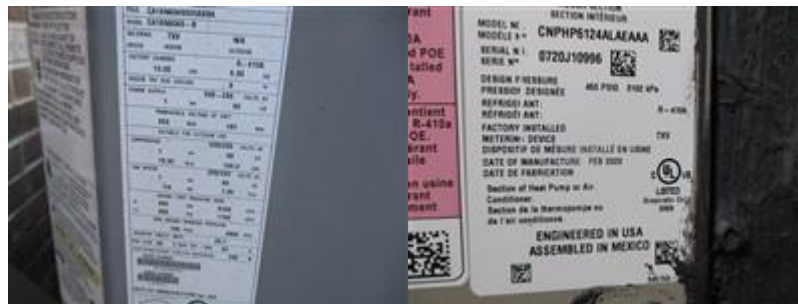
Label missing/weathered

Temperature differential: Supply 63 Return: 78 Differential: 15

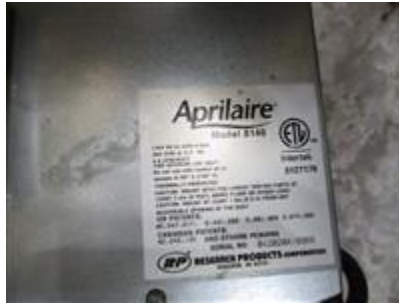
There is an Aprilair connected to the intake which is not within the scope of this survey.
