Inspection Report

Property Address:
6823 Garnet Trail Ln
Richmond TX 77469

Golden Scope Inspection, LLC

PROPERTY INSPECTION REPORT FORM

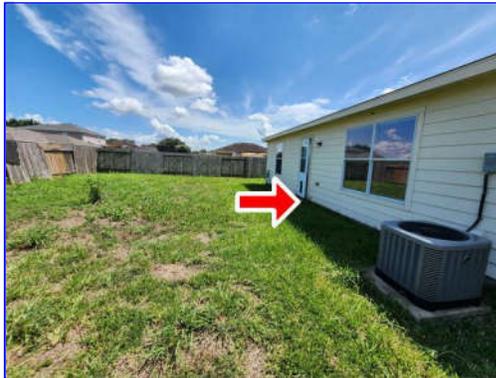
B. Item 4(Picture)

(2) The downspout need an extension with splash block to carry water away from the foundation. Failure to add these extensions may potentially adversely affect the foundation performance long term.

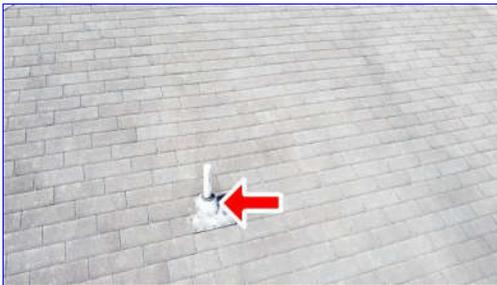
C. Item 29(Picture)

(6) Exposed nail heads at the roof surface should be sealed to prevent water intrusion.

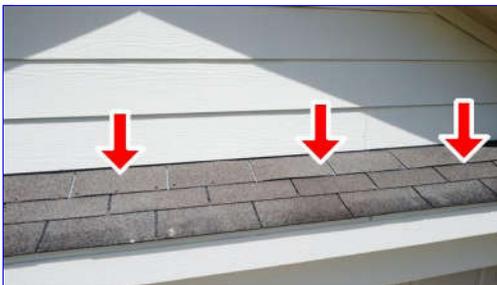
C. Item 30(Picture)

(7) Drip edge flashing along the roof edge was observed to be missing, damaged or installed improperly. Drip edge flashing is needed to support roofing at the roof edge and to protect the roof decking from moisture. A qualified, verified roofing contractor should be consulted regarding this condition or any repairs that may be needed.

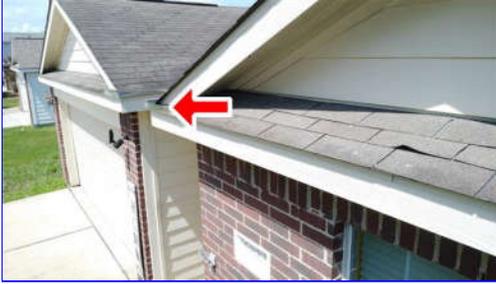
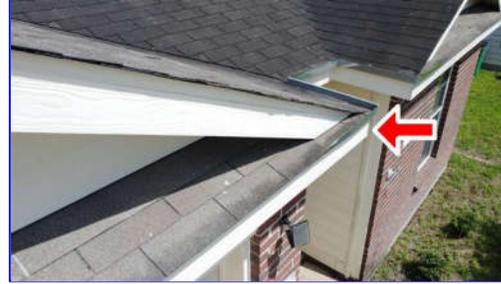
(8) A flashing, sometimes called a "California Gutter" is installed. This flashing diverts the intended flow of water down the roof, to a direction parallel with the shingles. In some case this can cause water to back up under the shingles, damaging the roof decking.

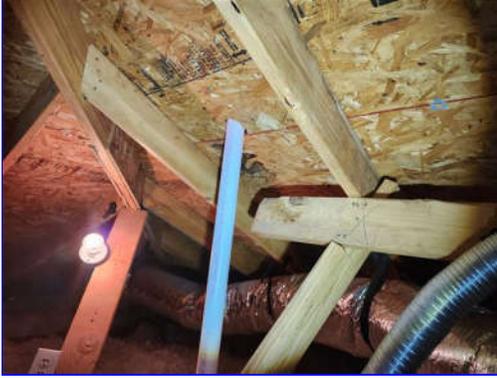
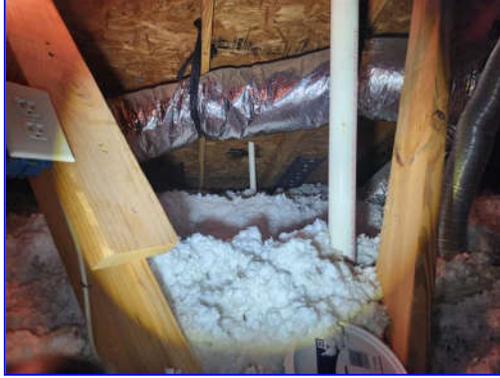
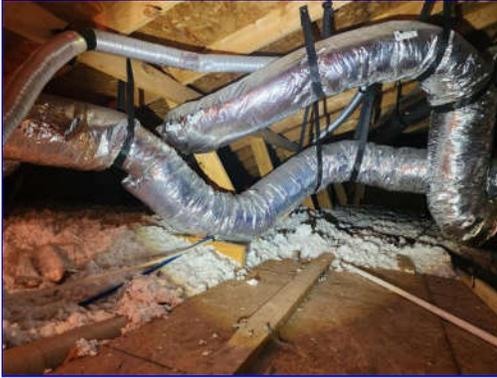
(3) Various sheathing was observed to be discolored. This appears to be from moisture intrusion. It is unknown if the cause of this condition has been repaired. A qualified, verified roofing contractor should be consulted for further evaluation.

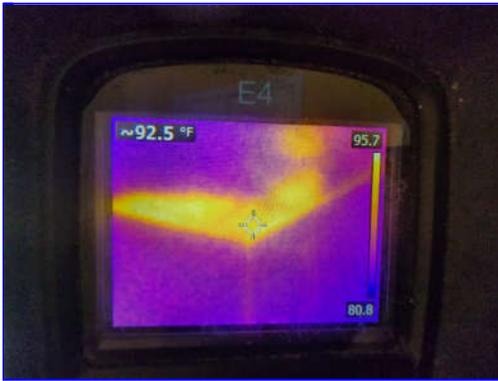
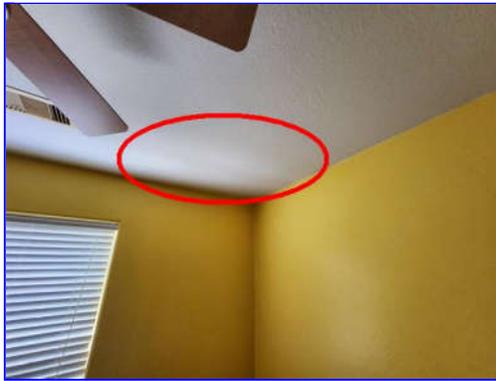
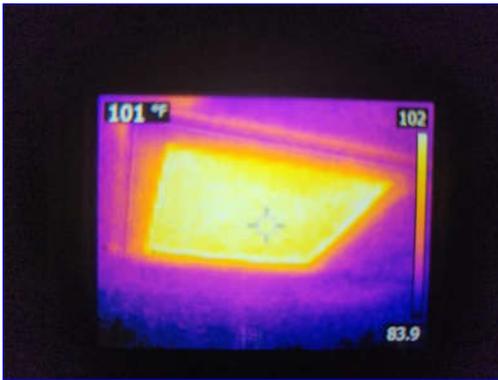
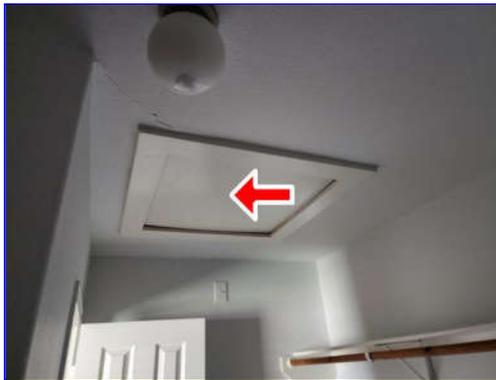
(4) Insulation was observed to be misplaced or moved from its proper location. Insulation should be replaced to the intended location. Insulation should cover the ceiling joists to prevent potential thermal bridging. Thermal bridging is the movement of heat across the framing that is more conductive than the materials around it. The framing material creates a path of least resistance for heat. Thermal bridging can be a source of energy loss in homes. This can lead to increased energy bills.

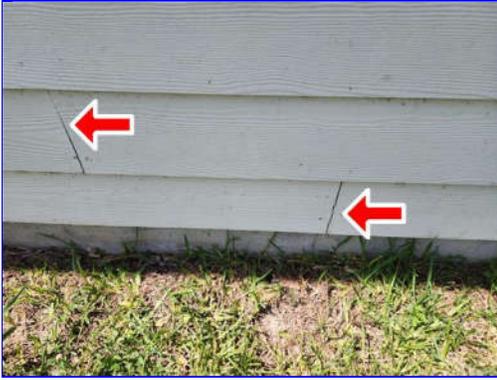
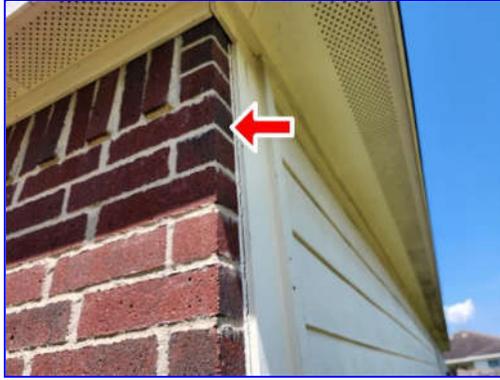
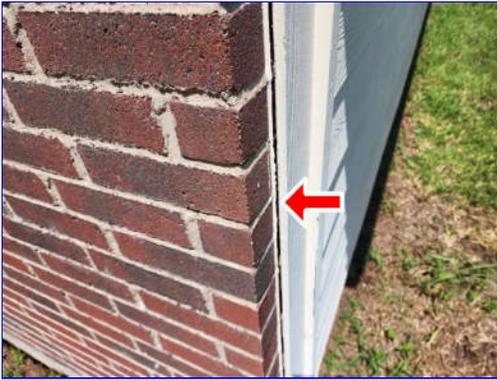
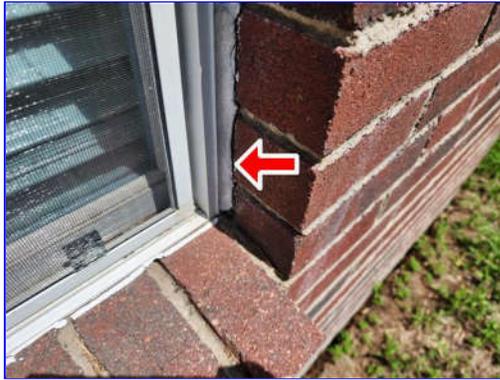
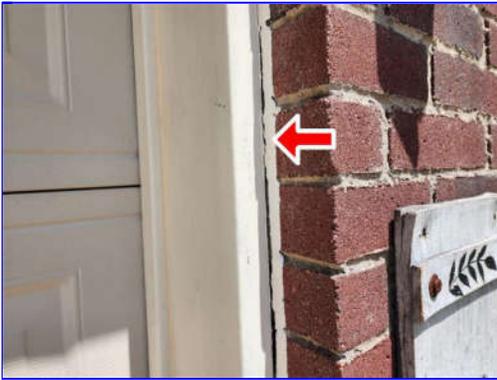
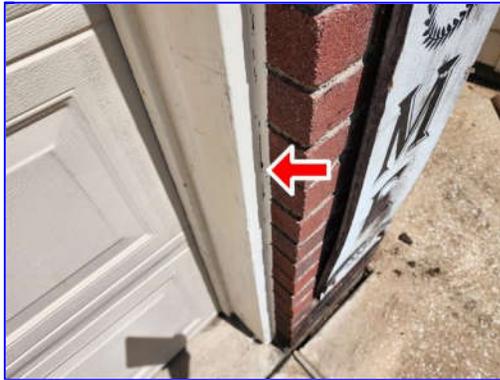
(2) Caulking trim, siding and windows in various locations, was observed to need improvement. Make improvements as needed.

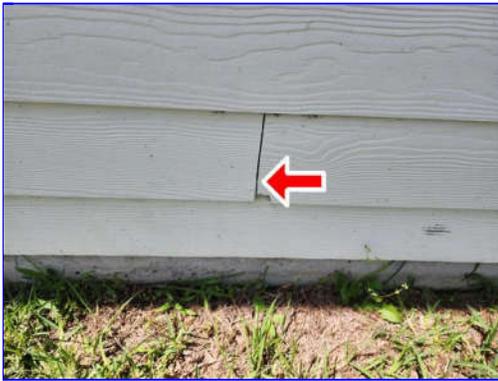
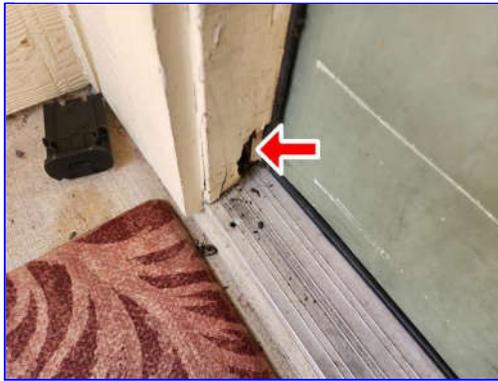
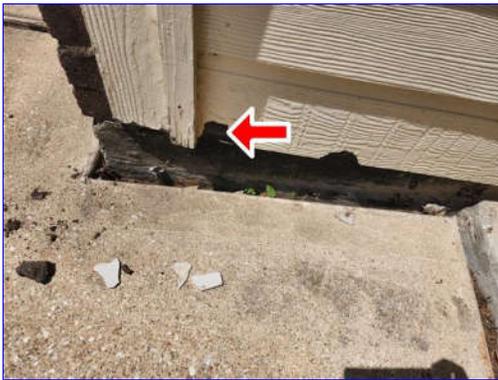
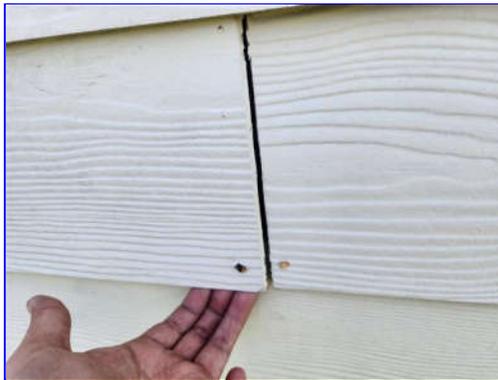
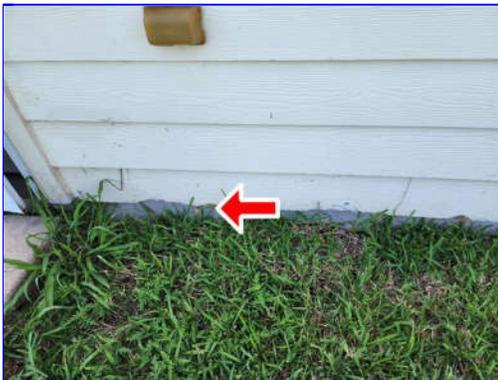
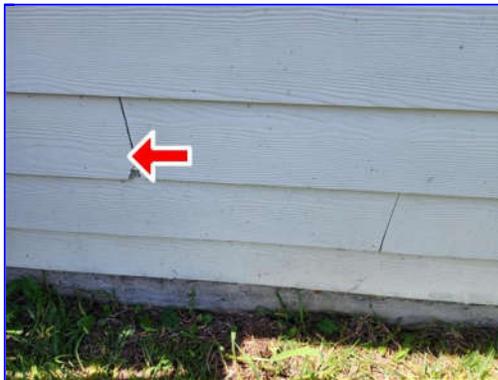
(3) The siding and/or trim was/were observed to have the following defect(s): in poor condition, loose or broken. This condition could lead to moisture intrusion into the home.

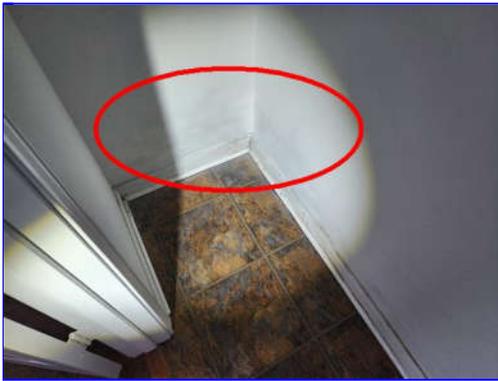
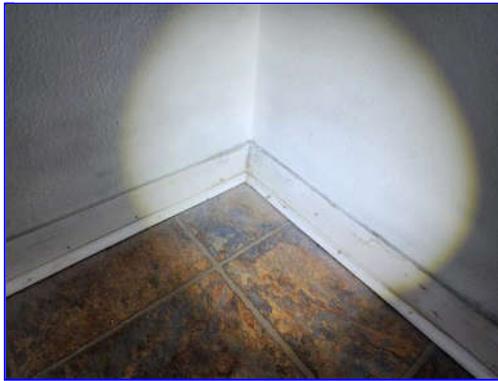
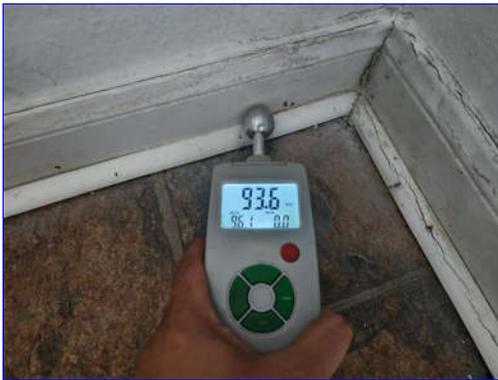
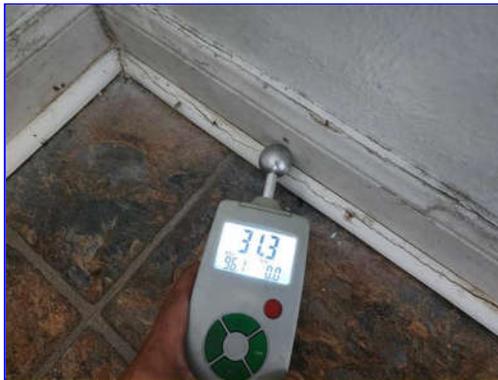
(5) The walls in right bedroom closets were observed to have the following defect(s): excessive moisture at the drywall and at the base boards. Excessive moisture at the wall was confirmed with a moisture meter. In the Inspectors opinion, this condition should be further investigated and repaired.

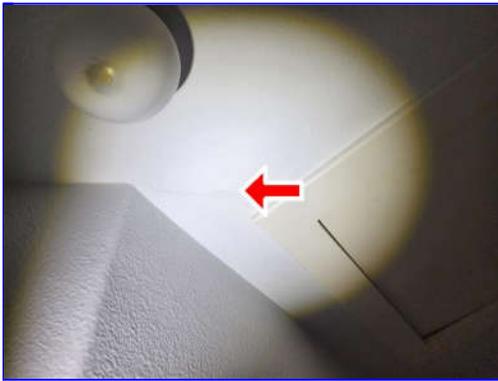
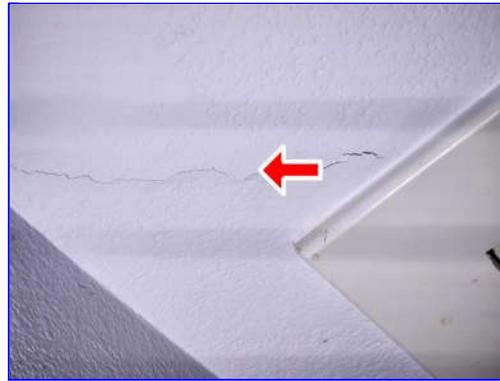
(2) Evidence of repairs/previous damage were observed. No evidence of excessive moisture was observed (confirmed when tested with a moisture meter). The cause of this condition was not determined. If sheetrock and insulation were affected by moisture, it should be removed, replaced and preventive measures for microbial hazards should be undertaken by a qualified, verified, licensed professional. The structural components related to this condition are not accessible to inspect for quality of installation, or possible component failure. This leave some degree of uncertainty regarding the condition. The buyer should obtain any and all information available regarding this condition prior to closing.

(3) Minor ceiling cracks were observed in master closet. Recommend to repair and monitor.

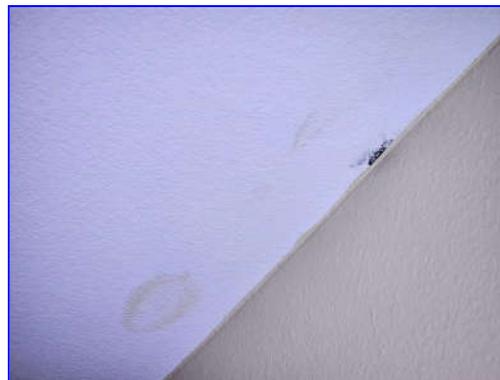
F. Item 5(Picture)

(4) Evidence of moisture intrusion was observed at the ceiling. No evidence of excessive moisture was observed (confirmed when tested with a moisture meter). Sheetrock and insulation were affected by moisture should be removed, replaced. Preventive measures for microbial hazards should be further evaluated or undertaken by a qualified, verified, licensed professional. The buyer should obtain any and all information available regarding this condition prior to closing.

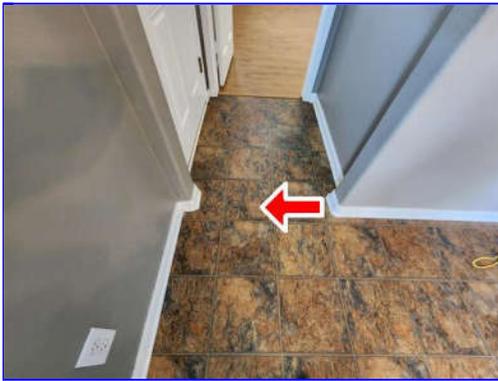
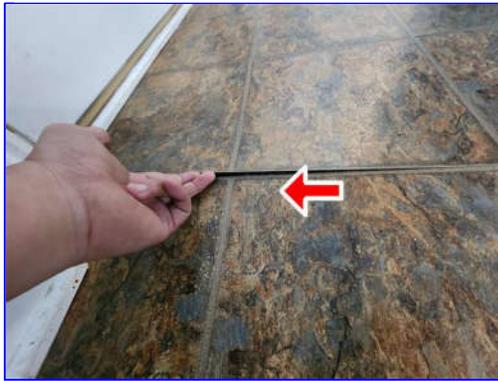
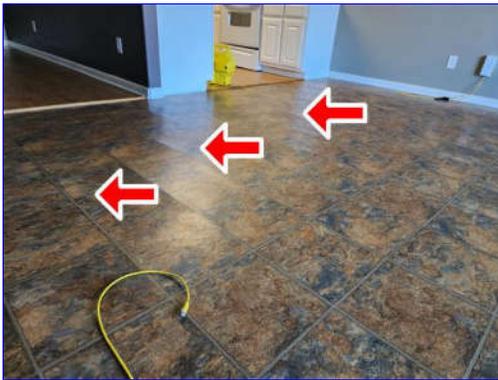
(5) The linoleum/vinyl flooring was observed to have the following defects: warped or initial deterioration. Repair or replace as needed.

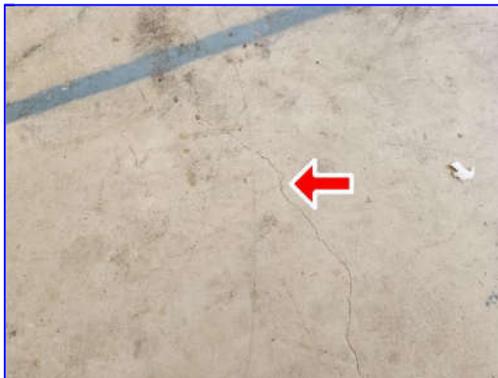
F. Item 10(Picture)

(6) There were cracks in the garage floor. This is typical of concrete and is not considered significant. it should be monitor for large separations or differential movement.

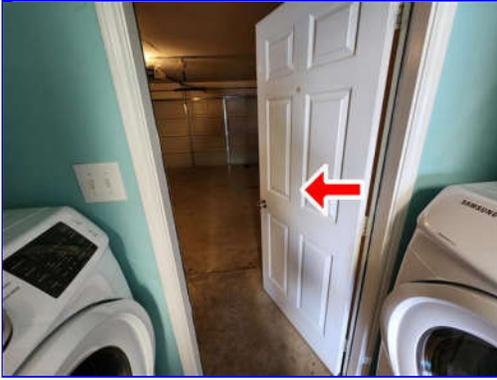
G. Item 1(Picture)

(1) The garage entry door(s) was/were observed to have the following defect(s): self closer is missing, this is a potential fire and safety hazard. Repair or replacement is needed.

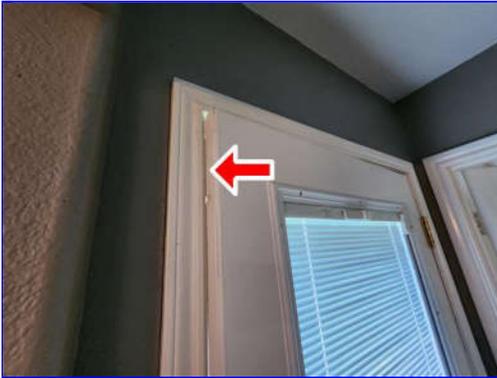
G. Item 2(Picture)

(2) The exterior door(s) at the rear of home was/were observed to have the following defect(s): does not shut properly. Repair or replacement is needed.

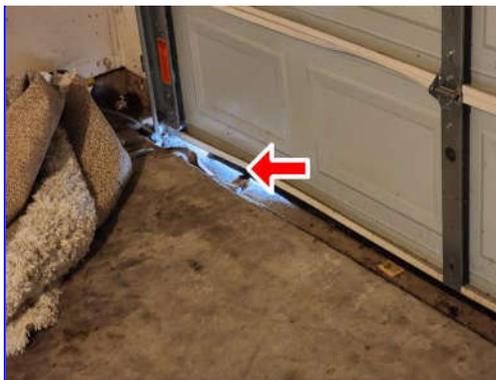
G. Item 4(Picture)

(3) The garage door(s) was/were observed to have the following defect(s): does not close tight at opening. Repair or replacement is needed.

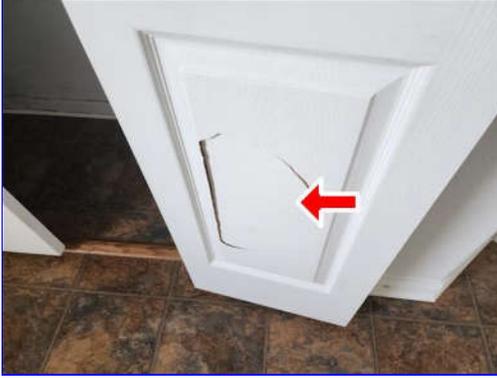
G. Item 5(Picture)

(4) The interior door at the in right bedroom was observed to have the following defect(s): damaged.

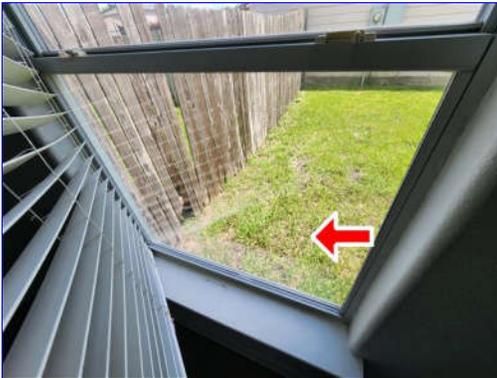
H. Item 1(Picture)

One or more window screens were observed to be missing or damaged. Repair or replacement is needed.

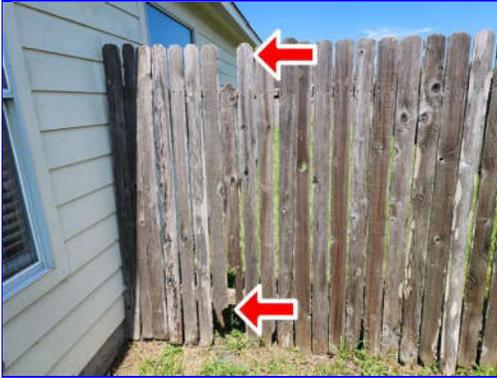
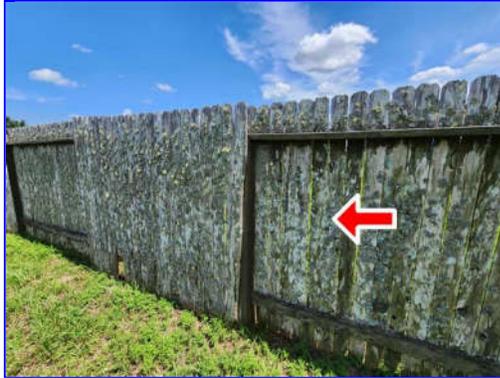
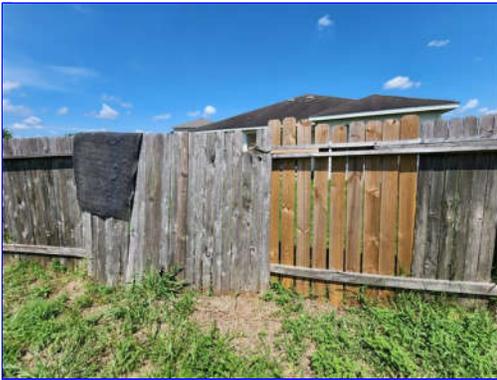
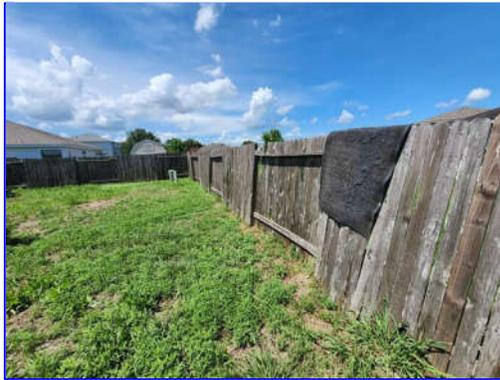
Fencing is old and deteriorated. Repairs should be made. A qualified contractor should be consulted regarding repair or replacement.

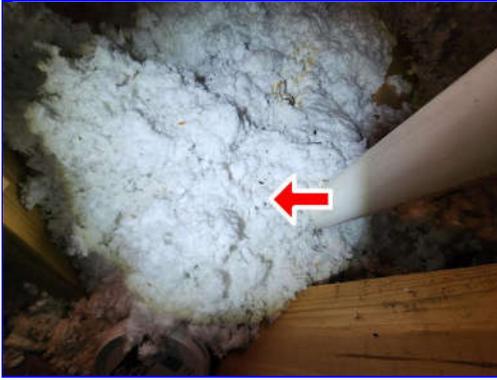
L. Item 24(Picture)

(4) There is evidence of possible vermin activity in the attic. A qualified, verified, licensed pest control specialist should be consulted regarding this condition and remediation.

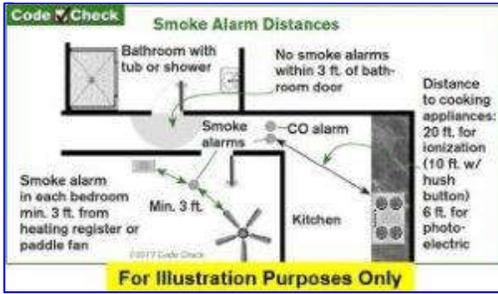
B. Item 1(Picture)

(4) Smoke detector(s) was/were observed to have the following defect(s): is/are chirping indicating the batteries are in need of replacement. Smoke detectors are critical to occupant safety and should be repaired as needed. By current standards smoke detectors are required in each sleeping area, in the vicinity outside the sleeping area, and one each inhabitable level of the home. Smoke detectors in newer homes are required to be hard wired to the electrical system, have battery backup, and be interlinked to activate all smoke detectors in the home if one is activated. All smoke detectors should have batteries replaced upon moving into the home. This ensures all batteries are new and in working order.

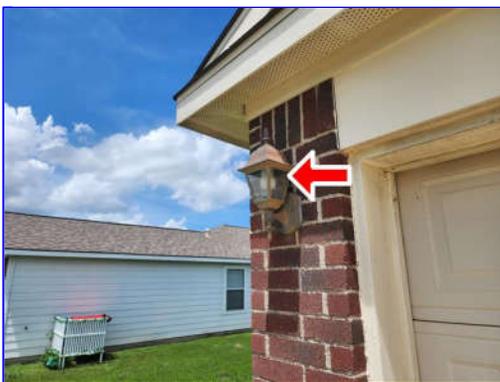
B. Item 4(Picture)

(5) Light fixture(s) in the interior/exterior was/were inoperative. If the fixture(s) does not work after replacing the bulb(s), a licensed electrician should be consulted.

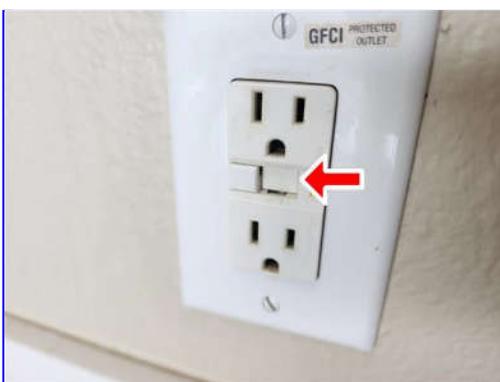
B. Item 8(Picture)

(6) One ground fault interrupt receptacle(s) in the master bathroom was observed to have the following defect(s): did not work or there is no power to outlet. A defective GFCI receptacle will affect other receptacles on this circuit, possibly in other rooms or in other locations requiring GFCI protection.

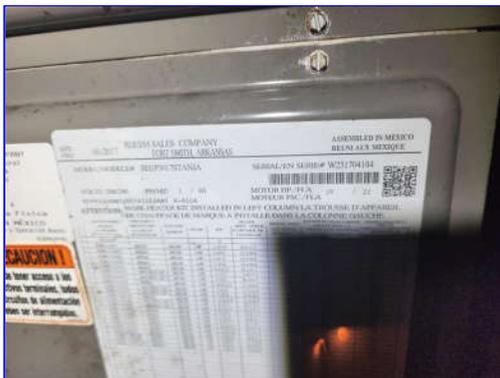
A. Item 1(Picture)

(1) View of Furnace(s) and Data Plate(s) (if available)

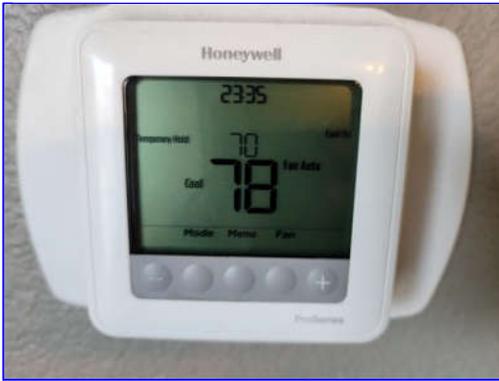
B. Item 4(Picture)

- (4) Deficient temperature differential (Delta-T) was observed at the time of inspection. The Delta-T of a cooling system ideally should be between 14-22 degrees from supply to return. The observed condition indicates repairs may be needed. A qualified, verified, licensed HVAC technician should be consulted regarding this condition and potential repairs to the system.

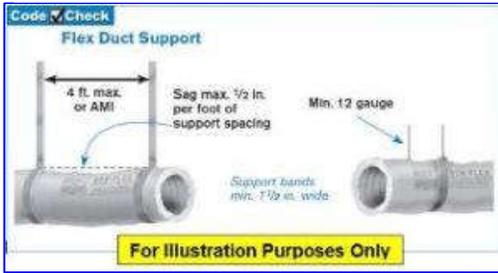
C. Item 3(Picture)

(3) HVAC flexible ducting should be hung and not left laying on the insulation and framing members. Ducts can sweat when in contact with other materials and or structural members. This can lead to organic microbial growth if not adjusted.

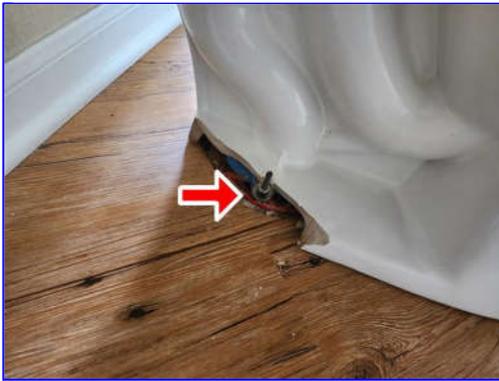
A. Item 5(Picture)

The toilet base was broken and loose at the floor. The toilet should be removed and replaced. The toilet and flange should be inspected for damage. When a toilet leaks at the floor is is possible for the leak to go between the foundation and the flooring cover and cause damage that is not visible to the inspector at the time of inspection. Further repairs may be possible.

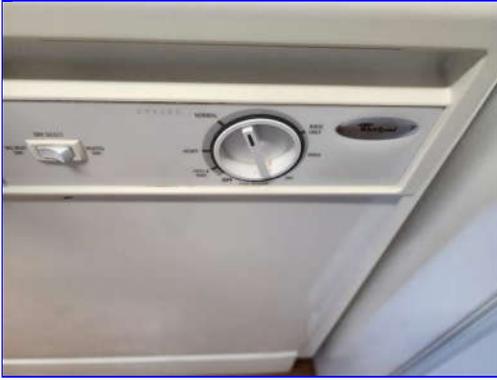
A. Item 6(Picture)

(3) After operating for several minutes, the dishwasher did not fill with water. The dishwasher was shut off to prevent possible damage to the appliance. This condition should be further investigated by a qualified appliance professional.

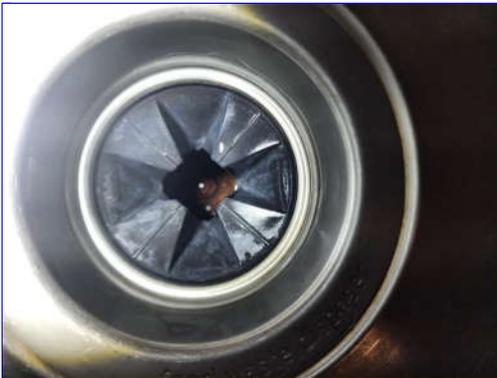
B. Item 1(Picture)

(2) The food disposal was observed to have the following defect(s): rusted inside at the blades. Repair as needed.

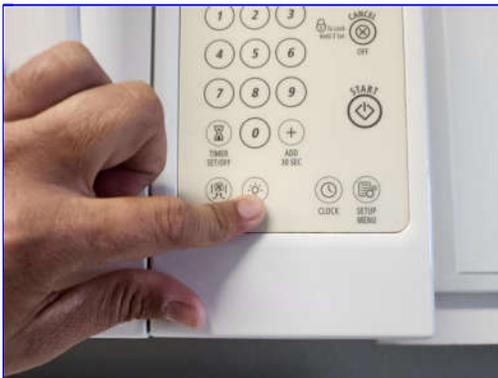
C. Item 4(Picture)

(2) The bulb for the range hood was observed to be inoperative. I recommend repair or replacement as needed.

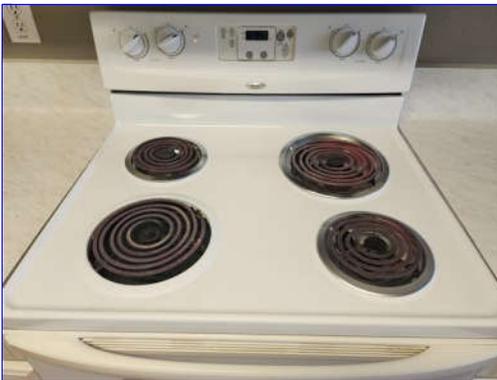
D. Item 4(Picture)

(3) The range was observed to be properly functioning as intended.

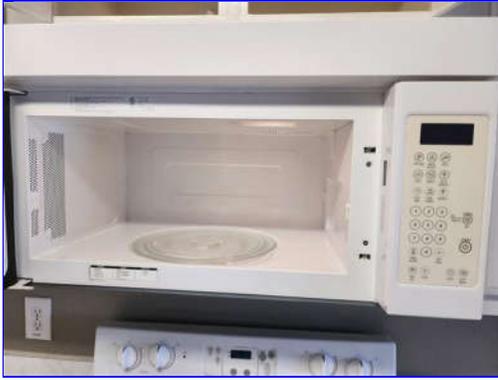
E. Item 1(Picture)

- (2) **Buyers Advisory Notice:** The inspector does not test microwave for radiation leakage.
- (3) The microwave oven was observed to be properly functioning as intended.

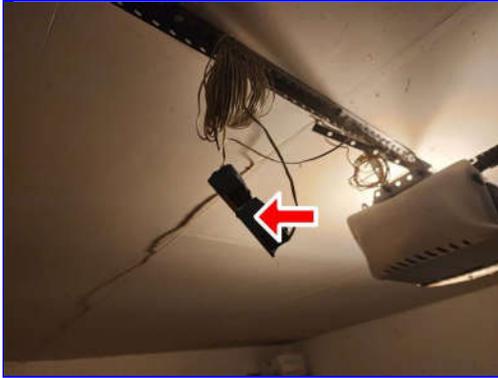
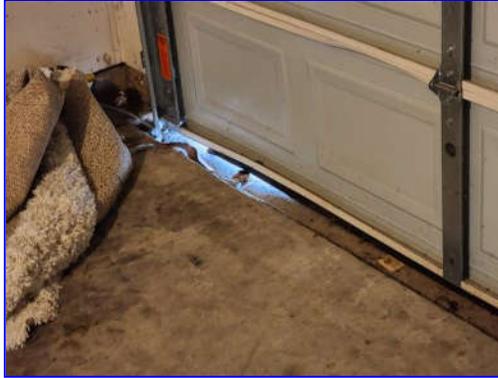
- (2) Garage door sensors were observed to be improperly installed. Garage door sensors should be below 6" of the garage floor. As always with appliances, manufacturer instructions should be followed.

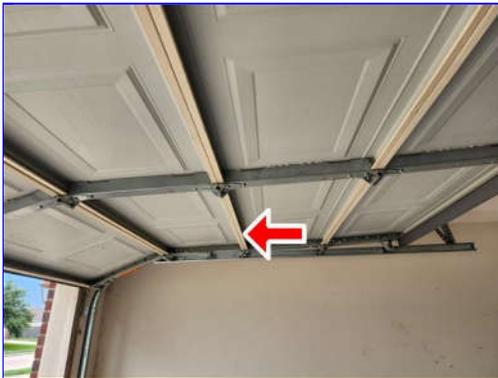
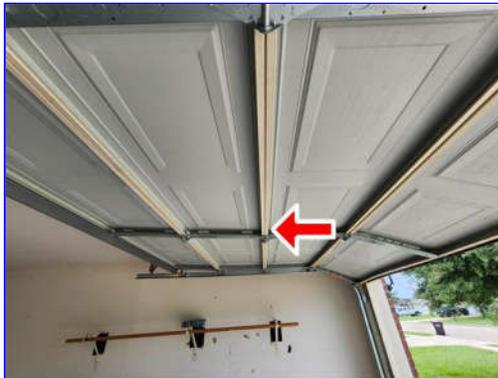
(3) The garage door operator and/or hardware was noisy and in need of lubrication, maintenance or other repairs.
