**Andrew Martinez**  
**726 McDaniel Street**  
**Houston, TX 77022**

**April 2, 2024**

# PROPERTY INSPECTION REPORT FORM

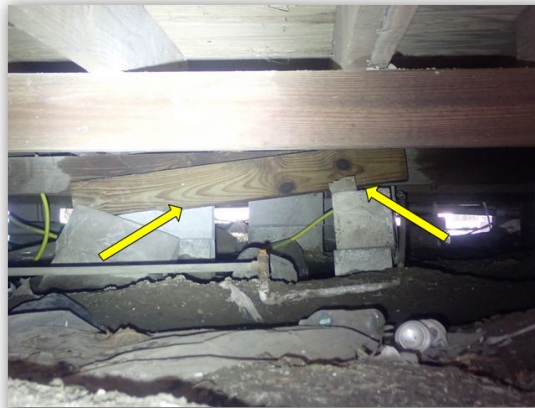
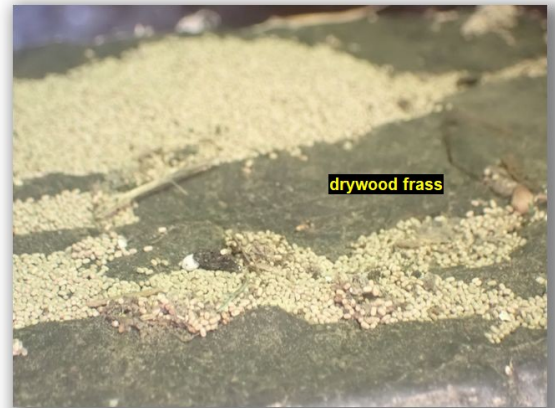
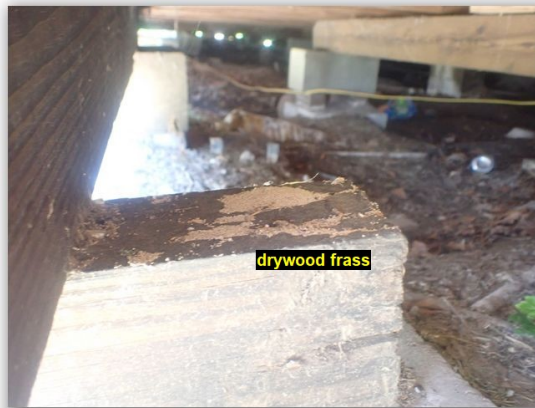
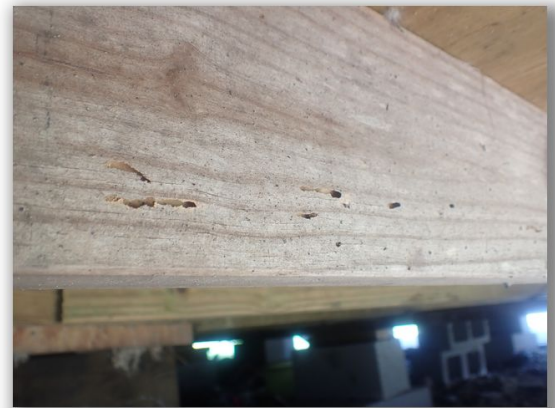
- One or more of the support piers are not in contact with the foundation beam. This condition should be further evaluated and corrected as necessary.
- One or more of the support piers are not level. This condition should be further evaluated and corrected as necessary.

- The sub-floor material has some deterioration and/or damage in one or more locations.
- All wood debris and/or trash should be removed from the crawl space.

- One or more piers are missing. Remediation is needed.

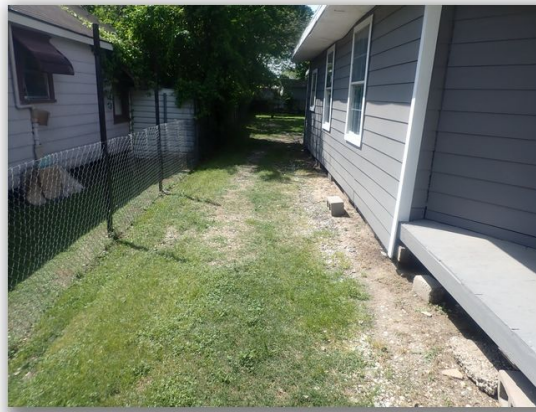
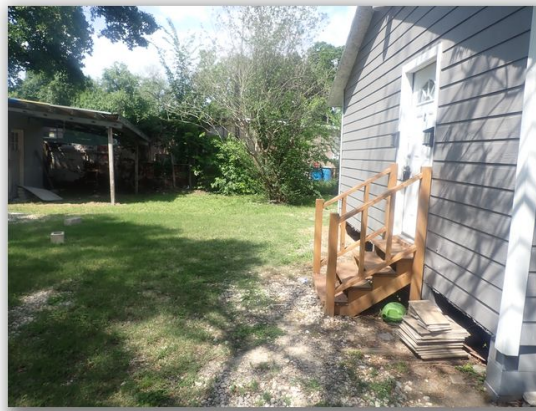
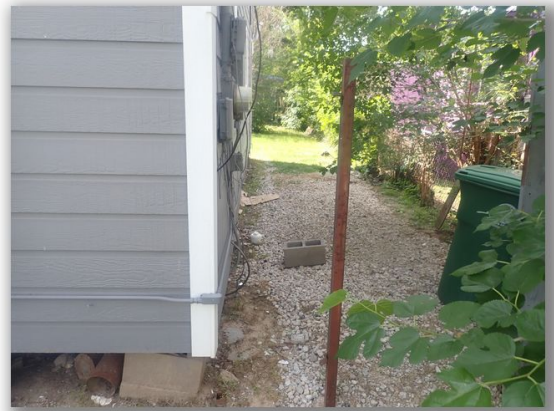
- Marginal site drainage was observed on the north, east, west and south sides of the structure. Proper drainage is needed to help prevent water from standing and/or ponding next to the foundation beam. Corrective measures may be needed if the water stands within 10-feet of the foundation perimeter beam for more than 24-hours.

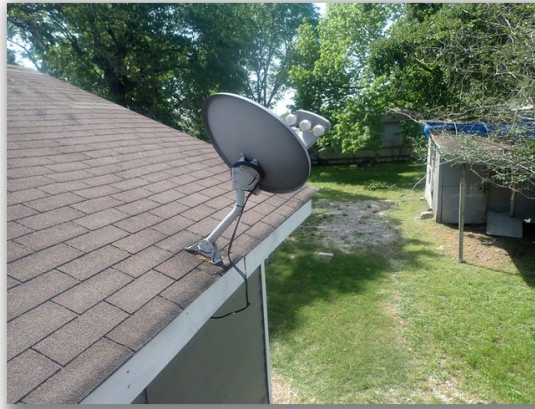
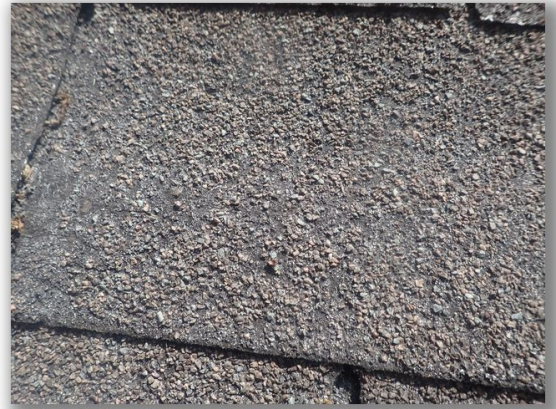
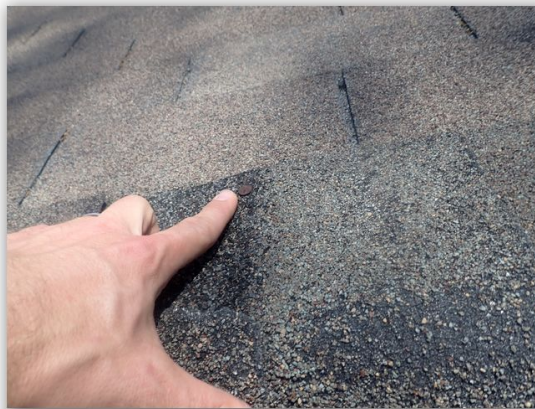
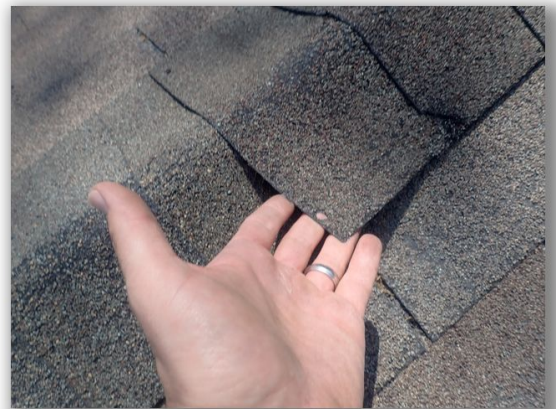
- The roofing material appears to be reaching the end of its serviceable life expectancy.
- Visible evidence of moisture intrusion (leaks) through the roofing material and/or flashing details were observed over unit B, Unit C, exterior soffits. The cause and remedy should be further evaluated and corrected as necessary.
- One or more of the shingles were observed to be lifting on the north, east, west and south sides of the roof structure.
- Damaged shingles were observed on the north, east, west and south sides of the roof structure.

- Missing shingles were observed on the west side of the roof structure.
- One or more of the ridge cap shingles were observed to be damaged.
- One or more shingles were not installed properly.
- Exposed fasteners were observed at the shingles in one or more locations.
- Shingle fasteners (staples and/or nails) were observed to be pushing through the roofing material.
- The fasteners at the satellite dish mount should be sealed to help prevent water leakage at this point.
- The composition roofing material has experienced granular loss in various locations throughout the roof.
- The inspector identified soft decking in one or more locations of the roof structure. It is recommended to add additional support in this area.

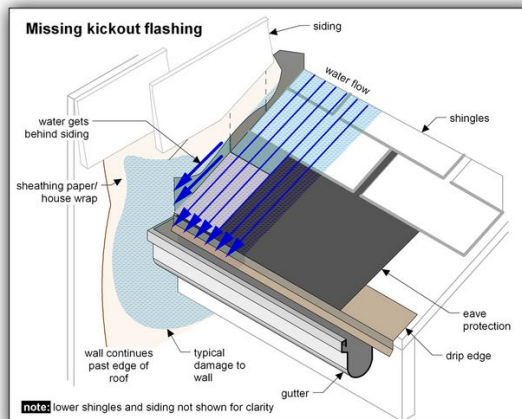
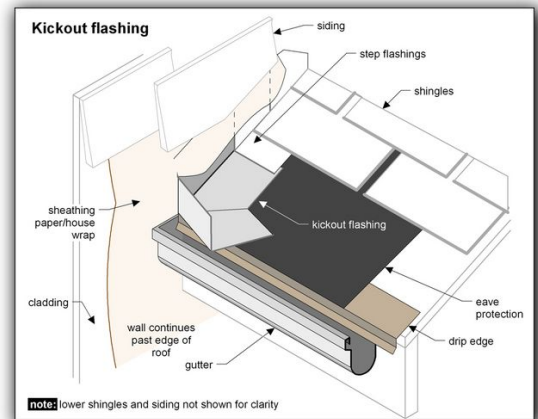
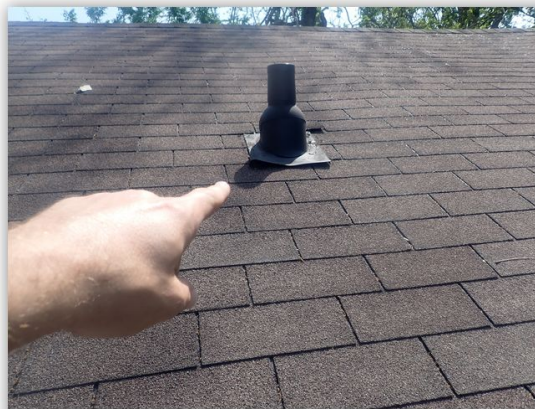
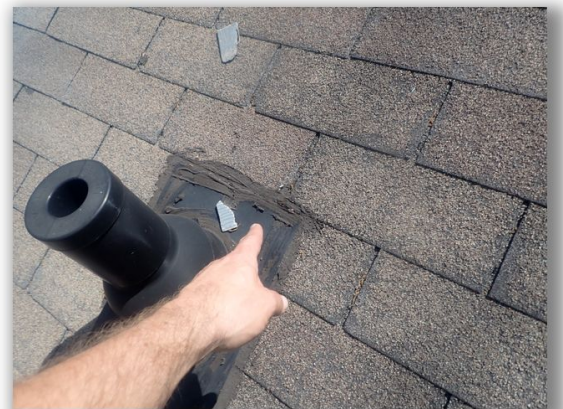
### Flashing Details

- Drip edge flashing details were observed to be missing on the north side of the roof structure. This condition could allow water penetration at this point.
- The flashing is damaged on the west side of the roof structure. This condition could allow water intrusion at this location.
- The flashing is not properly installed on the south side, east side, west side of the roof structure. This

condition could allow water intrusion at this location.

- The flashing is lifting and/or pulling loose on the south side, east side, west side of the roof structure. This condition could allow water intrusion at this location.
- One or more of the flashing detail flanges are not properly set into the roofing material. This condition could allow water intrusion at this location.
- It is recommended to paint the flashing details to prevent rust and/or UV damage.
- There was no kickout flashing details observed at the lower bottom edge of the roof line interface and the sidewall that continues past the edge of the roof. The lack of this kickout flashing could allow water to penetrate at these points.
- It is recommended to seal one or more of the plumbing vent stack rubber boots to prevent water intrusion at this location.

The flashing details should be checked, reset or repaired as necessary. The observations made to support the rendering of this opinion are listed but may not be limited to:

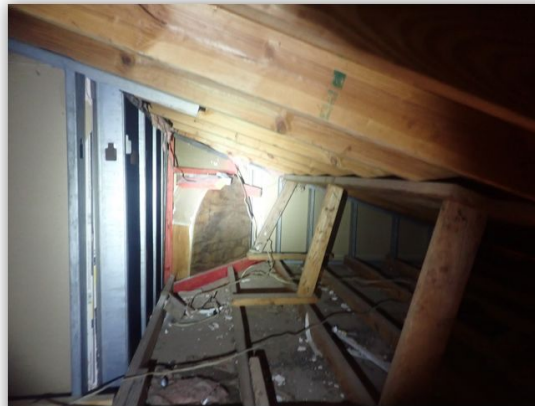
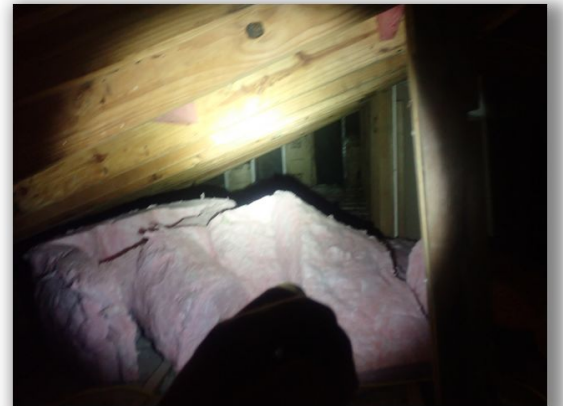
- One or more of the roof structure rafters were observed to be pulling away from the top ridge board.
- It is recommended to seal all openings between the soffit and roof covering to prevent pest/rodent intrusion at this point.
- The soffit material has some deterioration and/or damage on the north, east, west and south sides of the roof structure.
- The soffit material is sagging and/or pulling loose on the north, east, west and south sides of the roof structure.
- The fascia/frieze board material has some deterioration and/or damage on the south side of the roof structure.
- Wood rot was observed in the attic area.

**Note:** Visible evidence of rodent activity was observed in the attic area. It is recommended to have a Certified Pest Control Operator further evaluate this condition and make corrections as necessary.

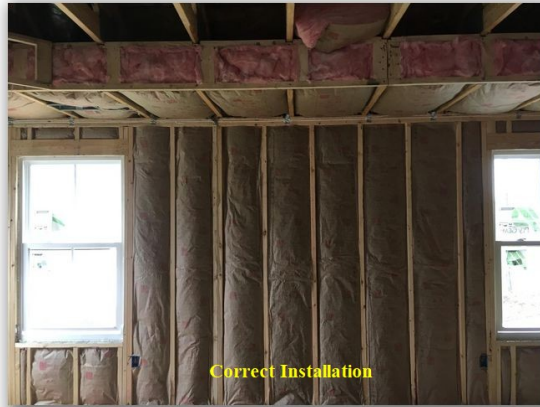
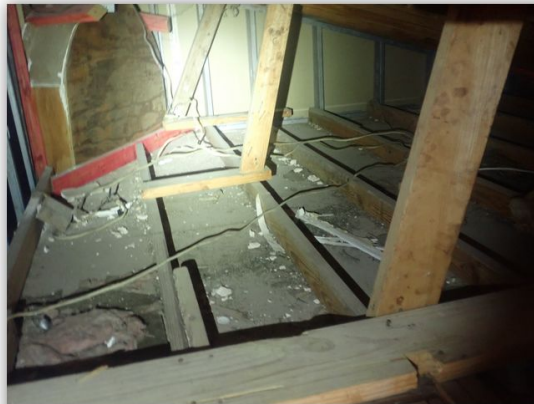
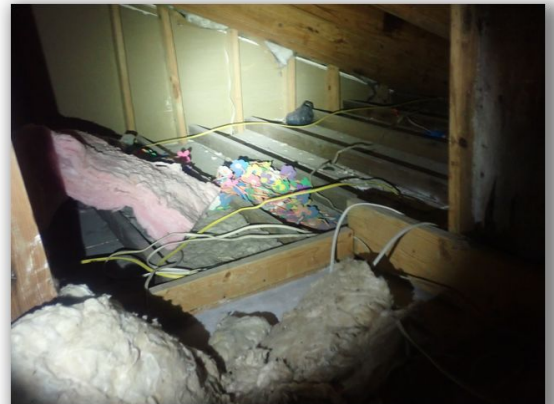
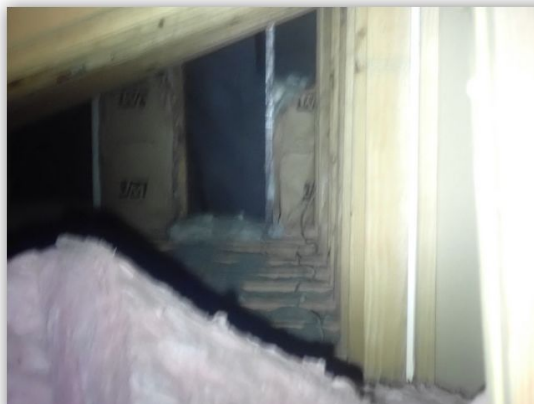
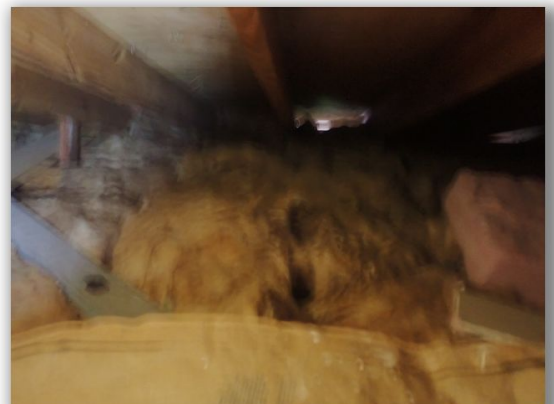
- The attic floor insulation was observed to be missing over unit C
- The attic floor insulation should be redistributed in one or more locations.
- The batt insulation is improperly installed. When installing paper faced batt insulation, the paper should always face in towards the home.

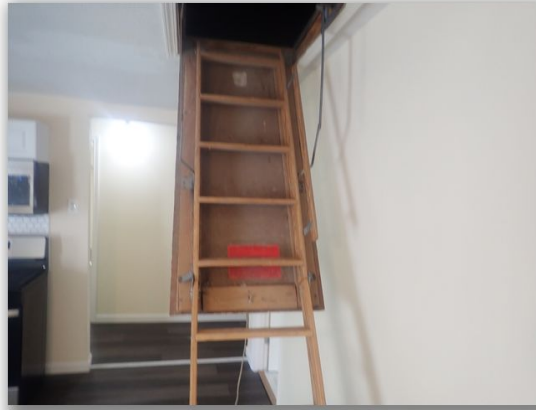
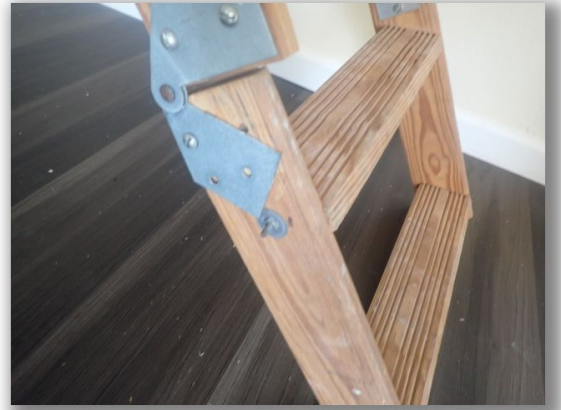
**Attic Ladder/Hatch Opening**

- Some of the attic ladder nuts and bolts were observed to be loose and/or missing. Improvements to the attic ladder are recommended for reasons of safety.

**Note:** There was no weather-stripping observed around the attic ladder/hatch opening. This is an "As Built" condition that does not meet current energy standards. It is recommended to weather-strip the ladder/hatch opening.

**Note:** The attic ladder/hatch door is not insulated at this time. This is an "As Built" condition that does not meet current energy standards. It is recommended to insulate the ladder/hatch door.

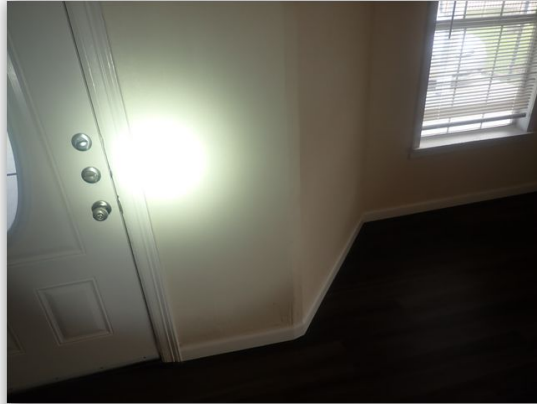
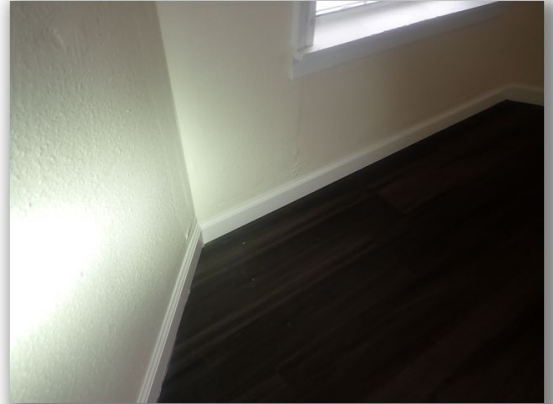
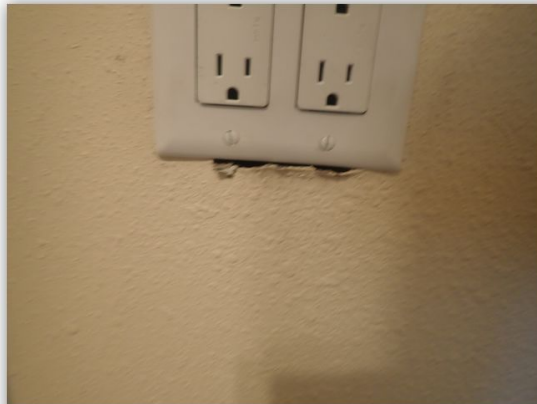
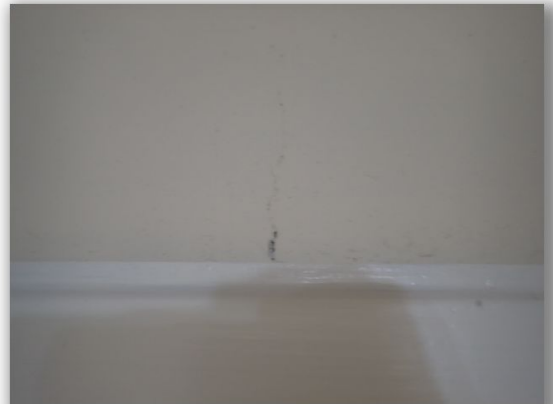
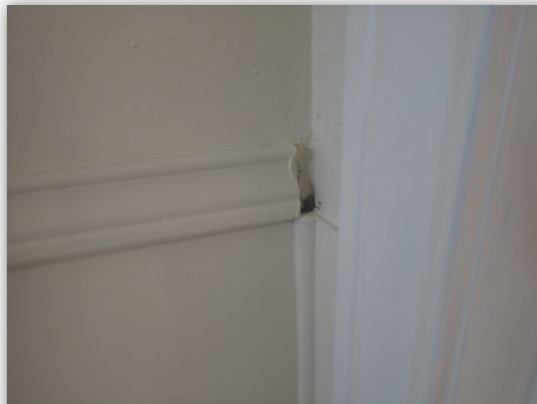
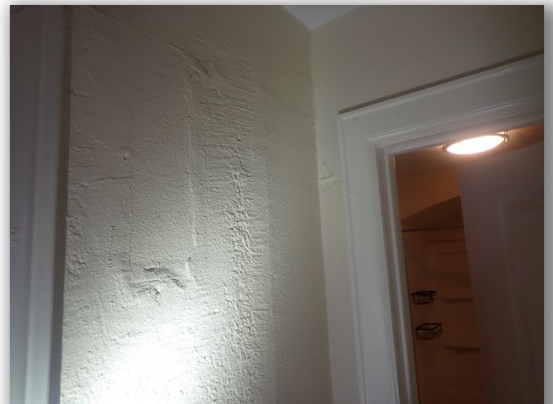
- The wall texture has some deterioration and/or damage in several locations throughout the house.
- Wall surface damage was observed in several locations throughout the house.
- Water stains/damage were observed on the baseboards in the unit B rear corner bedroom.

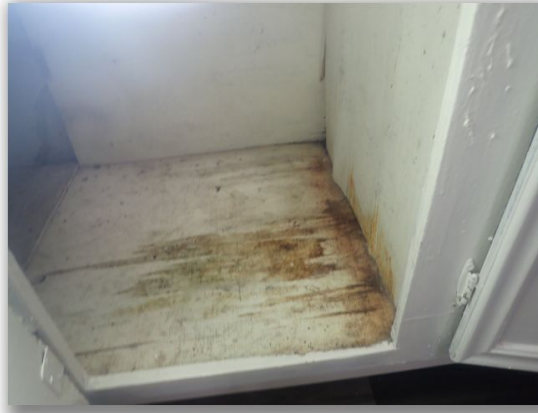
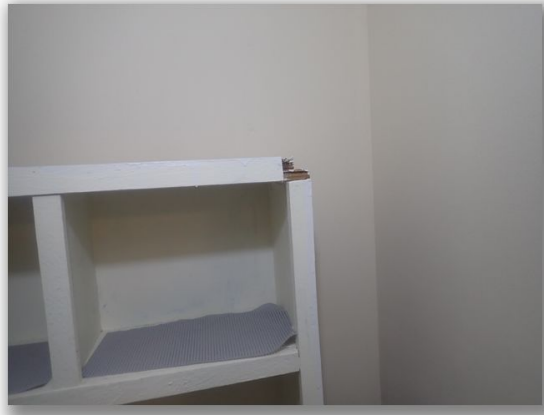
- Cabinet surface damage was observed in the unit A kitchen
- The cabinet drawers are not operating properly in the unit A kitchen.
- The cabinet doors are not operating properly in the unit A kitchen.
- The shelves were damaged in the Unit B Pantry

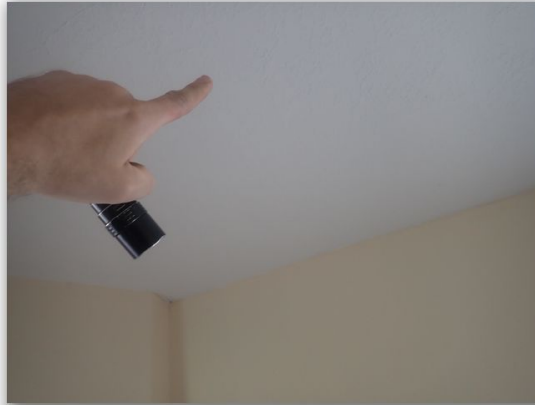
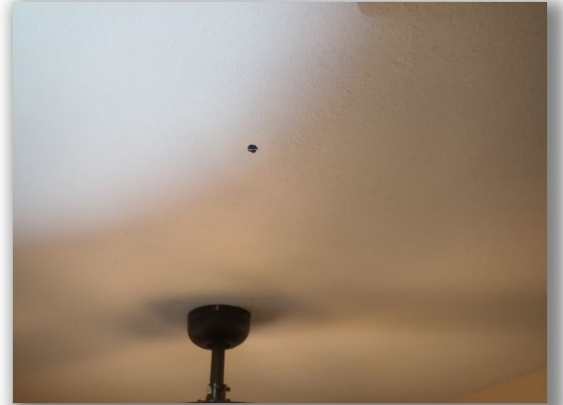
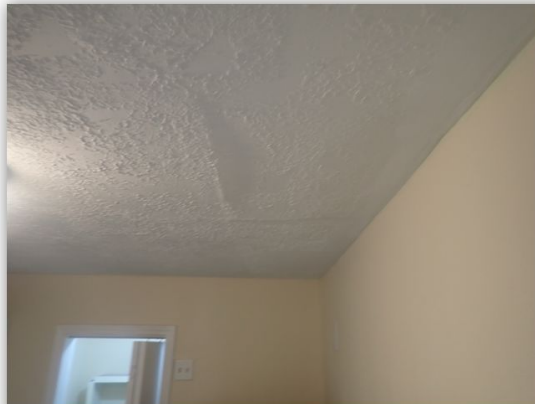
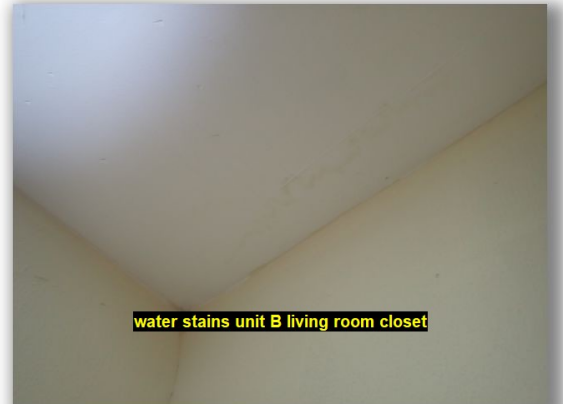
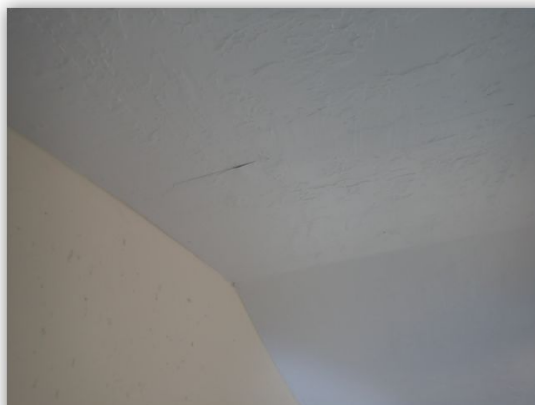
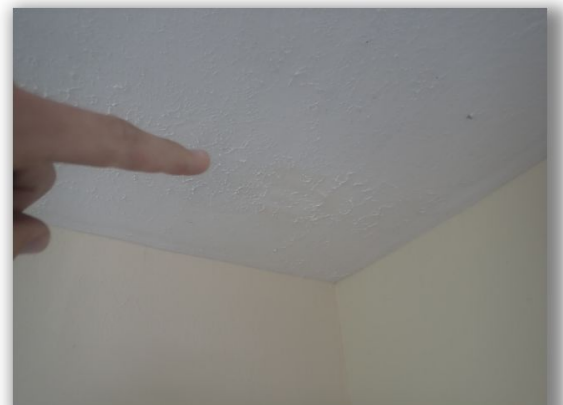
**Note:** Nail heads were observed to be pushing through the interior finish in one or more locations.

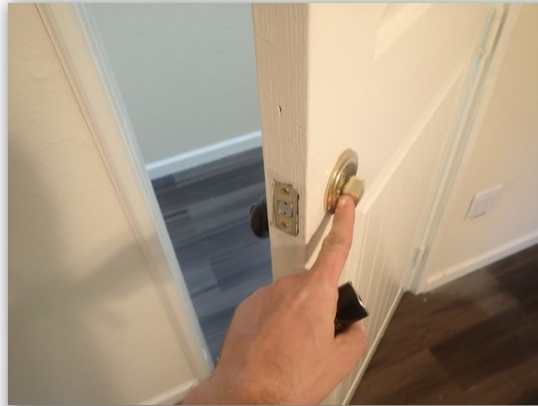
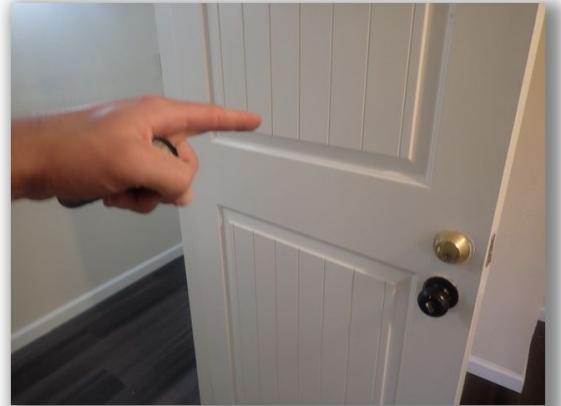
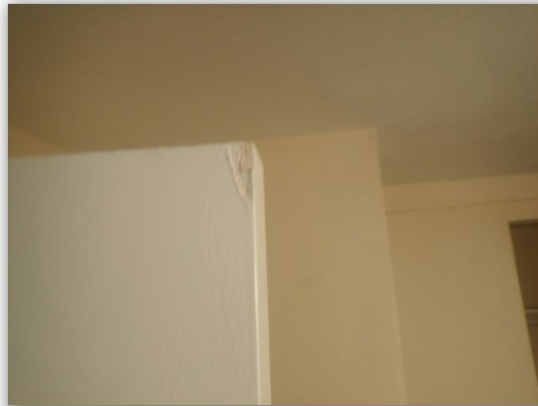
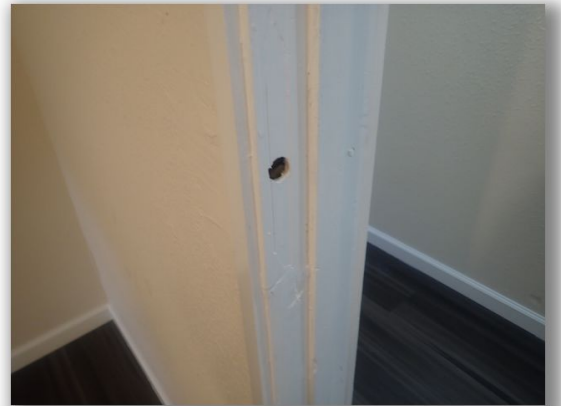
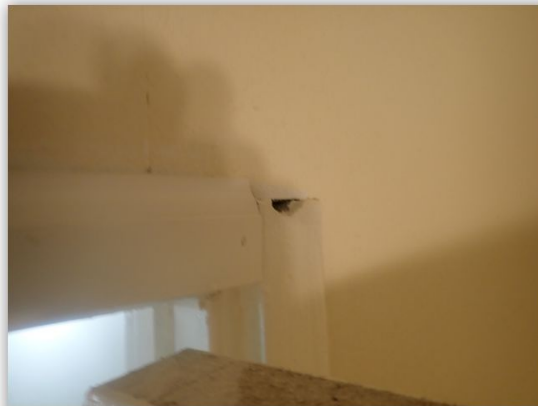
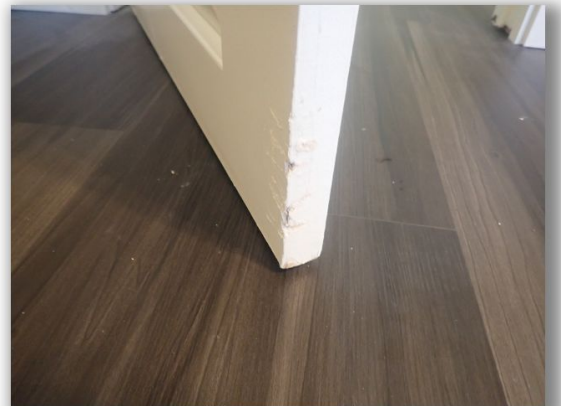
- Surface damage was observed to the door in several locations throughout the house.
- The door frame is damaged to several locations throughout the house.
- The door hardware does not function properly to the unit A rear middle bedroom, unit B rear corner bedroom.
- Hardware was missing to the unit A rear middle bedroom door.
- The door does not stay in position to several locations throughout the house.
- The unit A bathroom door was water damaged.
- The closet door is off track in the unit B rear corner bedroom closet.
- The door has poor clearance to the bathroom sink in unit B.

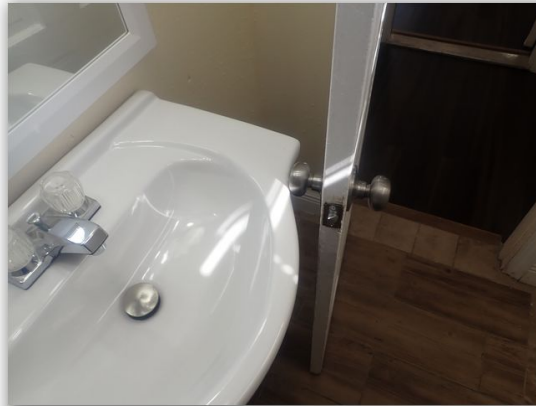
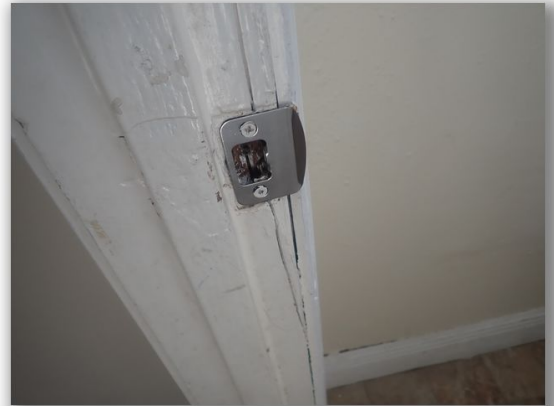
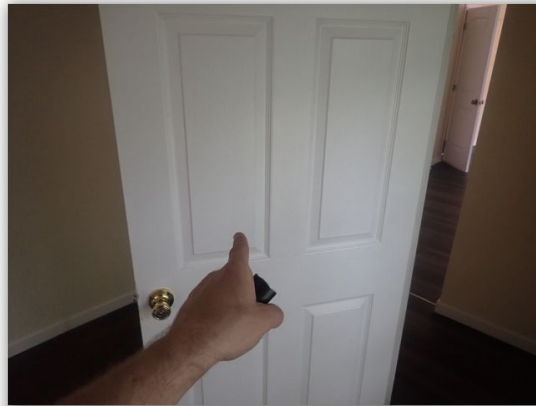
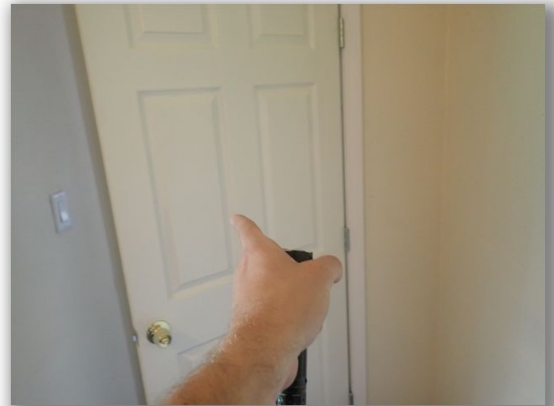
**Exterior Doors**

- Surface damage was observed to the door in the unit A front entry door.
- The door frame is damaged to the unit A front entry door, unit B front entry door.
- Weather-stripping improvements are recommended for the unit A front entry exterior door(s).
- The front entry door rubs the floor in unit A.
- Visible evidence of previous water intrusion was observed at and/or around the exterior unit C front entry door(s). The cause and remedy should be investigated and corrected as necessary.

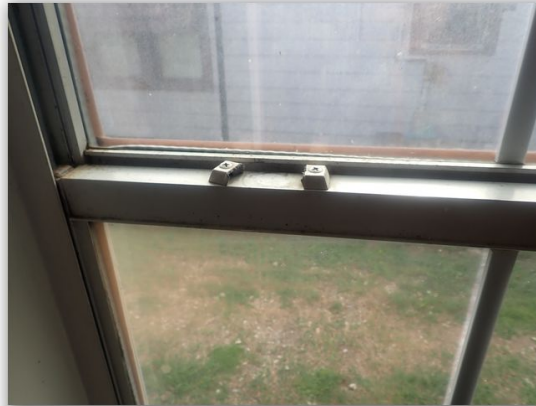
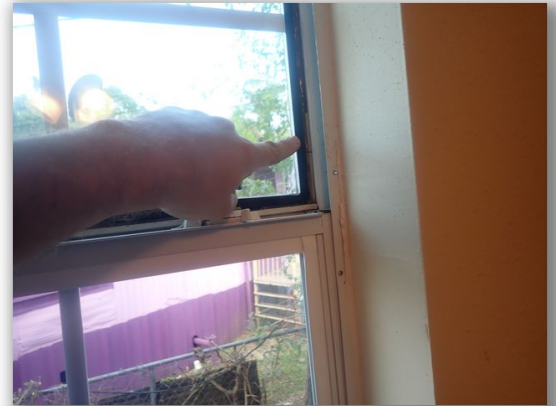
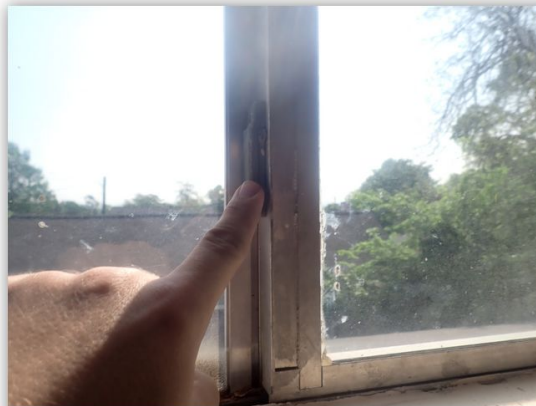
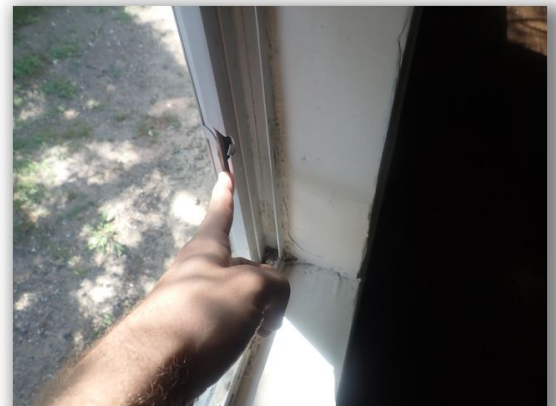
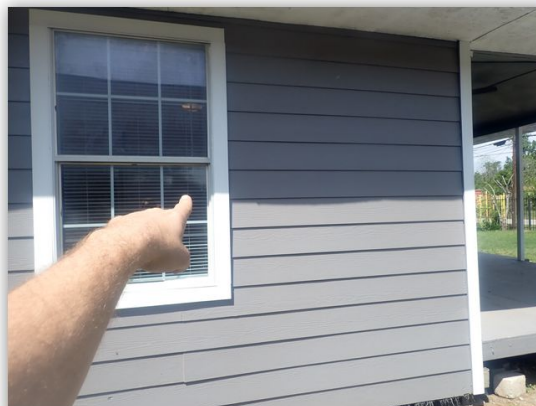
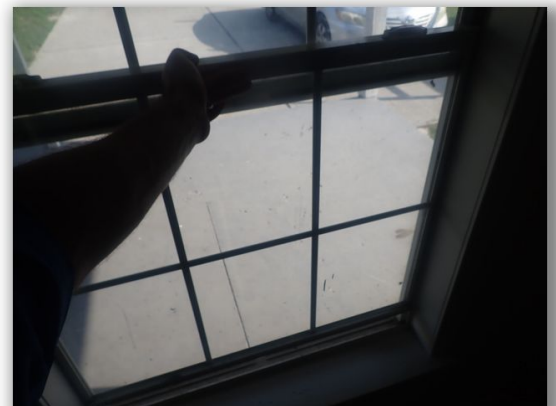
- Window lock(s) were observed to be damaged and/or missing in the unit A living room, unit B rear corner bedroom.
- The window weather-stripping is damaged and/or missing at one or more of the windows and improvements are recommended.
- The window guide is damaged and the window will not stay in the open position in the unit A living room.
- One or more of the thermal pane windows were observed to have lost their seals. This has resulted in condensation or a fog like film to develop between the panes of glass. The thermal pane windows no longer function as designed when they lose their seal and replacement may be necessary. The windows that have noticeably lost their seals are listed but may not be limited to the following:  
unit A living room.

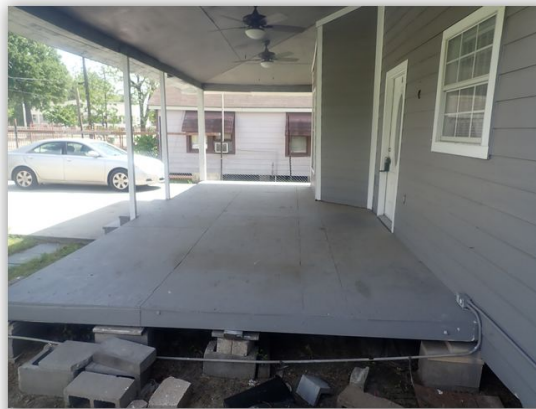
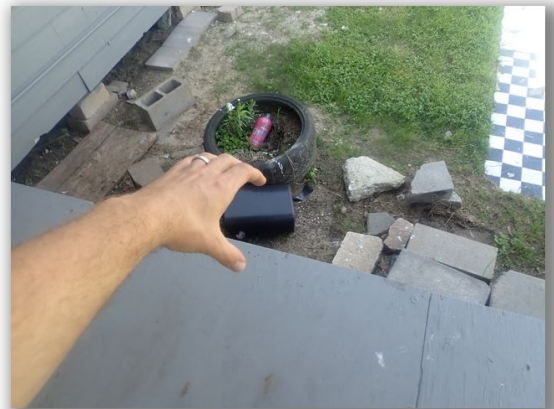
**Porches / Patio**

- There is no handrail in place for the steps with four or more risers. For improved safety, it is recommended that a handrail be installed.
- Some of the deck boards were observed to be warped and/or damaged.
- The deck material has some deterioration and/or damage. Repairs may be necessary to improve the deck quality.
- One or more of the porch support posts have deterioration and/or damage at the base of the post.

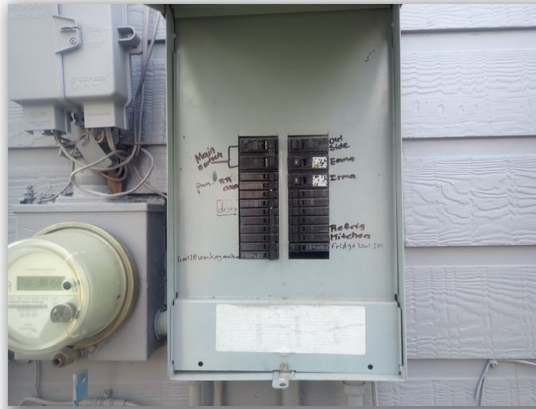
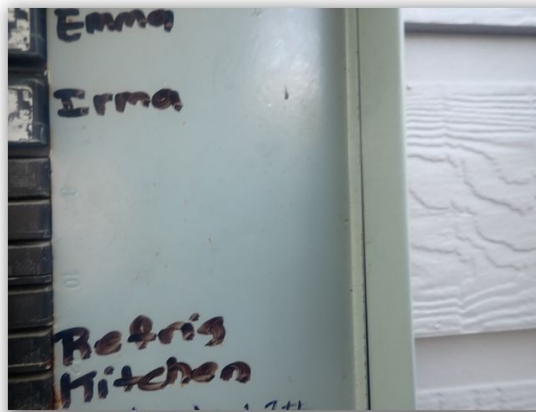
- The breakers (overcurrent devices) in the electrical panel are not properly labeled.
- There is no surge protection device installed at the panel box. Under the current National Electrical Code, all electrical systems should have surge protection. This is an "as built" condition. It is recommended to add a surge protection device to the panel box.
- There is no ground fault circuit interrupter type breaker for the dryer outlet installed at the panel box. This does not meet current building standards.
- All openings (missing knockouts) in the electrical cabinet cover plate (dead front) and /or cabinet should have fillers.
- Some of the electrical cabinet interior components were observed to have some rust and/or corrosion on them. This condition should be further evaluated and corrected as necessary.

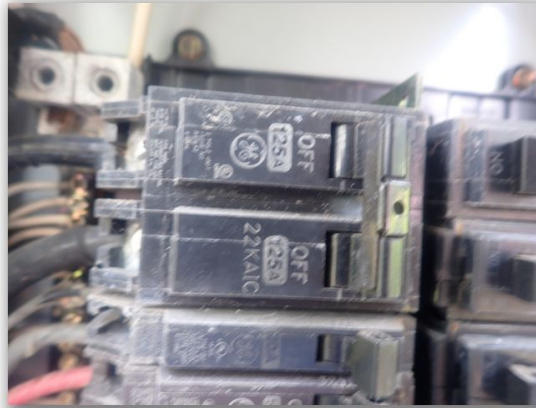
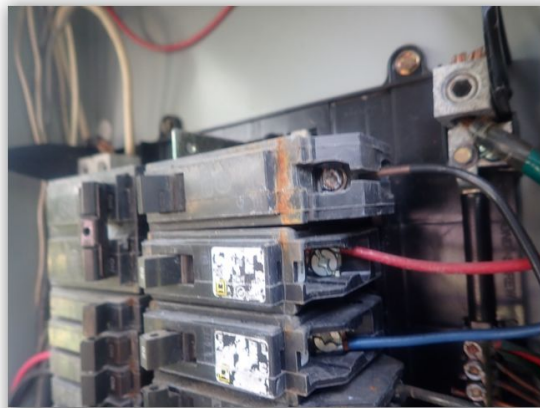
**Arc-Fault Circuit Interrupter Protection (AFCI)**

- None of the required dwelling unit devices, receptacle and lighting outlets (switches, receptacles and fixtures) are connected to an arc-fault circuit-interrupter (AFCI) circuit device. AFCI devices were first required under the 1999 National Electrical Code and under the 2014 NEC, all living space, kitchen and laundry room devices, receptacle and lighting outlets (switches, receptacles and fixtures) should be connected to an arc-fault circuit interrupter (AFCI) device.

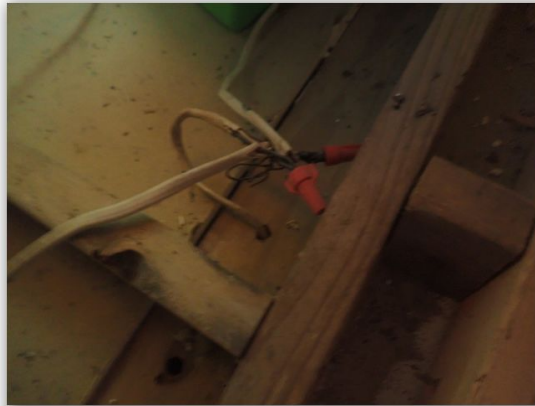
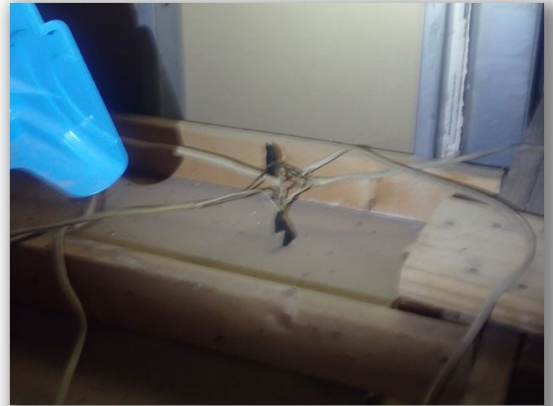
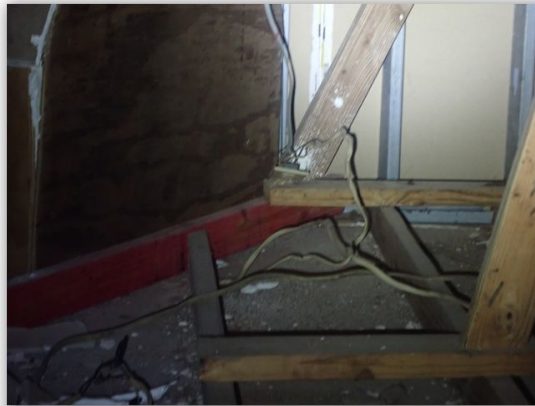
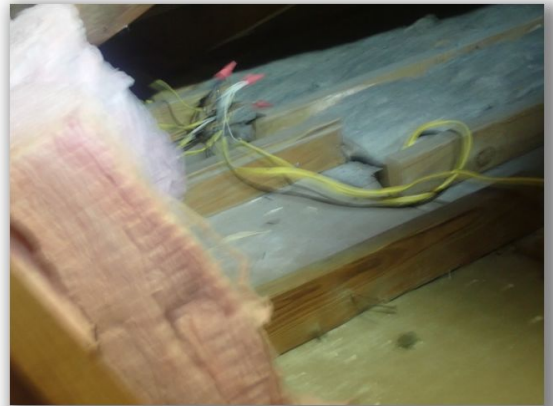
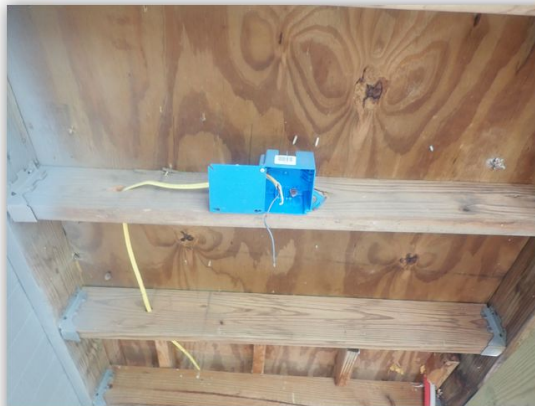
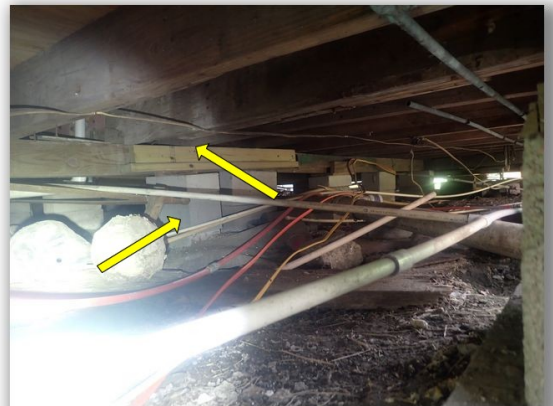
- Open electrical junction box(es) were observed in the south exterior wall. All open junction box(es) should be properly enclosed for reasons of safety.
- Spliced electrical wires were observed in the attic area. Spliced wires should be properly enclosed in junction box(es) for reasons of safety.
- Electrical wires were observed to be lying on the ground in the crawl space area. The wires laying on the ground in the crawl space should be raised and properly secured to a floor joist or beam.
- Open end wires were observed in the crawl space. Open end wires should be properly enclosed in a junction box for reasons of safety.

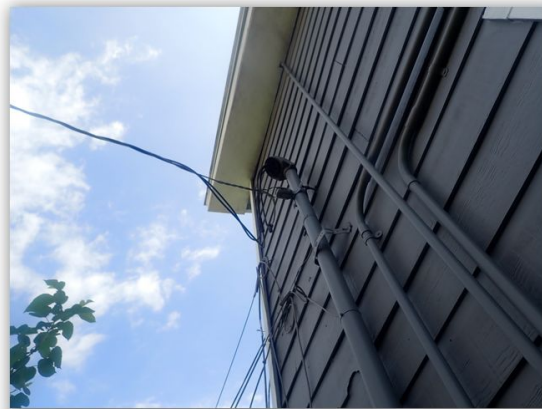
**Grounding / Bonding**

- I was unable to locate the electrical bond connection for the gas piping back to the grounding electrode system. All bond connections should be accessible for inspection, repair or replacement. This condition should be further investigated and corrected if necessary.

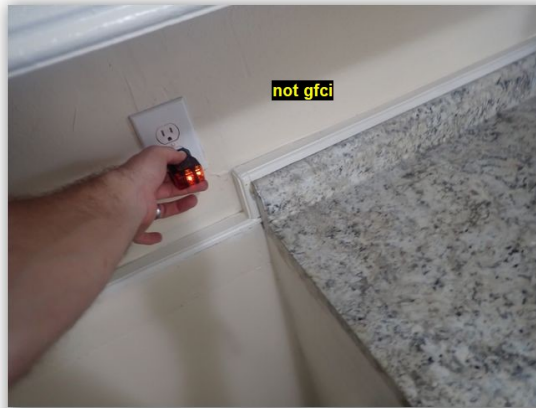
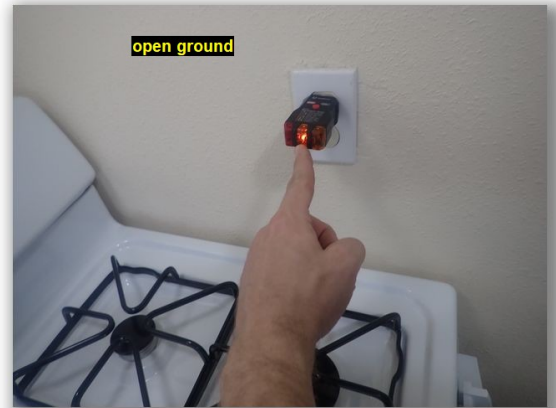
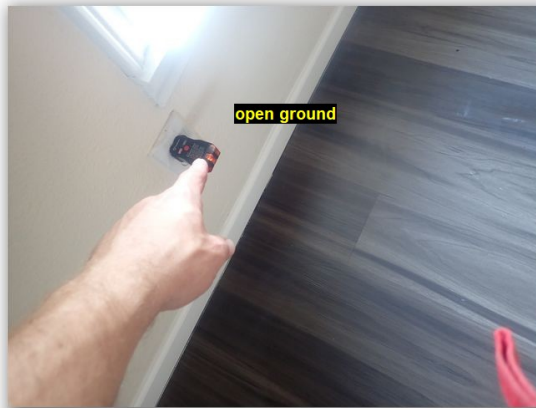
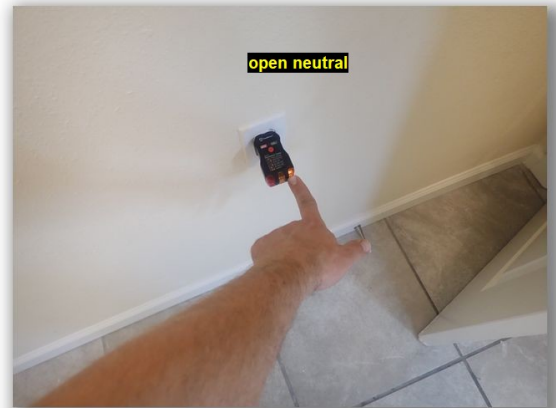
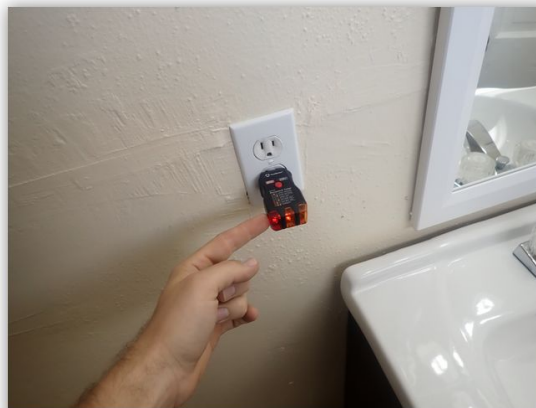
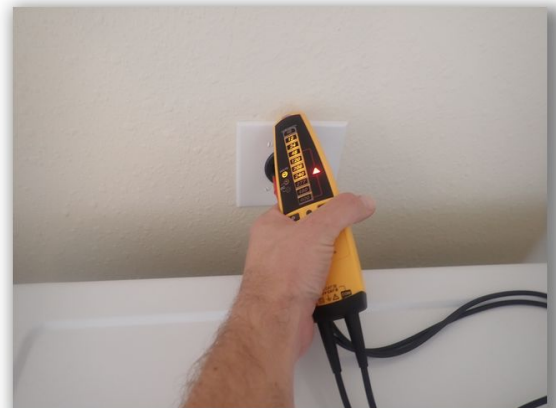
- Not all receptacles installed are tamper resistant receptacles at the time of inspection. Under current building standards, all receptacles that are less than five and a half feet above the floor should be tamper resistant. This is an "as built" condition, but per TREC standards of practice, we are required to report this condition as deficient. Tamper Resistant outlets are required per the 2008 National Electric Code. You may consider corrective measures for improved safety.

- All exterior receptacles should have weather tight covers. The receptacle weather cover plate is damaged and/or missing on the north exterior wall, west exterior wall.

- One or more of the receptacles were observed to have an open ground connection in the unit A living room, unit A kitchen.
- One or more of the receptacles were observed to have an open neutral connection in the Unit A bathroom.

- One or more of the receptacle cover plates are damaged in several locations throughout the house.

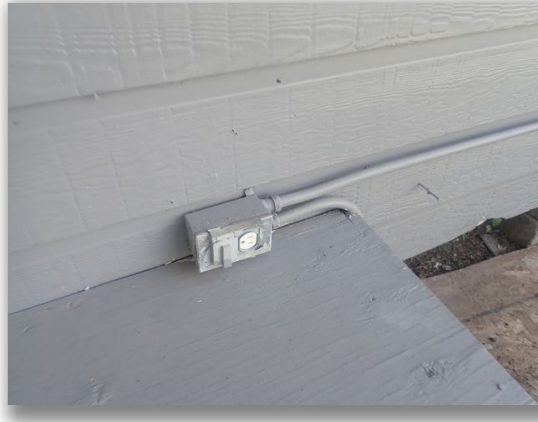
**Arc-Fault Circuit Interrupter Protection (AFCI)**

- None of the required dwelling unit devices, receptacle and lighting outlets (switches, receptacles and fixtures) are connected to an arc-fault circuit-interrupter (AFCI) circuit device. AFCI devices were first required under the 1999 National Electrical Code and under the 2014 NEC, all living space, kitchen and laundry room devices, receptacle and lighting outlets (switches, receptacles and fixtures) should be connected to an arc-fault circuit interrupter (AFCI) device.

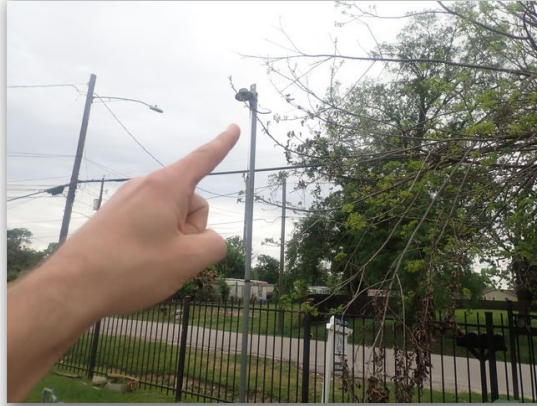
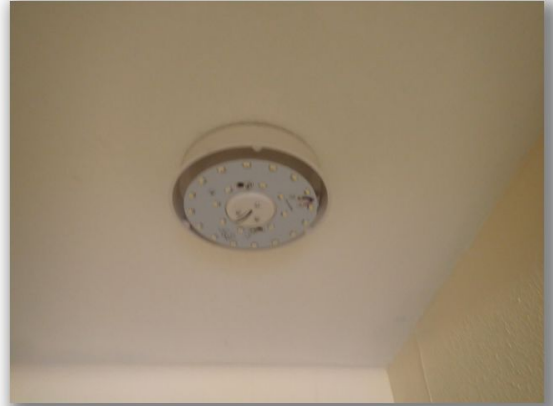
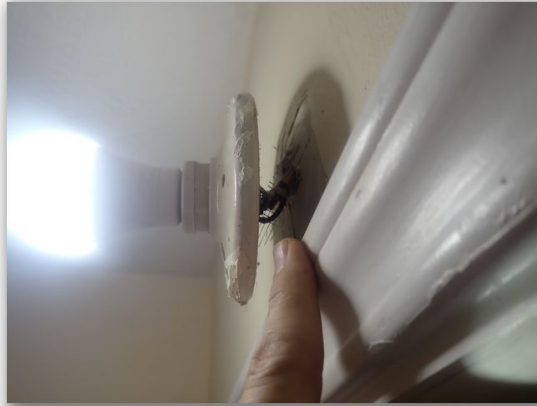
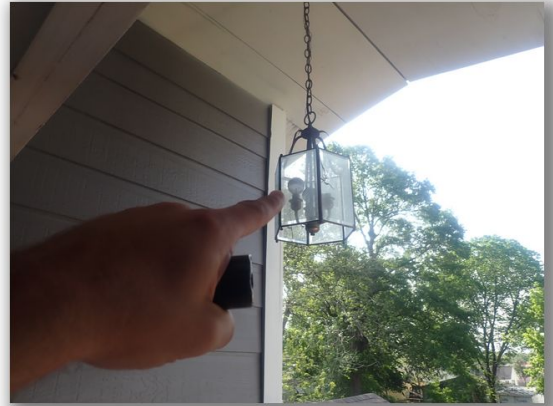
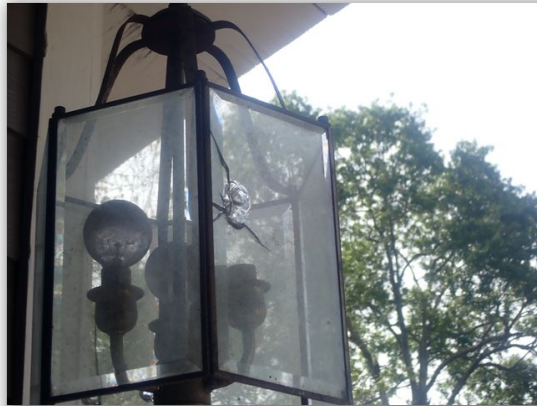
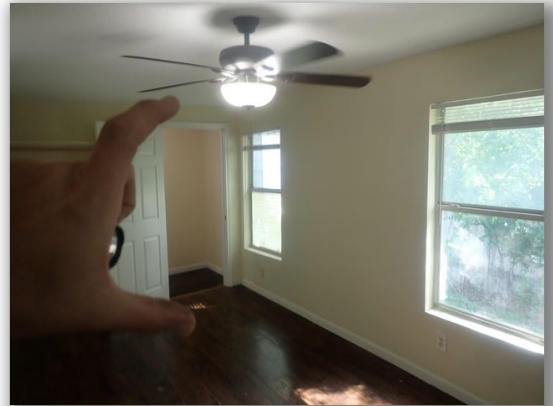
- One or more of the light fixture globes and/or covers are missing in the unit A rear corner bedroom, unit B pantry.
- One or more of the light fixtures are loose at the mount in the unit b pantry.
- One or more of the light fixtures are inoperative in the front yard, unit B front porch, unit A front porch. This may be due to a bad bulb or some other unknown condition. This condition should be further evaluated and corrected as necessary.
- The exterior light fixture was damaged to the unit B front porch.

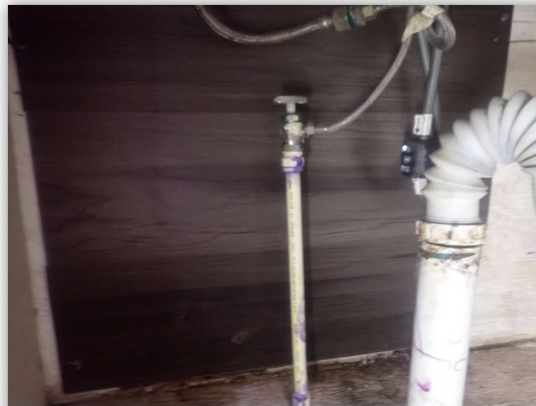
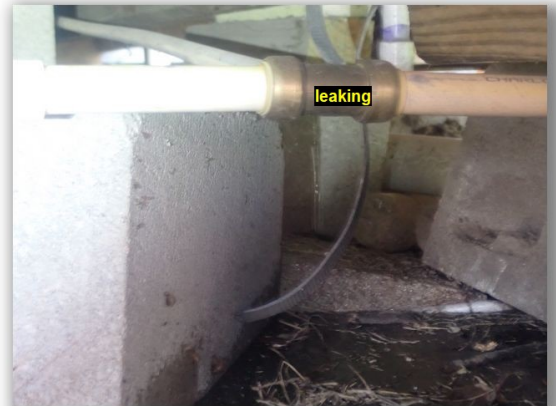
- A major leak was observed in the crawl space. The location of the leak could not be observed due to the clutter in the crawl space. Pooling water was observed in and around the crawl space. There was little to no water pressure at the plumbing fixtures on the property. Repairs are needed.
- Multiple supply pipes were observed to be leaking in the crawl space area.
- One or more supply pipes were not properly supported in the crawl space. Remediation is recommended.
- One or more supply pipes in the crawl space were installed between piers and beams/joists. Remediation is needed.
- All exposed water supply lines in the crawl space area should be properly insulated to prevent freeze damage.
- All exposed water supply lines on the exterior of the structure should be properly insulated to prevent freeze damage.

**Note:** Previous repairs to the water supply system components were observed. The inspector is unable to identify/verify the extent of the repairs. The homeowner should be consulted on the previous water supply system repairs performed and possible warranty information that may apply.
