**Andrew Martinez**  
**726 McDaniel Street**  
**Houston, TX 77022**

**April 2, 2024**

# PROPERTY INSPECTION REPORT FORM

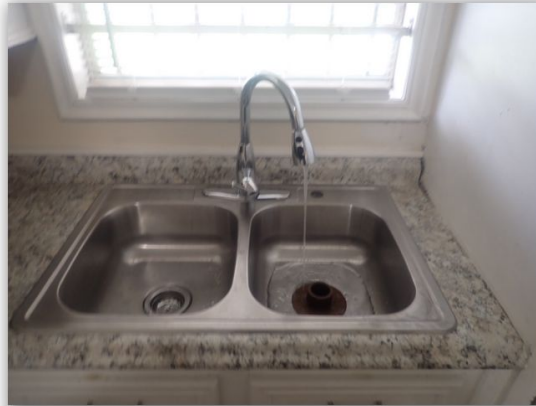
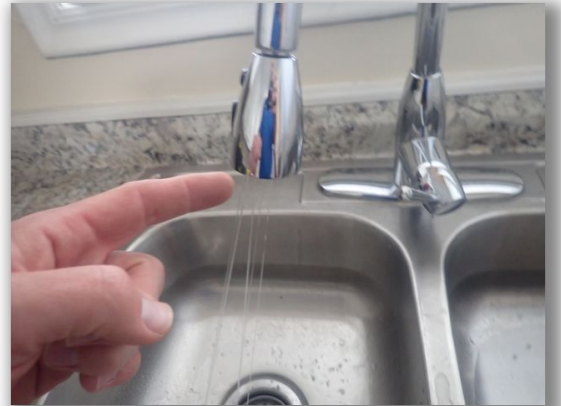
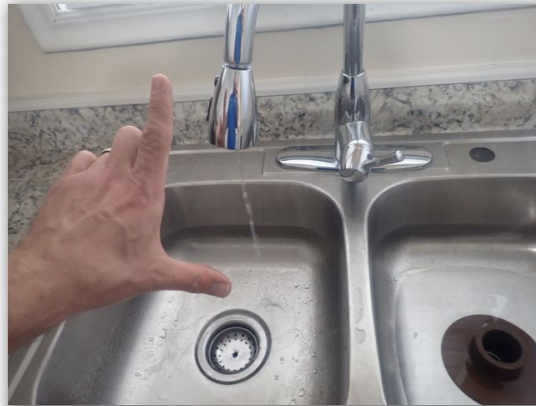
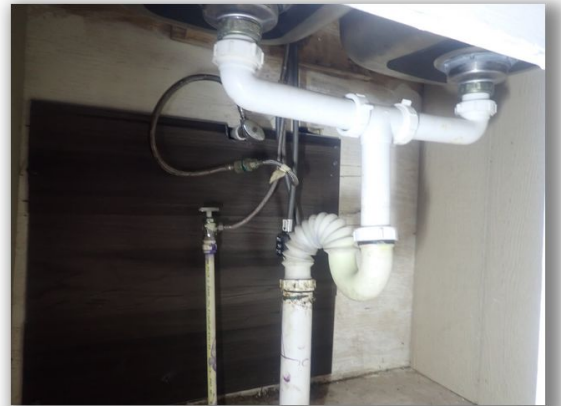
**Unit A Kitchen Sink**

- The faucet has little to no water pressure. The cause and remedy should be further evaluated. Repairs are needed.
- The sprayer head is not working properly.
- There is a S-trap (drain trap) in place under the sink. This type of drain trap does not meet current plumbing standards.
- The shelf in the cabinet under the sink is damaged.
- The drain line is made of corrugated material. It is recommended to use smooth wall/PVC type material to prevent blockage/poor drainage.

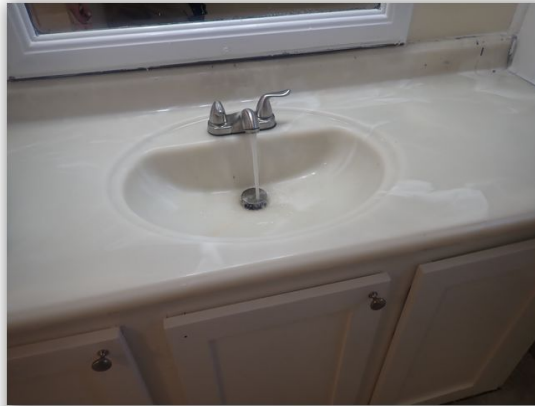
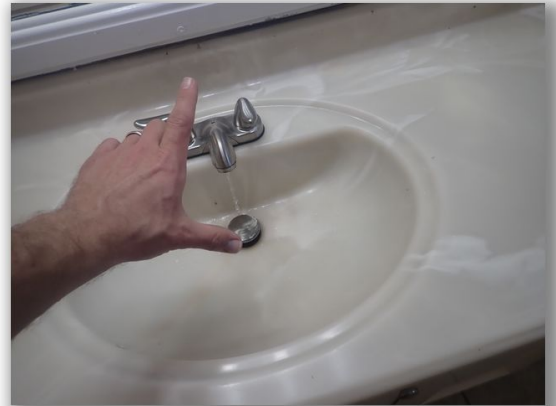
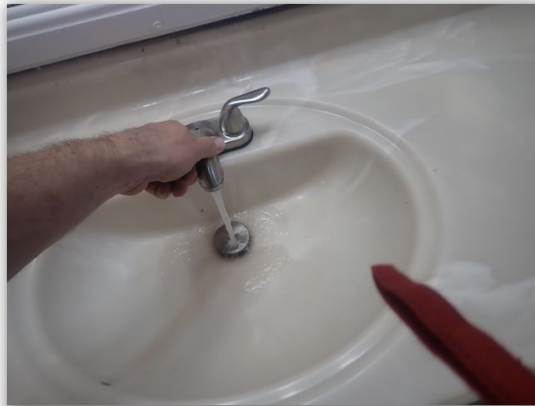
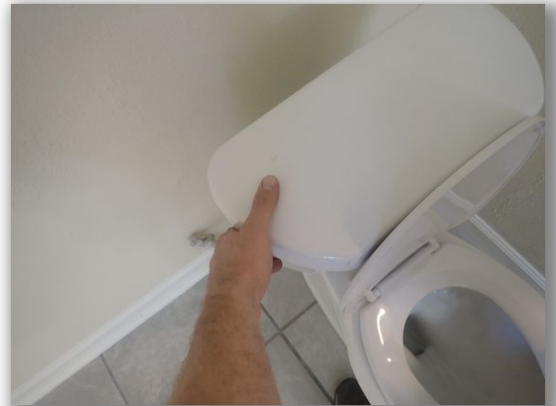
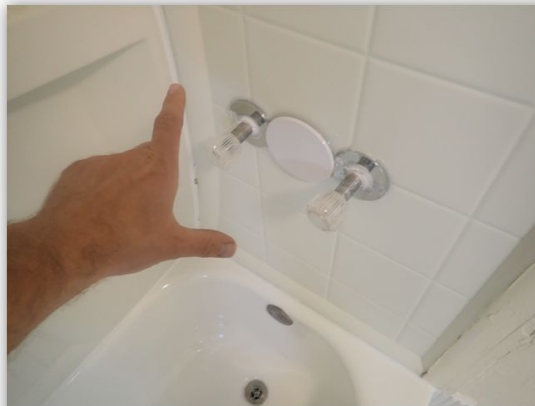
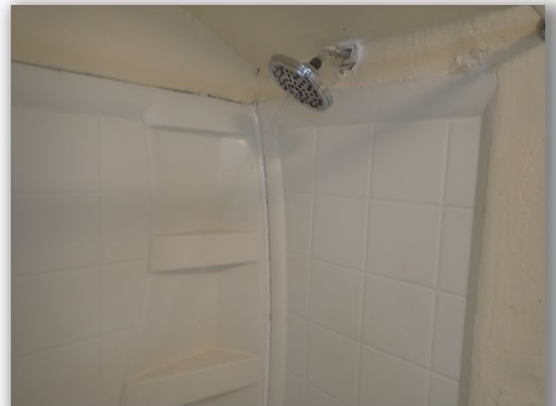
**Unit A Bathroom**

- The faucet has little to no water pressure. The cause and remedy should be further evaluated. Repairs are needed.
- The faucet hot/cold water orientation is reversed.
- The drain leaks water into the cabinet.

- Cracked, deteriorated and/or missing grout and/or caulking should be repaired or replaced as necessary.
- The faucet has little to no water pressure. The cause and remedy should be further evaluated. Repairs are needed.

- The commode tank is loose at the bowl connection.

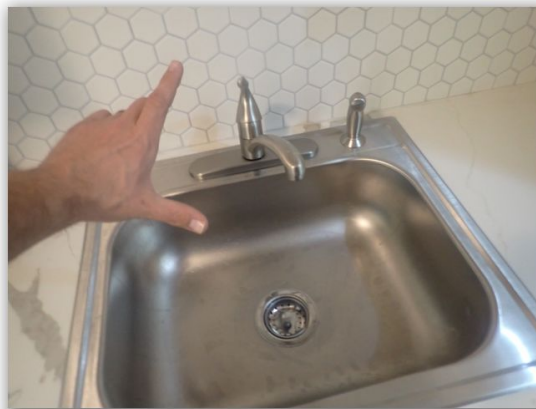
**Unit B Kitchen Sink**

- The faucet has little to no water pressure. The cause and remedy should be further evaluated. Repairs are needed.

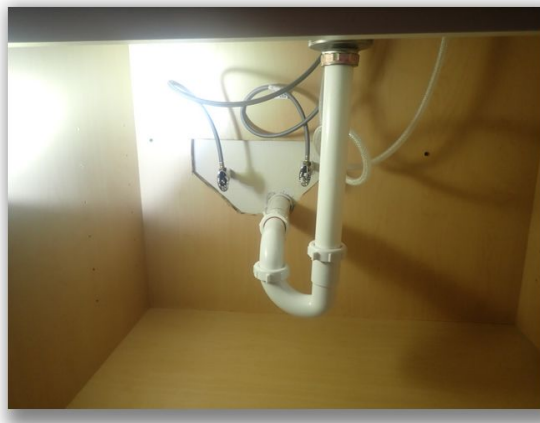
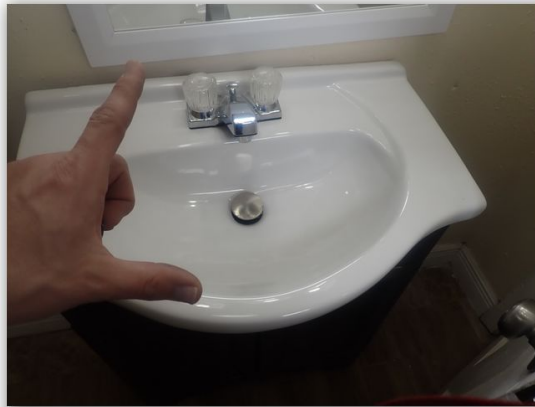
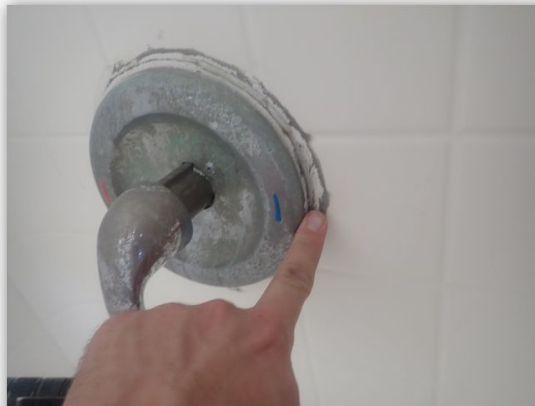
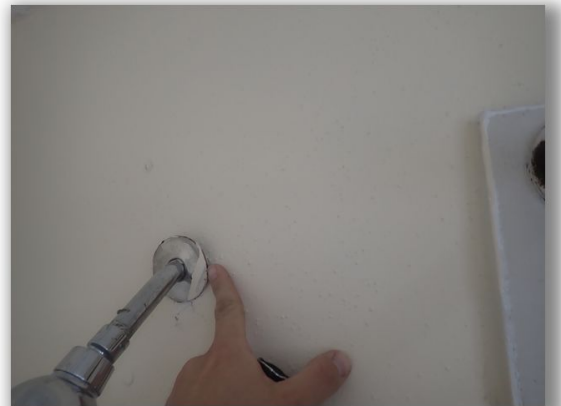
**Unit B Bathroom**

- The faucet has little to no water pressure. The cause and remedy should be further evaluated. Repairs are needed.

- The faucet has little to no water pressure. The cause and remedy should be further evaluated. Repairs are needed.
- Cracked, deteriorated and/or missing grout and/or caulking should be repaired or replaced as necessary.
- The tub spout is not properly sealed at the wall. This condition has the potential to allow water to leak back into the wall cavity.
- The faucet assembly is not properly sealed at the wall. This condition has the potential to allow water to leak back into the wall cavity.
- The bathtub/shower surface was damaged. Repairs are recommended.

- The commode is inoperative. The cause and remedy should be further evaluated and corrected as necessary.
- The commode tank is loose at the bowl connection.

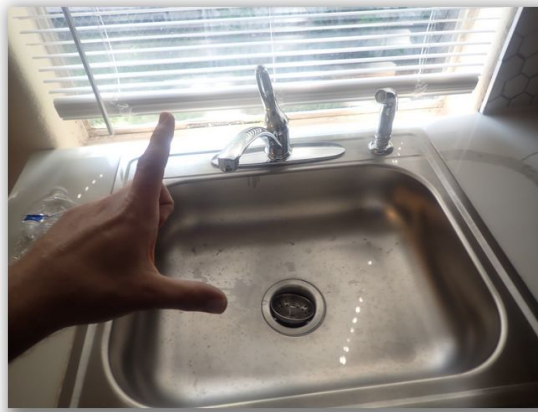
**Unit C Kitchen Sink**

- The faucet has little to no water pressure. The cause and remedy should be further evaluated. Repairs are needed.

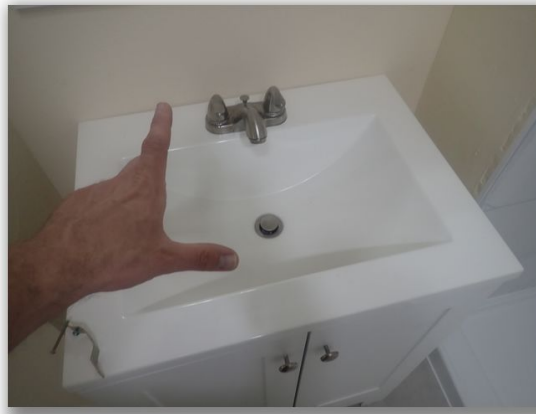
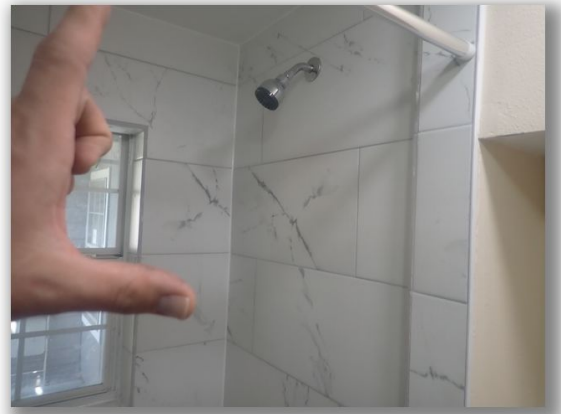
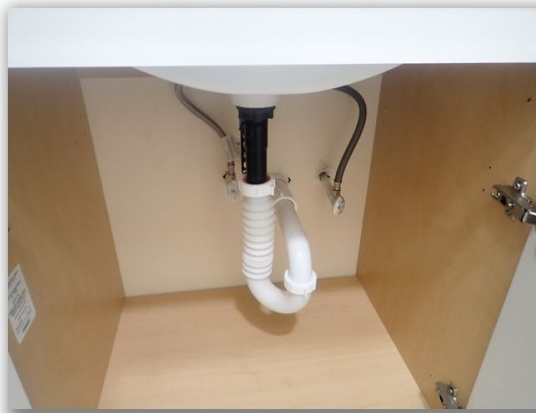
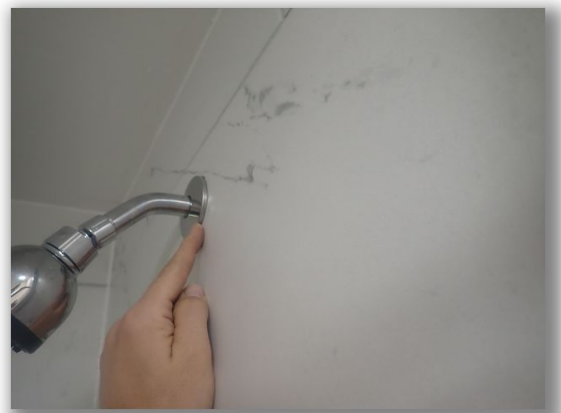
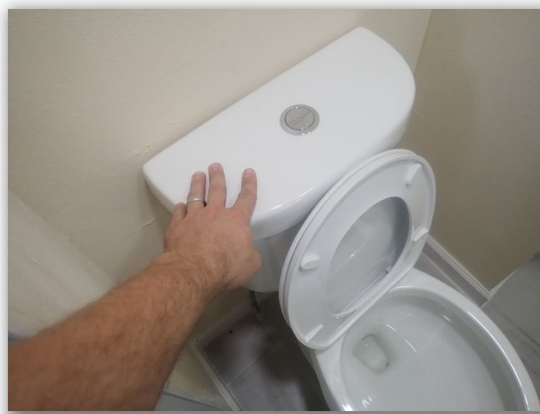
**Unit C Bathroom.**

- The faucet has little to no water pressure. The cause and remedy should be further evaluated. Repairs are needed.
- The drain line is made of corrugated material. It is recommended to use smooth wall/PVC type material to prevent blockage/poor drainage.

- The faucet has little to no water pressure. The cause and remedy should be further evaluated. Repairs are needed.
- The faucet assembly is not properly sealed at the wall. This condition has the potential to allow water to leak back into the wall cavity.

- The commode is inoperative. The cause and remedy should be further evaluated and corrected as necessary.
- The commode tank is loose at the bowl connection.

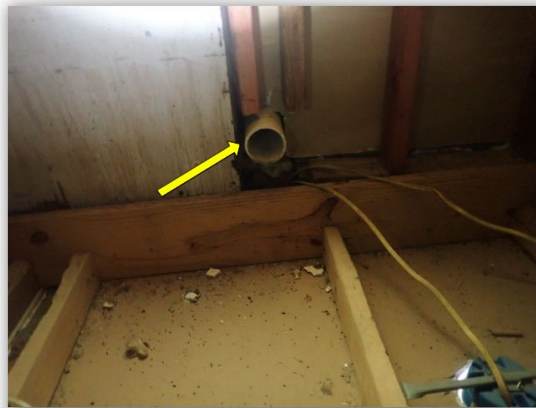
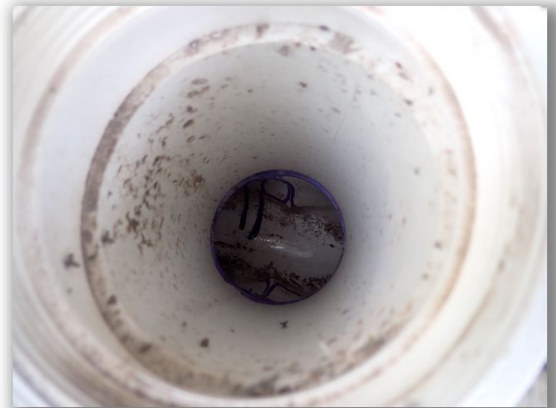
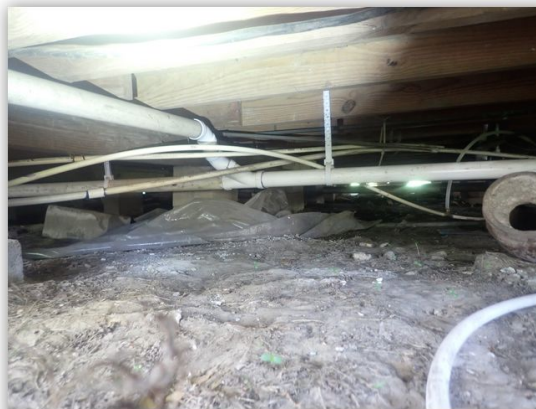
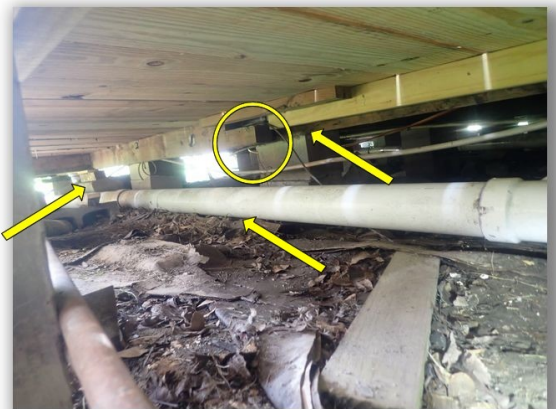
- One or more of the vent stacks was observed to be terminating into the attic space in unit C. All vent stacks should terminate to the exterior of the structure and not into the attic space.
- One of the drain pipes in the crawl space is separated. Further evaluation and repairs are needed.
- The waste pipes in the crawl space should be better supported.

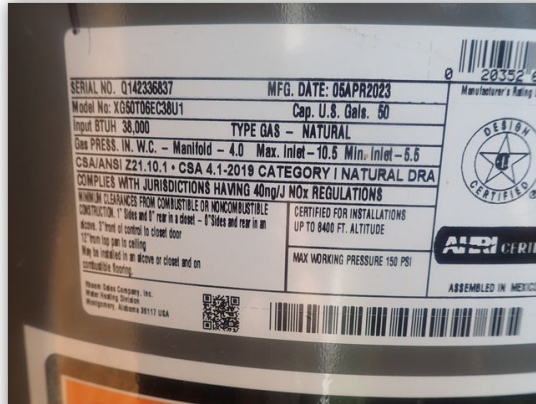
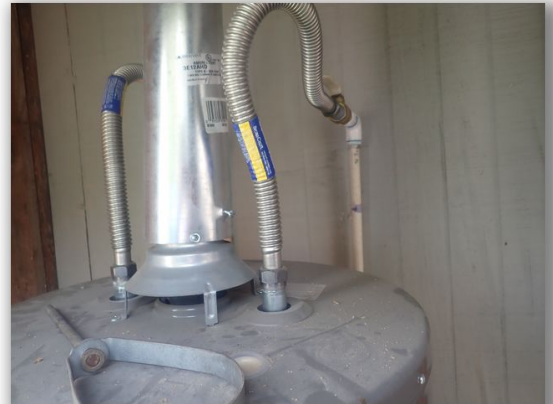
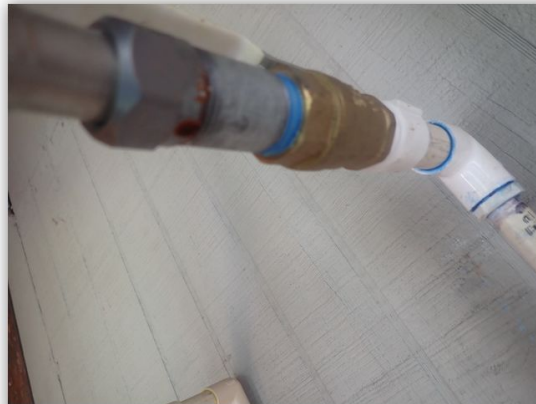
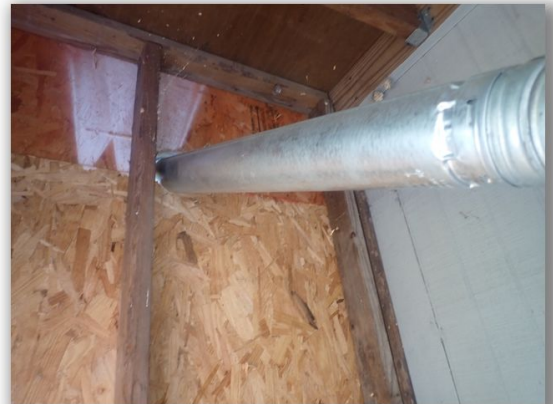
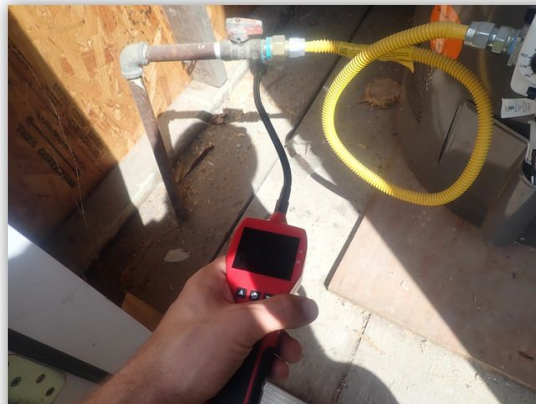
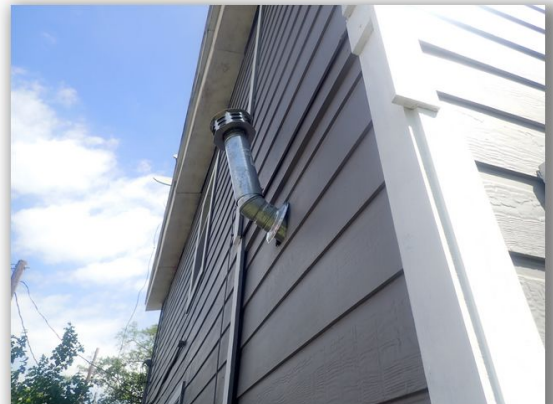
- The fittings at the top of the water heater are made of dissimilar metals (galvanized steel connected to copper and/or brass). It is recommended to replace the galvanized steel fittings with brass or copper fittings or install a dielectric union between the two dissimilar metals to prevent electrolysis from occurring.

- Some corrosion was observed at the water supply connections at the top of the water heater.
- The water heater compartment has inadequate combustion air ventilation. There should be a minimum of 100 square inches of combustion air ventilation provided within 12-inches of the top and bottom of the closet.

- The water heater gas supply line is not equipped with a sediment trap just before the gas appliance connector. This condition does not meet current installation requirements and should be corrected.

- The water heater flue (vent pipe) has inadequate clearance from combustible materials. Double walled vent pipes should have at least 1-inch of clearance and single walled vent pipes should have at least 6-inches of clearance from combustible material.

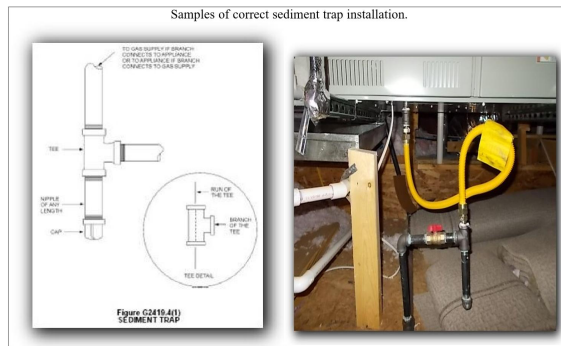
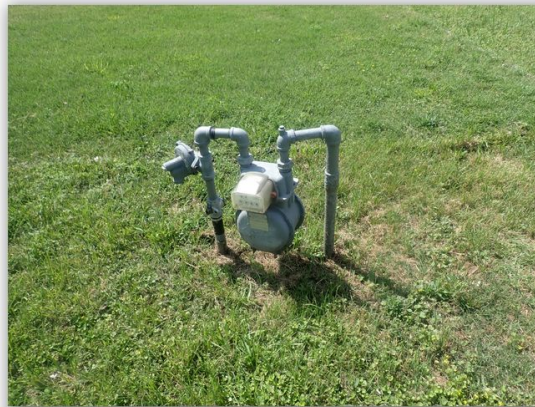
- The Water Heater gas supply line is not equipped with a sediment trap just before the gas appliance connector. This condition does not meet current installation requirements and should be corrected.

- I was unable to locate the electrical bond connection for the gas piping back to the grounding electrode system. All bond connections should be accessible for inspection, repair or replacement. This condition should be further investigated and corrected if necessary.

- Corrugated Stainless Steel Tubing (CSST) was observed to be in use at the time of this inspection. This product is known to have various installation and grounding / bonding problems or deficiencies. Full evaluation of this product is beyond the scope of this inspection. You are strongly encouraged to have a licensed plumber evaluate the installation and a licensed electrician investigate for proper bonding and grounding of this component of the gas distribution system. **Such follow-up should take place prior to the expiration of any time limitations such as option or warranty periods.** Evaluations by qualified tradesmen may lead to the discovery of additional deficiencies which may involve additional repair costs.

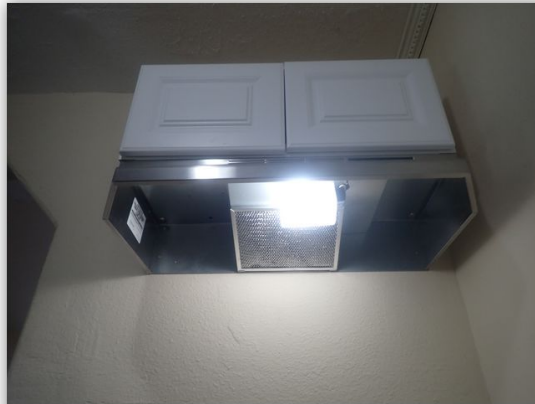
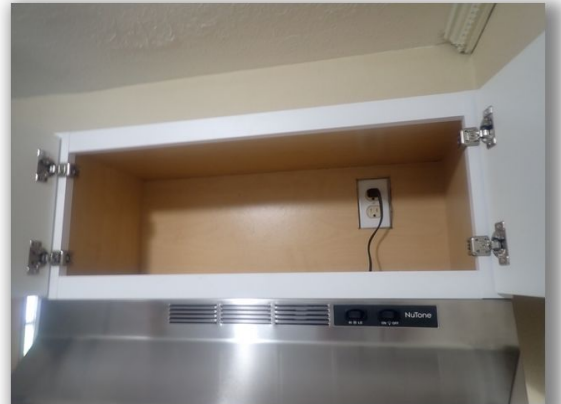
##### Unit B

- The vent hood is blowing air through the top of the unit and not the front vents.

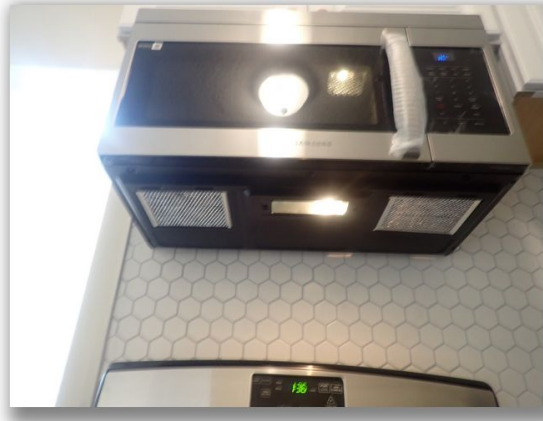
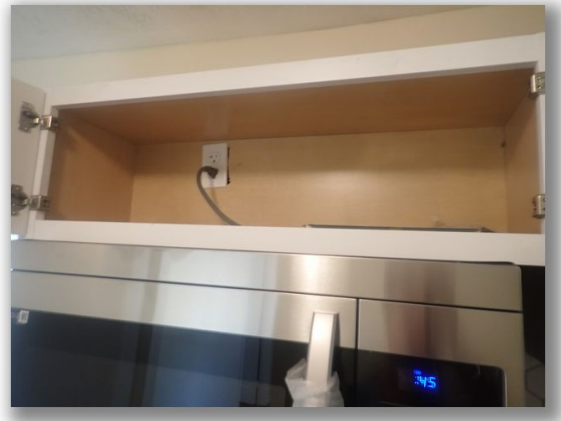
**Unit C**

- The vent hood is blowing air through the top of the unit and not the front vents.

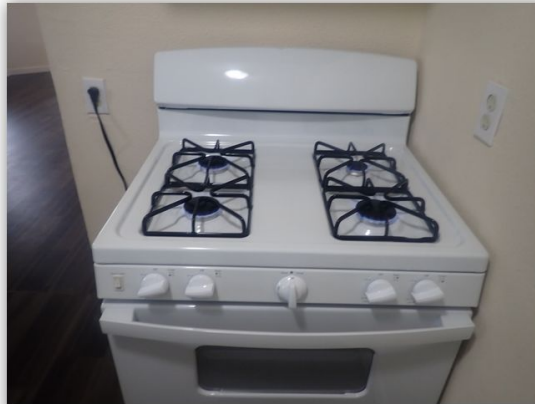
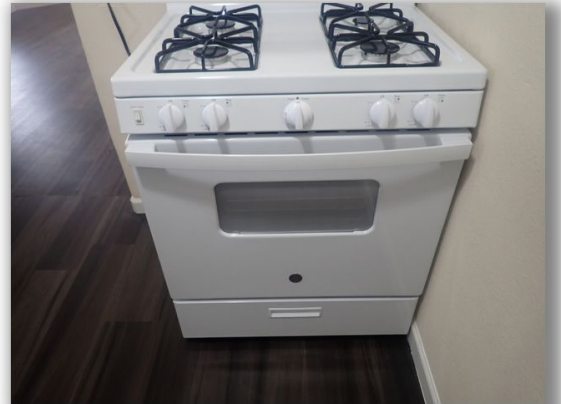
- The gas shutoff valve is in a poor location and is hard to reach.

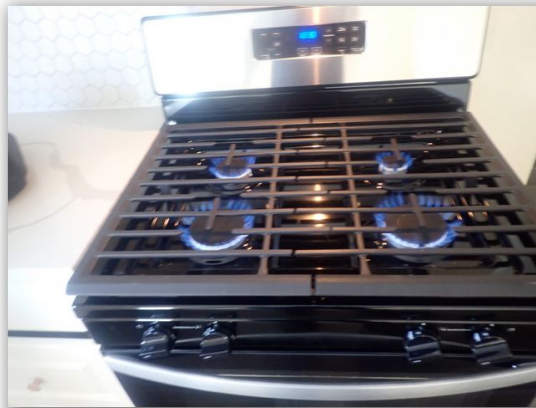
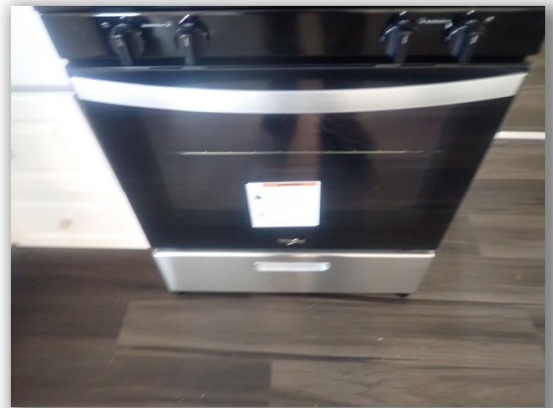
**Unit C Range**

- The gas shutoff valve is in a poor location and is hard to reach.

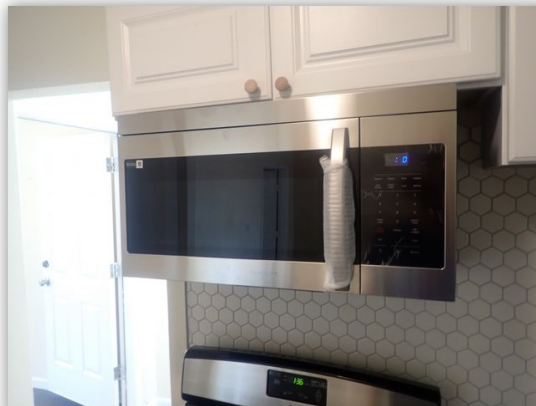
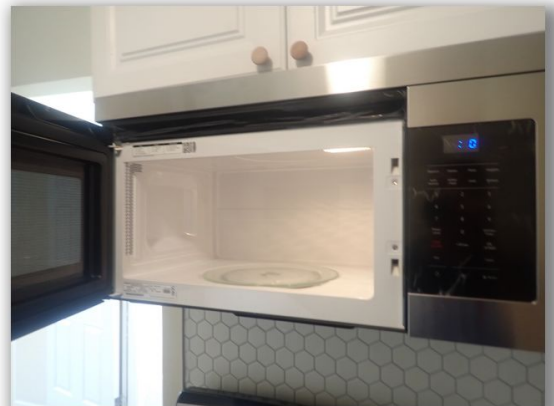
**Unit C Microwave**

- Damage was observed to the exterior of the microwave.

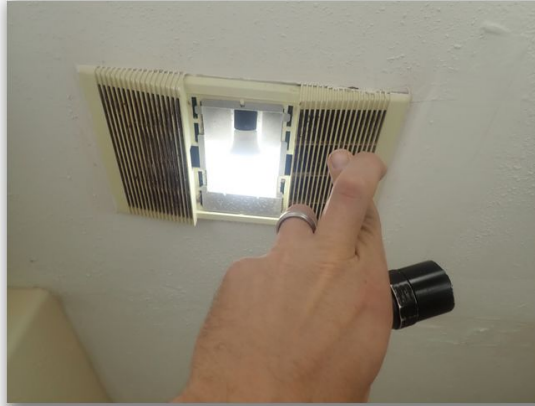
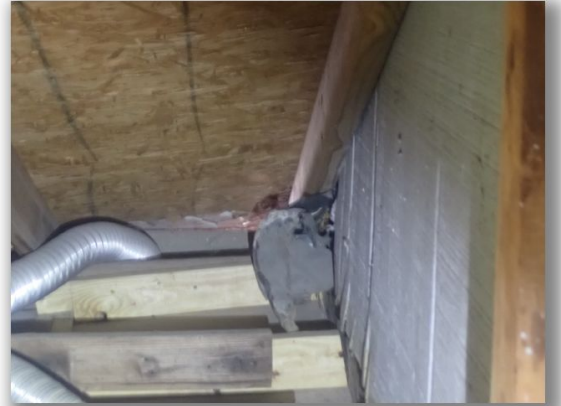
- One or more of the bathroom/laundry room areas are not equipped with a mechanical exhaust vent. This is an "as-built" condition that does not meet current manufacturers or mechanical installation standards.
- The mechanical exhaust vent fan was dirty in the unit B bathroom.
- The mechanical exhaust vent fan is inoperative in the unit B bathroom.
- One or more of the mechanical exhaust vent systems was observed to be terminating to the soffit / eave area. This is an "as-built" condition that does not meet current manufacturers or mechanical installation standards.

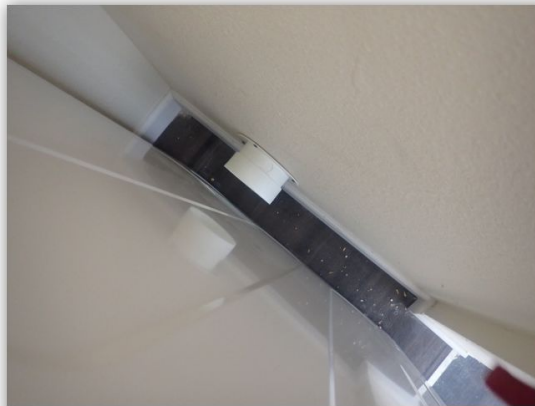
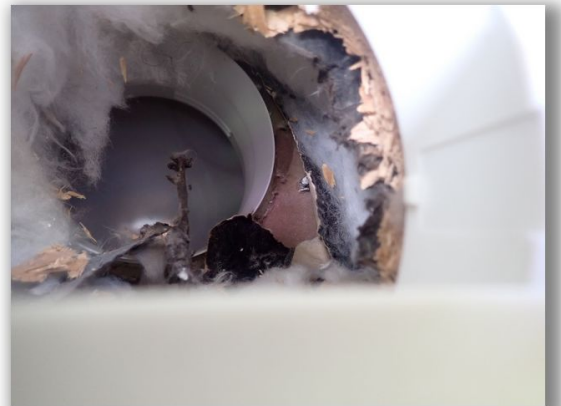
- The dryer exhaust termination cap / cover is not listed for use with dryer exhaust systems.
- The vent pipe does not reach the exterior termination vent.

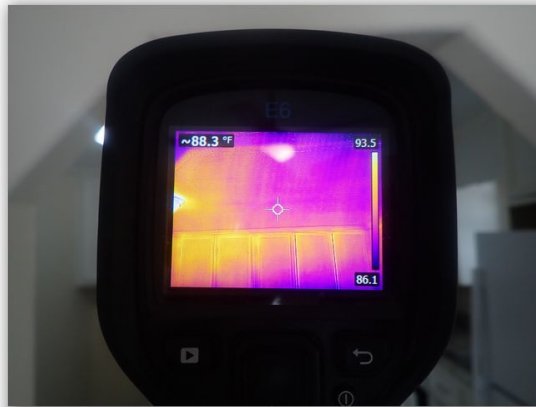
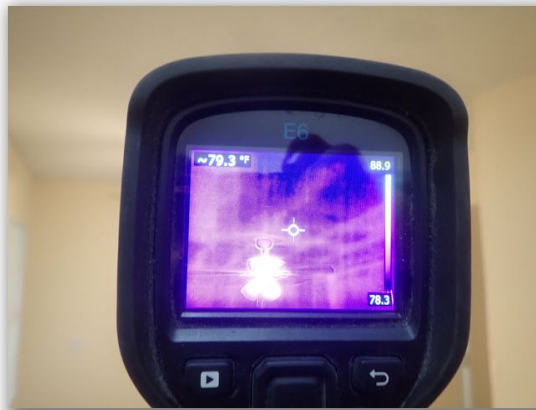
- Elevated moisture was observed in the Unit B rear corner bedroom, unit C kitchen.. The cause should be further evaluated and corrected as necessary. **Additional Note:** Due to the elevated moisture, other adverse conditions such as mold-like substance growth, wood rot/deterioration and wood destroying insects are possible.
- Missing insulation was observed at the ceiling in unit C

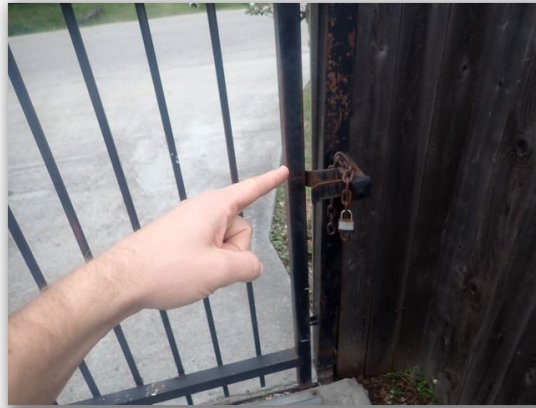
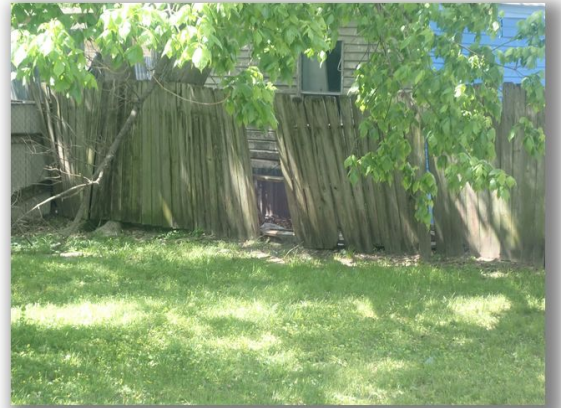
- The metal driveway fence does not latch properly.
- The overall condition of the fence material, railing and posts are in poor condition and repair or replacement is recommended.
- One or more of the fence boards are pulling loose.
- One or more of the fence boards are damaged / deteriorated and repairs are recommended.
- One or more of the posts are damaged and the fence panels are leaning.

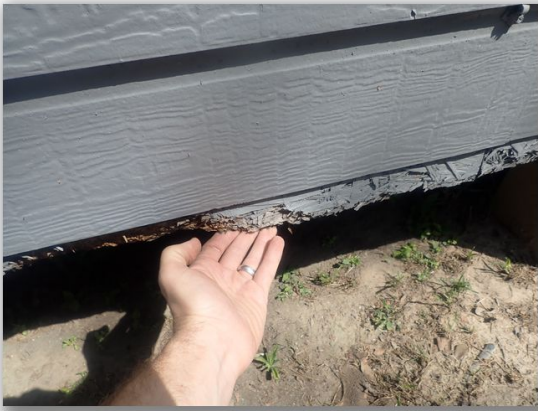
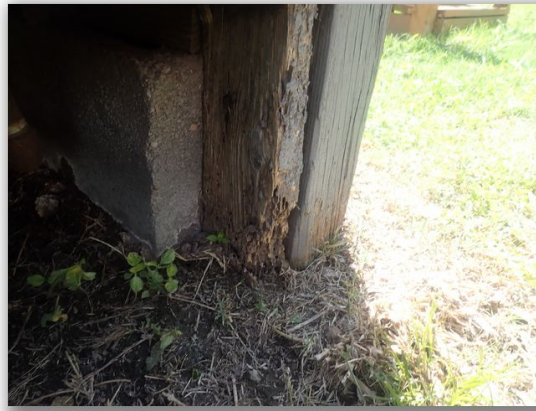
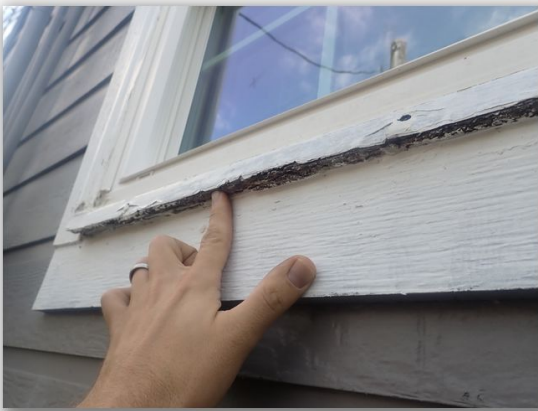
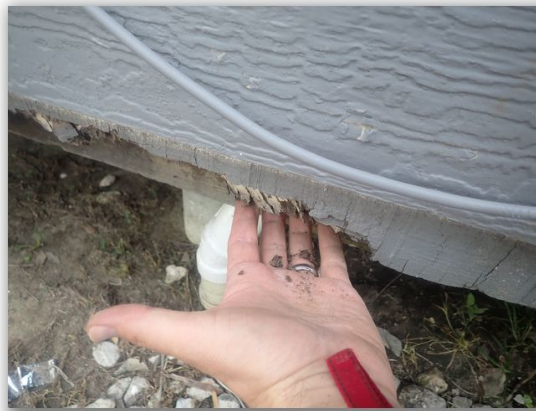
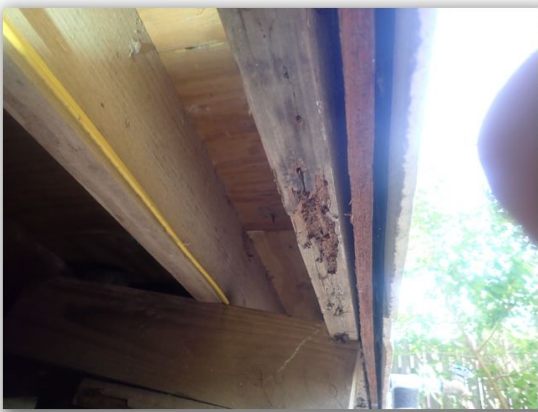
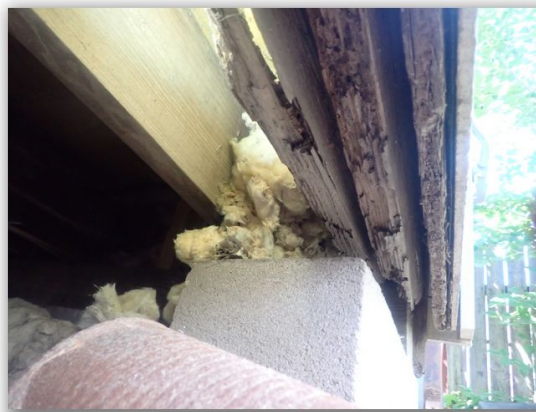
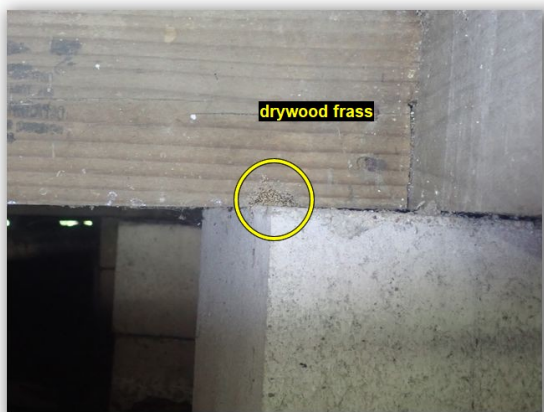
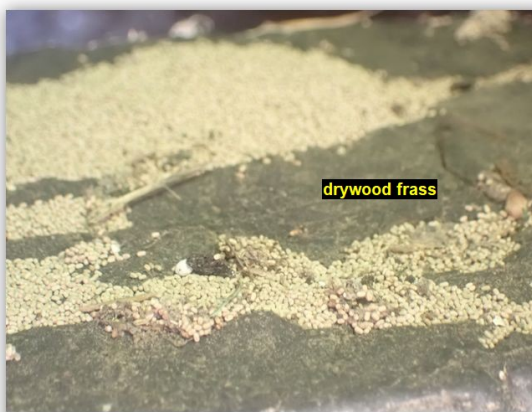
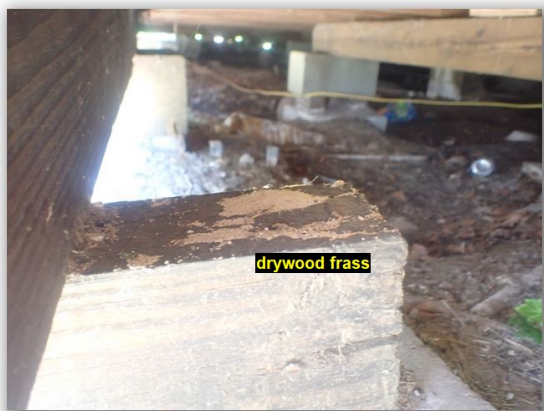
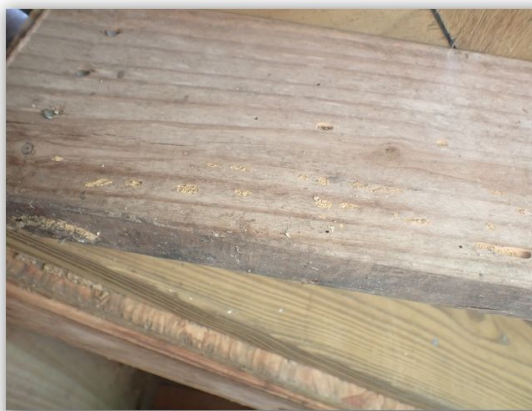
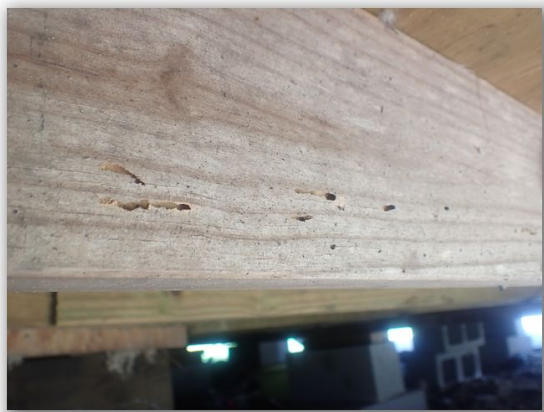
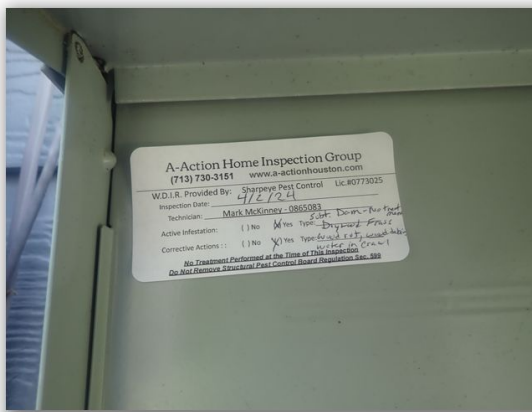
Additional Comments An ACTIVE Infestation of termites was discovered at the time of this inspection. See diagram for location(s). Treatment Recommended., There is visible evidence of a previous WDI infestation at the time of this

inspection without signs of previous treatment or records of previous treatment. Treatment is recommended at this time. See diagram for location(s).

The digital pictures within this report are a representative sample of active/previous wood destroying insects, locations of active/previous infestations, inaccessible areas, conducive conditions, deficiencies or damages in place and should not be considered to show all. There will be active/previous wood destroying insects, locations of active/previous infestations, inaccessible areas, conducive conditions, deficiencies or damages not represented with digital imaging.
